**Cultural heritage impact assessment for
THE PROPOSED SWAZILAND RAIL LINK, WESTERN SECTION,
MPUMALANGA REGION**

Report No: 2013/JvS/063
Status: Final
Revision No: 0
Date: September 2013

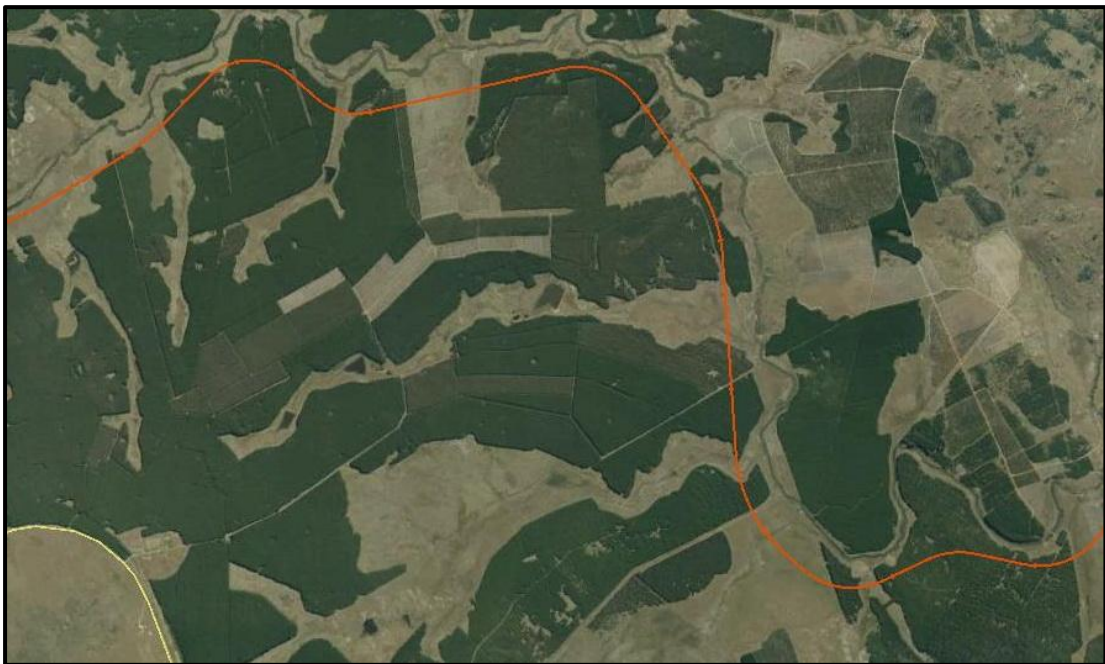
Fig. 1. The proposed railway line going through plantations.
(Photo: Google Earth)

- In the east the large-scale development of plantations might have had a devastating effect on heritage resources in an era prior to their legislative protection. The dense tree cover also makes the detection of possible sites very difficult (e.g. Fig. 1).

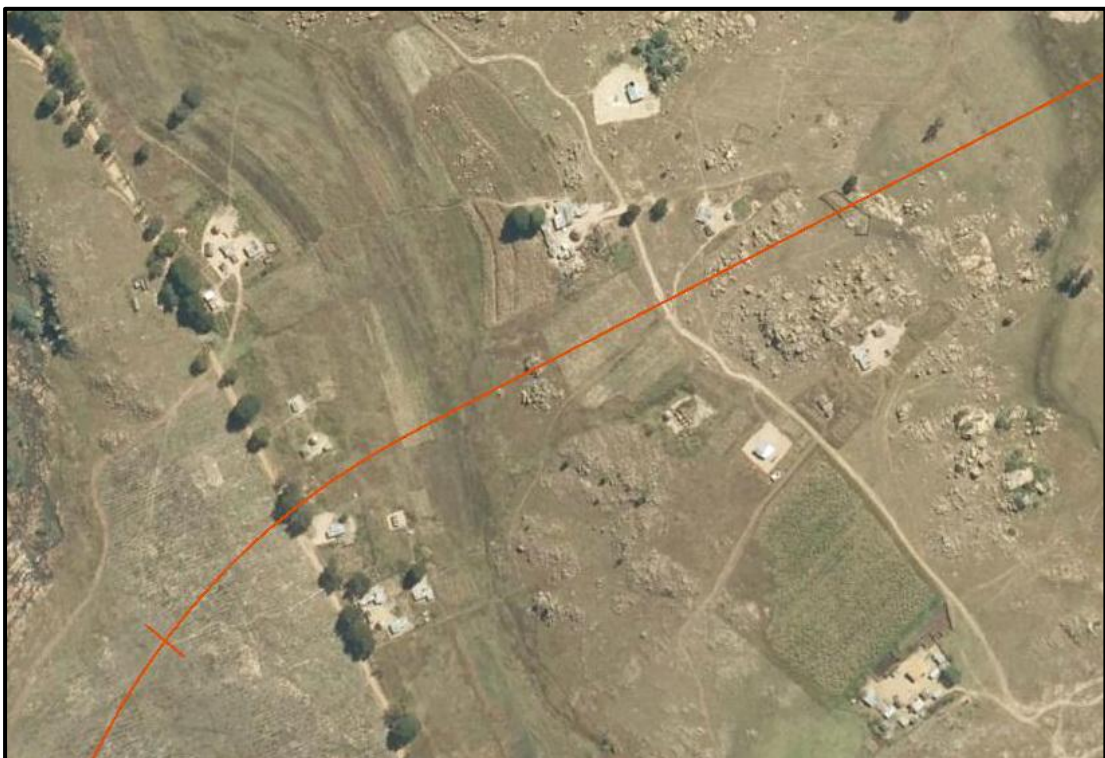
Fig. 2. Example of how the railway line would pass through settled areas.
(Photo: Google Earth)

- In other areas the proposed line cut through rural communities (e.g. Fig. 2). As no information on public participation with regard to the development of the railway line is available, it was difficult to access these areas as the concern is that questions in this regard might lead to the development of unnecessary stress, and therefore resistance, in these communities.

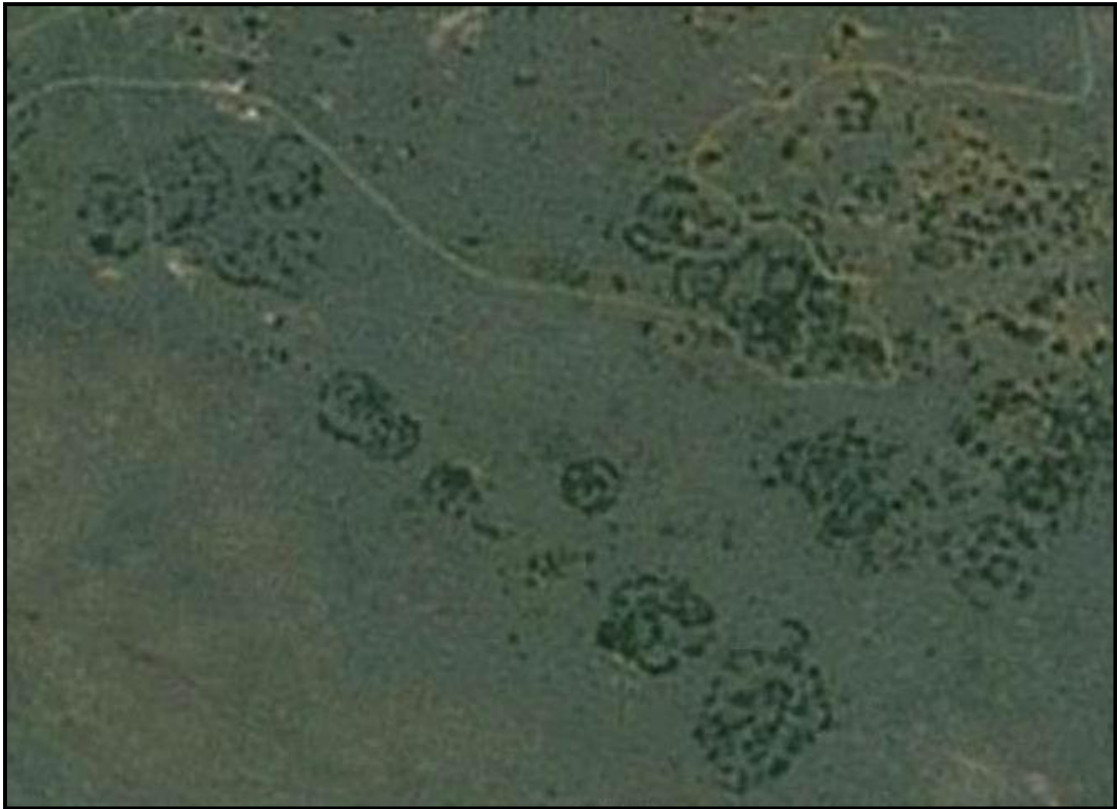
Fig. 6. Late Iron Age stone walled sites identified by means of aerial photographs.
(Photo: Google Earth).

A number of stone-walled archaeological sites, which are dated to the Late Iron Age (c. AD 1640 - AD 1830s), were identified west of the study area, and some of them have been excavated (Taylor 1979, Pelsner et al 2007) (Fig. 6). These sites are conventionally associated with Tswana-speaking people.

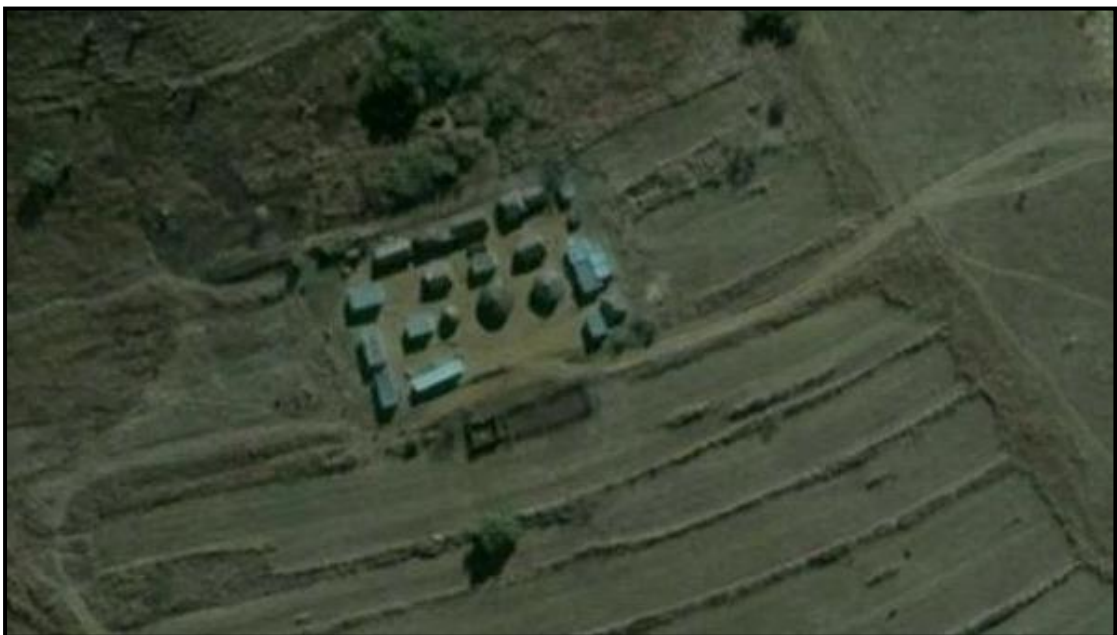
Fig. 7. "Traditional" Swazi homestead in the former Swazi homeland of KaNgwane.
(Photo: Google Earth)

Whereas it is impossible to correlate any living group of people to Early Iron Age communities, it is possible, by using ethnographic evidence, to identify some of the groups of people that entered the region in pre-colonial times (i.e. the Later Iron Age) and are currently settled in the larger region. The Tswana-speakers were located to the south and west in the study area, with the Ndzundza Ndebele (Nguni-speakers) to the north. The eastern section of the study area was occupied by Swazi-speakers (Fig. 7), also of Nguni origin.

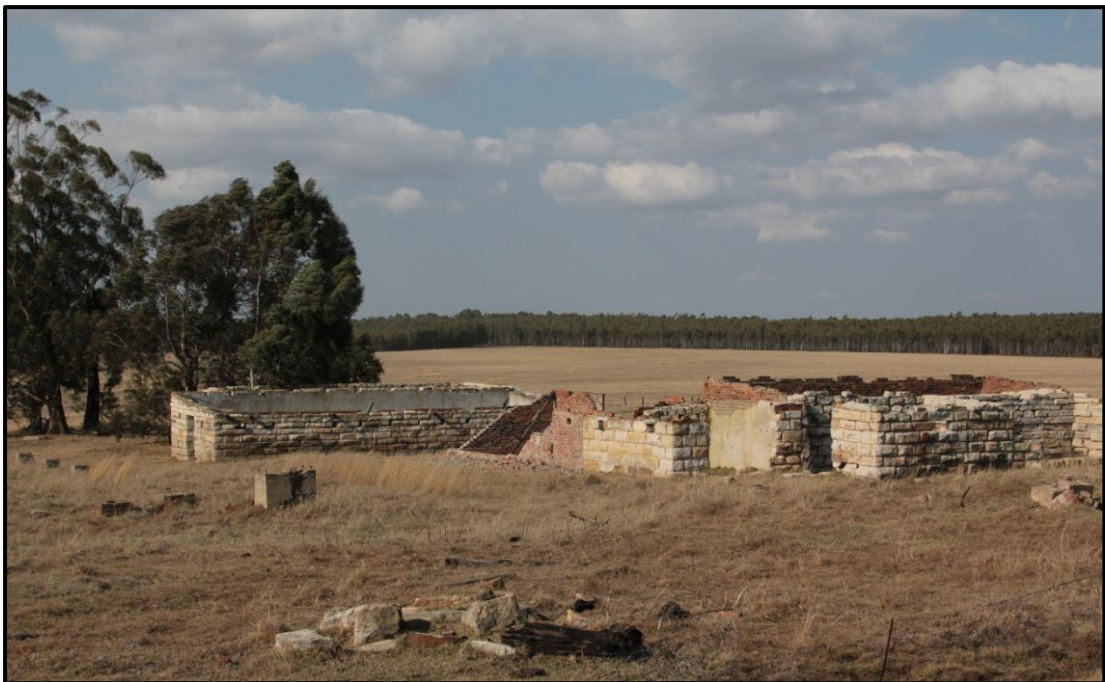
Fig. 8. Outbuildings at an abandoned farmstead adjacent to the railway line.

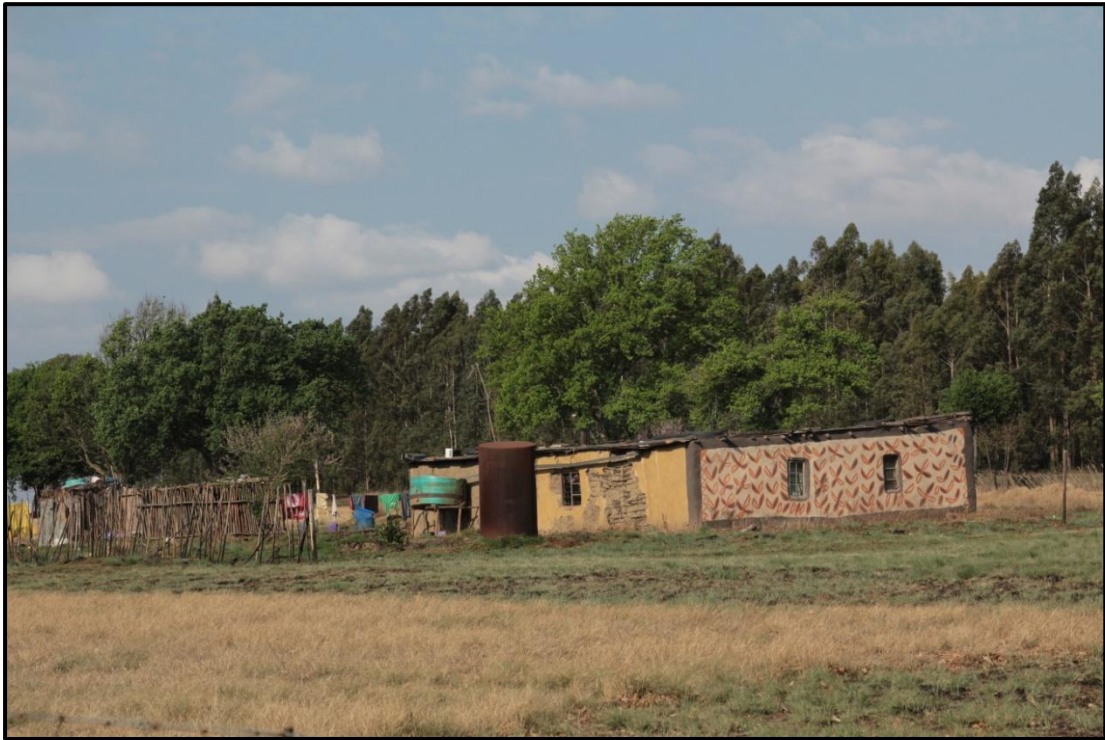
Fig. 9. Typical farm labourer homestead adjacent to the railway line.

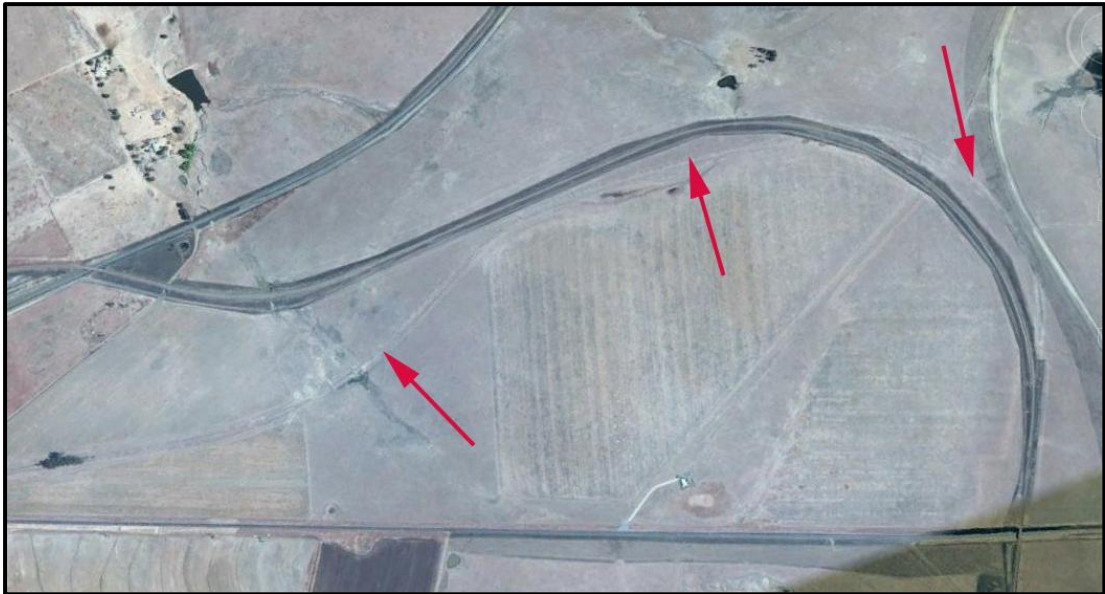
Undoubtedly sections of these early lines have been upgraded over time. This is for example noticeable in the change of alignments (e.g. Fig. 12) as well as in the heightening and strengthening of some of the smaller culverts. In addition dates ranging between 1936 to 1973 were noticed on some of the rails that were laid in the track.

Fig. 12. A previous alignment of the railway line in the Davel region.
(Photo: Google Earth)

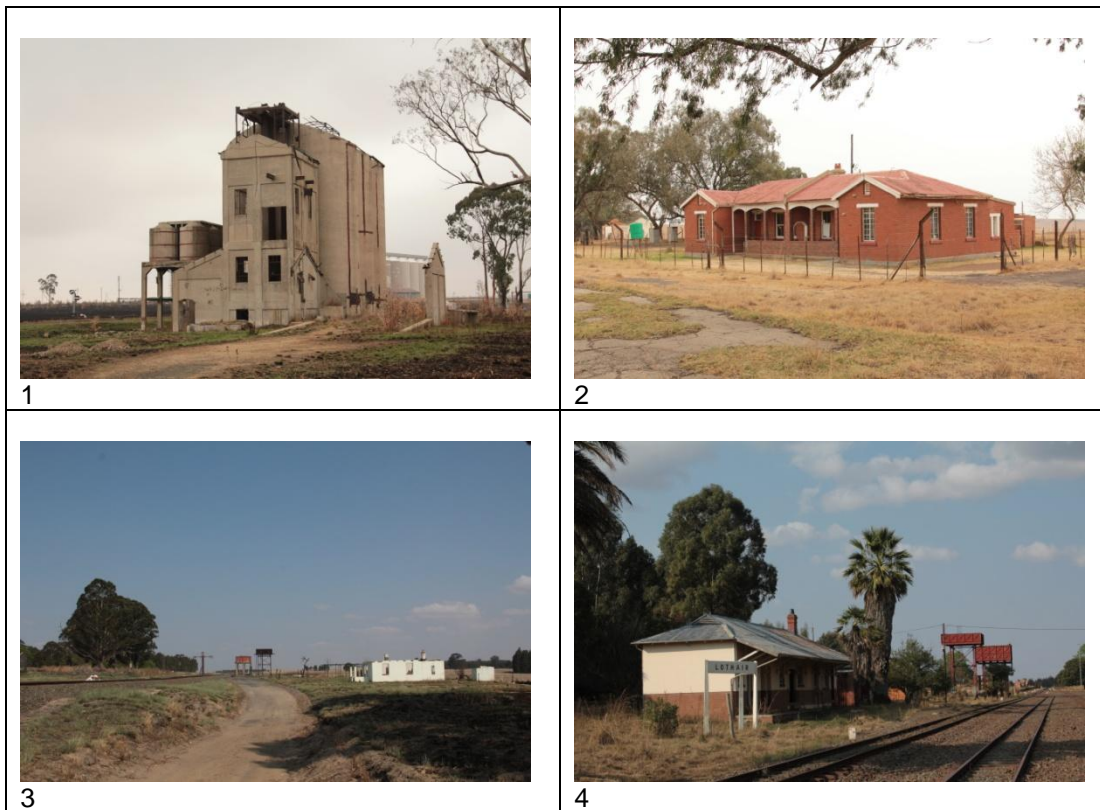
No. 1: Old silos adjacent to the railway line and station. This type of silo was developed during the 1940s. It is an all concrete structure. Although it has been abandoned when a larger, more modern facility was constructed some distance away, it is still in a sound condition.

No.4: The station building at Lothair. It is still in use and as a result is in a good condition

No. 3: The buildings that made up this station have been demolished and vandalised. The water tanks and water point is still in a good condition. As these features are inside the railway lines, the probability that it would be impacted on is very high. If that is to be the case, it should be documented (architectural drawings, descriptions and full photographic documentation) unless such information can be access from Transnet Heritage Foundation. After acceptance of this documentation by SARHA, application for a permit for its destruction can be applied for.

Fig. 14. Various identified stations.

No. 1: Although this building has been abandoned for some time, it is still in a good state of repair. It is unclear if it would be impacted on by the proposed. If that is to be the case, it should be documented (architectural drawings, descriptions and full photographic documentation) unless such information can be access from Transnet Heritage Foundation. After acceptance of this documentation by SARHA, application for a permit for its destruction can be applied for.

No. 2: This building is still in a good state of repair. It is unclear if it would be impacted on by the proposed. If that is to be the case, it should be documented (architectural drawings, descriptions and full photographic documentation) unless such information can be access from Transnet Heritage Foundation. After acceptance of this documentation by SARHA, application for a permit for its destruction can be applied for.

No. 4: This building is still in a good state of repair. It is unclear if it would be impacted on by the proposed. If that is to be the case, it should be documented (architectural drawings, descriptions and full photographic documentation) unless such information can be access from Transnet Heritage Foundation. After acceptance of this documentation by SARHA, application for a permit for its destruction can be applied for.

- If there is no impact on the station building, no further action would be required.

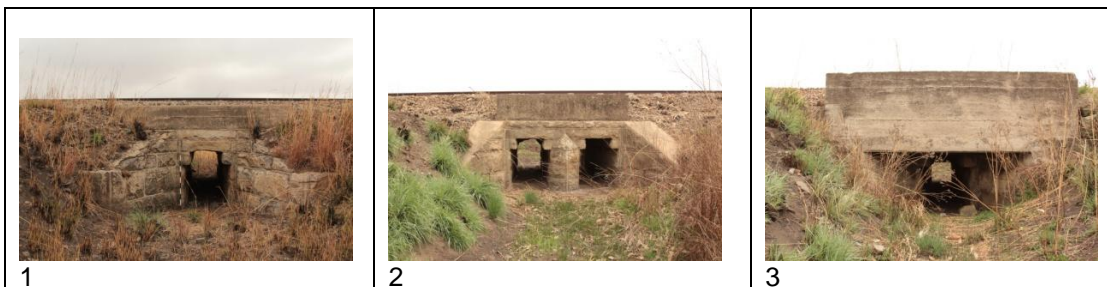
Location	Davel - Breyten Section
Description	<p>Approximately 20 culverts were identified on this section of the line. Some of these have already been upgraded, being strengthened with concrete. Three different versions were identified:</p> <ul style="list-style-type: none"> • A large single span sandstone culvert, that, due to earlier realignment of the line, is now located some distance off the existing line; • Small single span culverts of dressed sandstone; • Small two span culverts of dressed sandstone.
Significance	Medium on a regional level – Grade III
Mitigation	<p>As these features are inside the railway lines, the probability that it would be impacted on is very high. If that is to be the case, at least one of each of the two types should be documented (architectural drawings, descriptions and full photographic documentation) unless such information can be accessed from Transnet Heritage Foundation. After acceptance of this documentation by SARHA, application for a permit for its destruction can be applied for.</p> <ul style="list-style-type: none"> • If there is no impact on the culverts, no further action would be required.

Fig. 16. Types of culverts on this section of the line.

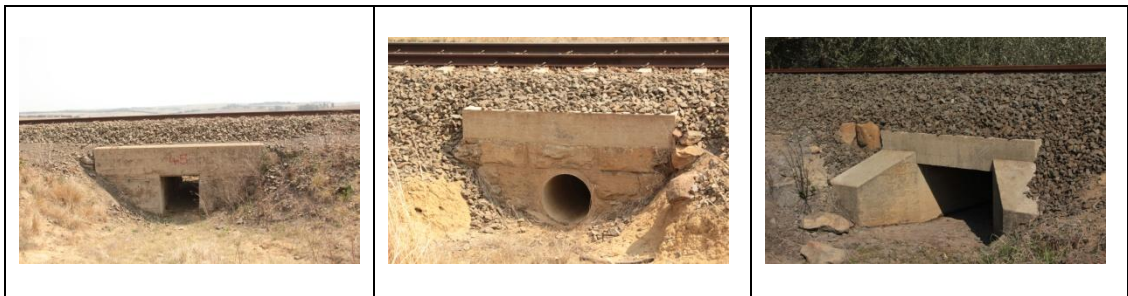
Location	Breyten - Ermelo Section
Description	
<p>Approximately 5 culverts were identified on this section of the line. Some of these have already been upgraded, being strengthened or having been rebuilt. Two different versions were identified:</p> <ul style="list-style-type: none"> • Small single span culverts of dressed sandstone. • Small single span culverts of dressed sandstone, into which have been inserted a pre-cast concrete pipe 	
Significance	Medium on a regional level – Grade III
Mitigation	
<p>As these features are inside the railway lines, the probability that it would be impacted on is very high. If that is to be the case, at least one of each of the two types should be documented (architectural drawings, descriptions and full photographic documentation) unless such information can be accessed from Transnet Heritage Foundation. After acceptance of this documentation by SARHA, application for a permit for its destruction can be applied for.</p> <ul style="list-style-type: none"> • If there is no impact on the culverts, no further action would be required.

Fig. 18. Types of culverts on this section of the line.

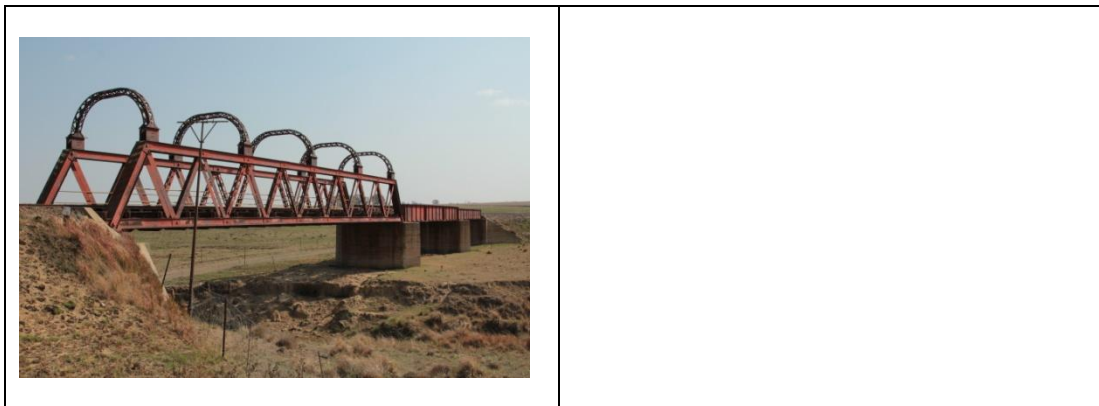
Significance	High on a regional level – Grade III
---------------------	--------------------------------------

Fig. 20. The bridge across the Vaal River

Mitigation	In all probability this feature is older than 60 years, although it might have been upgraded in the past. As this feature is inside the railway lines, the probability that it would be impacted on is very high. If that is to be the case, it should be documented (architectural drawings, descriptions and full photographic documentation) unless such information can be access from Transnet Heritage Foundation. After acceptance of this documentation by SARHA, application for a permit for its destruction can be applied for.
	<ul style="list-style-type: none"> If there is no impact on the culverts, no further action would be required.

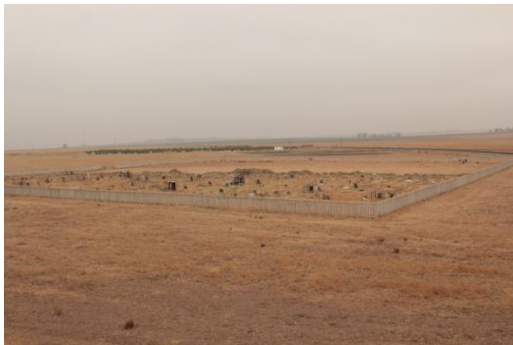
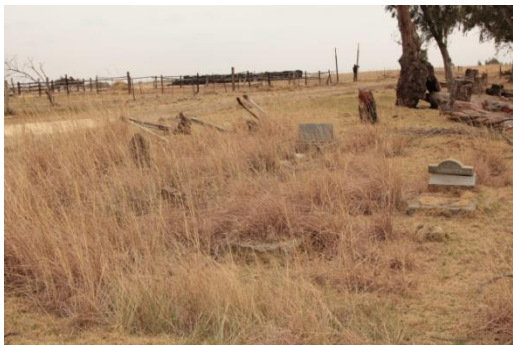
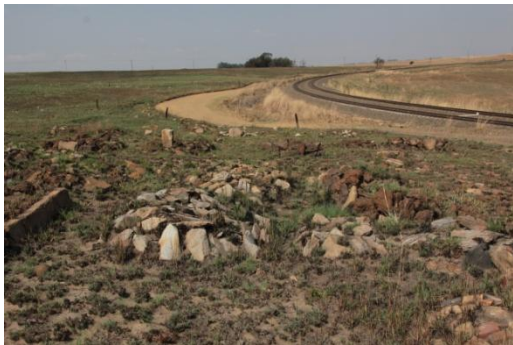
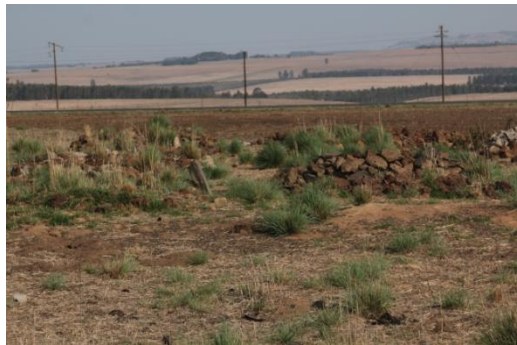
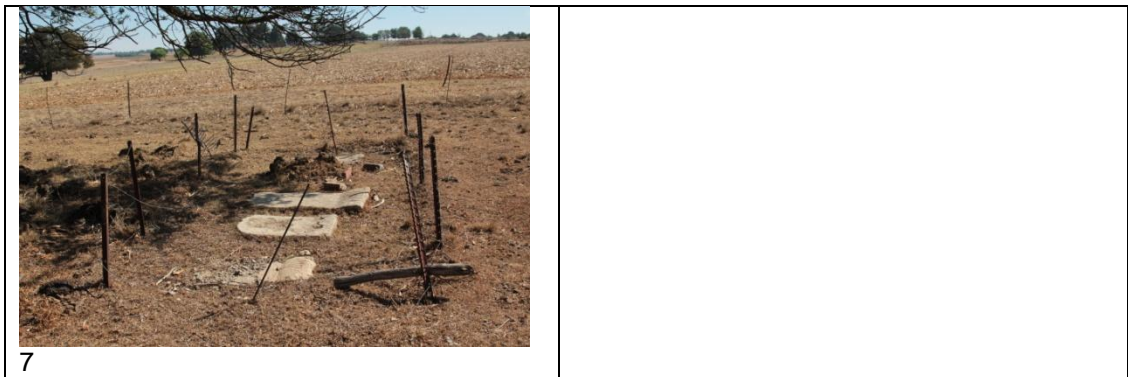
Description
 One formal cemetery (No. 1 above) has been identified. In addition six informal burial places (No. 2 – 7) have been identified. The latter six are all located inside or directly adjacent to the railway servitude. They range in size from a single grave to as many as fifty. Headstone on some of the graves indicates that they are older than 60 years. In most cases the graves are only marked with stone cairns, making it difficult to determine their age. However, it was also noted that some of the graves have recently been cleaned, indicating that they are still visited by family, which might be an indication that they are not

Fig. 22. The identified burial places.

all that old.	
Significance	High on a local level – Grade III
Mitigation	
<ul style="list-style-type: none"> • The official cemetery is well fenced and would not be impacted on by the proposed development. • The six informal burial places have a high risk of impact. It is recommended that they are left in place and fenced off during the upgrade/construction of the railway line. If that is impossible, they will have to be relocated after proper procedures have been followed – see Appendix 3.
