**PHASE I HERITAGE IMPACT ASSESSMENT FOR THE
FOUR STREETS PALACE, PARLIAMENT, BANK AND
MUTUAL FOR THE EXTENSION OF THE PROPOSED
BEAUTIFICATION OF CHURCH SQUARE AND ITS
ASSOCIATED STREETS
PRETORIA TSHWANE GAUTENG**

November 2013

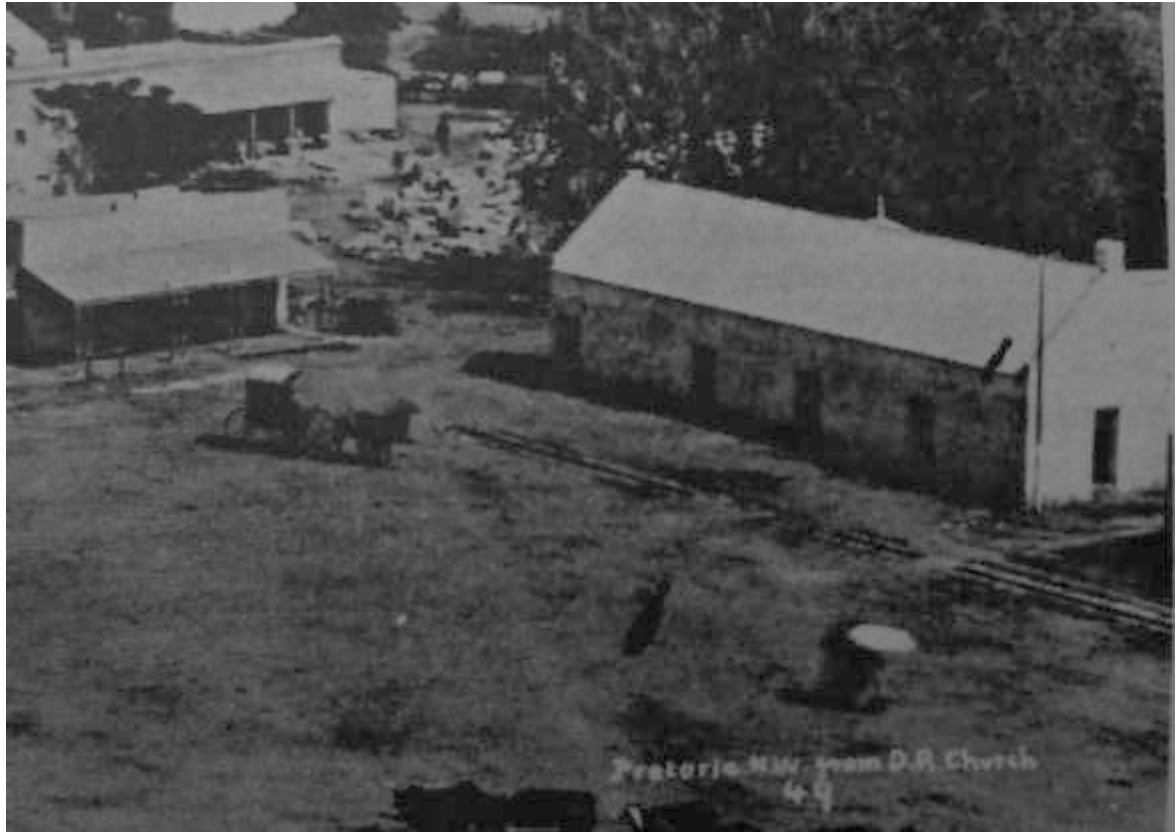
Fig. 11 North-western corner of Church Square circa 1890. Note water furrows now paved with slate, but sidewalks are still dirt. (National Cultural History Museum)

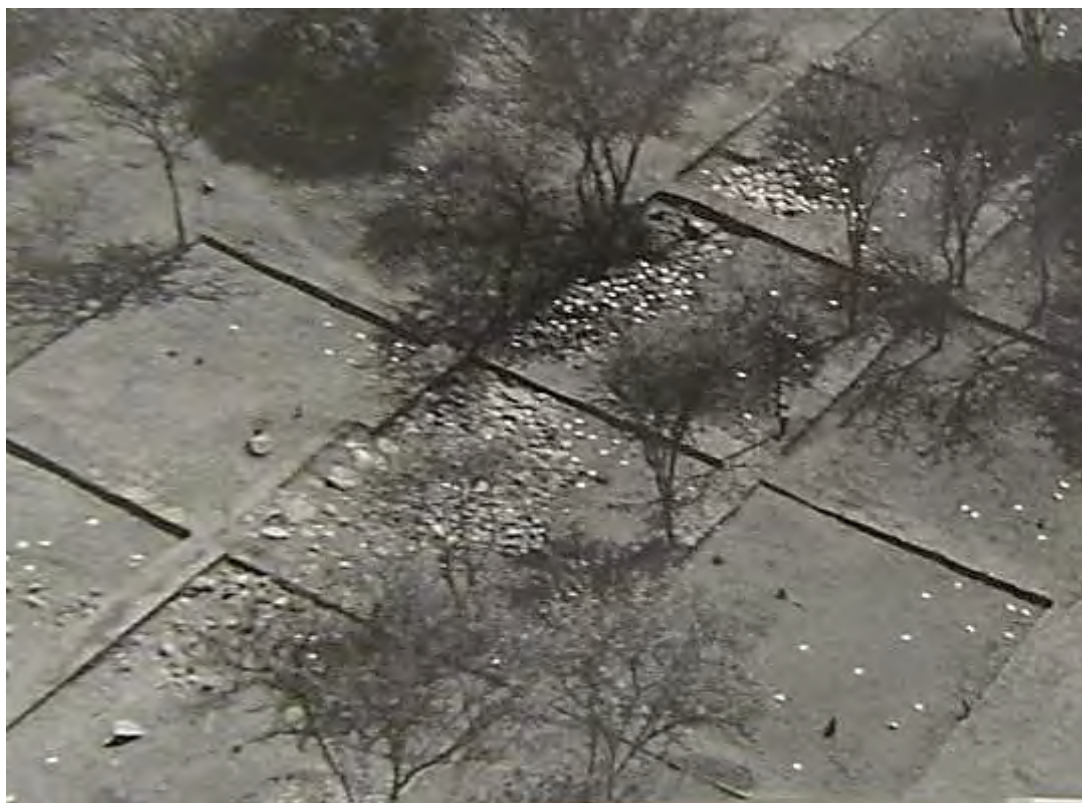
Fig. 13 Excavations of a water furrow in Schoemansdal. The town existed only for 19 years between 1848 and 1867. Over 300 items were retrieved from these four blocks. It is expected that water furrows around Church Square will similarly yield cultural materials. (Photograph SM Miller 1988)

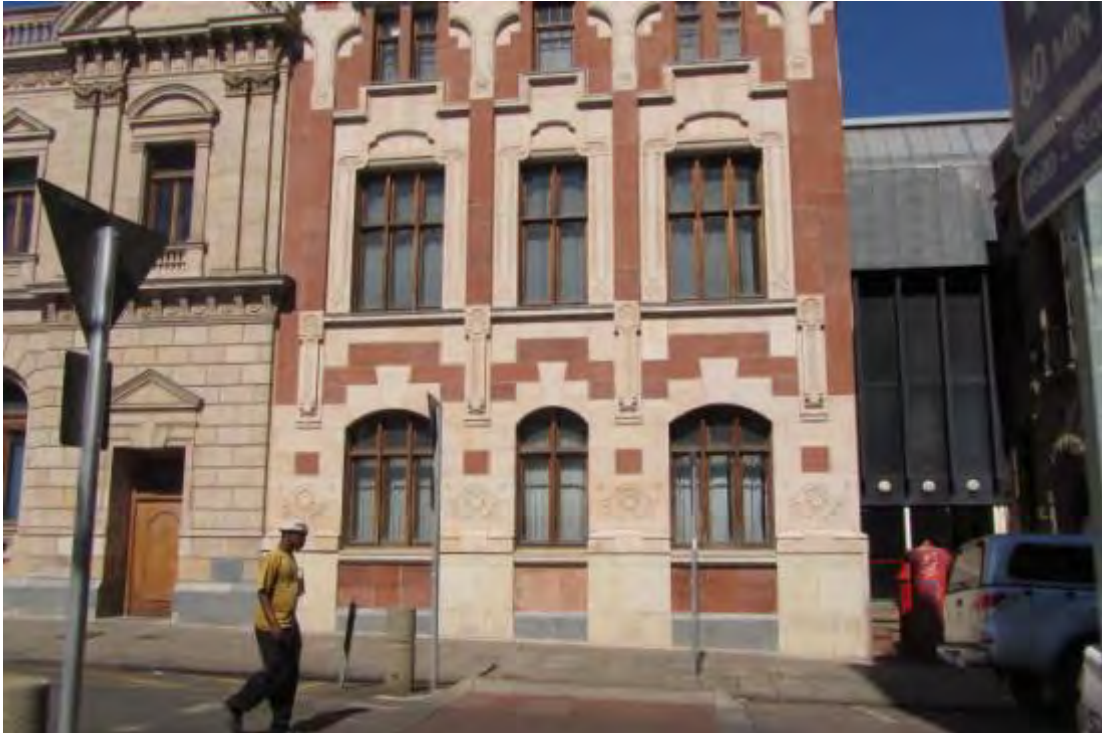
Fig. 20 A record of a protected building (National Bank and Mint 1892). Note historical granite kerbing but absence of slate flagstone paving at the south end of Palace Street. (Photograph SM Miller 2013)

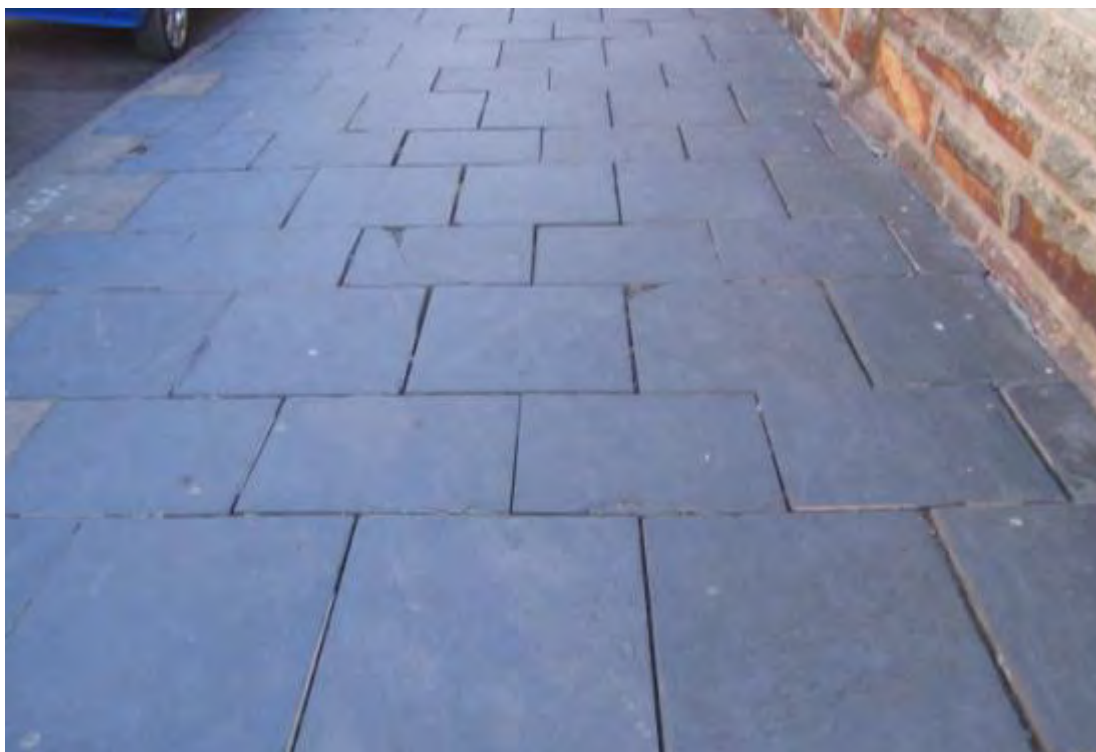
Fig. 22 *Historical slate flagstone paving and historical granite kerbing along the south-eastern section of Block 1. It appears as if these flagstones may have been trimmed and re-positioned. (Photograph SM Miller 2013)*

- 12.2 The final design of the streetscape and pavements must be approved by SAHRA before construction can proceed.
- 12.3 All the historical kerbing and paving must be retained or replaced *in situ*.

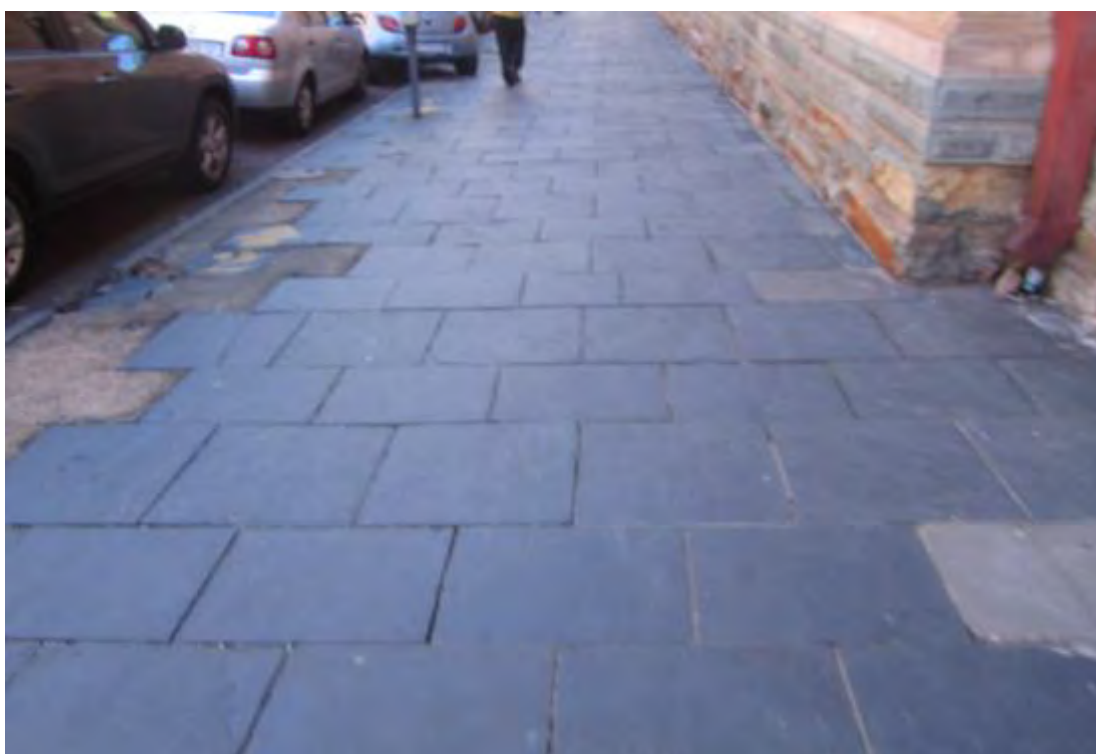
Fig. 23 *Historical slate flagstone paving and historical granite kerbing along the north-eastern section of Block 1. It appears as if these flagstones may have been lifted, trimmed and re-laid in recent times. (Photograph SM Miller 2013)*

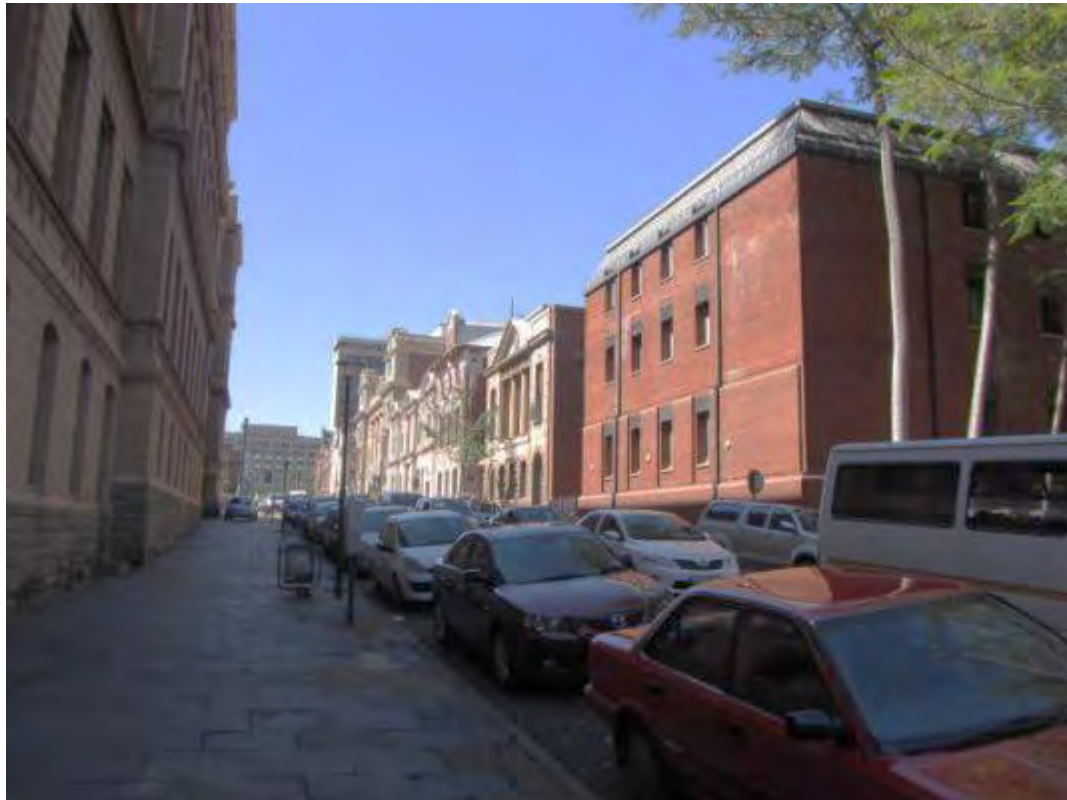
Fig. 24 Historical slate flagstone paving and historical granite kerbing along the north-eastern section of Block 1. (Photograph SM Miller 2013)

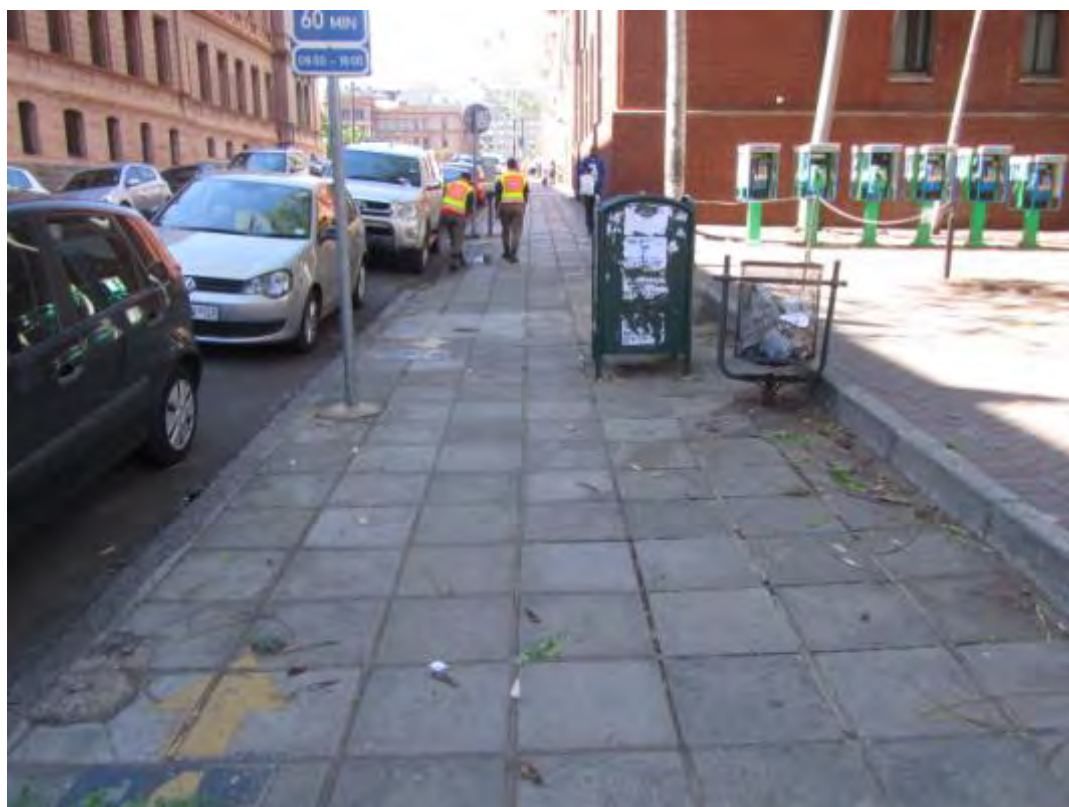
Fig. 26 Modern paving and historical granite kerbing along the north-western section of Block 1. (Photograph SM Miller 2013)

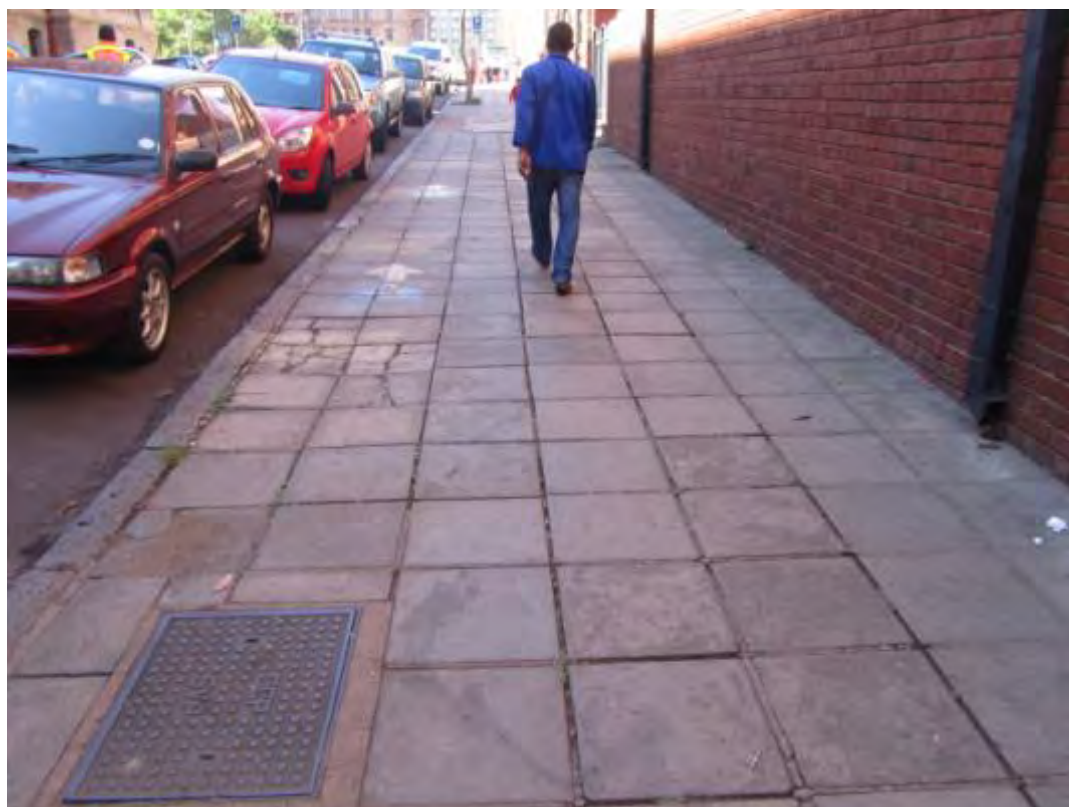
Fig. 27 Modern paving and historical granite kerbing along the central western section of Block 1. (Photograph SM Miller 2013)

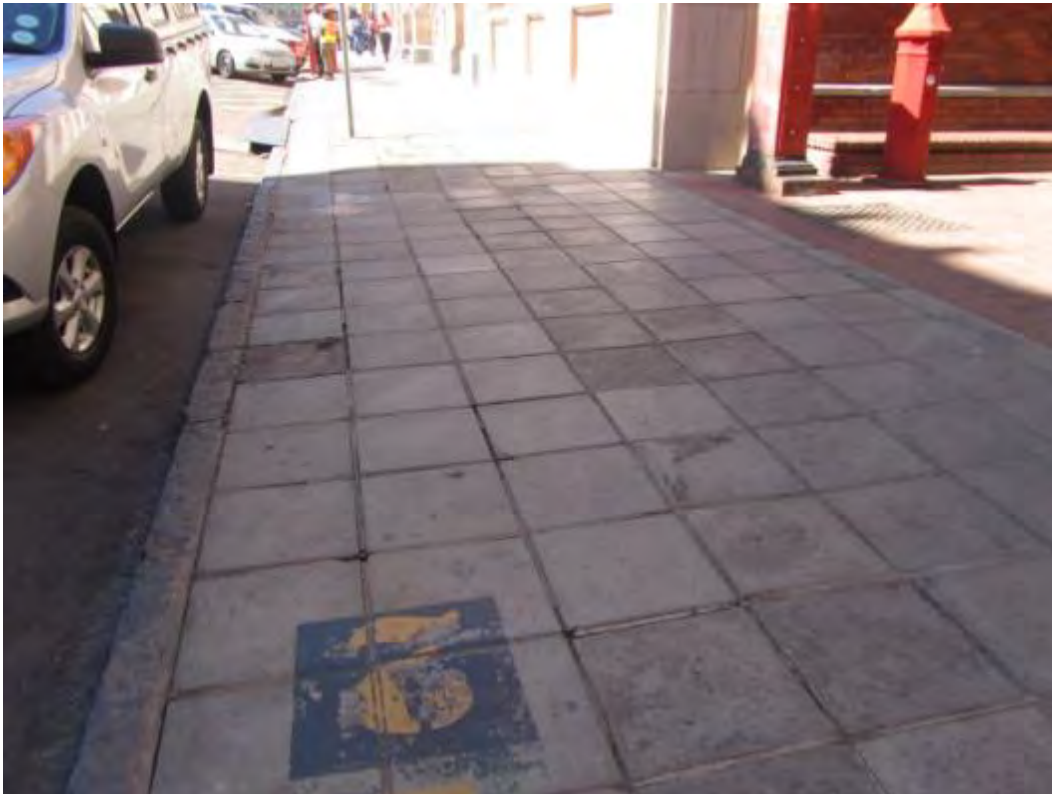
Fig. 28 Modern paving and historical granite kerbing along the south-western section of Block 1. (Photograph SM Miller 2013)

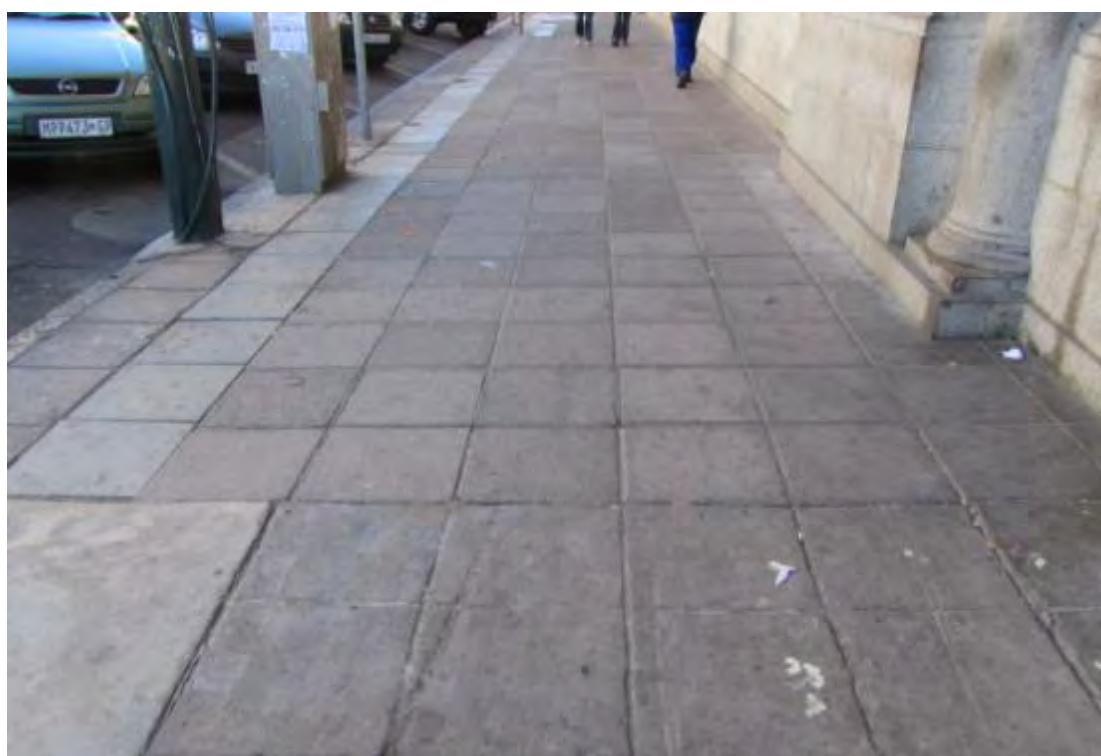
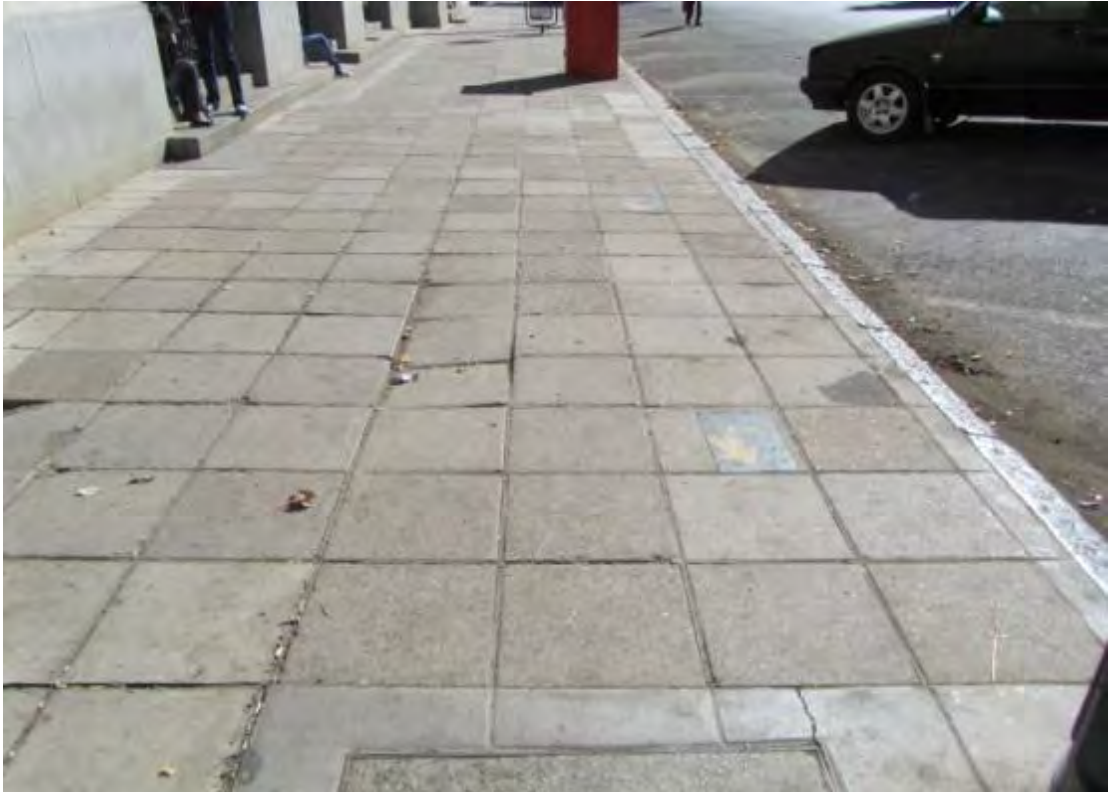
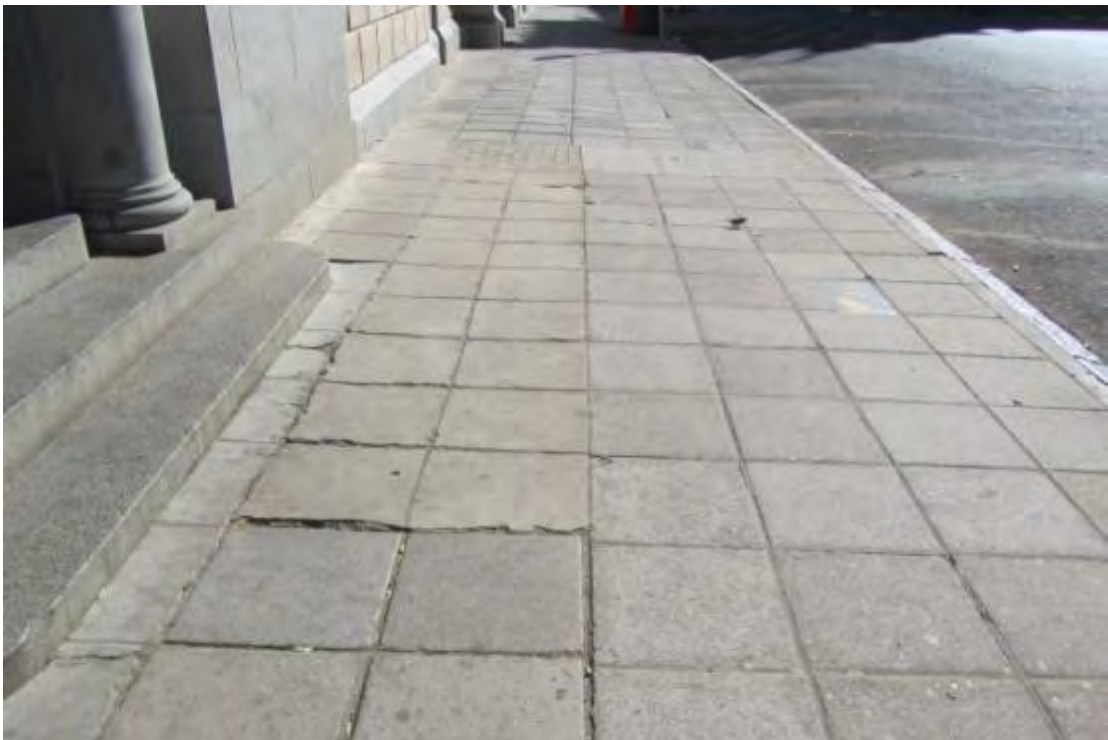
Fig. 31 Modern paving and historical granite kerbing along the western section of the Square. (Photograph SM Miller 2013)

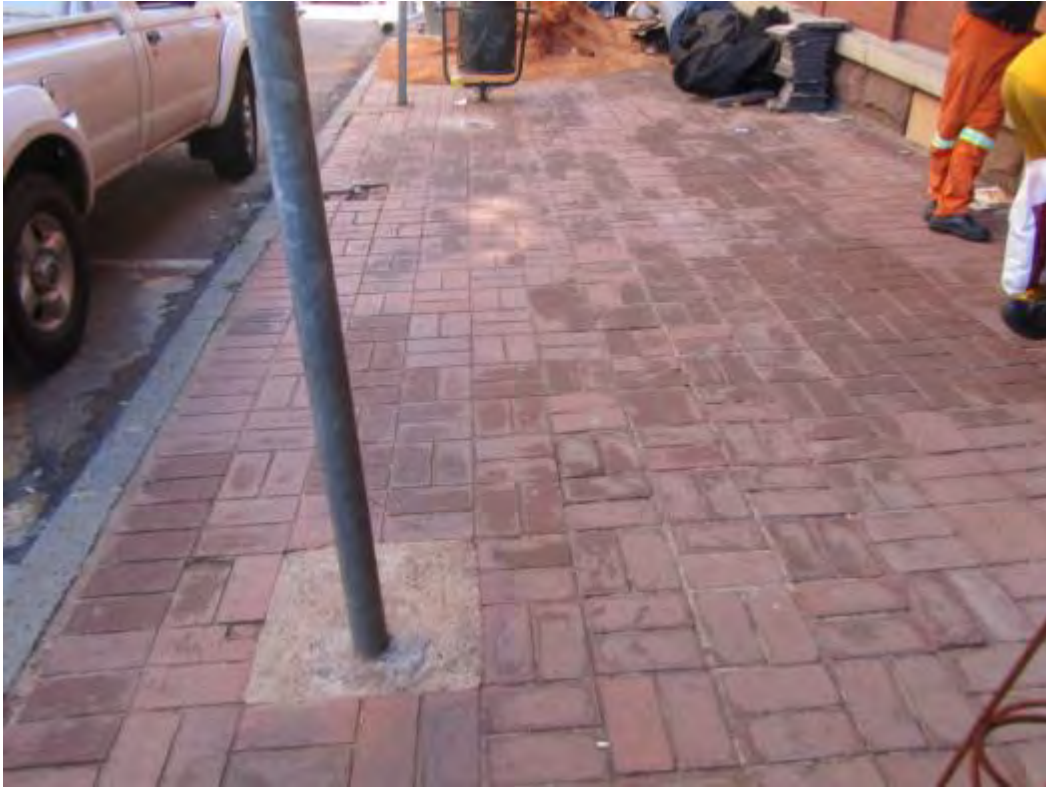
Fig. 34 *Modern paving and historical granite kerbing along the south-eastern section of Block 2. (Photograph SM Miller 2013)*

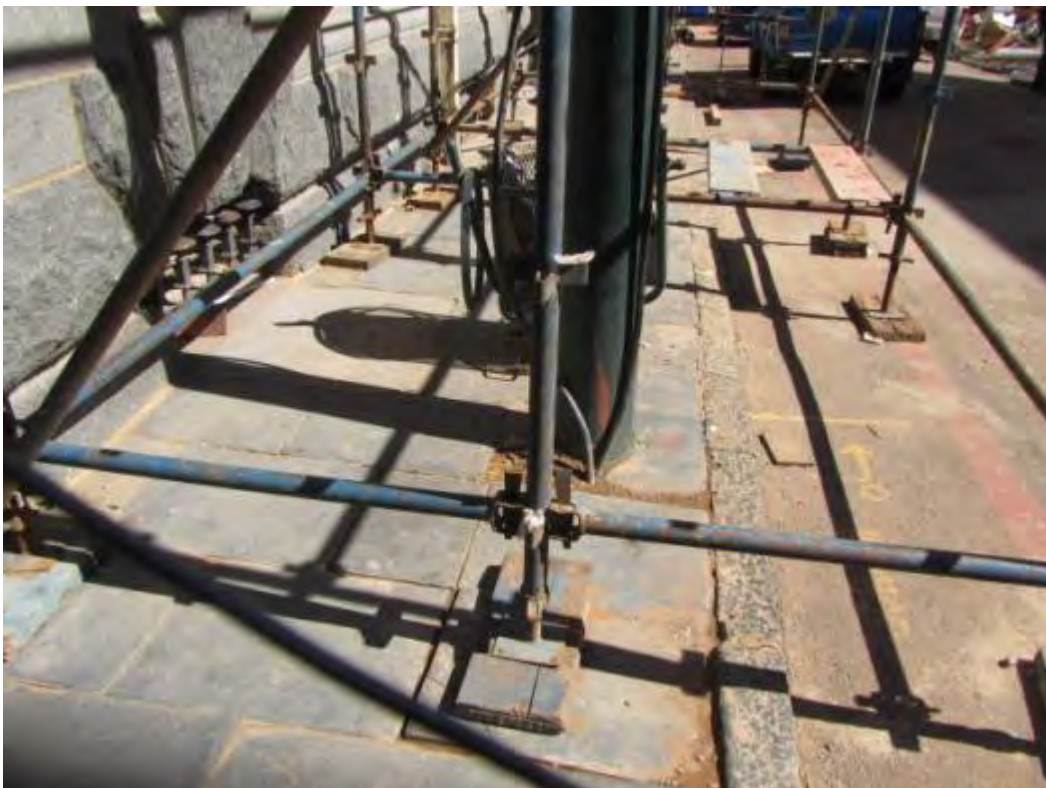
Fig. 35 *Historical slate paving and historical granite kerbing along the south-western section of Block 2 under scaffolding for restoration on the Mutual Insurance Building. (Photograph SM Miller 2013)*

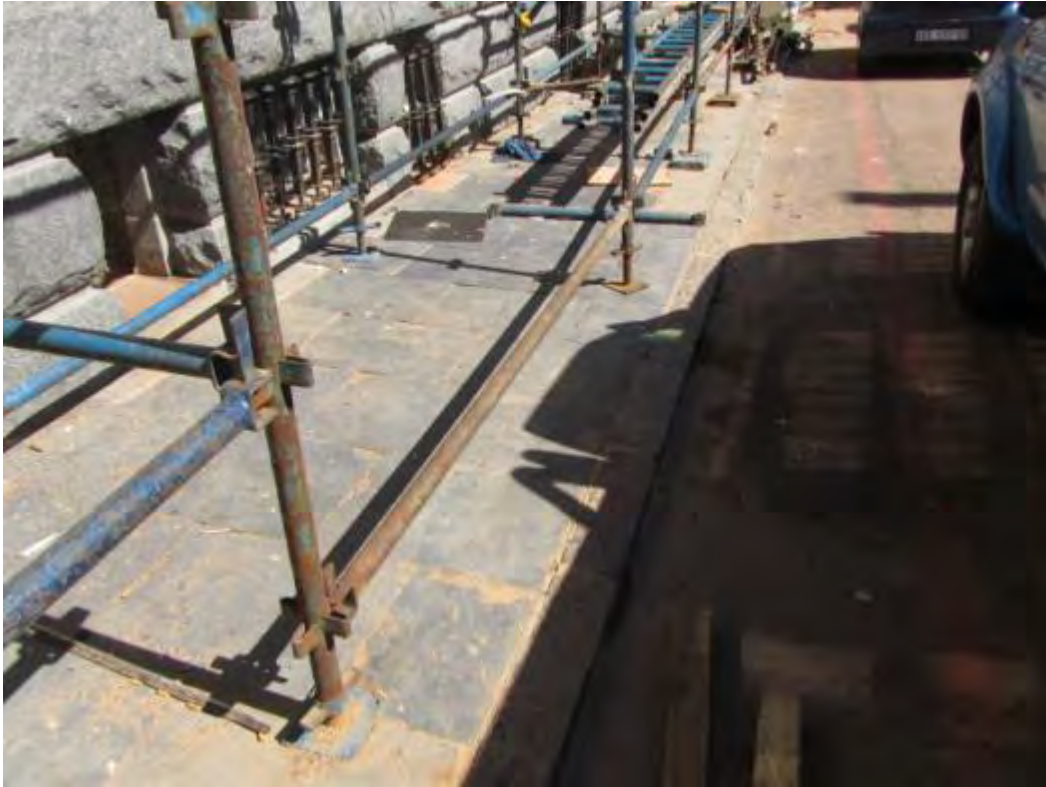
Fig. 38 *Improper placement of scaffolding on historical slate paving. (Photograph SM Miller 2013)*

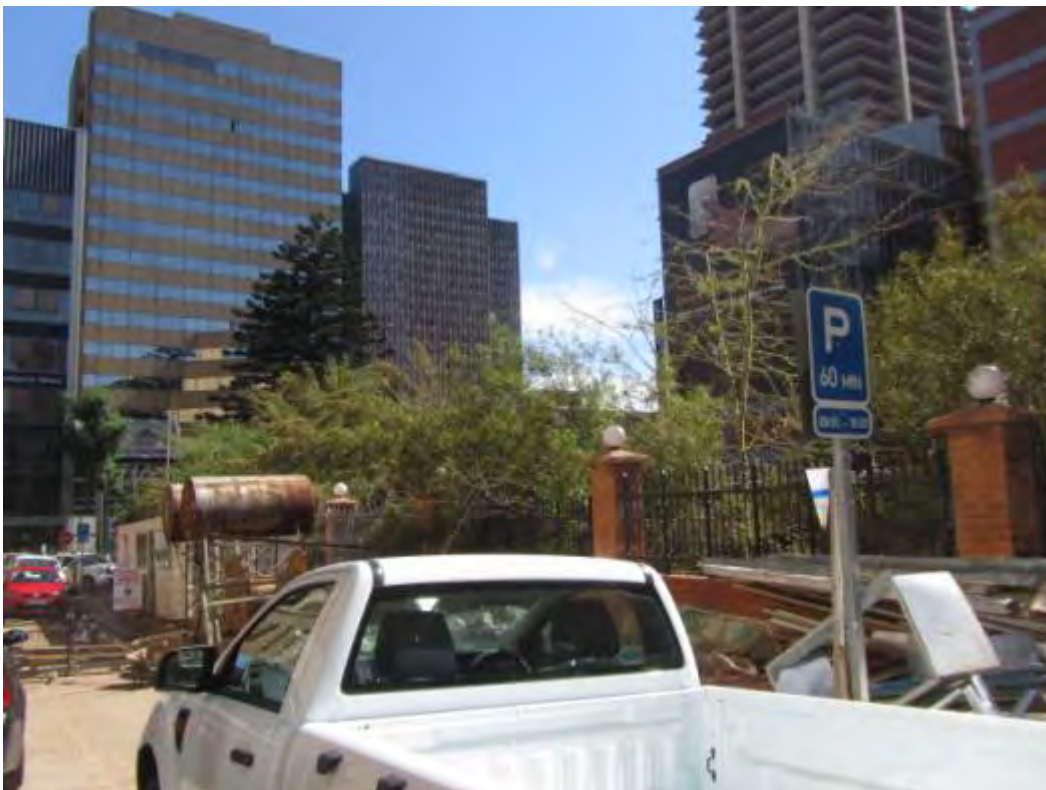
Fig. 39 *Mutual Street used as contractor's camp, with a green area in background. (Photograph SM Miller 2013)*

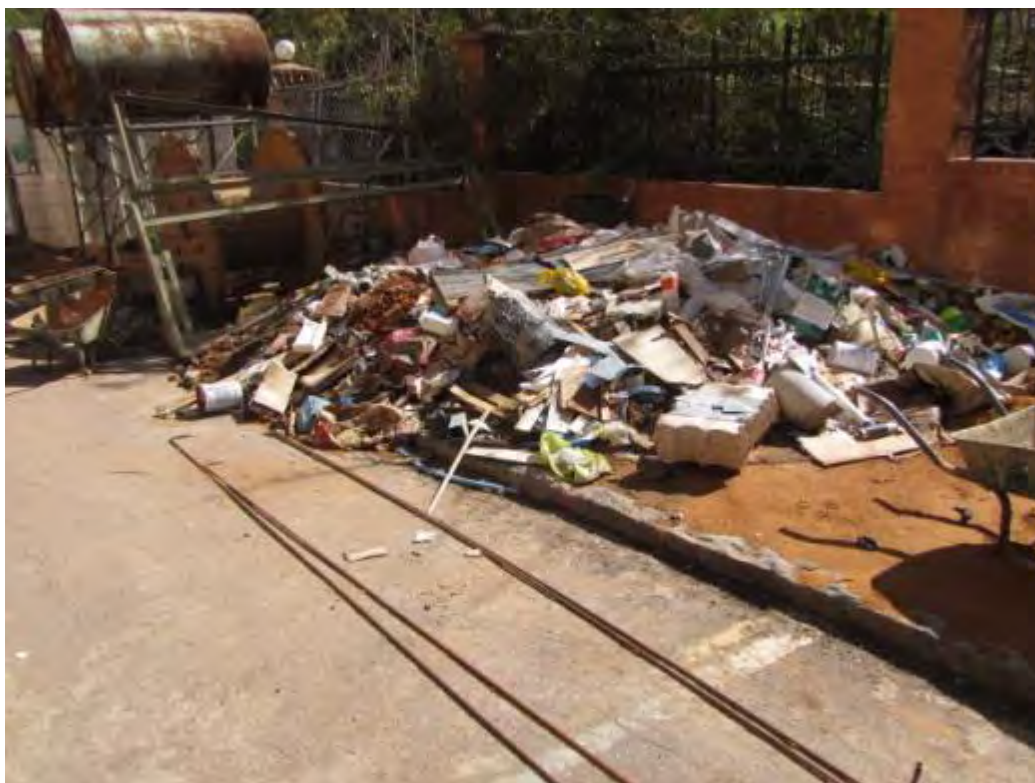
Fig. 40 Mutual Street used as contractor's camp, with green area in background. (Photograph SM Miller 2013)

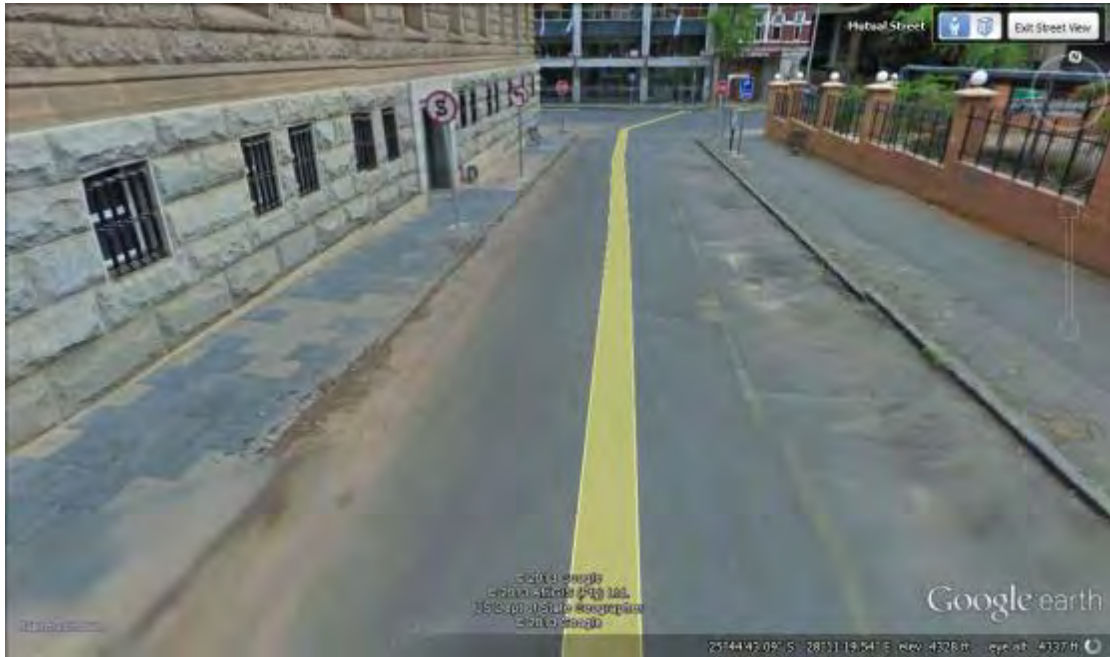
Fig. 44 An image from 2009 providing a view of the actual conditions in Mutual Street with regard to paving and granite kerbing. (Google Earth Street View 2009)

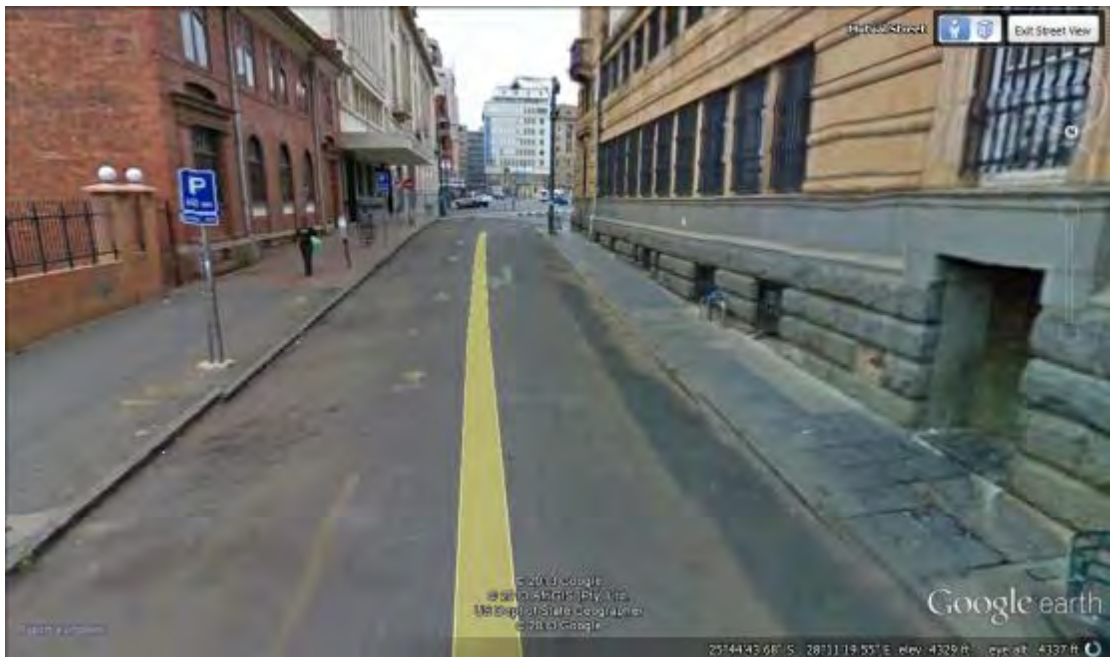
Fig. 45 Image from 2009 showing paving and granite kerbing in Mutual Street. (Google Earth Street View 2009)

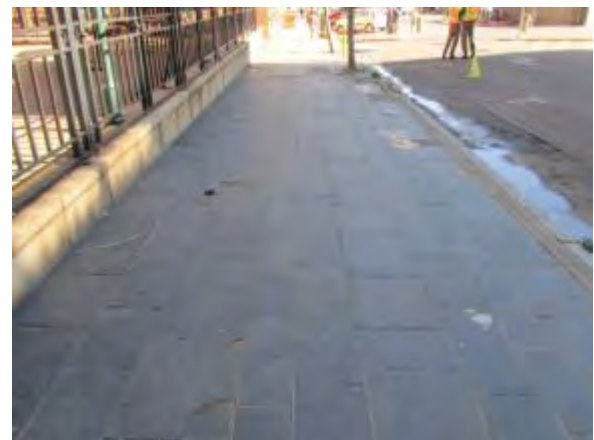
Figs 50 and 51 *Historical slate flagstone paving and historical granite kerbing along the central western section of Block 3. (Photograph SM Miller 2013*

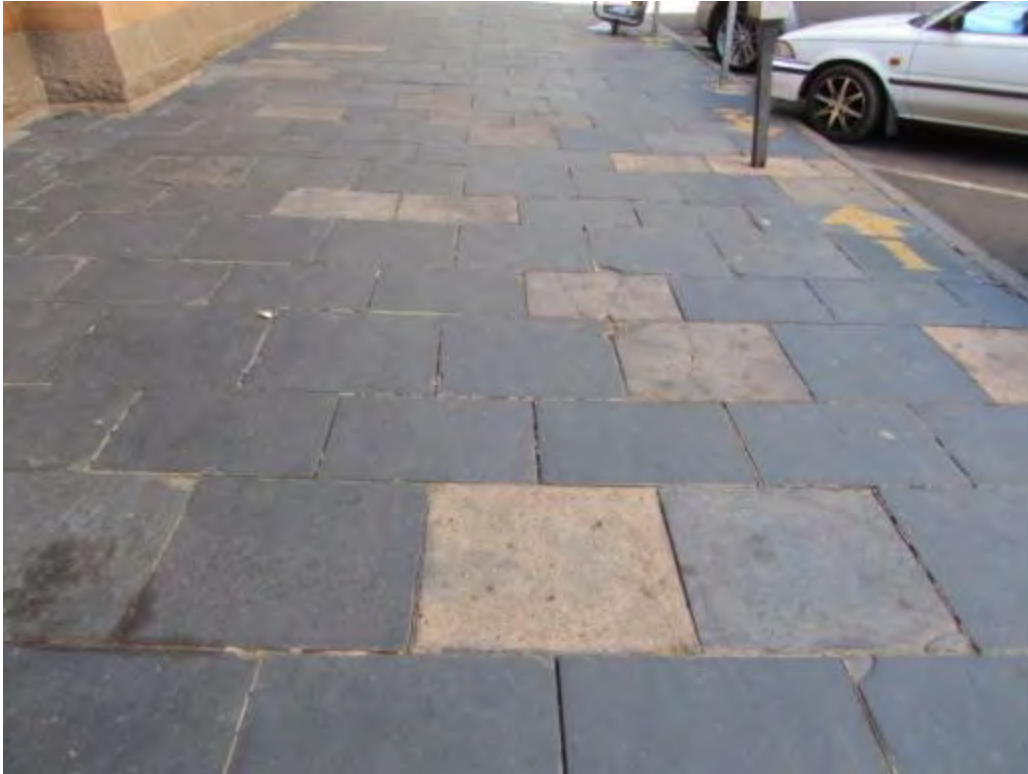
Fig. 54 Historical slate flagstone paving and historical granite kerbing along the central eastern section of Block 3. (Photograph SM Miller 2013)

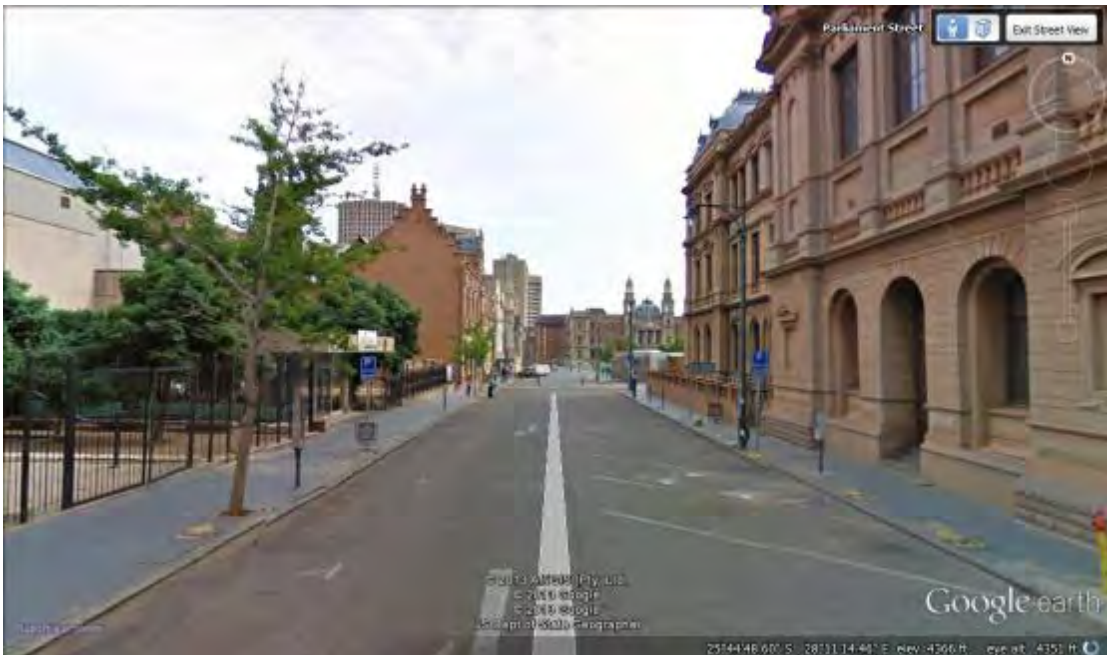
Fig. 59 This image from 2009 provides a view of the actual conditions in Mutual Street regarding paving and granite kerbing. (Google Earth Street view 2009)

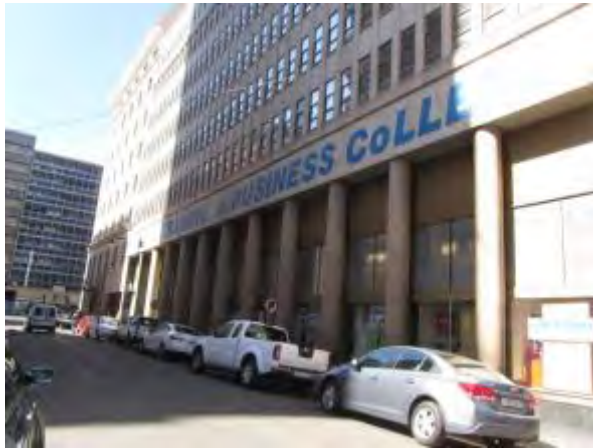
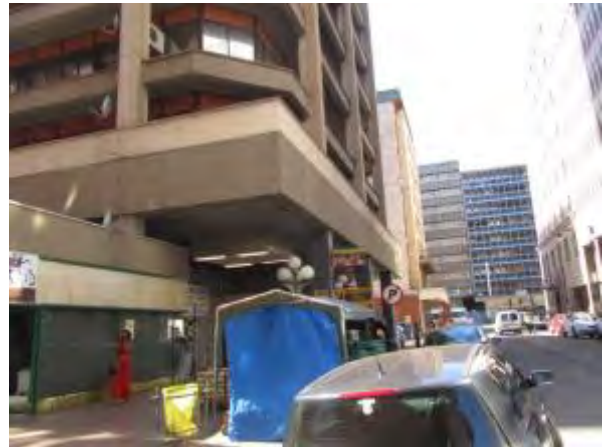
Figs 62 and 63 Historical slate flagstone paving and historical granite kerbing along the north-eastern section of Block 4. (Photograph SM Miller 2013)

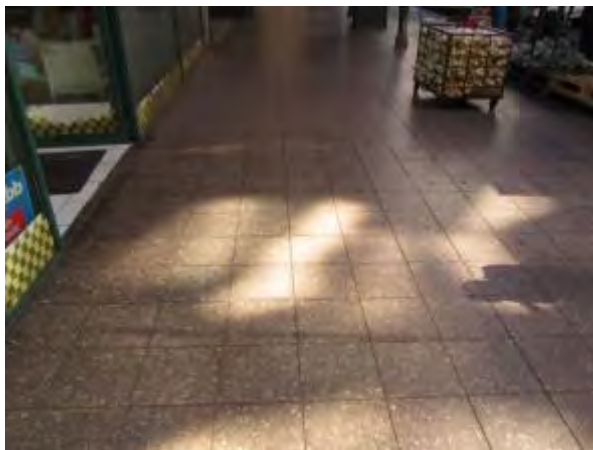
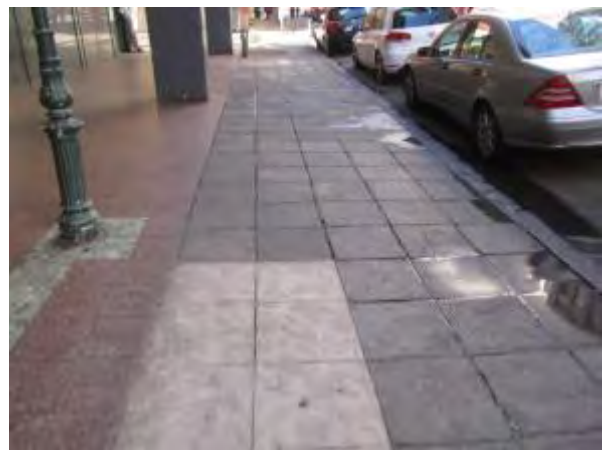
Figs 64 and 65 Historical slate flagstone paving and historical granite kerbing along the north-eastern section of Block 4. (Photograph SM Miller 2013)

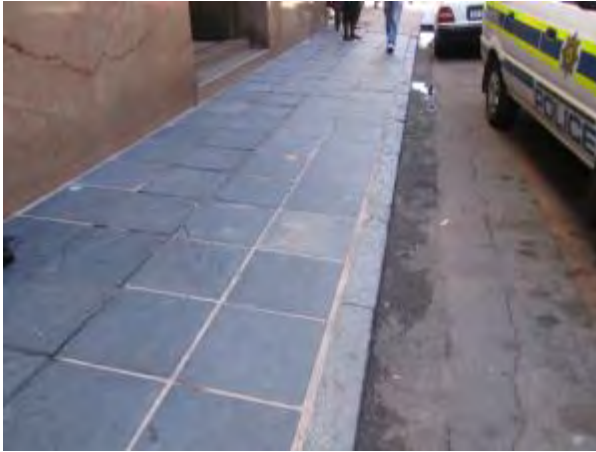
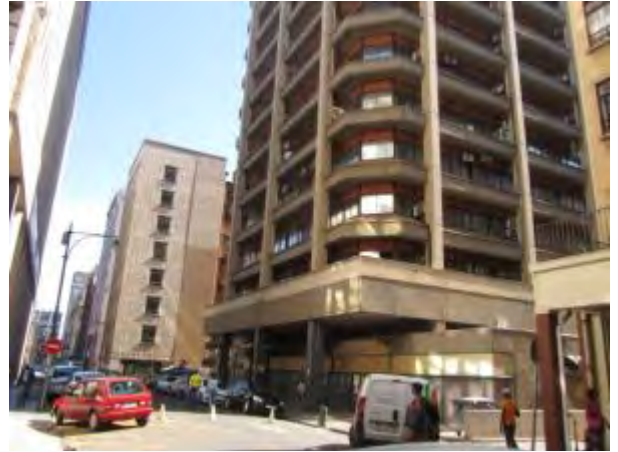
Figs 67 and 68 *Historical slate flagstone paving and historical granite kerbing along the north-eastern section of Block 4. (Photograph SM Miller 2013)*

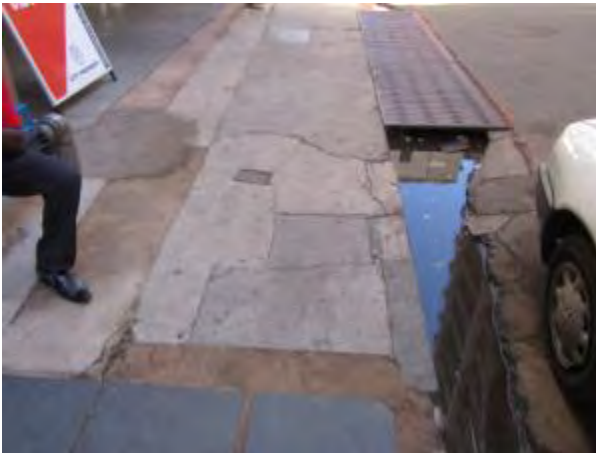
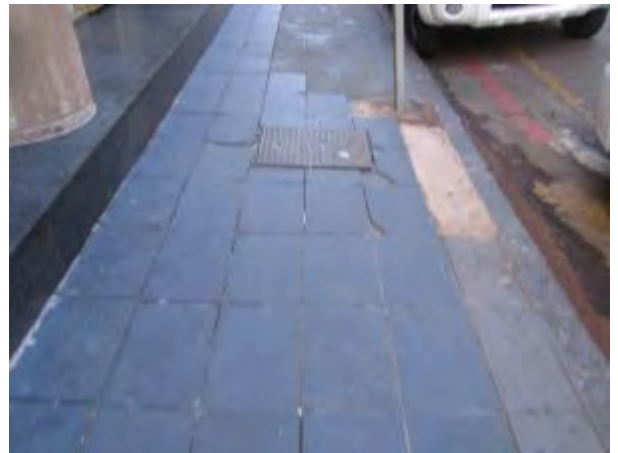
Figs 69 and 70 *Historical slate flagstone paving and historical granite kerbing along the north-eastern section of Block 4. (Photograph SM Miller 2013)*

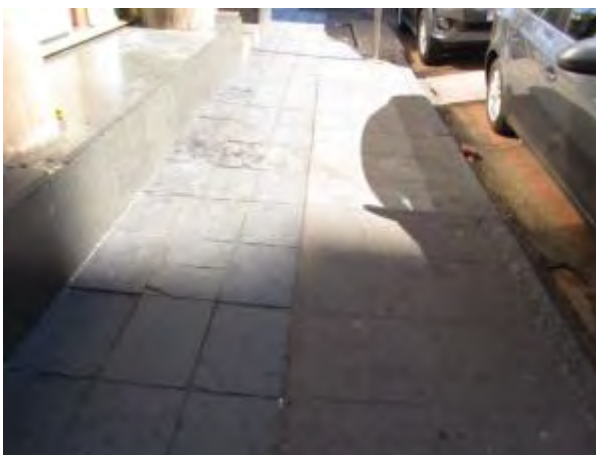
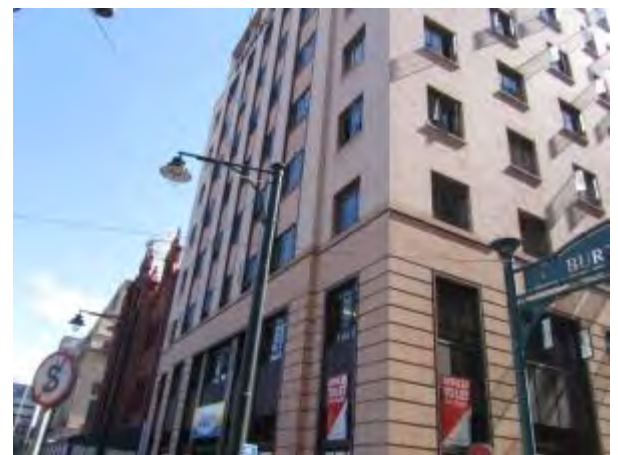
Figs 71 and 72 *Historical slate flagstone paving and historical granite kerbing along the north-eastern section of Block 4. (Photograph SM Miller 2013)*
