Phase 1 Cultural Heritage Assessment:

# AMENDMENT TO AN ENVIRONMENTAL AUTHORISATION FOR THE PROPOSED THETA PROJECT, NEAR PILGRIM'S REST, MPUMALANGA

#### **Report No:** 2019/JvS/042

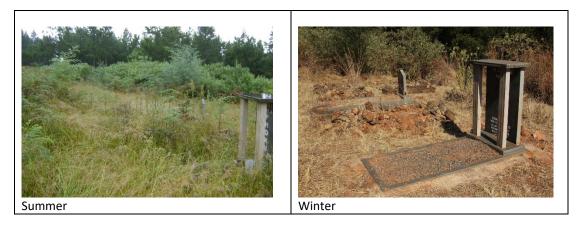
Figure 1. Seasonal variations in ground visibility

During the first field survey, the vegetation cover was high and thick, obscuring ground visibility, making the location and evaluation of the various identified features very difficult. Therefore, a second visit was undertaken during the winter when the vegetation cover was down, and all identified features were revisited. Unfortunately, some areas could not be accessed due to the presence of very aggressive illegal miners, colloquially referred to as "zama-zama's."

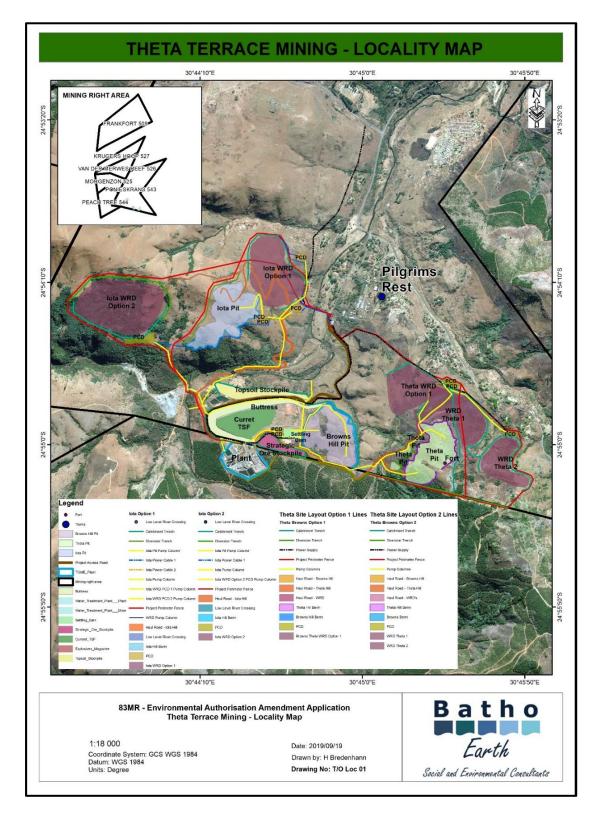
Figure 1: General Site Layout – Scoping Phase

The engineering feasibility study formed the basis for the permitting phase, and informed the initial site layout (Figure 1) which was incorporated into the Environmental Authorisation application which comprises a Scoping Phase and an Environmental Impact Assessment Phase, which results in the development of an Environmental Management Plan for consideration by the competent authority (The Department of Minerals Resources and Energy).

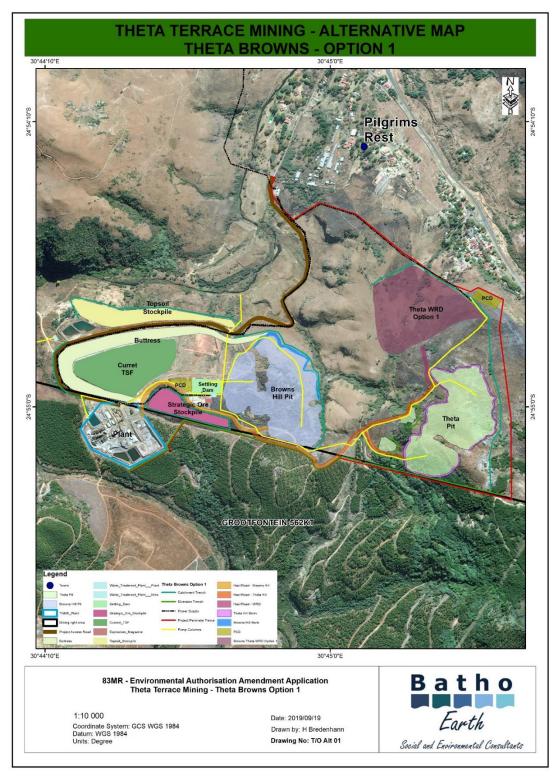
Figure 2: Theta & Browns - Option 1

- Theta/Browns Waste Rock Dump Option 1: This option is situated between both Browns and Theta Pit (Figure 2);
- Theta/Browns Waste Rock Dump Option 2: Located to the north eastern side of Theta Pit, incorporates two smaller pockets separated by a tributary (Figure 3);
- Iota Waste Rock Dump Option 1: Located to the north western corner of the Iota Pit (Figure 4); and
- Iota Waste Rock Dump Option 2: Is located to the north eastern boundary of the Iota Pit (Figure 5).

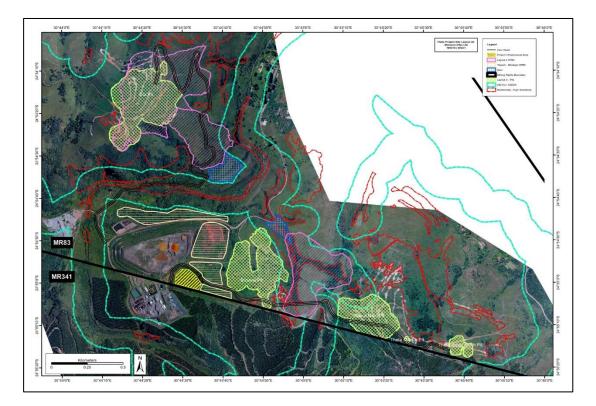
Figure 6: Revised layout (EIA/EMP Phase)

In this instance, the pit shells were reduced in size and waste rock dump sites were relocated to avoid/minimise the impacts on the ground-truthed portions of highest biodiversity significance to minimize the extent of areas requiring detailed rehabilitation and to limit the requirements for offsets of residual impacts.

Refer to Figure 6 for the revised site layout plan which will be incorporated into the Environmental Impact Assessment Report and Environmental Management Plan. Additional seasonal studies are planned as part of the ongoing environmental, social and rehabilitation programmes. The results of these planned studies might decrease current uncertainties to which the precautionary principle was applied which could lead to future layout developments.

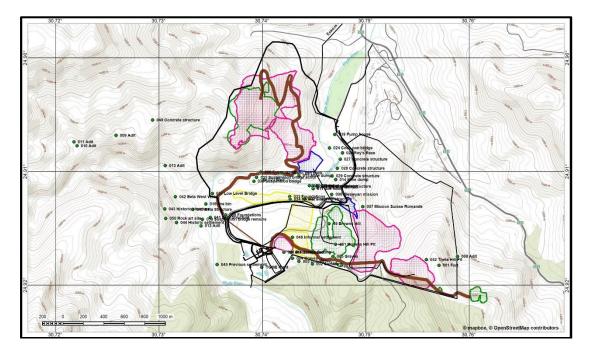
Figure 6. Known heritage sites in relation to the development

After evaluating the identified sites with reference to them being impacted on by the proposed development, we are left with only a few (Table 2 below). However, there are a number which will not be directly impacted on but are viewed to be of high enough significance to be listed as sites to be avoided and are consequently also included in Table 2.

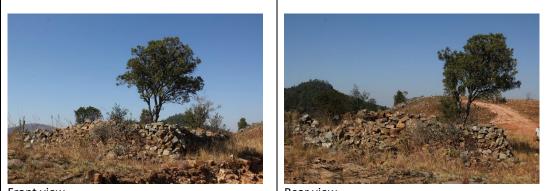
A rectangular structure of packed stone. It occupies a commanding position on a hill overlooking not only Pilgrim's Rest town, but the larger region as well.

Research has shown that the intended function of this feature might be a fortification that was built in preparation for expected hostilities that might arise during the so-called Sekhukhune War's (1876-1879). As far as is known, it fortunately was never used for its intended purpose.

Front view

Rear view

Fort (No. 1): It is recommended that this structure is retained in place.

• Currently, the Theta Pit boundary approaches the fort to within about 22m. It is recommended that a buffer zone of at least 15m is created around the outer edges of the fort and that this is formalised with a suitable, permanent fence (with an access gate).

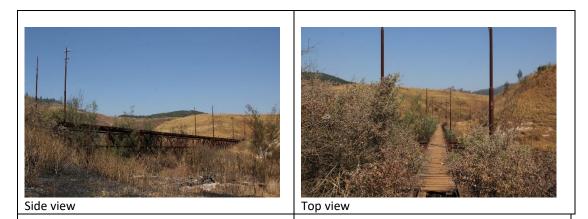
A section of the old electrified cocopan track extending from the road towards TGME (at the old pump station) westwards to the metal bridge across the Blyde River. This track operated between Beta Mine and the Central Reduction Works but represents only a small section of what was in use over the larger region. Unfortunately, most of this feature that was used in the larger region have been vandalised.

Track and electricity pylons

Although this site is located outside the development area, a section further to the east will be impacted on due to the proposed construction of a new pollution control dam (PCD). As this is a linear development, it would be prudent to retain and maintain this eastern section of the line including the bridge as an example of this type of technology.

(2) Archaeological investigation: If the site cannot be avoided it should be documented in full before destruction.

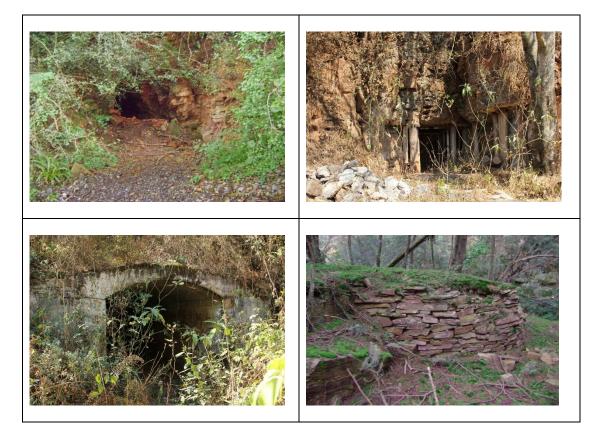
A number of old adits are scattered around the larger region. Most are simple holes dug into the side of the hill, whereas others are shored up with stone walls, concrete casings and pillars.

None of the built ones are known to be located in the development area, but they are mentioned here in case some unknown ones are located during future mining operations.

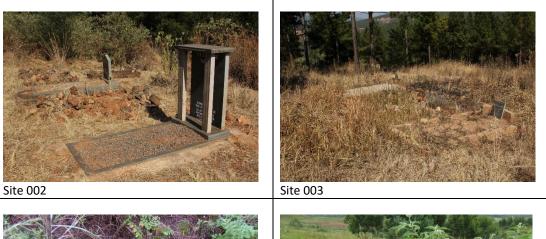
The graves all belong to former labourers at the mine or their family members. The burial sites range in size from nearly 60 individuals to as few as two or three persons.

Some of the sites were much overgrown with vegetation and have little evidence of grave markers, making their verification very difficult.

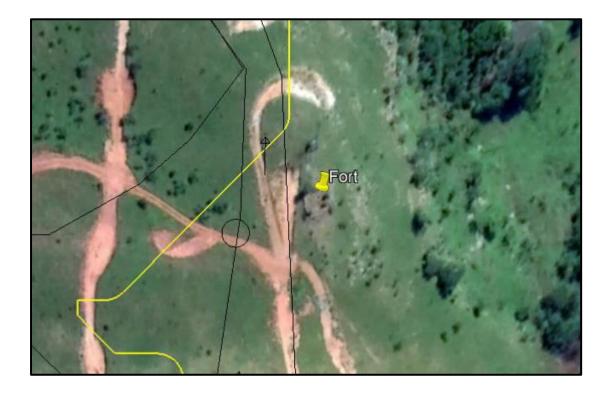
• Currently, the Theta Pit boundary approaches the fort to within about 22m – see image below. It is recommended that a buffer zone of at least 15m is created around the outer edges of the fort and that this is formalised with a suitable, permanent fence (with an access gate).

Fort (No. 1): It is recommended that this structure is retained in place.

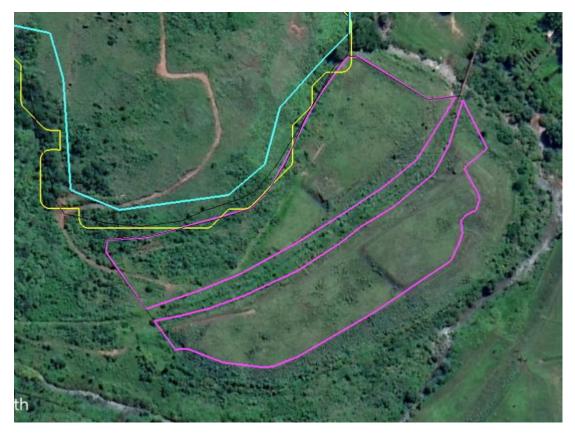
Cocopan track and bridge (No. 24 - 26): A section of the remaining cocopan track will be impacted on due to the proposed construction of a pollution control dam (PCD).

- This feature is older than 60 years and therefore enjoy general protection under the Heritage Act. As this is a linear development, an impact on even a section of it would have a proportionate high impact on the occurrences of similar features in the larger landscape. Large sections this feature has already been destroyed, with this the only section that is still reasonable intact.
- It is therefore proposed that the section of the track extending from the road towards TGME (at the old pump station) westwards across the metal bridge crossing the Blyde River westwards as far as possible be declared a no-go section and that it is protected and retained as a sample of this type of technology.
- It is also sufficiently close to the reduction works to be used part of a possible future tourism attraction.

The proposed solution is to split the PCD in two sections, in effect straddling the cocopan track, but still retaining it – see image below.
