**CES: PROPOSED MBSA CLARKEBURY ROAD UPGRADE
PROJECT, CLARKEBURY AREA, OR TAMBO DISTRICT
MUNICIPALITY, EASTERN CAPE PROVINCE**

Archaeological Impact Assessment

ARCHAEOLOGICAL IMPACT ASSESSMENT (AIA) OF AREAS DEMARCTED FOR UPGRADING TO A SURFACE STANDARD MBSA CLARKEBURY ROAD UPGRADE PROJECT, CLARKEBURY AREA, OR TAMBO DISTRICT MUNICIPALITY, EASTERN CAPE PROVINCE

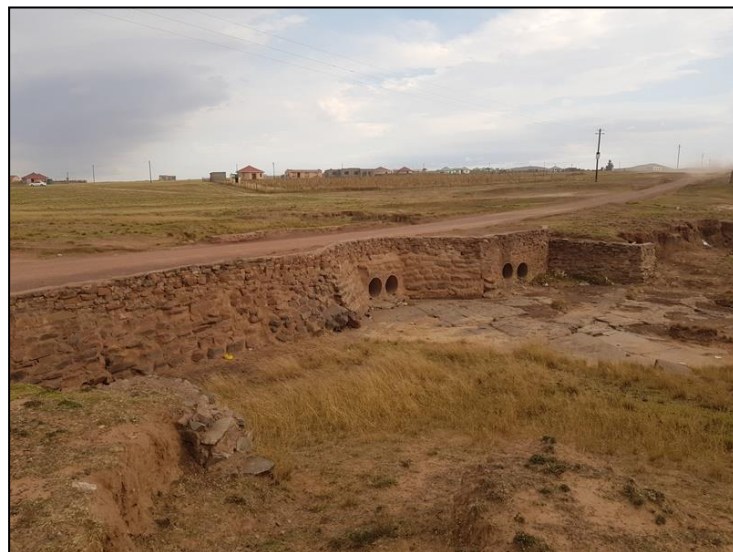
Figure 3-5: View of an existing road culvert in the Singeni area.

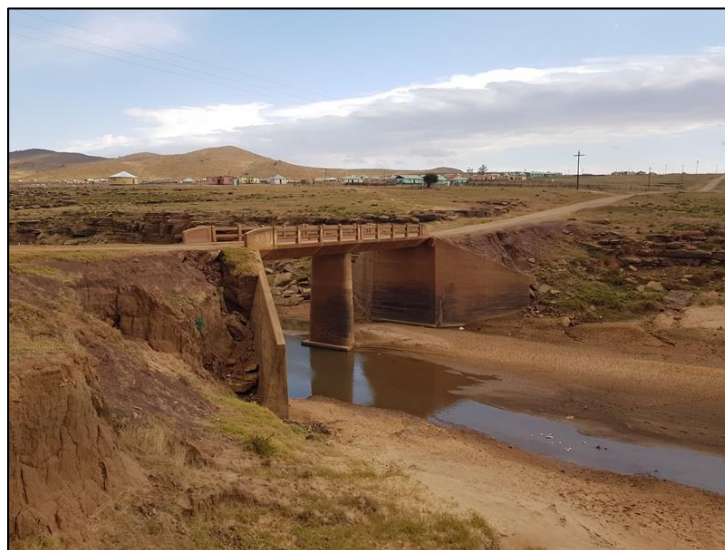
Figure 3-8: View of an existing road culvert in the Mtshayelweni area.

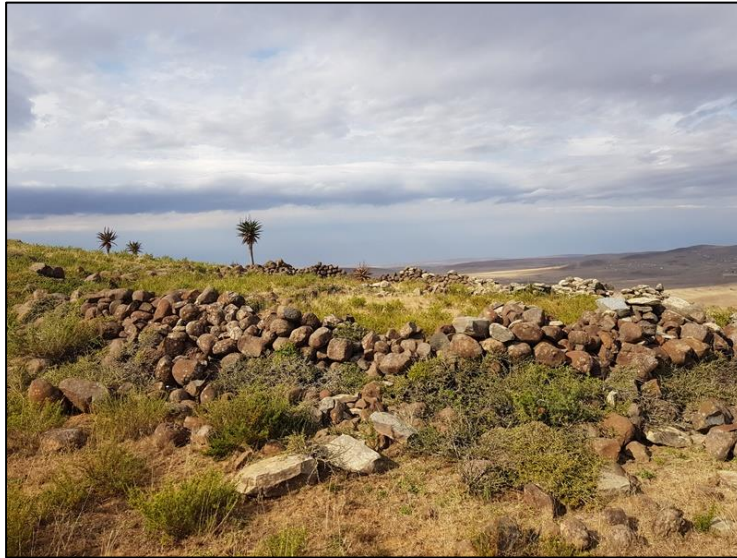
A frontier zone between the north and the south, the Eastern Cape landscape contains traces of precolonial Iron Age Farmer Period remnants. A large settlement area consisting out of elaborate stone walled enclosures was documented on the summit of a hill at Qulugu, at the site proposed for the road quarry. At the site, a series of circular stone wall enclosures of varying sizes occur across an area of approximately 4ha over much of the flat hilltop. The fairly well-preserved structures, which are in places overgrown with aloë and other shrubs, were built with round stones, in some instances to a height of more than 1.5m. Clear entrances are demarcated by monoliths at many of the enclosures, which were probably used as livestock "kraals". Ashy soil occurs in a central part of the site in association of a number of stone cairns which might be the remains of gran bin stands. A small stone cairn occurs along the more secluded southern periphery of the site on a high rise which provides a look-out point to the surrounding landscape and the Tora River below. No material culture was observed at the site and a clear temporal context for the structures is not known but it is likely that the stone walls date to the terminal phases the Iron Age farmer period in the area. This inference is made based on the fact that the stone enclosures are exclusively circular in shape whereas squarely built enclosures, commonly found in the surrounding landscape, would occur on newer Historical or Contemporary period sites. In addition, the site is situated away from current and historical settlement areas and homesteads and its general appearance do not resemble Historical period livestock enclosures in the surrounding landscape. Finally, many of the stones in the walls are covered with rock lichens along exposed surfaces with no growth evident on obstructed sides. Lichens are known to grow at a slow rate, particularly on exposed soil surfaces which in this instance, suggests an older date range for the stone walls. The site is thus an archaeological site of medium significance which is protected under the National Heritage Resource Act (NHRA 1999). As it is situated in an area demarcated as a stone quarry, impact on the site might occur and mitigation measure will apply.

Figure 5-1: View of circular stone wall enclosure at Site EXIGO-MCRU-IA01.

- An extensive later Iron Age Farmer Period stone walled complex (**Site EXIGO-MCRU-IA01**) have the potential to inform on the spread of Iron Age communities in the interior of the Eastern Cape and the site is of medium heritage significance. The complex occurs at the site proposed for the quarry and it is primarily recommended that an alternative site for the quarry be identified to avoid impact on the heritage resource. A conservation buffer of at least 20m around the site should be implemented and the area should be monitored on a frequent basis by an informed ECO in order to avoid the destruction of existing and previously undetected heritage remains. Should impact on the site prove inevitable it should be adequately documented by means of a Phase 2 Specialist Study. Such a study should minimally include the mapping, documentation and possible sampling of the site in order to conserve the historical fabric of the heritage resource. The necessary alteration and/or destruction permits should be obtained from the relevant Heritage Resources Authorities prior to site sampling and destruction.

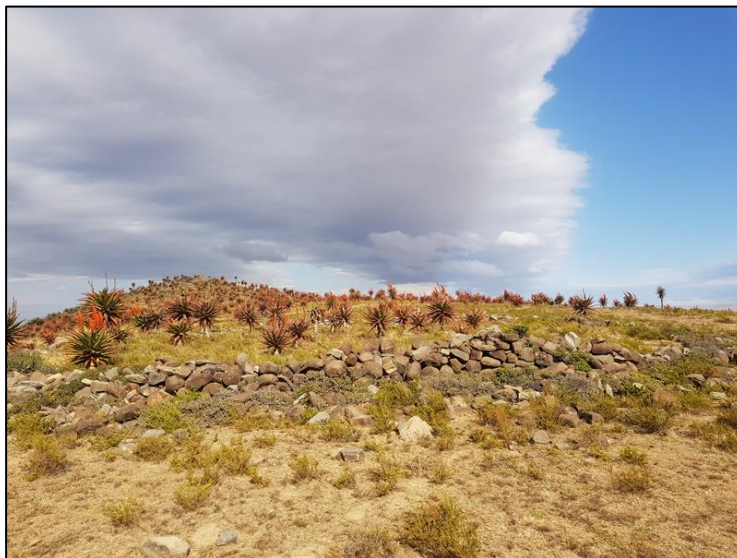
Figure 5-2: Stone walls on a high hill at Site EXIGO-MCRU-IA01.

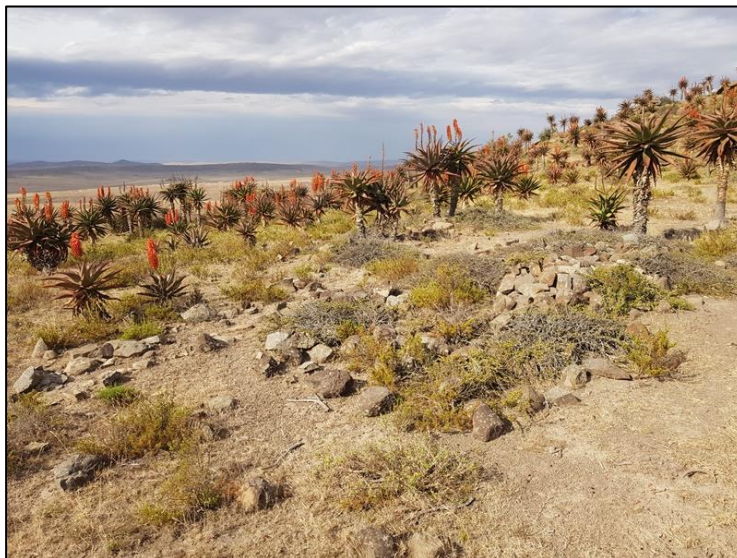
Figure 5-3: Ashy soil and possible grain bin stand foundations at Site EXIGO-MCRU-IA01.

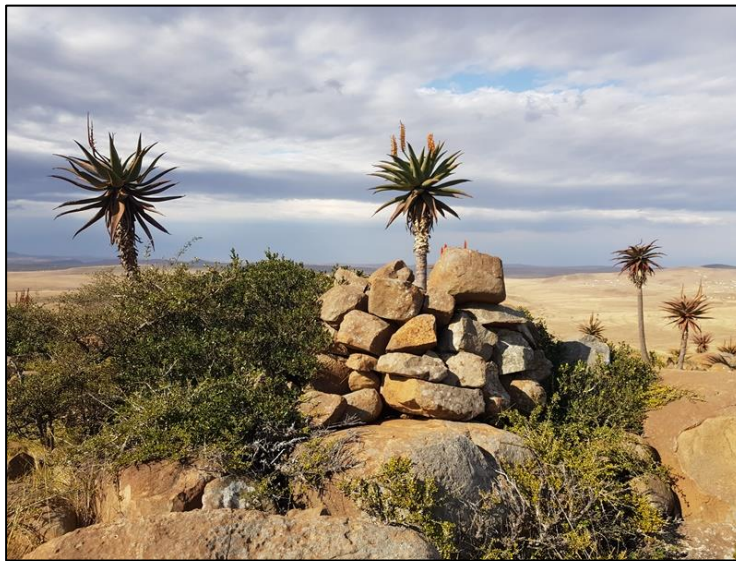
Figure 5-4: A small stone cairn at Site EXIGO-MCRU-IA01.

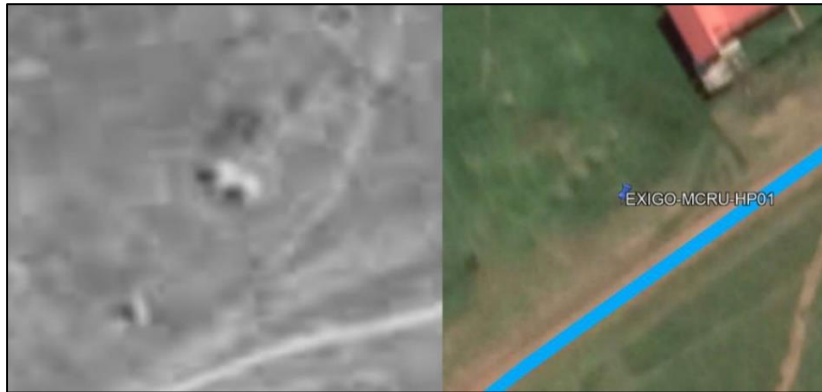
The dilapidated remains of a homestead, consisting out of the foundations of at least 3 huts as well as the partially intact walls of a stone wall enclosure were noted in the KuMbunga area along the road upgrade alignment. Material culture such as glass, metal and plastic occur at the site. An absolute age for the structures could not be ascertained but an analysis of historical aerial photographs indicates that the area

was relatively densely populated during the previous century. According to indications, the homesteads were in use by around 1938 and the structures are probably older than 60 years - and generally protected under the National Heritage Resource Act (NHRA 1999). However, the features are poorly preserved and they are of medium-low significance but a permit for the destruction of the structures is required subject to the NHRA should these sites be impacted on by the proposed road upgrade project.

Figure 5-6: Site EXIGO-MCRU-HP01 indicated on an archive aerial image (1938, left) and current aerial imagery (right).

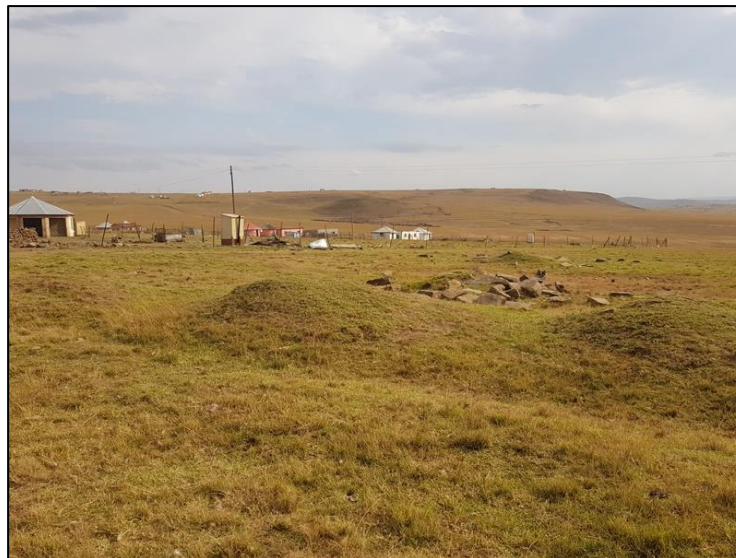
Figure 5-7: View of building foundation remains at Site EXIGO-MCRU-HP01.

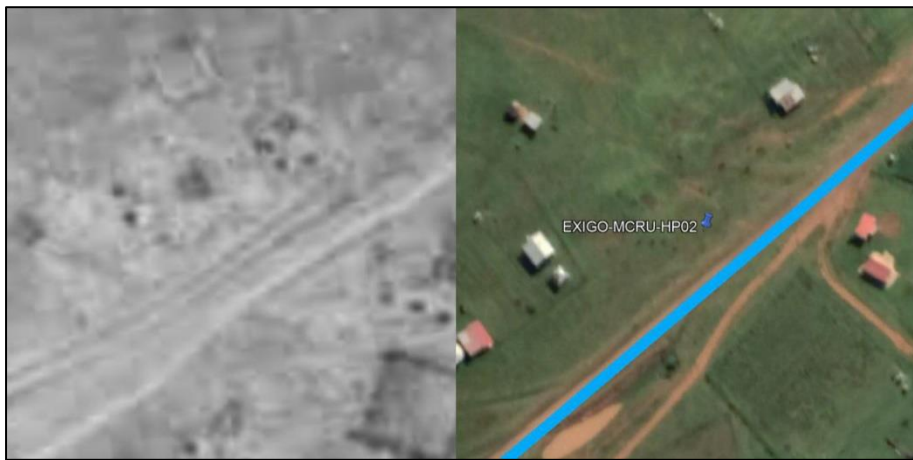
The remains of another homestead, consisting out of the foundations of at least 2 huts was noted in the KuMbanga area along the road upgrade alignment. Material culture such as glass, metal, plastic and a broken lower grindstone occur at the site. An absolute age for the site could not be ascertained but an analysis of historical aerial photographs indicates that the area was relatively densely populated during the previous century. According to indications, the homestead was in use by around 1938 and the structures are probably older than 60 years - and generally protected under the National Heritage Resource Act (NHRA 1999). However, the features are poorly preserved and they are of medium-low significance but a permit for the destruction of the structures is required subject to the NHRA should these sites be impacted on by the proposed road upgrade project.

Figure 5-9: Site EXIGO-MCRU-HP02 indicated on an archive aerial image (1938, left) and current aerial imagery (right).

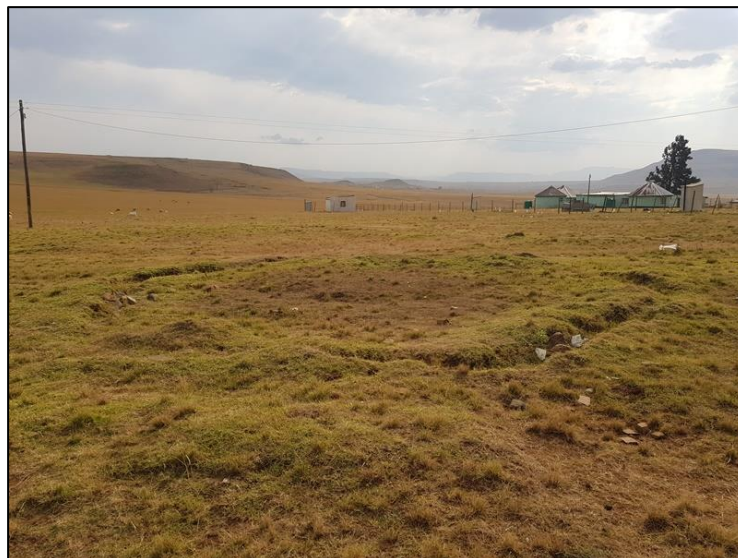
Figure 5-10: View of a hut foundation at Site EXIGO-MCRU-HP02.

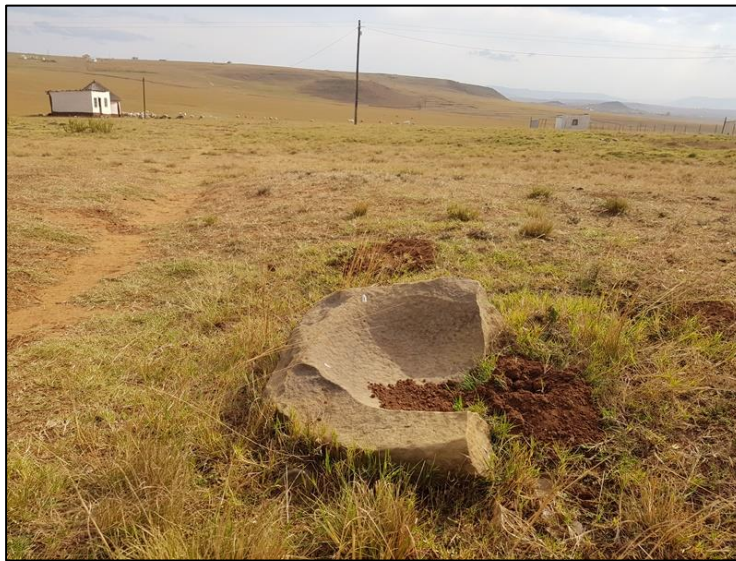
Figure 5-11: View of a broken upper grindstone at Site EXIGO-MCRU-HP02.

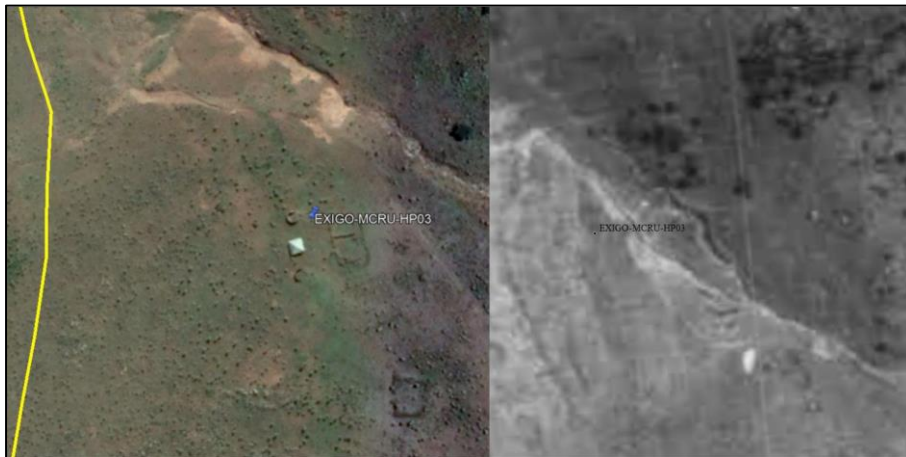
A Historical Period homestead complex consisting of a single room building, hut remains as well as elaborate livestock enclosures occur in the Qulugu area direct east of the proposed quarry site. The square building was constructed out of mud brick with a pitched corrugated iron roof. The building is typical of Historical Period architecture of the rural areas in the Eastern Cape. In addition, a number of square stone wall enclosures occur around the dwelling. The site is visible on archive aerial photographs and it is older than 60 years - and generally protected under the National Heritage Resource Act (NHRA 1999). However, the dwelling does not seem to hold any particular social or historical value and it is of medium-low heritage significance. A permit for the destruction of the structures is required subject to the NHRA should these sites be impacted on by the proposed road upgrade project.

Figure 5-13: Site EXIGO-MCRU-HP03 indicated on an archive aerial image (1938, right) and current aerial imagery (left).

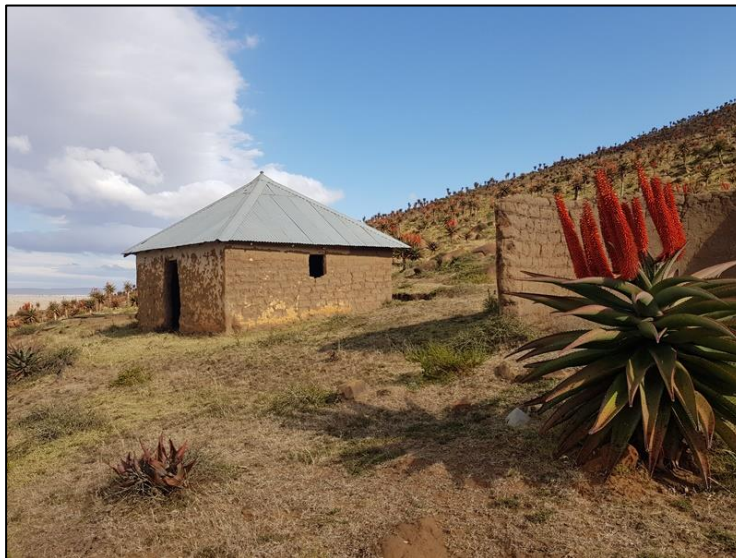
Figure 5-14: View of a mud brick dwelling and hut remains (right) at Site EXIGO-MCRU-HP03.

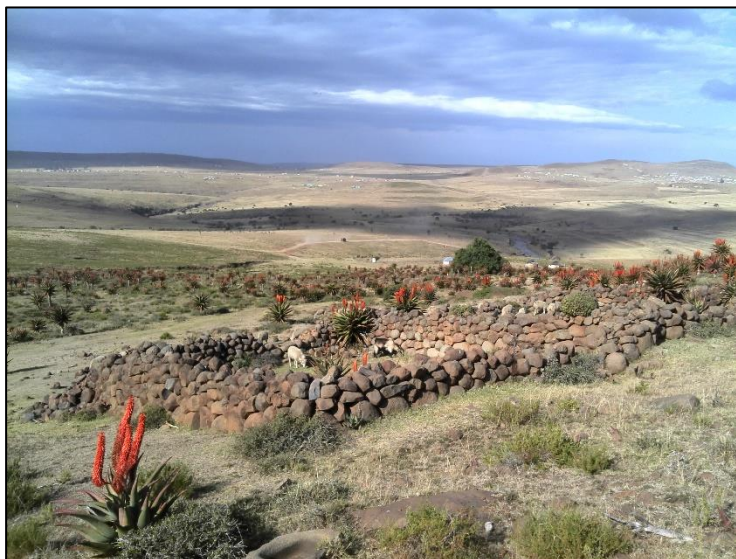
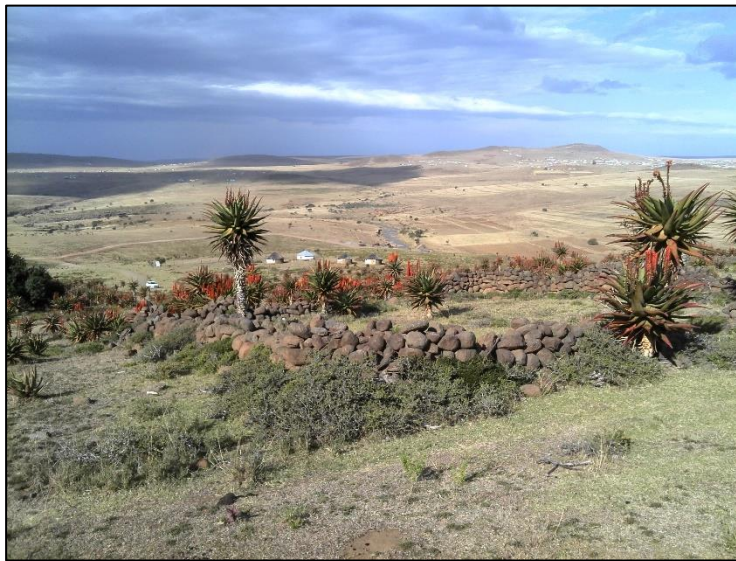
Figure 5-15: View of stone walled livestock enclosures at Site EXIGO-MCRU-HP03.

Figure 5-16: View of stone walled livestock enclosures at Site EXIGO-MCRU-HP03.

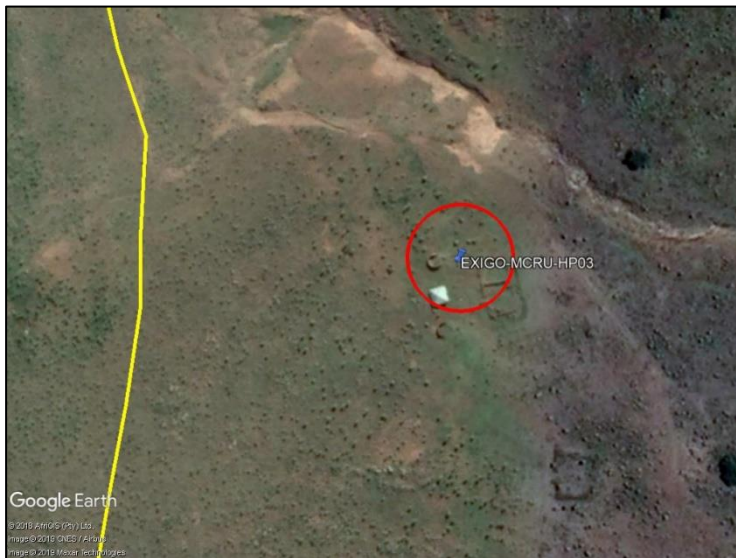
Figure 5-17: Site EXIGO-MCRU- HP03 and a required 20m conservation buffer (red line) in relation to the site proposed for the quarry (yellow line).

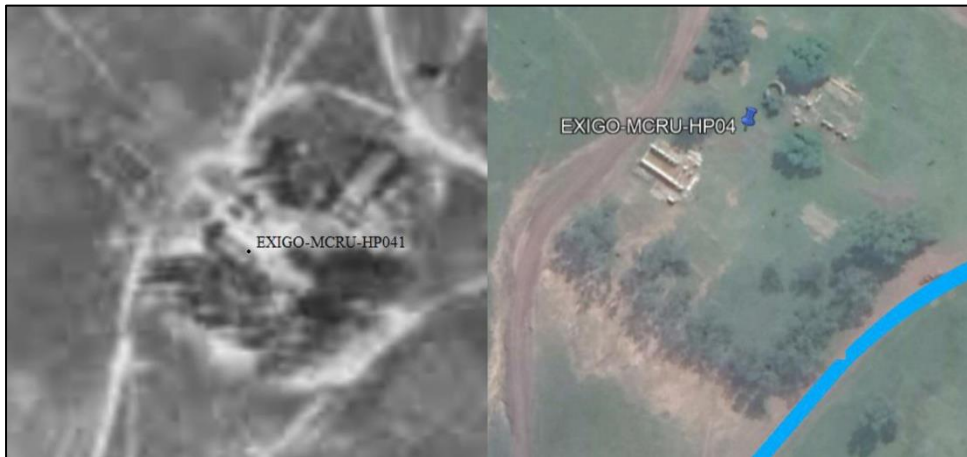
The remains of a compound of Historical Period multi room buildings occur along the road upgrade alignment in the Ntlakwevenkile area. Here, a large multi-room rectangular building once held the Phillipsdale Trading Store and the remains of a sandstone house and a mud brick building occur in its vicinity. An interesting feature at the site is the wall remains of a rondel structure, constructed out of skillfully shaped sandstone blocks. The building remains display typical Historical Period architectural features of the rural areas in the Eastern Cape. The site is visible on archive aerial photographs, it is older than 60 years and generally protected under the National Heritage Resource Act (NHRA 1999). Even though the buildings might afford a better understanding of architectural, settlement and social developments in the Clarkebury landscape, the site is dilapidated and poorly preserved, and it is rated as of medium-low heritage significance. A permit for the destruction of the structures is required subject to the NHRA should these sites be impacted on by the proposed road upgrade.

Figure 5-18: Site EXIGO-MCRU-HP04 indicated on an archive aerial image (1938, left) and current aerial imagery (right).

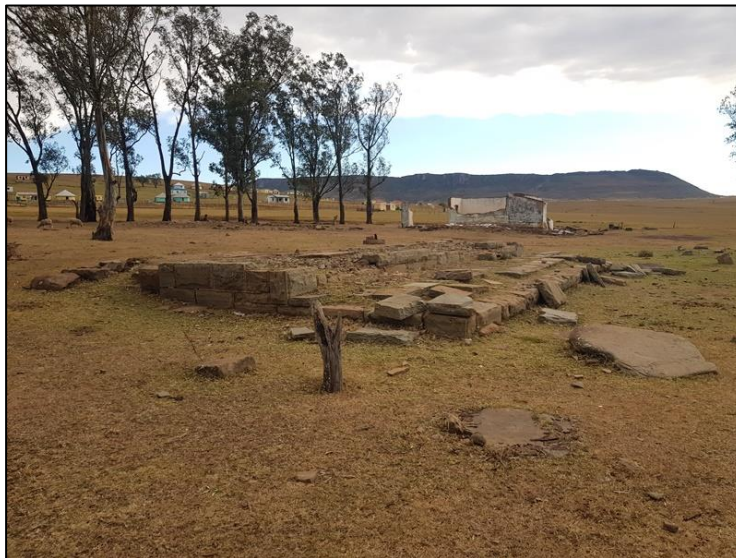
Figure 5-19: View of a sandstone building foundation at Site EXIGO-MCRU-HP04.

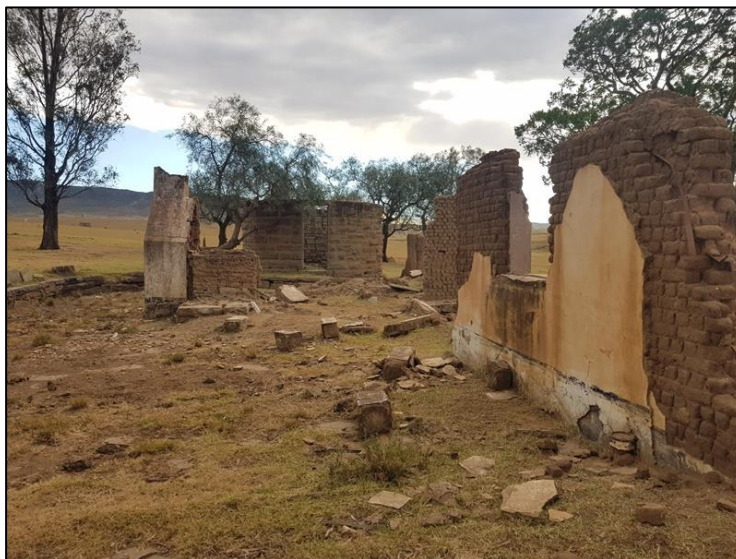
Figure 5-20: View of building remains remains at Site EXIGO-MCRU-HP04. Note the stone rondel in the middle background.

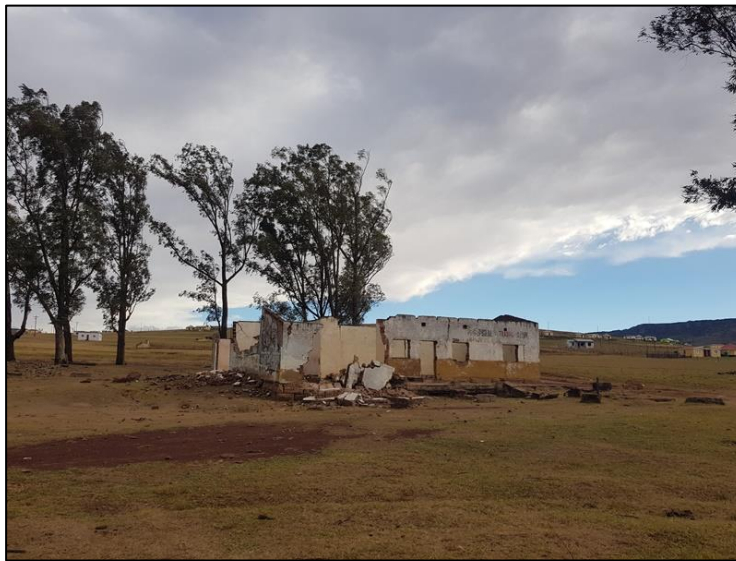
Figure 5-21: View of the remains of the Phillipsdale Trading Store at Site EXIGO-MCRU-HP04.

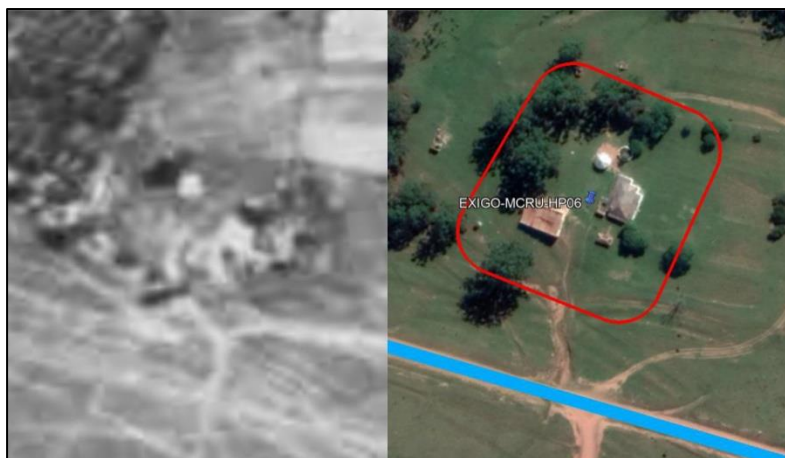
The remains of another compound of Historical Period multi room buildings occur near the south-western offset of the road upgrade alignment south of the Mjanyana area. Here, a large rectangular building once held the Lookout Trading Store and a well-preserved farm house structure, constructed out a plastered up brick, occur in its vicinity. The Lookout Trading Store building has been deserted and it is in a dilapidated state but the farm house is currently occupied. The building remains display typical Historical Period architectural features of the rural areas in the Eastern Cape. The site is visible on archive aerial photographs, it is older than 60 years and generally protected under the National Heritage Resource Act (NHRA 1999). The site and its buildings might afford a better understanding of architectural, settlement and social developments in the Clarkebury landscape and it is rated as of medium heritage significance. As such, careful mitigation measures subject to the NHRA will be required should the site be impacted in any way by the proposed road upgrade.

Figure 5-30: Site EXIGO-MCRU-HP06 (the Lookout Trading Store complex) indicated on an archive aerial image (1938, left) and current aerial imagery (right).

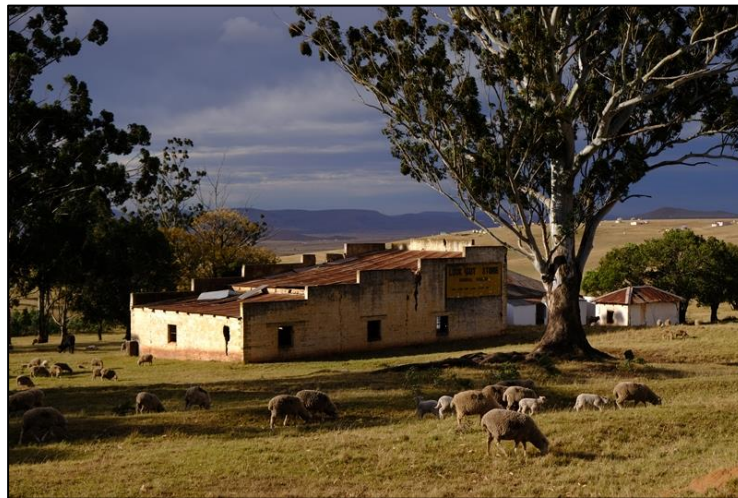
Figure 5-31: View of the Lookout Trading Store and a farmhouse behind it at Site EXIGO-MCRU-HP06.

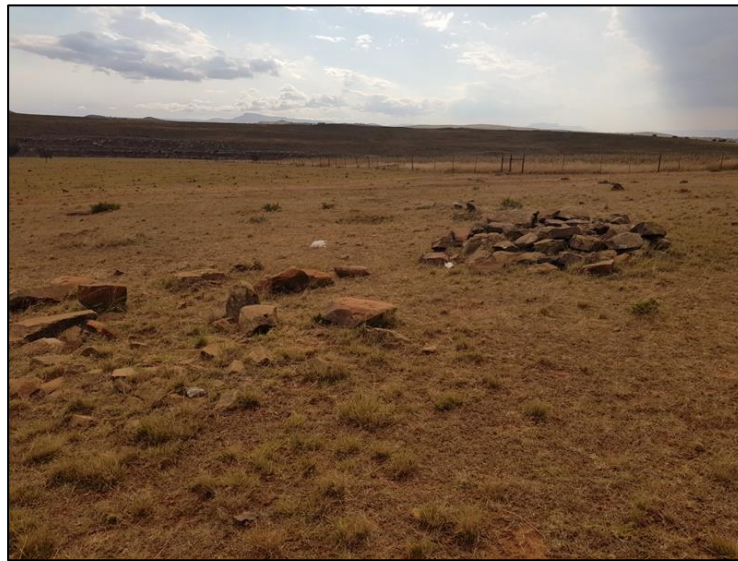
A single grave occurs in an open field in the Luqolweni area directly north of the existing Clarkebury Road. According to local communities, the grave belongs to a member of the Mdaga family who passed away in 1964. The burial is indicated by a large stone cairn, the grave is not fenced off and preservation thereof is fair. The burial site is of high heritage significance, it is situated in the close proximity of the proposed road upgrade route and if a conservation buffer of 20m cannot be maintained, the burial should be relocated according to the applicable social and statutory requirements.

Figure 5-56: View of the burial site at Site EXIGO-MCRU-BP12.

- Graves and burials identified within and in close proximity of the road upgrade, and within the proposed quarry site route are of high significance and these sites require specific mitigation measures. As such, for **Site EXIGO-MCRU-BP12** occurring within the project area it is recommended that the burial be relocated by a qualified archaeologist in accordance with relevant legislation, permitting, statutory permissions and subject to any local and regional provisions and laws and by-laws pertaining to human remains. A full social consultation process should occur in conjunction with the mitigation of cemeteries and burials (see Addendum B). For burial sites occurring less than 10m from impact areas (**Site EXIGO-MCRU-BP07, Site EXIGO-MCRU-BP10, Site EXIGO-MCRU-BP11, Site EXIGO-MCRU-BP19, Site EXIGO-MCRU-BP20**) the implementation of a heritage conservation buffer of at least 3m and the erection of a temporary construction barricade along areas where construction might encroach is recommended. Note that this recommended relaxation of the standard 50m buffer for burials in closed proximity of the alignment is subject to approval by the SAHRA Burial Grounds and Graves (BGG) Unit. The burials should be individually fenced where a fence of at least 1.5m should be erected no closer than 1m from the grave dressing feature. The fence should have an access gate with clear signage to indicate the heritage sensitivity status of the site. Site access should be implemented and arranged with relatives associated with the burials. A site management plan detailing strict site management conservation

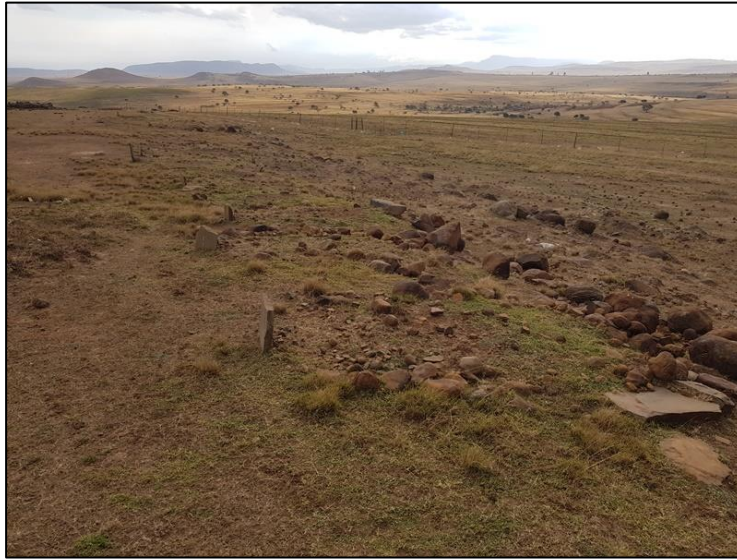
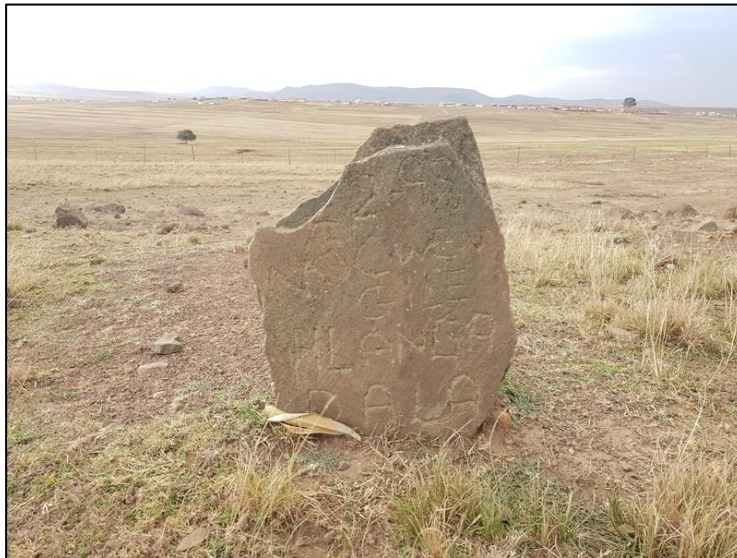
A large community cemetery containing an unknown number of graves occurs in the Ngqubusini area directly north of the existing Clarkebury Road. The majority of burials are indicated by elongated soil mounds and stone cairns which are covered in surface grass and stones. Some burials bear hand-carved headstones and a date of “1898” (?) were noted on one of the headstones. As such, it might be assumed that many of the burials in the cemetery date to the Historical Period. Material culture such as glass and enamel containers were noted in associated with some of the graves. The cemetery is not fenced off but the general condition of the graves is poor. The burial site is of high heritage significance, it is situated in close proximity vicinity of the proposed road upgrade route and a conservation buffer should be observed along with the implementation of strict monitoring protocols. Alternatively, the burials should be relocated according to the applicable social and statutory requirements, should impact prove inevitable.

Figure 5-45: View of the burial site at Site EXIGO-MCRU-BP07.

Figure 5-46: View of a hand-carved headstone at Site EXIGO-MCRU-BP07.

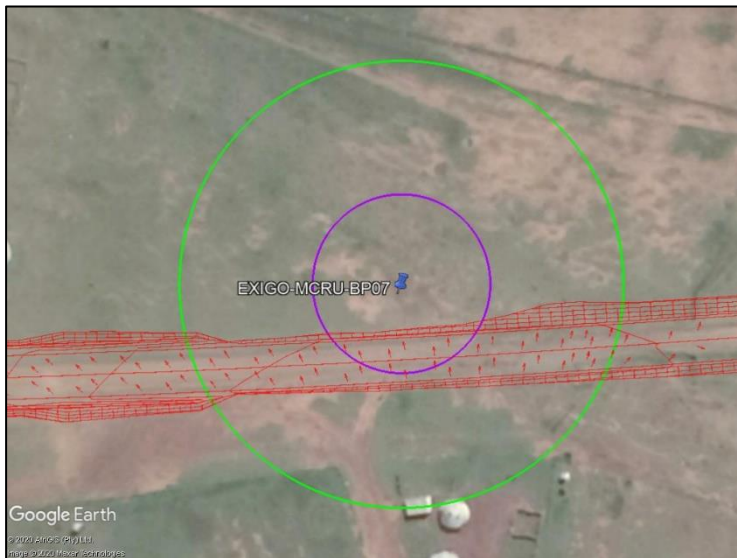
Figure 5-47: Site EXIGO-MCRU-BP07 with 20m buffers (purple) and 50m buffer (green) indicated in relation to the road design (red lines).

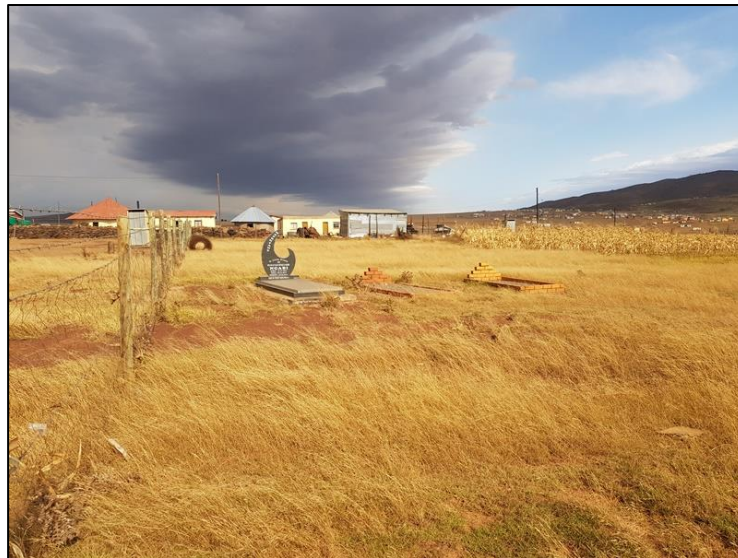
Three graves occur in a crop open in the Luqolweni area directly south of the existing Clarkebury Road. One of the graves is dressed with a marble gravestone and the other burials are indicated by concrete and brick slabs and brick headstones. The graves are not fenced off but they are generally well preserved. The burial site is of high heritage significance, it is situated in close proximity vicinity of the proposed road upgrade route and a conservation buffer should be observed along with the implementation of strict monitoring protocols. Alternatively, the burials should be relocated according to the applicable social and statutory requirements, should impact prove inevitable.

Figure 5-52: View of the burial site at Site EXIGO-MCRU-BP10.

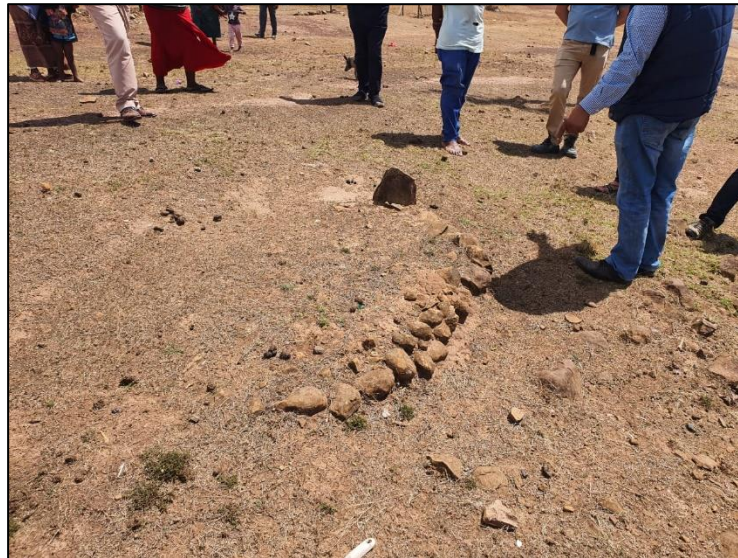
heritage significance, it is situated in close proximity vicinity of the proposed road upgrade route and a conservation buffer should be observed along with the implementation of strict monitoring protocols. Alternatively, the burial should be relocated according to the applicable social and statutory requirements, should impact prove inevitable.

Figure 5-54: View of the burial site at Site EXIGO-MCRU-BP11.

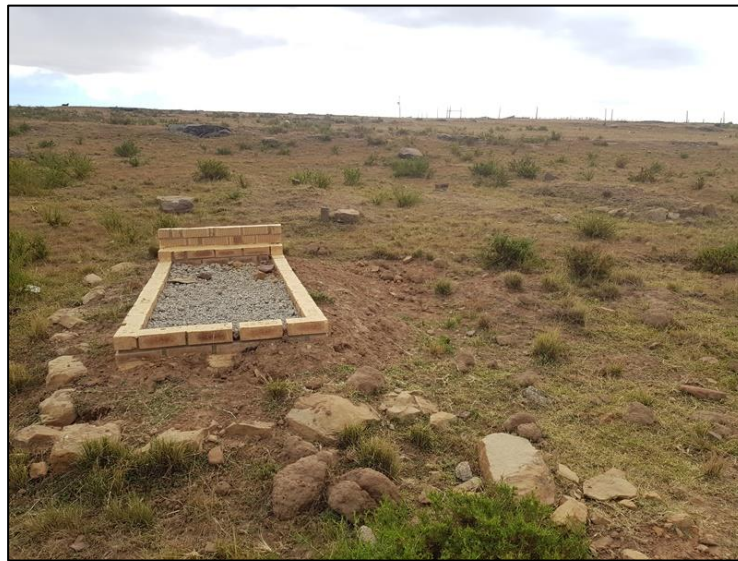
A single grave occurs in an open field in the Ncityana area north of the existing Clarkebury Road. The burial is indicated by a brick structure with stone foundations and filled in with gavel. The grave is not fenced off but it remains in a goof state of preservation. The burial site is of high heritage significance, it is situated in close proximity vicinity of the proposed road upgrade route and a conservation buffer should be observed along with the implementation of strict monitoring protocols. Alternatively, the burial should be relocated according to the applicable social and statutory requirements, should impact prove inevitable.

Figure 5-70: View of the burial site at Site EXIGO-MCRU-BP19.

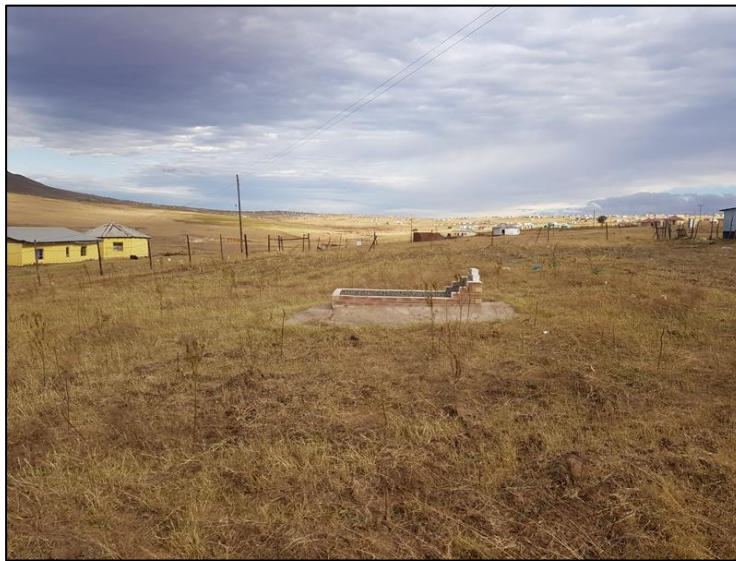
Another single grave occurs in a crop field in the Ncityana area south of the existing Clarkebury Road. The burial is indicated by a brick structure which is filled in with gavel. The grave is not fenced off but it remains in a good state of preservation. The burial site is of high heritage significance, it is situated in close proximity vicinity of the proposed road upgrade route and a conservation buffer should be observed along with the implementation of strict monitoring protocols. Alternatively, the burial should be relocated according to the applicable social and statutory requirements, should impact prove inevitable.

Figure 5-72: View of the burial site at Site EXIGO-MCRU-BP20.

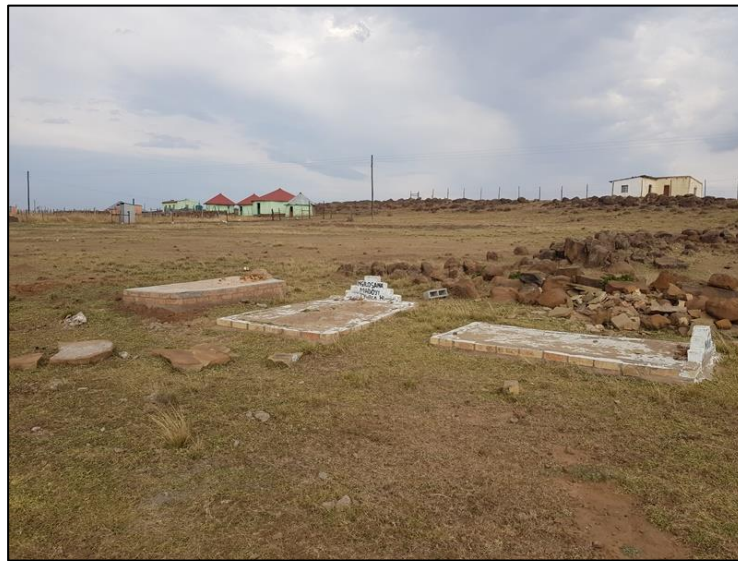
Three graves occur in an open field in the Ngqubusini area directly south of the existing Clarkebury Road. The burials are indicated by concrete and brick slabs and brick headstones. The graves are not fenced off but they are generally well preserved. The burial site is of high heritage significance, it is situated in the close proximity of the proposed road upgrade route and a conservation buffer of 50m should be observed. Alternatively, the burials should be relocated according to the applicable social and statutory requirements, should impact prove inevitable.

Figure 5-43: View of the burial site at Site EXIGO-MCRU-BP06.

- For burial sites occurring less than 50m from impact areas (**Site EXIGO-MCRU-BP06, Site EXIGO-MCRU-BP13, Site EXIGO-MCRU-BP21, Site EXIGO-MCRU-BP22**) the implementation of a heritage conservation buffer of at least 20m is recommended subject to approval by the SAHRA Burial Grounds and Graves (BGG) Unit. The burials should be individually fenced where a fence of at least 1.5m should be erected no closer than 1m from the grave dressing feature. The fence should have an access gate with clear signage to indicate the heritage sensitivity status of the site. Site access should be implemented and arranged with relatives associated with the burials. A site management plan detailing strict site management conservation measures should be compiled for the grave sites. It is essential that sites be monitored on a weekly basis by the heritage specialist / informed ECO in order to detect any impact on the resource at the earliest opportunity.

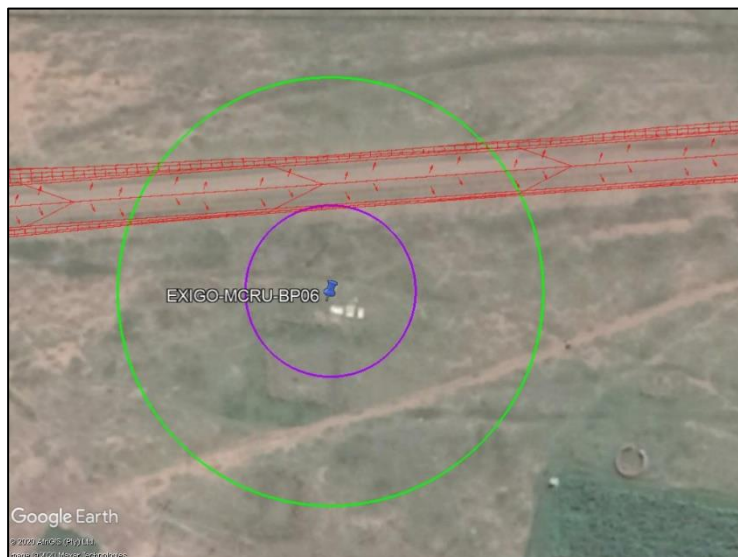
Figure 5-44: Site EXIGO-MCRU-BP06 with 20m buffers (purple) and 50m buffer (green) indicated in relation to the road design (red lines).

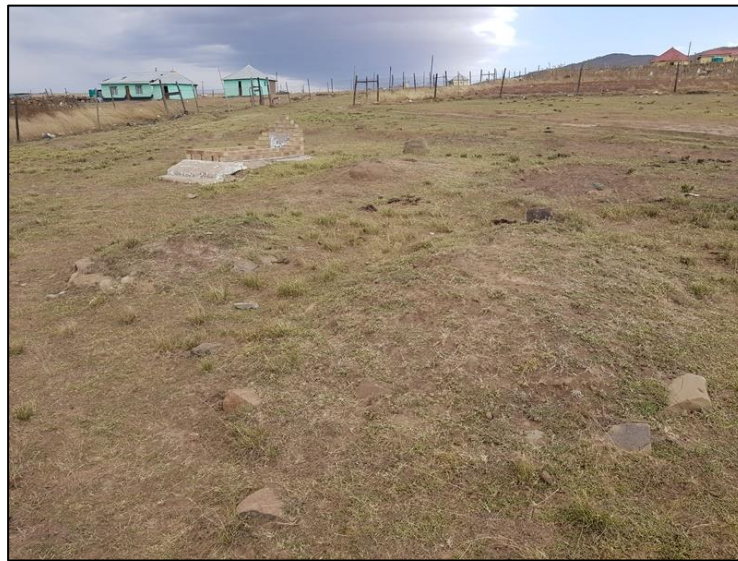
A small cemetery containing at least 4 graves occurs in an open field in the Singeni area directly south of the existing Clarkebury Road. One of the burials is indicated by a brick and concrete dressing and the other graves are indicated by elongated soil and stone mounds which are covered in surface grass and stones. The graves are not fenced off and they are not well preserved. The burial site is of high heritage significance, it is situated in the close proximity of the proposed road upgrade route and a conservation buffer of 50m should be observed. Alternatively, the burials should be relocated according to the applicable social and statutory requirements, should impact prove inevitable.

Figure 5-58: View of the burial site at Site EXIGO-MCRU-BP13.

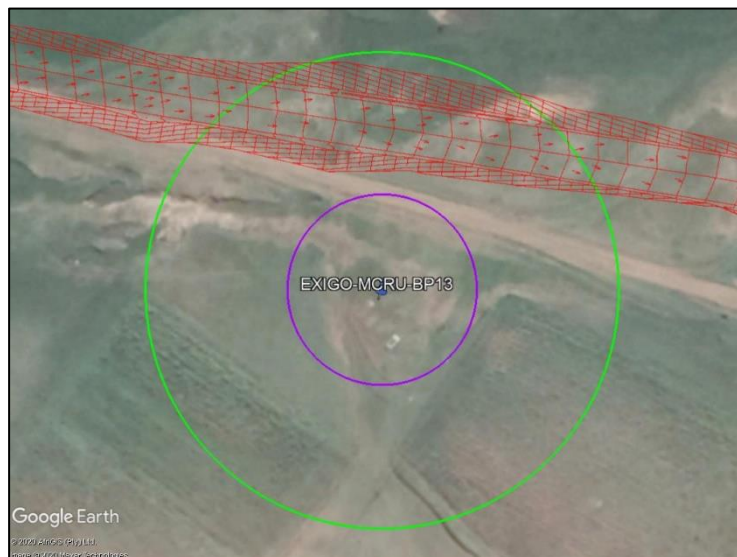
Figure 5-59: Site EXIGO-MCRU-BP13 with 20m buffers (purple) and 50m buffer (green) indicated in relation to the road design (red lines).

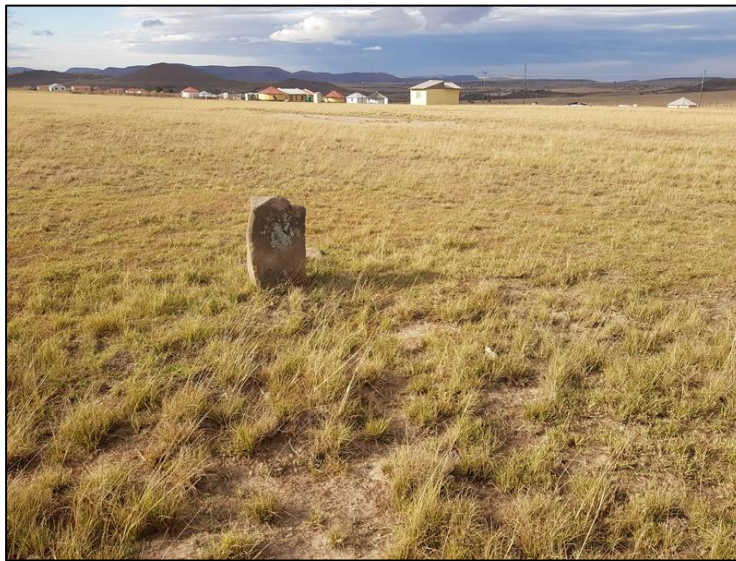
A possible single burial occurs in an open field in the Ncityana area directly north of the existing Clarkebury Road. The potential burial is indicated by an upright monolith which is not marked. The potential burial site is of high heritage significance, it is situated in close proximity of the proposed road upgrade route and a conservation buffer of 50m should be observed. Alternatively, the burial should be relocated according to the applicable social and statutory requirements, should impact prove inevitable.

Figure 5-76: View of the burial site at Site EXIGO-MCRU-BP22.

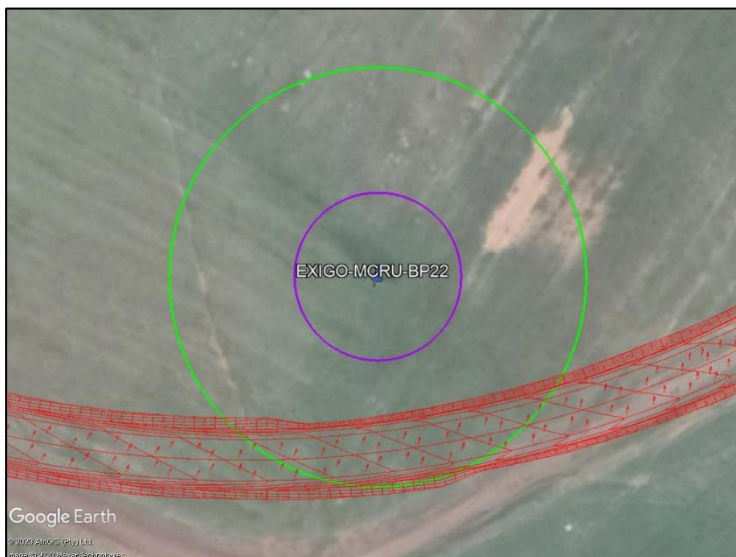
Figure 5-77: Site EXIGO-MCRU-BP22 with 20m buffers (purple) and 50m buffer (green) indicated in relation to the road design (red lines).

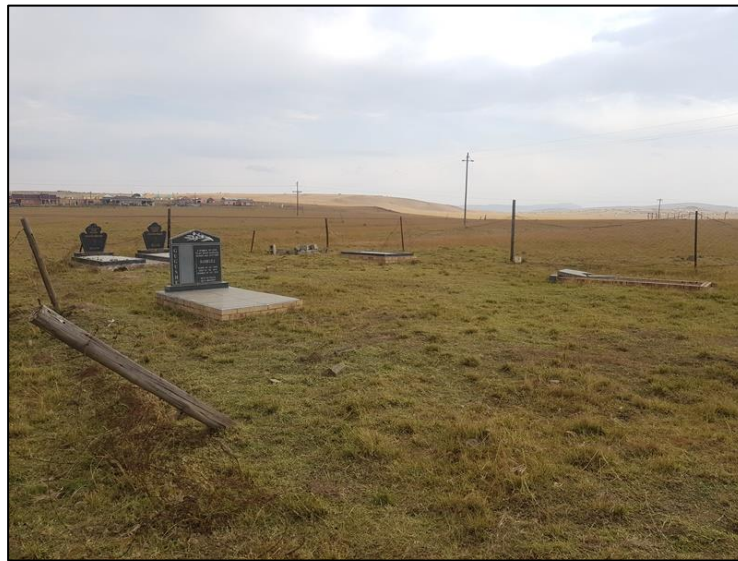
A small cemetery containing at least 7 graves occurs in the KuMbanga area directly east of the DR08034-N2 road. The majority of burials are indicated by concrete and marble stone bases and marked marble headstones. Single graves are indicated by elongated soil mounds which are covered in surface grass and stones. Material culture such as glass and enamel containers were noted in associated with some of the graves. The cemetery is fenced off and the general condition of the graves is good. The burial site is of high heritage significance, it is situated in the general vicinity of the proposed road upgrade route and a conservation buffer of 50m should be observed. Alternatively, the burials should be relocated according to the applicable social and statutory requirements, should impact prove inevitable.

Figure 5-33: View of the burial site at Site EXIGO-MCRU-BP01.

- For burial sites occurring within the larger project landscape (**Site EXIGO-MCRU-BP01, Site EXIGO-MCRU-BP02, Site EXIGO-MCRU-BP03, Site EXIGO-MCRU-BP04, Site EXIGO-MCRU-BP05, Site EXIGO-MCRU-BP08, Site EXIGO-MCRU-BP09, Site EXIGO-MCRU-BP14, Site EXIGO-MCRU-BP15, Site EXIGO-MCRU-BP16, Site EXIGO-MCRU-BP17, Site EXIGO-MCRU-BP18**) the implementation of a heritage conservation buffer of at least 50m is recommended subject to approval by the SAHRA Burial Grounds and Graves (BGG) Unit. It is essential that sites be monitored on a frequent basis by the heritage specialist / informed ECO in order to detect any impact on the resource at the earliest opportunity.

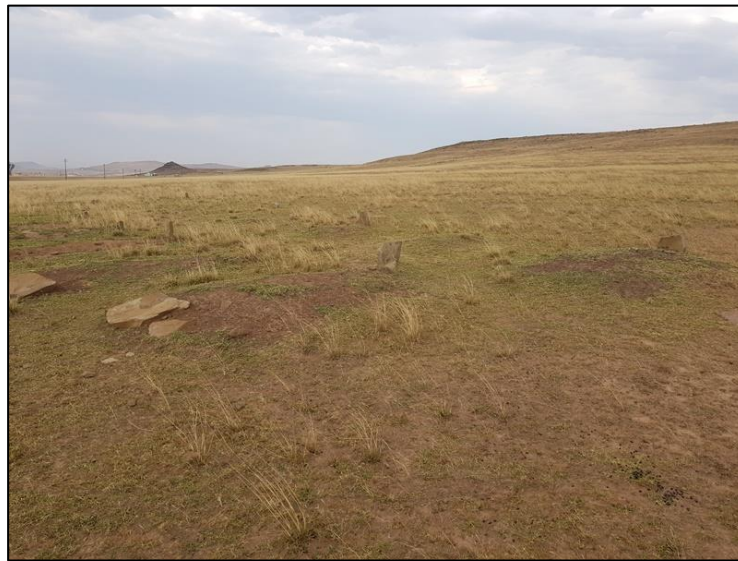
At least 8 graves occur in an open field in the Mtshayelweni area directly south of the existing Clarkebury Road. The burials are indicated by soil mounds and some graves bear unmarked rocks headstones. The site is not fenced and the graves are in a poor state of preservation. The burial site is of high heritage significance, it is situated in close proximity of proposed road upgrade route and a conservation buffer of 50m should be observed. Alternatively, the burials should be relocated according to the applicable social and statutory requirements, should impact prove inevitable.

Figure 5-35: View of the burial site at Site EXIGO-MCRU-BP02.

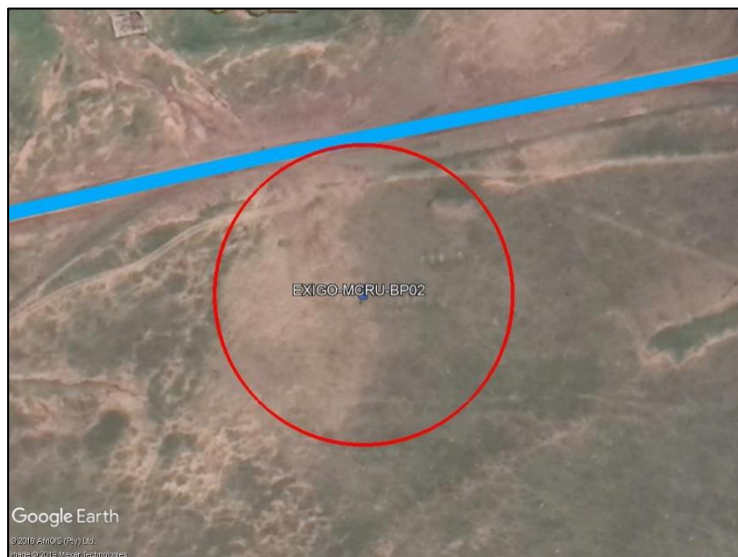
Figure 5-36: Site EXIGO-MCRU-BP02 and a required 50m conservation buffer (red line) in relation to the road alignment (blue line).
