**CES: PROPOSED MBSA CLARKEBURY ROAD UPGRADE
PROJECT, CLARKEBURY AREA, OR TAMBO DISTRICT
MUNICIPALITY, EASTERN CAPE PROVINCE**

Archaeological Impact Assessment

ARCHAEOLOGICAL IMPACT ASSESSMENT (AIA) OF AREAS DEMARCTED FOR UPGRADING TO A SURFACE STANDARD MBSA CLARKEBURY ROAD UPGRADE PROJECT, CLARKEBURY AREA, OR TAMBO DISTRICT MUNICIPALITY, EASTERN CAPE PROVINCE

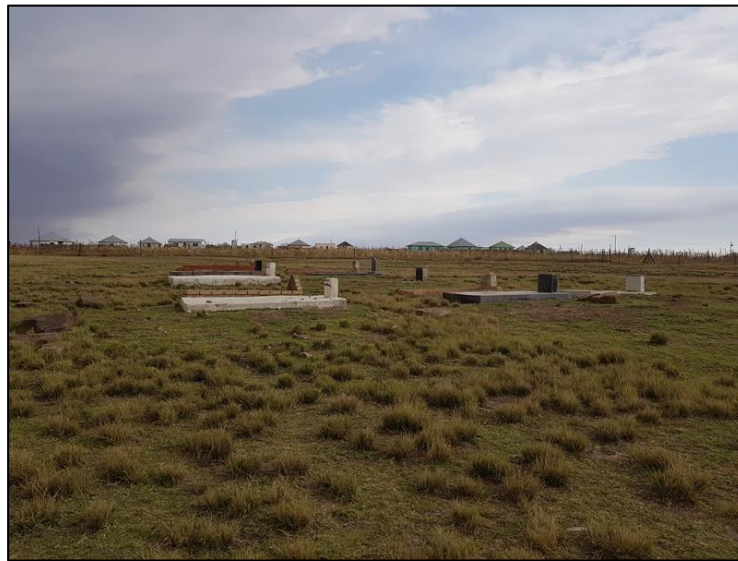
A small cemetery containing at least 7 graves occurs in the Ngqubusini area south of the existing Clarkebury Road. The majority of burials are indicated by concrete slabs and cement headstones. Single graves are indicated by elongated soil mounds which are covered in surface grass and stones. Material culture such as glass and enamel containers were noted in associated with some of the graves. The cemetery is not fenced off but the general condition of the graves is good. The burial site is of high heritage significance, it is situated in the general vicinity of the proposed road upgrade route and a conservation buffer of 50m should be observed. Alternatively, the burials should be relocated according to the applicable social and statutory requirements, should impact prove inevitable.

Figure 5-37: View of the burial site at Site EXIGO-MCRU-BP03.

- For burial sites occurring within the larger project landscape (**Site EXIGO-MCRU-BP01, Site EXIGO-MCRU-BP02, Site EXIGO-MCRU-BP03, Site EXIGO-MCRU-BP04, Site EXIGO-MCRU-BP05, Site EXIGO-MCRU-BP08, Site EXIGO-MCRU-BP09, Site EXIGO-MCRU-BP14, Site EXIGO-MCRU-BP15, Site EXIGO-MCRU-BP16, Site EXIGO-MCRU-BP17, Site EXIGO-MCRU-BP18**) the implementation of a heritage conservation buffer of at least 50m is recommended subject to approval by the SAHRA Burial Grounds and Graves (BGG) Unit. It is essential that sites be monitored on a frequent basis by the heritage specialist / informed ECO in order to detect any impact on the resource at the earliest opportunity.

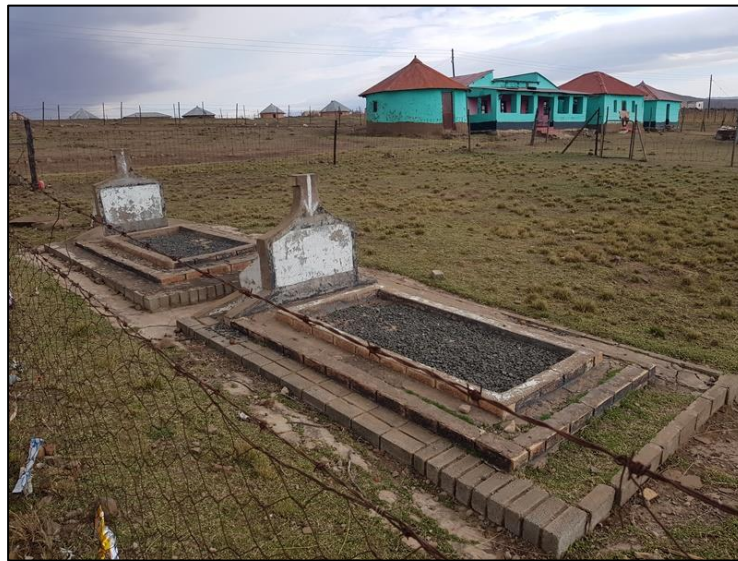
Two graves occur within a homestead complex in the Ngqubusini area south of the existing Clarkebury Road. The burials are covered with brick and filled-in gravel grave dressings bearing cement headstones. The cemetery are fenced off but the general condition of the graves is good. The burial site is of high heritage significance, it is situated in the general vicinity of the proposed road upgrade route and a conservation buffer of 50m should be observed. Alternatively, the burials should be relocated according to the applicable social and statutory requirements, should impact prove inevitable.

Figure 5-39: View of the burial site at Site EXIGO-MCRU-BP04.

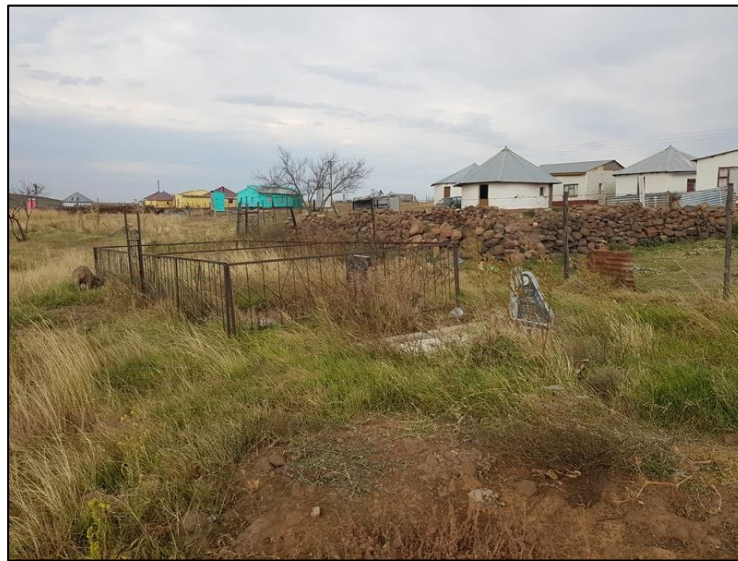
A small cemetery containing at least 5 graves occurs next to a homestead in the Ngqubusini area south of the existing Clarkebury Road. The majority of burials are indicated by concrete slabs and marked marble headstones. Single graves are indicated by elongated soil mounds which are covered in surface grass and stones. Some of the graves are individually fenced off with cast iron fences and the general condition of the graves, which are partially obstructed by surface vegetation, is good. The burial site is of high heritage significance, it is situated in the general vicinity of the proposed road upgrade route and a conservation buffer of 50m should be observed. Alternatively, the burials should be relocated according to the applicable social and statutory requirements, should impact prove inevitable.

Figure 5-41: View of the burial site at Site EXIGO-MCRU-BP05.

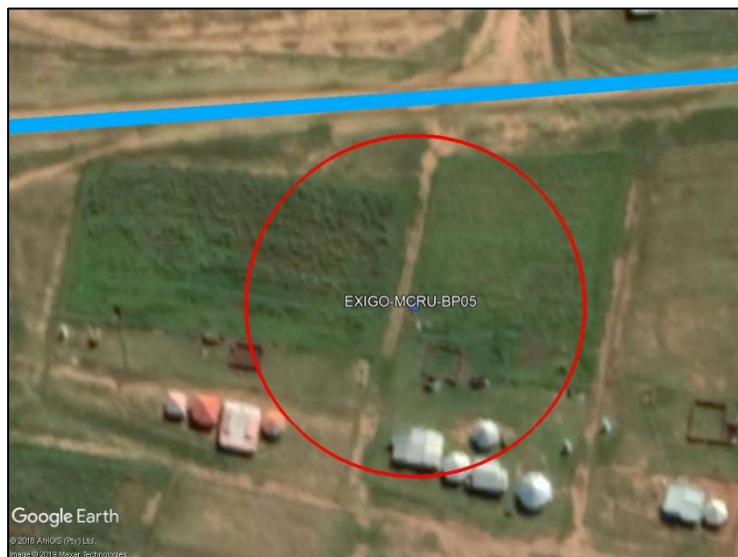
Figure 5-42: Site EXIGO-MCRU-BP05 and a required 50m conservation buffer (red line) in relation to the road alignment (blue line).

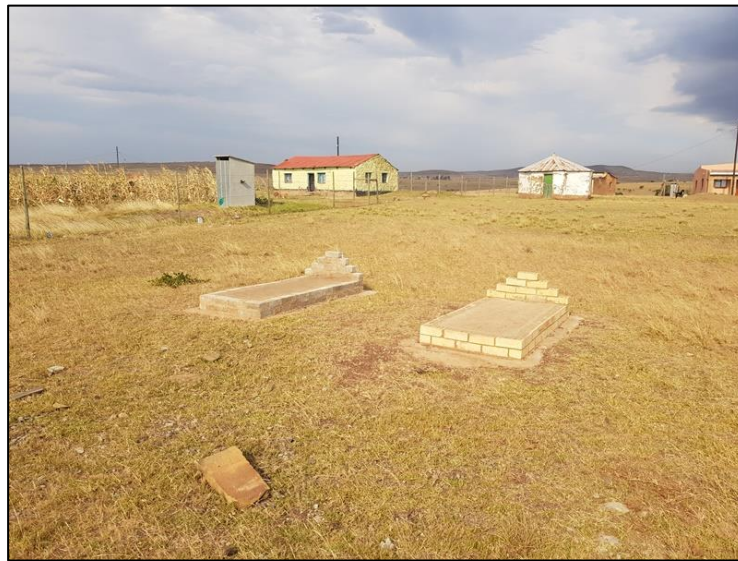
Two graves occur in an open field in the Luqolweni area south of the existing Clarkebury Road. The burials are indicated by concrete and brick slabs and brick headstones. The graves are not fenced off but they are generally well preserved. The burial site is of high heritage significance, it is situated in the close proximity of the proposed road upgrade route and a conservation buffer of 50m should be observed. Alternatively, the burials should be relocated according to the applicable social and statutory requirements, should impact prove inevitable.

Figure 5-48: View of the burial site at Site EXIGO-MCRU-BP08.

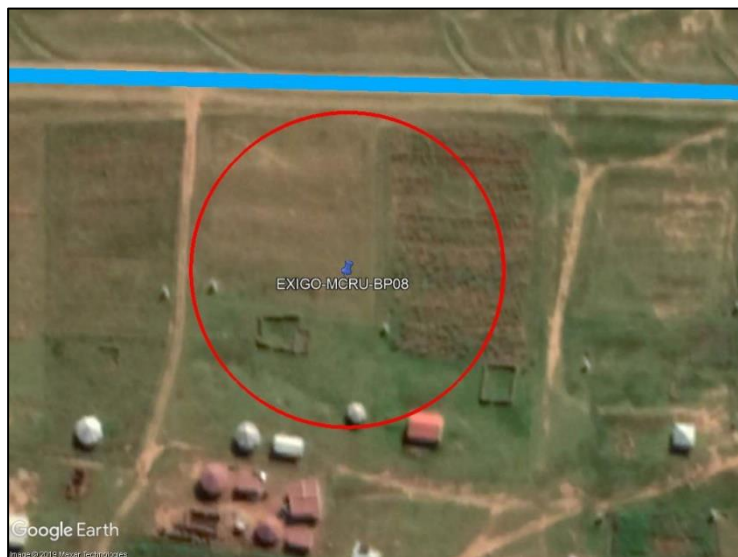
Figure 5-49: Site EXIGO-MCRU-BP08 and a required 50m conservation buffer (red line) in relation to the road alignment (blue line).

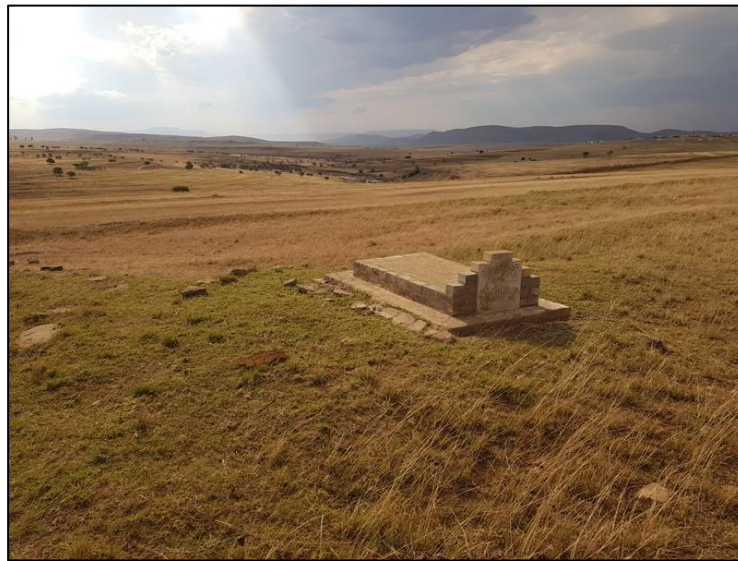
A single grave occurs in an open field in the Luqolweni area directly north of the existing Clarkebury Road. The burial is indicated by a concrete and brick grave dressing with brick headstone. The grave is not fenced off but it is generally well preserved. The burial site is of high heritage significance, it is situated in the close proximity of the proposed road upgrade route and a conservation buffer of 50m should be observed. Alternatively, the burial should be relocated according to the applicable social and statutory requirements, should impact prove inevitable.

Figure 5-50: View of the burial site at Site EXIGO-MCRU-BP09.

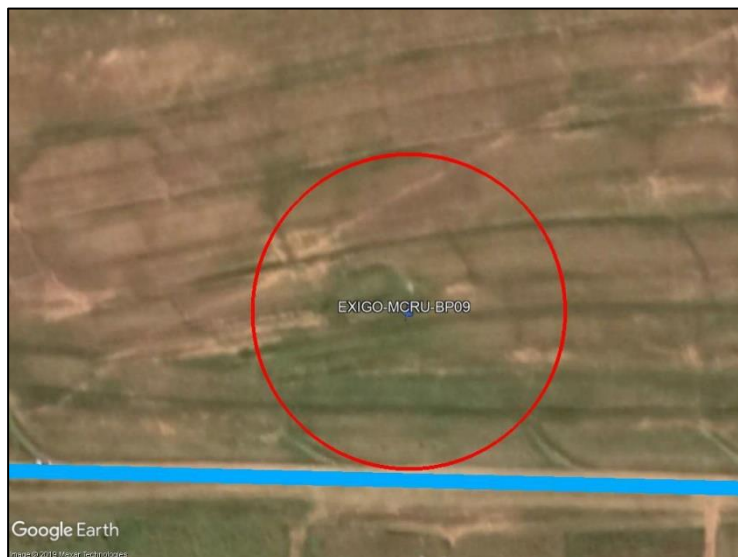
Figure 5-51: Site EXIGO-MCRU-BP09 and a required 50m conservation buffer (red line) in relation to the road alignment (blue line).

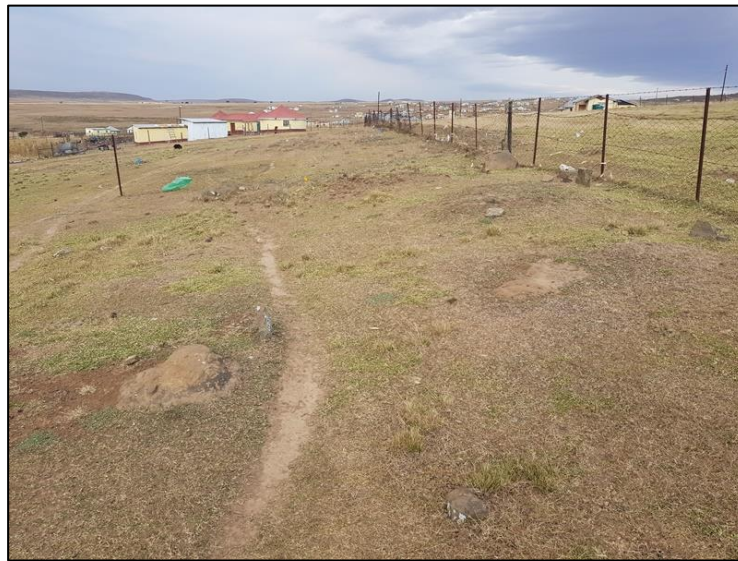
At least four graves occur next to a crop field in the Singeni area directly south of the existing Clarkebury Road. The poorly visible burials are indicated by soil mounds and stone cairns. The graves are not fenced off and they are not well preserved. The burial site is of high heritage significance, it is situated in the close proximity of the proposed road upgrade route and a conservation buffer of 50m should be observed. Alternatively, the burials should be relocated according to the applicable social and statutory requirements, should impact prove inevitable.

Figure 5-60: View of the burial site at Site EXIGO-MCRU-BP14.

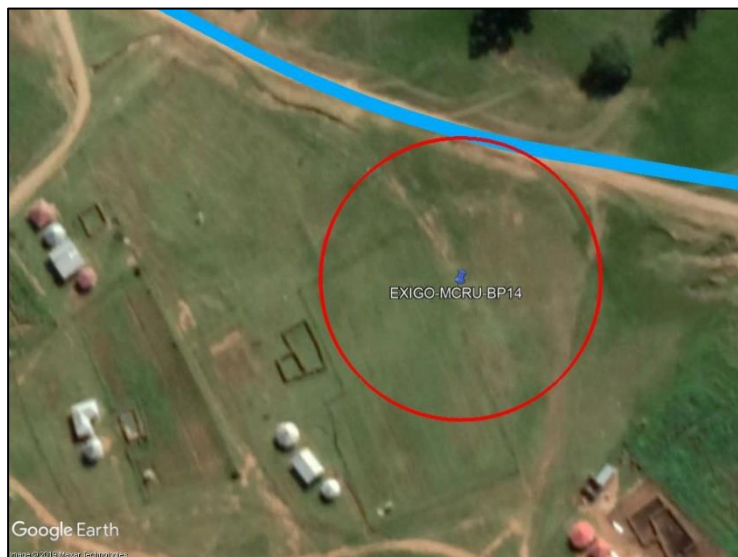
Figure 5-61: Site EXIGO-MCRU-BP14 and a required 50m conservation buffer (red line) in relation to the road alignment (blue line).

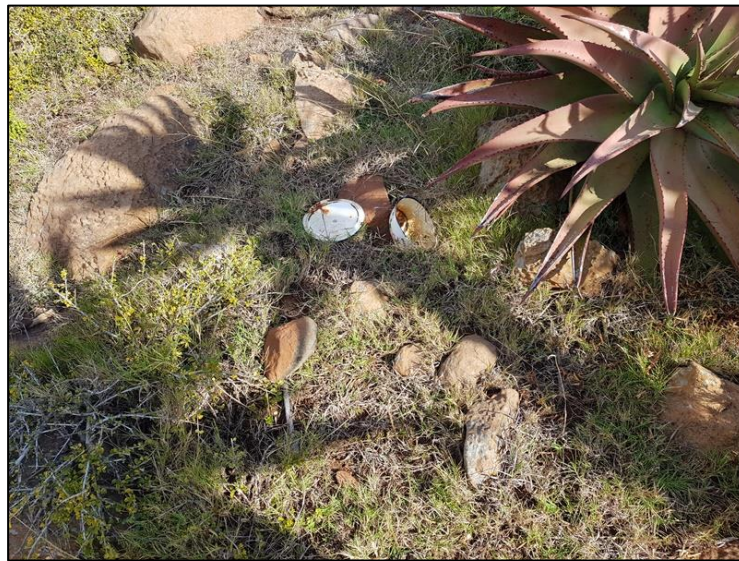
A possible burial site occurs on the summit of a hill at Qulugu, at the site proposed for the road quarry. The potential burial is indicated by an elongated stone cairn which is covered in surface grass and aloe. Material culture such as glass and enamel containers and serving bowls were observed where they were placed on the cairn. The secluded location of the potential grave coupled with its placement on the summit of a prominent hill might imply that the burial might have belonged to a high-status individual but it should be noted that local communities bear no knowledge of a burial site at this location (see Addendum 1). The potential burial is not fenced, it is of high heritage significance if indeed a human grave and a conservation buffer of 50m should be observed at all times. Alternatively, the possible burial should be relocated according to the applicable social and statutory requirements, should impact prove inevitable.

Figure 5-62: View of the potential burial site at Site EXIGO-MCRU-BP15.

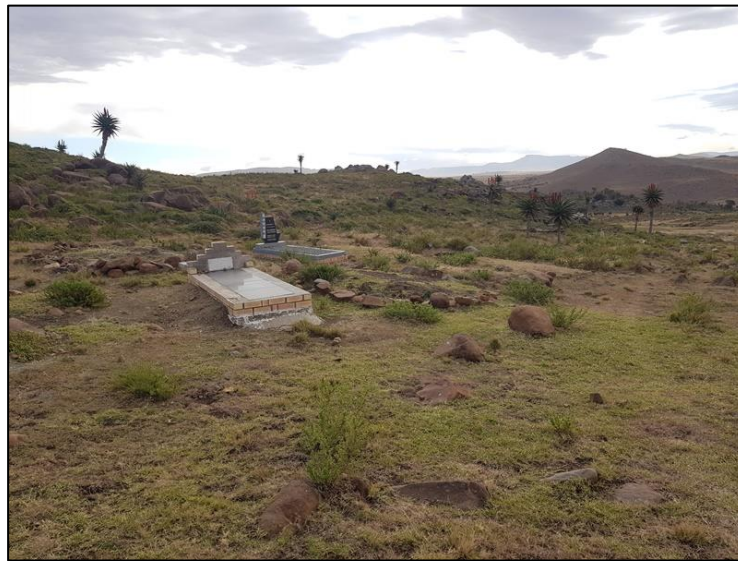
A small cemetery containing at least 6 graves occurs in an open field in the Singeni area south of the existing Clarkebury Road. One of the burials is indicated by a marble grave dressing and another is indicated with a brick and concrete structure. The other graves are indicated by elongated soil and stone mounds which are covered in surface grass and stones. The graves are not fenced off and they remain in a fair state of preservation. The burial site is of high heritage significance, it is situated in the general vicinity of the proposed road upgrade route and a conservation buffer of 50m should be observed. Alternatively, the burials should be relocated according to the applicable social and statutory requirements, should impact prove inevitable.

Figure 5-64: View of the burial site at Site EXIGO-MCRU-BP16.

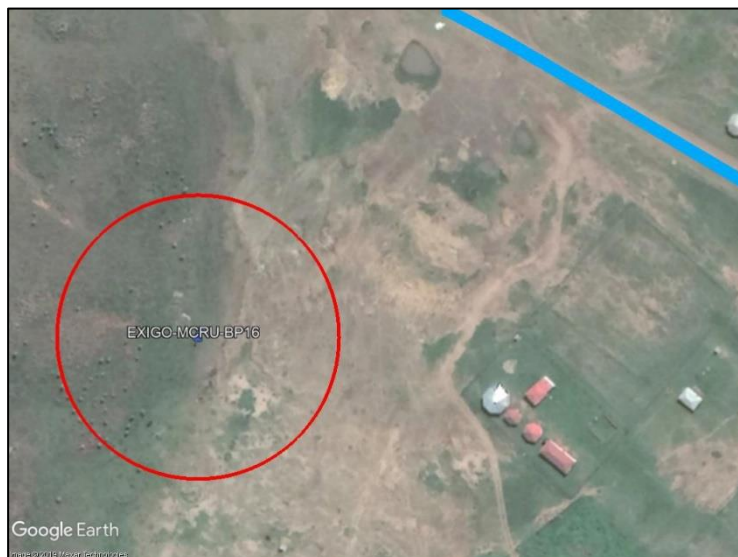
Figure 5-65: Site EXIGO-MCRU-BP16 and a required 50m conservation buffer (red line) in relation to the road alignment (blue line).

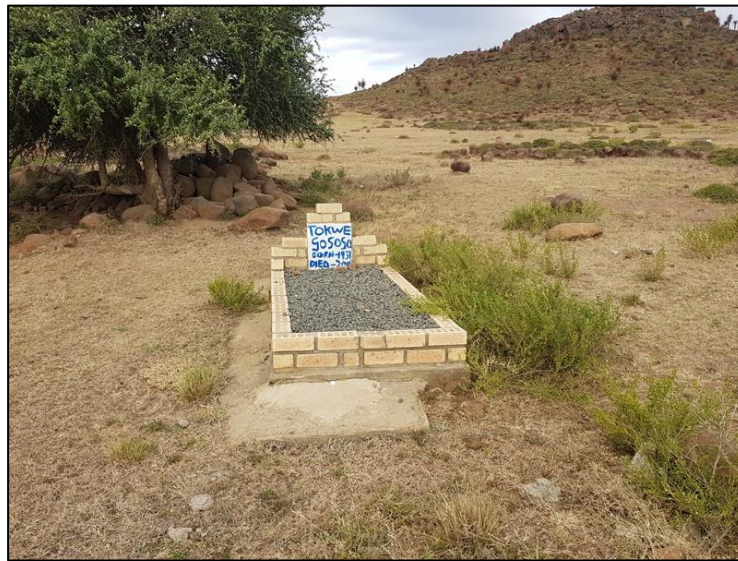
A single grave occurs next to a quarry in an open field in the Singeni area south of the existing Clarkebury Road. The burial is indicated by a brick structure which is filled in with gavel. A concrete headstone bears the name, birth date and date of passing (2011?) of the deceased. The grave is not fenced off but it remains in a goof state of preservation. The burial site is of high heritage significance, it is situated in the general vicinity of the proposed road upgrade route and a conservation buffer of 50m should be observed. Alternatively, the burial should be relocated according to the applicable social and statutory requirements, should impact prove inevitable.

Figure 5-66: View of the burial site at Site EXIGO-MCRU-BP17.

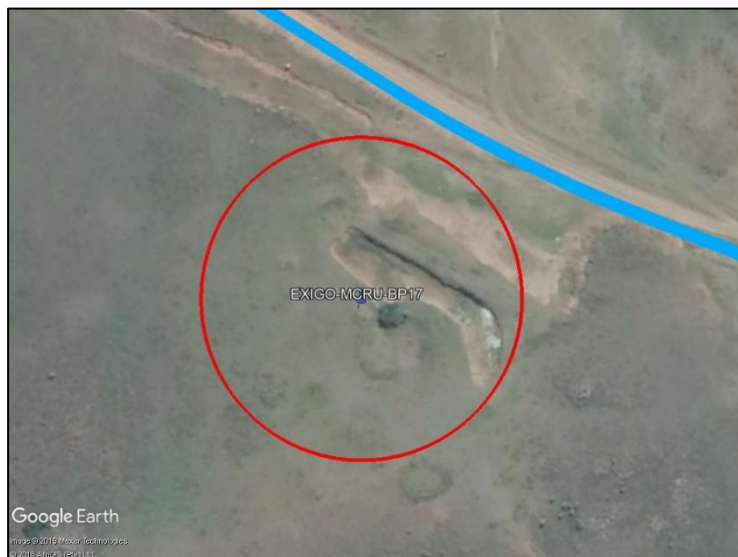
Figure 5-67: Site EXIGO-MCRU-BP17 and a required 50m conservation buffer (red line) in relation to the road alignment (blue line).

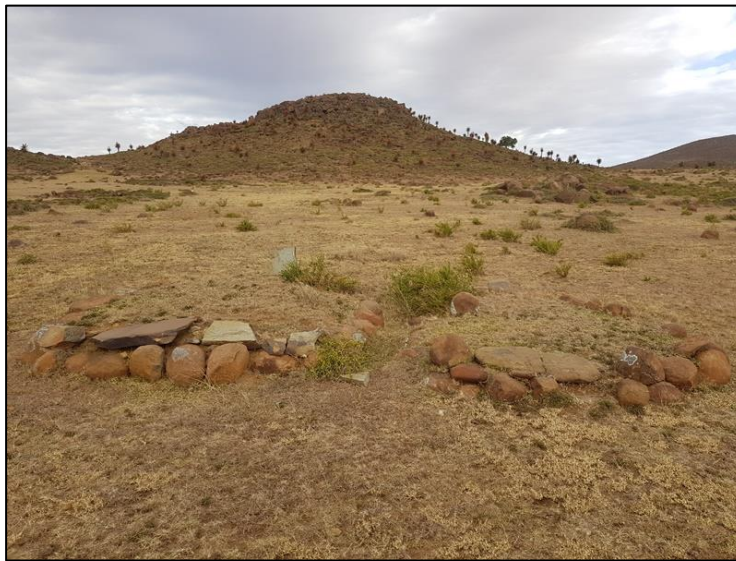
Two graves occur near a small quarry in an open field in the Singeni area south of the existing Clarkebury Road. The burials are indicated by elongated soil and stone mounds which are covered in surface grass. The graves are not fenced off and they remain in a fair state of preservation. The burial site is of high heritage significance, it is situated in the general vicinity of the proposed road upgrade route and a conservation buffer of 50m should be observed. Alternatively, the burials should be relocated according to the applicable social and statutory requirements, should impact prove inevitable.

Figure 5-68: View of the burial site at Site EXIGO-MCRU-BP18.

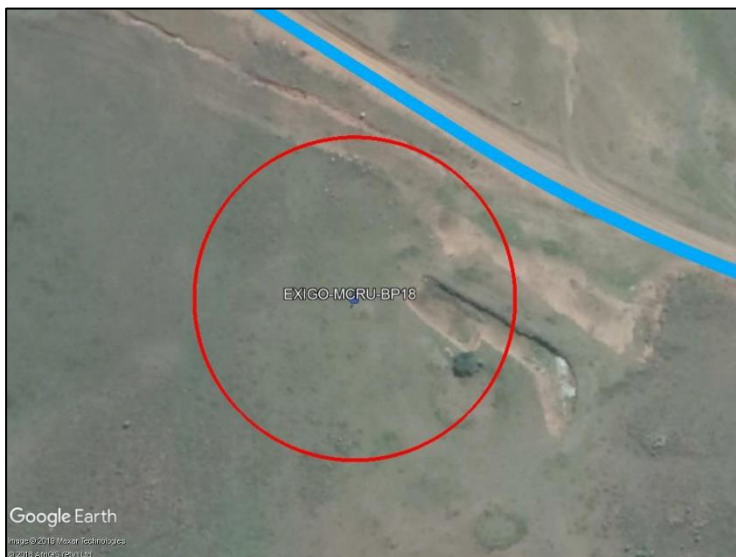
Figure 5-69: Site EXIGO-MCRU-BP18 and a required 50m conservation buffer (red line) in relation to the road alignment (blue line).

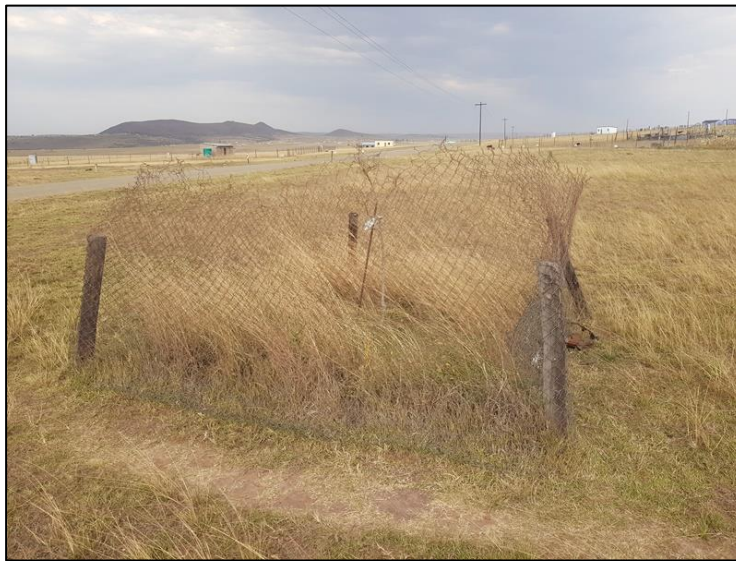
A small enclosure consisting of wooden posts and a wire fence encloses a small tree at the eastern offset of the road upgrade alignment in the KuMbanga area. Even though the site is probably not of heritage importance, any social or cultural association to the feature should be considered and observed.

Figure 5-78: View of the fenced tree at Site EXIGO-MCRU-FT01.

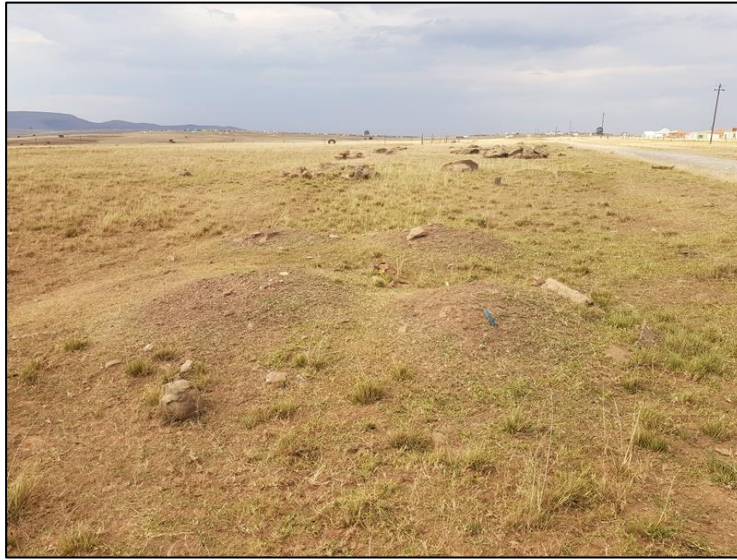
Four large mounds were noted in an open field in the Luqolweni area directly north of the existing Clarkebury Road. Initially, these features were flagged as human burials but local communities indicated that horses were buried at the site. Apparently, the horses were killed by lightning where after they were buried under the mounds. Even though the site is not of heritage importance, cognizance should be taken of the fact that human burials do occur in the immediate landscape. Any social or cultural association to the feature should also be considered and observed.

Figure 5-80: View of the burial site at Site EXIGO-MCRU-FT02.
