HERITAGE IMPACT ASSESSMENT

MR 356 Eden

Vanwyksdorp – Eden Municipality, Western Cape

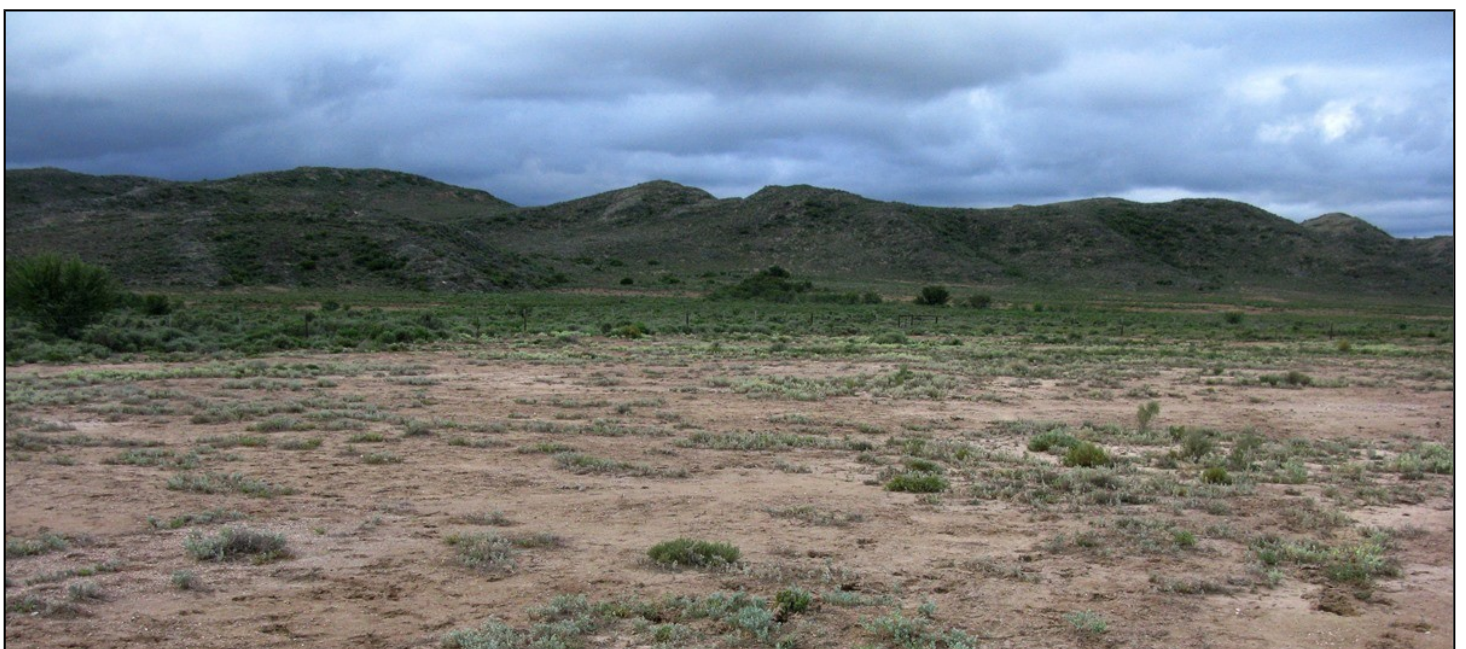
Figure 2: View across the flat-lying borrow pit study area showing pale grey-brown silty alluvial soils with low hills of Karoo Formation rocks in the background (Almond 2013: 4)

Dr John Almond conducted a palaeontological field assessment and provided a report outlining geological context, palaeontological heritage and palaeontological sensitivity. The borrow pit is to be excavated into marginal marine sediments of the Karies Formation (Upper Bokkeveld Group). Important Middle Devonian fossil assemblages of fish, plants, non-marine bivalves and trace fossils have been recorded elsewhere from this stratigraphic unit. However, the Upper Bokkeveld sediments in the study area are highly weathered and cleaved, so their palaeontological sensitivity is correspondingly very low. The overlying silty alluvial soils and fine downwasted quartz-rich gravels are apparently unfossiliferous (Almond, 2013: 1).

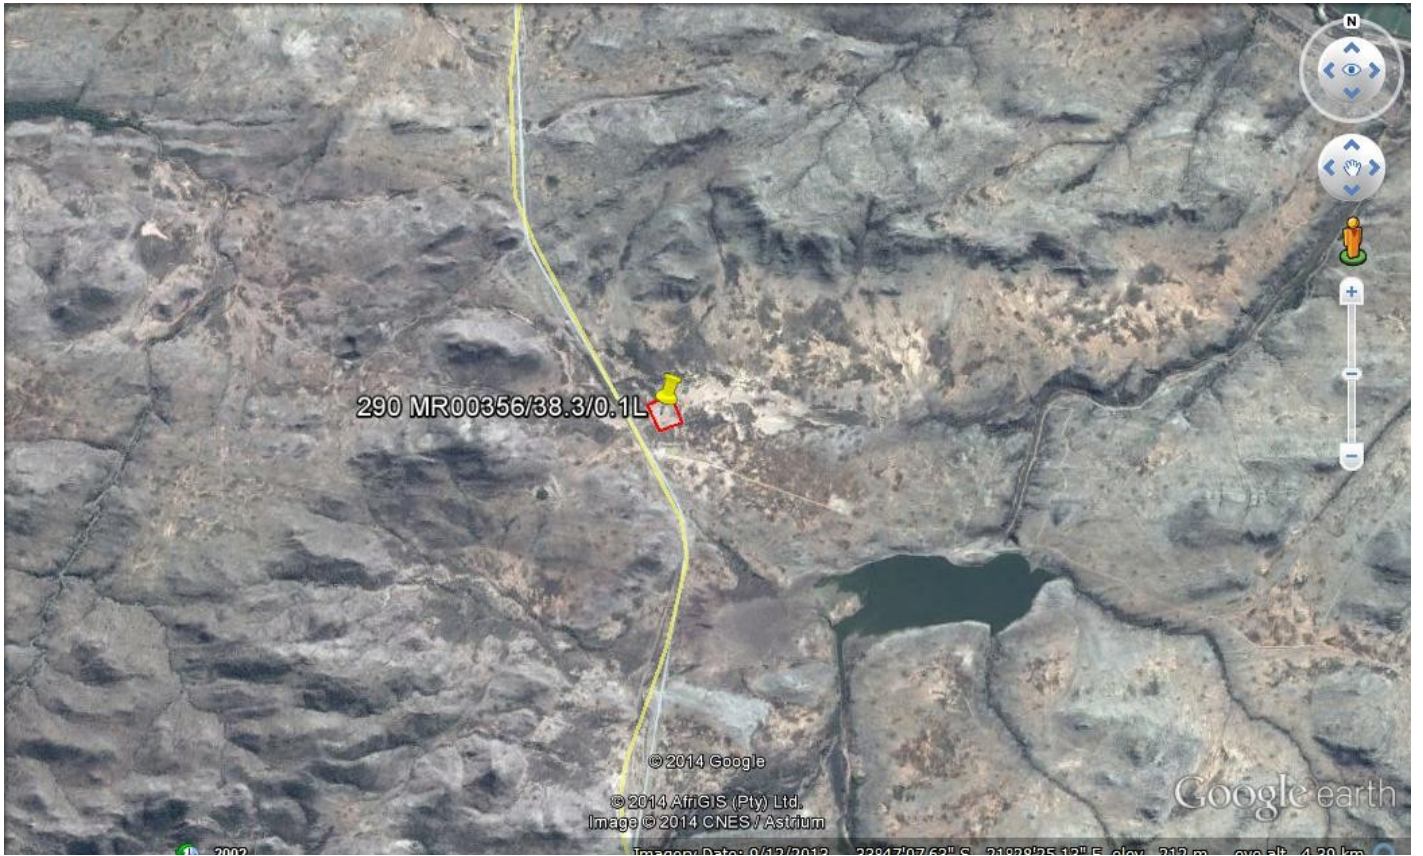
Figure 3: Site context and borrow pit location (Google earth, May 2014)

Proposal is for an extension of an existing borrow pit located along the unsealed MR 356/38.3/0.1L approximately 4.4 km southeast of Vanwyksdorp, Eden District Municipality. The pit is located in fairly flat to gently sloping terrain to the south of an east-west trending range of low hills 3 km south of the Grootrivier. Semi-desert grass and succulents surround the borrow pit. The site is situated on MR356 Road Reserve in private ownership Eden Municipality. Borrow pit co-ordinates are 33°47'5.15"S, 21°28'18.93"E

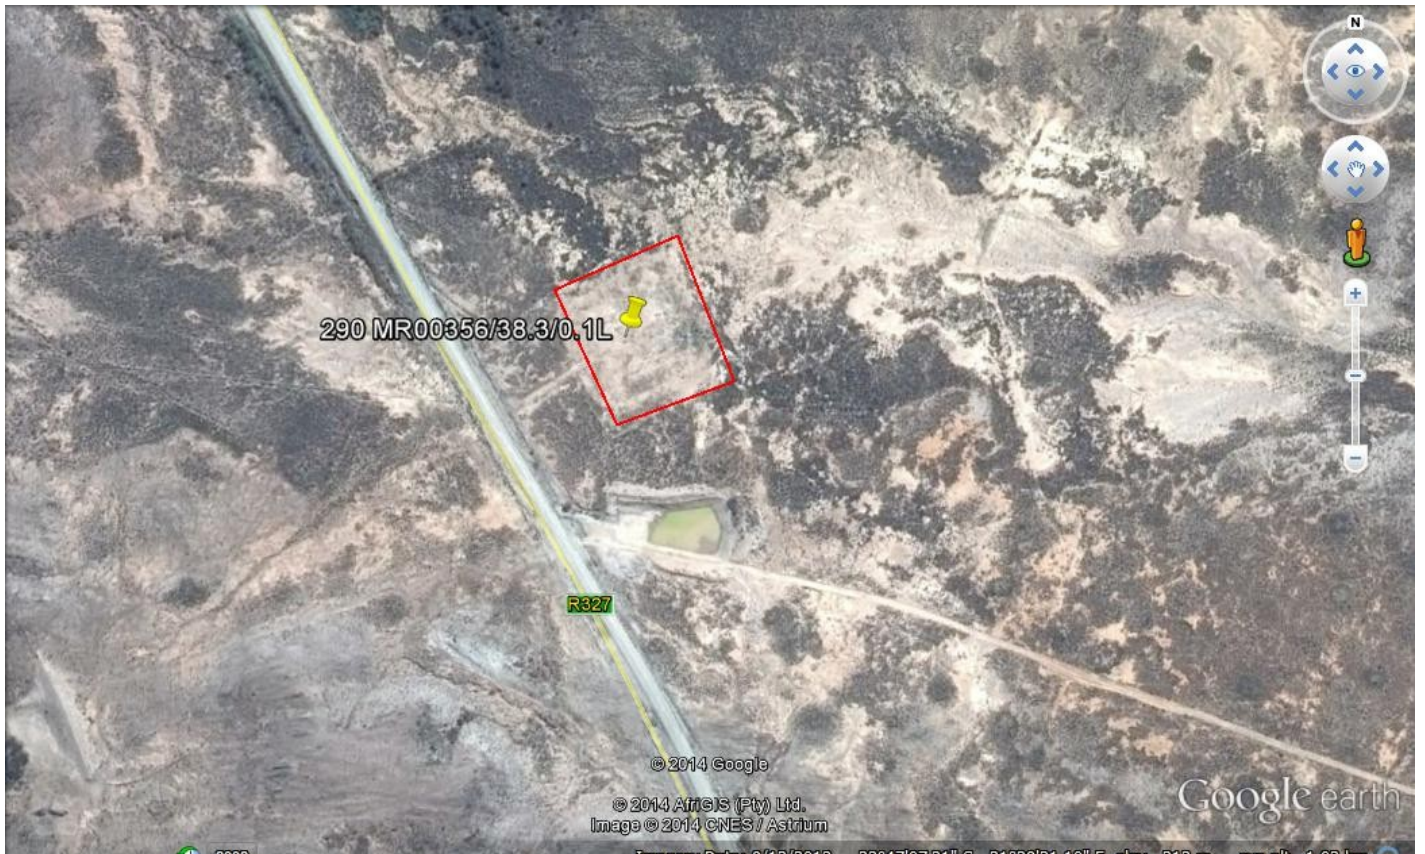
Figure 4: Aerial view of borrow pit and preliminary pit area (Google earth, May 2014)
