**ARCHAEOLOGICAL IMPACT ASSESSMENT
OF THE PROPOSED EXTENSION OF A BORROW PIT ON
ERF 521, UNIONDALE, EDEN DISTRICT MUNICIPALITY,
WESTERN CAPE**

(Assessment conducted under Section 38 (8) of the National Heritage Resources Act as part
of a Heritage Impact Assessment)

AUGUST 2014

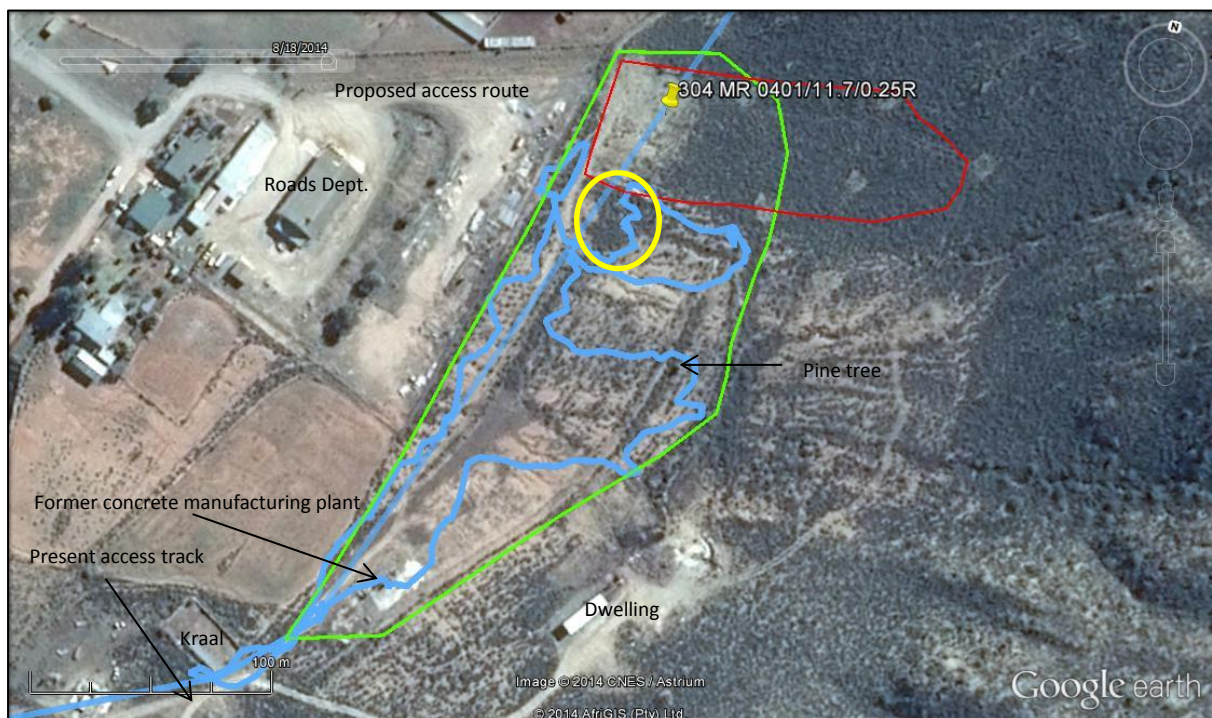
Environment: The proposed pit extension is located in a fairly flat-lying, highly disturbed area at the north-eastern edge of Uniondale (Figures 1 and 2). The relative positions of the original and revised proposed extensions, as well as the location of the cemetery identified by Halkett (2013), are given in Figure 2. It can be seen that the revised polygon (in green) overlaps with the original one (in red) and both proposed extensions overlap with the cemetery (in yellow, Figures 3, 5, 9 and 10). A small existing borrow pit is located in the northwest corner of both polygons. Buildings and structures associated with the Eden District Municipality Roads Department and private homes lie on the western side of the polygon. A damaged stone-walled kraal and simple dwelling are situated to the southwest and southeast of it respectively (Figures 2, 4, 6 and 11). Man-made soil berms occur along the eastern and western margins of the polygon (Figures 6 and 8). Signs of dumping and digging are evident throughout the affected area. The southern part also contains the remains of a former concrete manufacturing plant (Figures 2 and 8). At present access to the site is via the southern track, but the proposed future access route will be an extension of the existing servitude past the Roads Dept. buildings (Figure 2). Colluvial mudrock gravel with dispersed quartz and quartzite clasts overlies Bokkeveld rocks. Scattered renosterbos (*Elytropappus rhinocerotis*) bushes occur in areas which have not been cleared.

Figure 2: Google earth image showing the revised proposed extension to borrow pit 304 (in green) and the tracks of the field survey (in blue). The original polygon surveyed by Halkett (2013) is indicated in red and the farm cemetery in yellow. The yellow pin marks the position of the existing pit. The location of other structures and points of reference mentioned in the text are also marked.

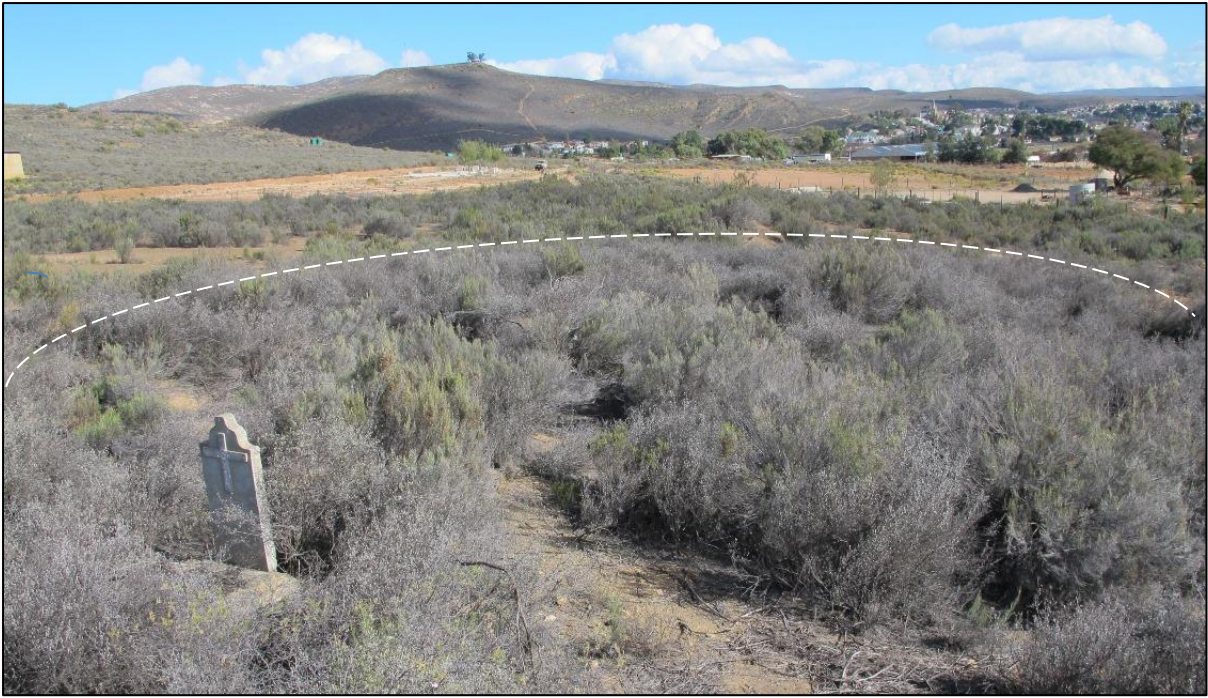
Figure 3: View towards the southwest of the polygon with the single formal gravestone and the cemetery, indicated by the dashed white line, in the foreground.

The old farm graveyard recorded by Halkett (2013) was re-located in the north-western part of the affected area. As the graves and possible graves were fully recorded by Halkett, who also inspected the original polygon, the present survey concentrated on covering the remainder of the revised proposed extension. No further graves were noted, nor were any Stone Age or historical archaeological remains observed within the affected area, although the stone-walled kraal situated outside the polygon is of obvious historical interest. Several quartzite chunks appeared to be naturally damaged rather than intentionally flaked.

With the exception of the cemetery, most of the affected area is of low archaeological heritage significance. The cemetery is however of high local significance and should be conserved and protected during mining activities.

- The graveyard must be fenced and a buffer zone established. Halkett (2013) suggests that the width of the buffer be determined by the engineers taking into account the depth of the proposed mining;

- The location of the cemetery must be taken into account when the route of the future access track to the northwest of the polygon is finally laid out;
- If any human remains are found during the development of the proposed extension, work in that area must cease, the remains must be protected in situ and Heritage Western Cape (HWC) must be notified. A permit for the exhumation and reburial of any such remains will have to be issued by the South African Heritage Resources Agency (SAHRA). All such work will be to the cost of the developer.

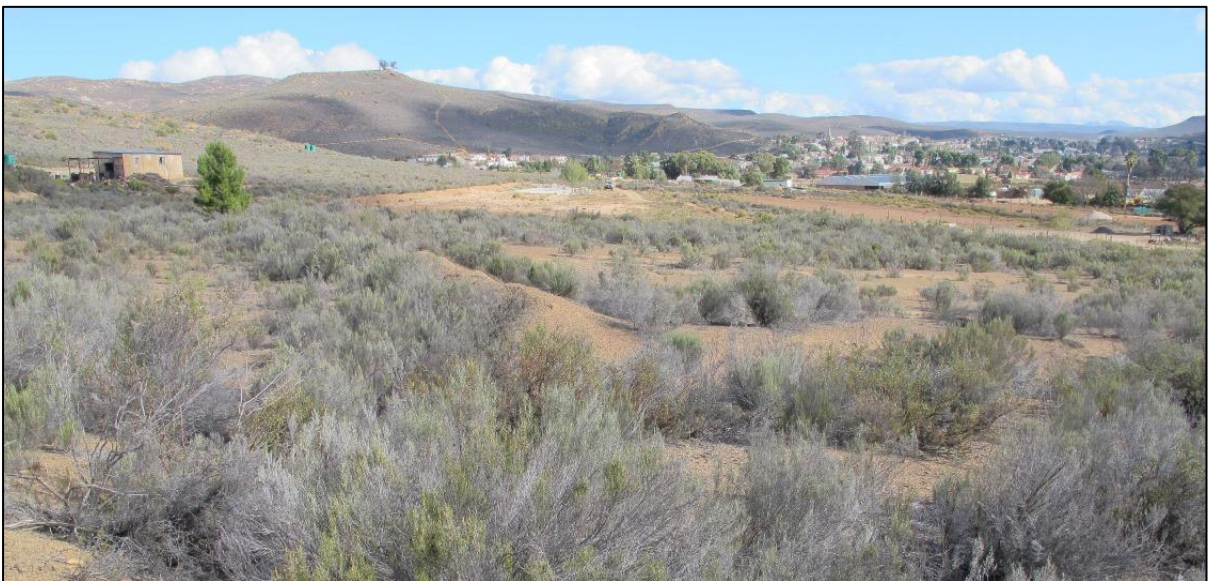
Figure 4: View towards the southwest of the eastern half of the affected area with the dwelling, pine tree and a couple of the soil berms evident on the left and the former concrete manufacturing plant visible in the middle ground.

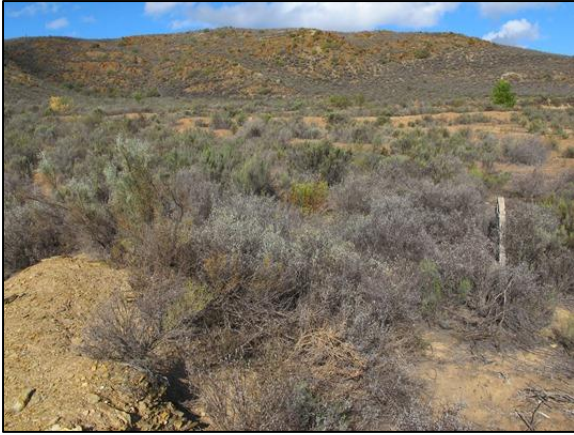
Figure 5: View towards the east from the graveyard. The pine tree is evident on the right of the image. Figure 6: View towards the southwest showing one of the soil berms.

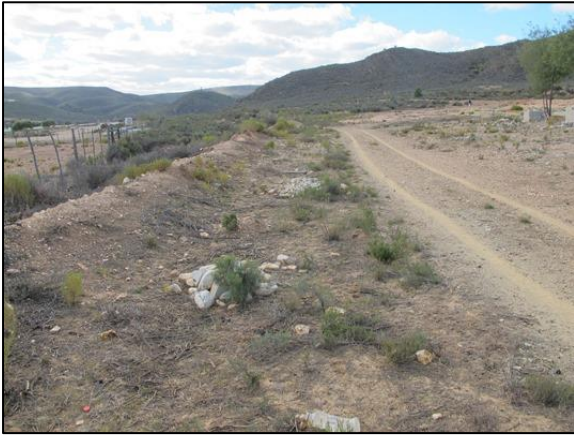
Figure 7: View towards the northeast along the disturbed western margin of the polygon. Figure 8: View towards the northeast with part of the former concrete manufacturing plant visible in the foreground.

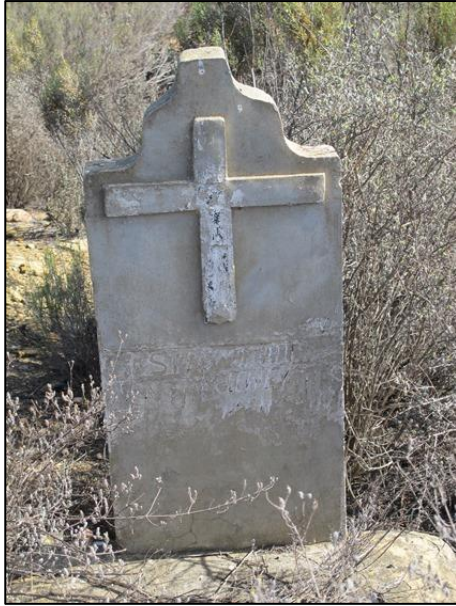
Figure 9: Detail of the single formal gravestone. Figure 10: Headstone marking one of the informal graves. The ruler is about 15cm in length.

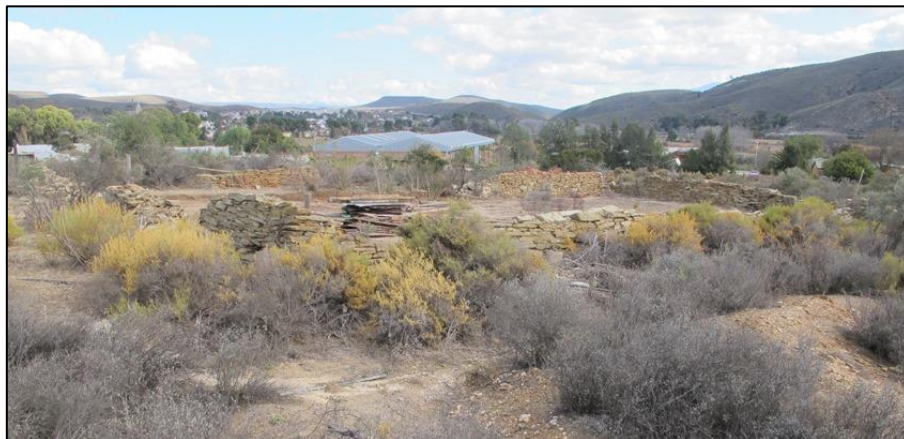
Figure 11: View towards the southwest of the damaged stone-walled kraal just outside the polygon.

Although the stone-walled kraal does not lie within the polygon, it is of local heritage significance. The present access route passes directly to the east of it and further damage may be inflicted on the historical remains by heavy vehicle traffic. The proposed northern access route is therefore to be recommended, as long as the buffer zone around the graveyard is respected.
