HERITAGE IMPACT ASSESSMENT

27 August 2014

DR 2404 Central Karoo

Murraysburg – Central Karoo District Municipality, Western Cape

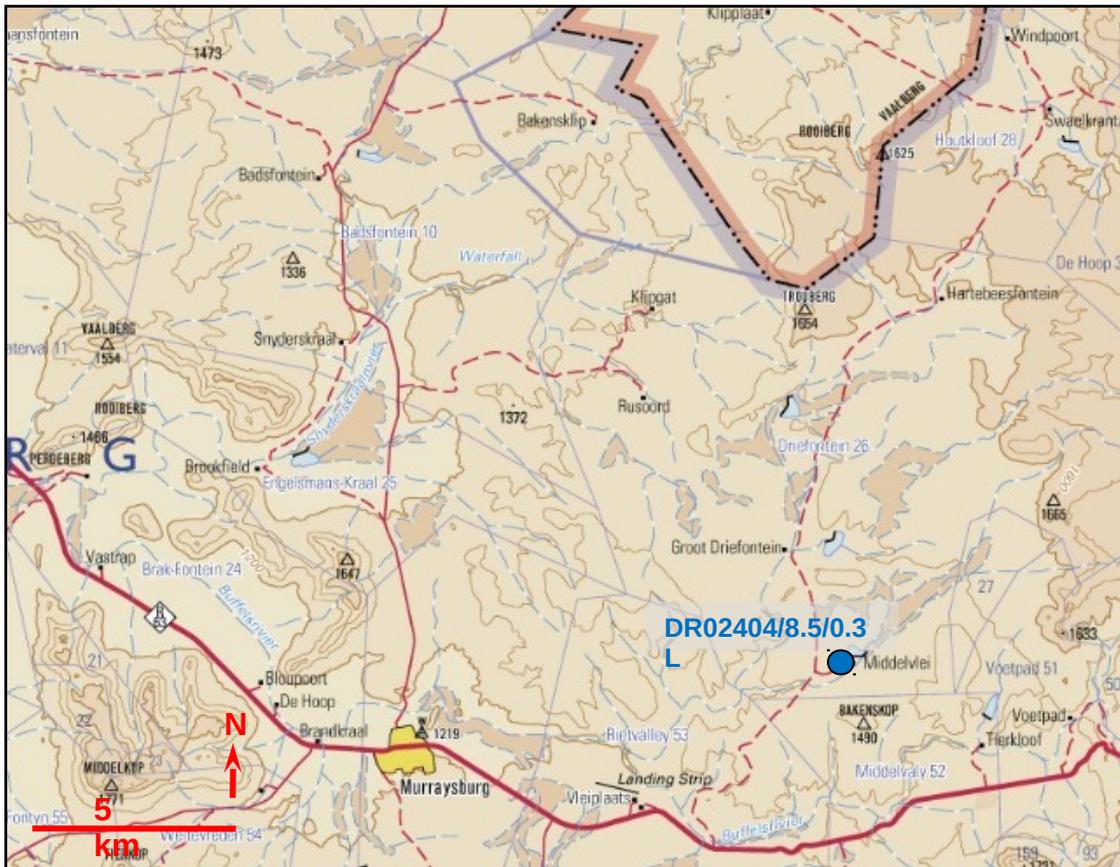
Figure 1: Extract from topographical sheets 3320(Dr John E. Amond 2014:3)

The potential source of a wearing coarse gravel pit site is located along the unpaved DR 2404/8.5/0.3L is accessed from the N2 northeast of Murraysburg in Central Karoo District, Western Cape. The affected area lies west of the previous polygon and consists of slightly undulating terrain which slopes very gently to the south and south east. Ferruginised gravelly silty sand and sandstone slabs surround the borrow pit. Proposed borrow pit is located on Farm Driefontein 26. Borrow pit co-ordinates are 31°56'11.07"S and 23°53'43.97"E

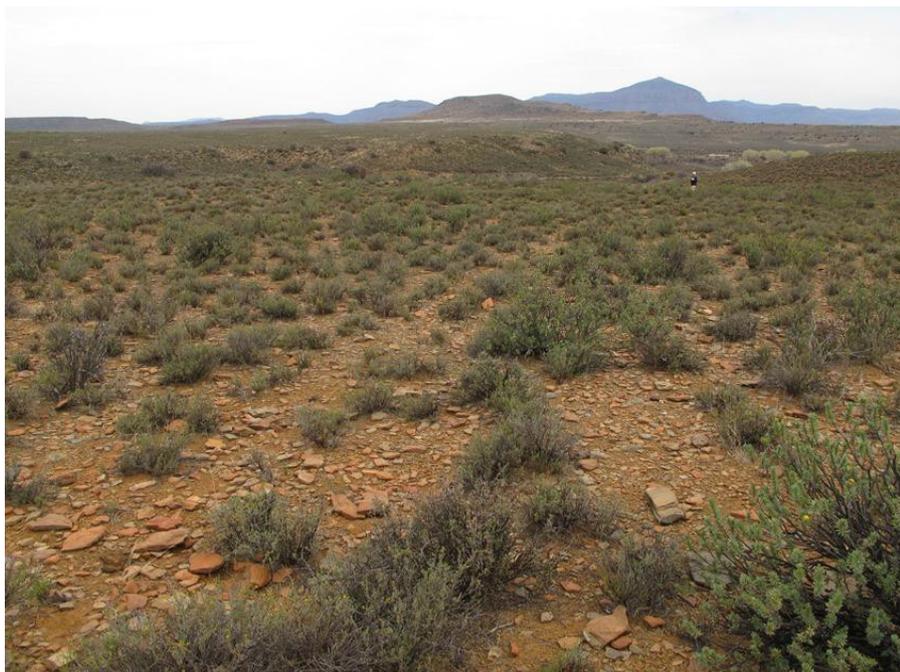
Figure 2: View towards the southeast with the gravelly sand in the foreground and the road in the background. (Tusenius 2014:addendum pg 2)

Madelon Tusenius conducted archaeological field assessment and provided report identifying and assessing archaeological resources, associated impact, assessment of significance and recommendations regarding any mitigation required. The affected area lies west of the previous polygon and consists of slightly undulating terrain which slopes very gently to the south and south east. No archaeological remains of any sort were observed during the survey of the revised polygon (Tusenius 2014: 2).

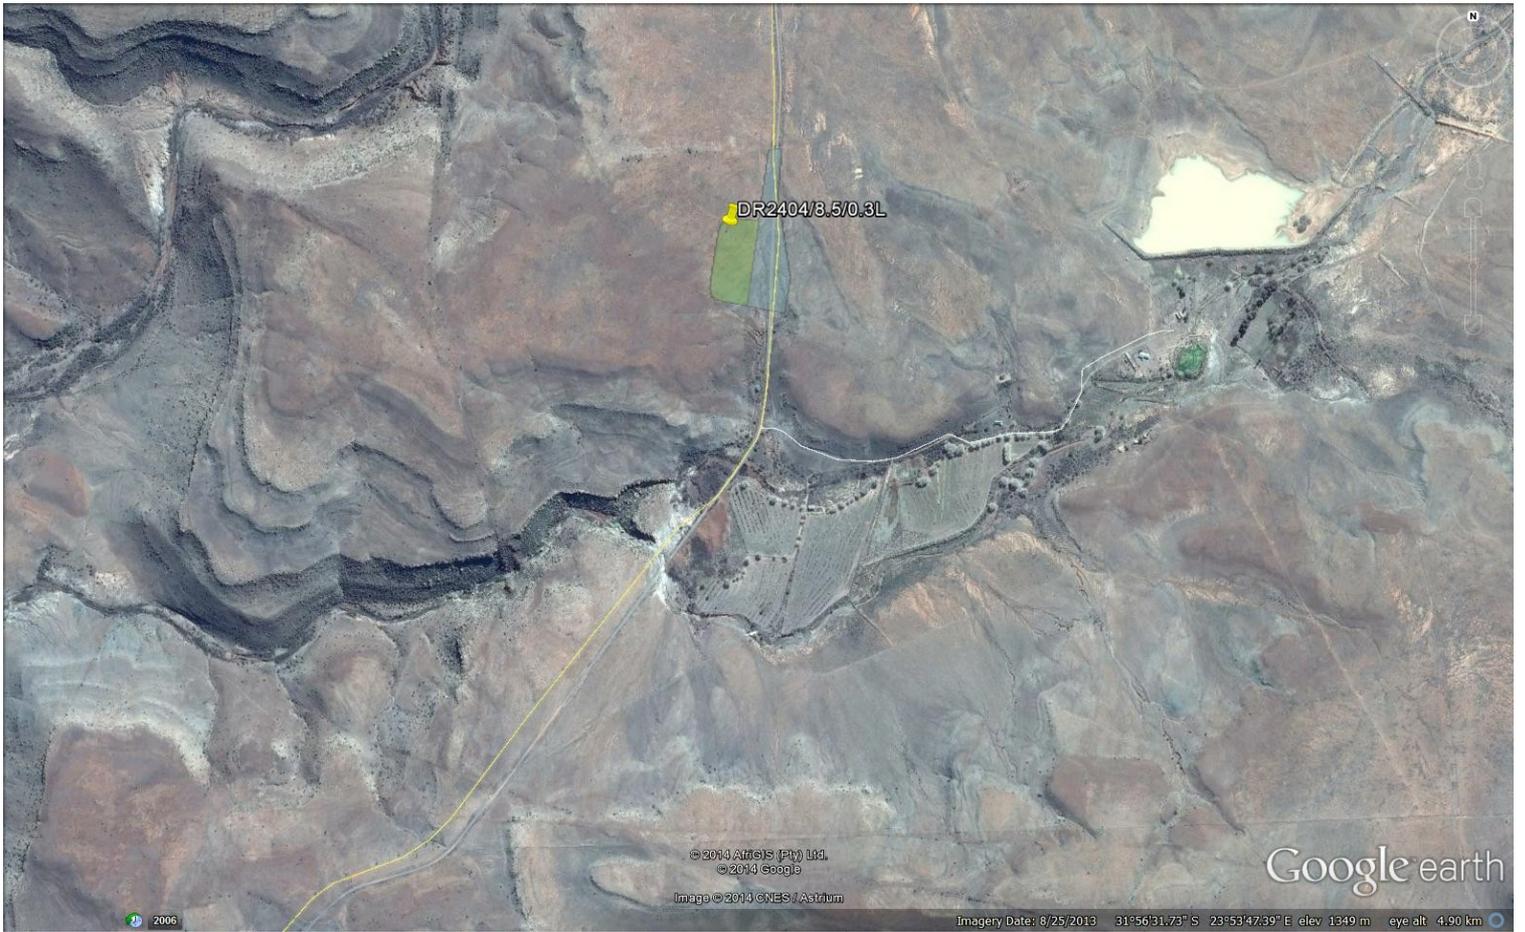
Figure 3: Site context and borrow pit location (Google earth, April 2014)

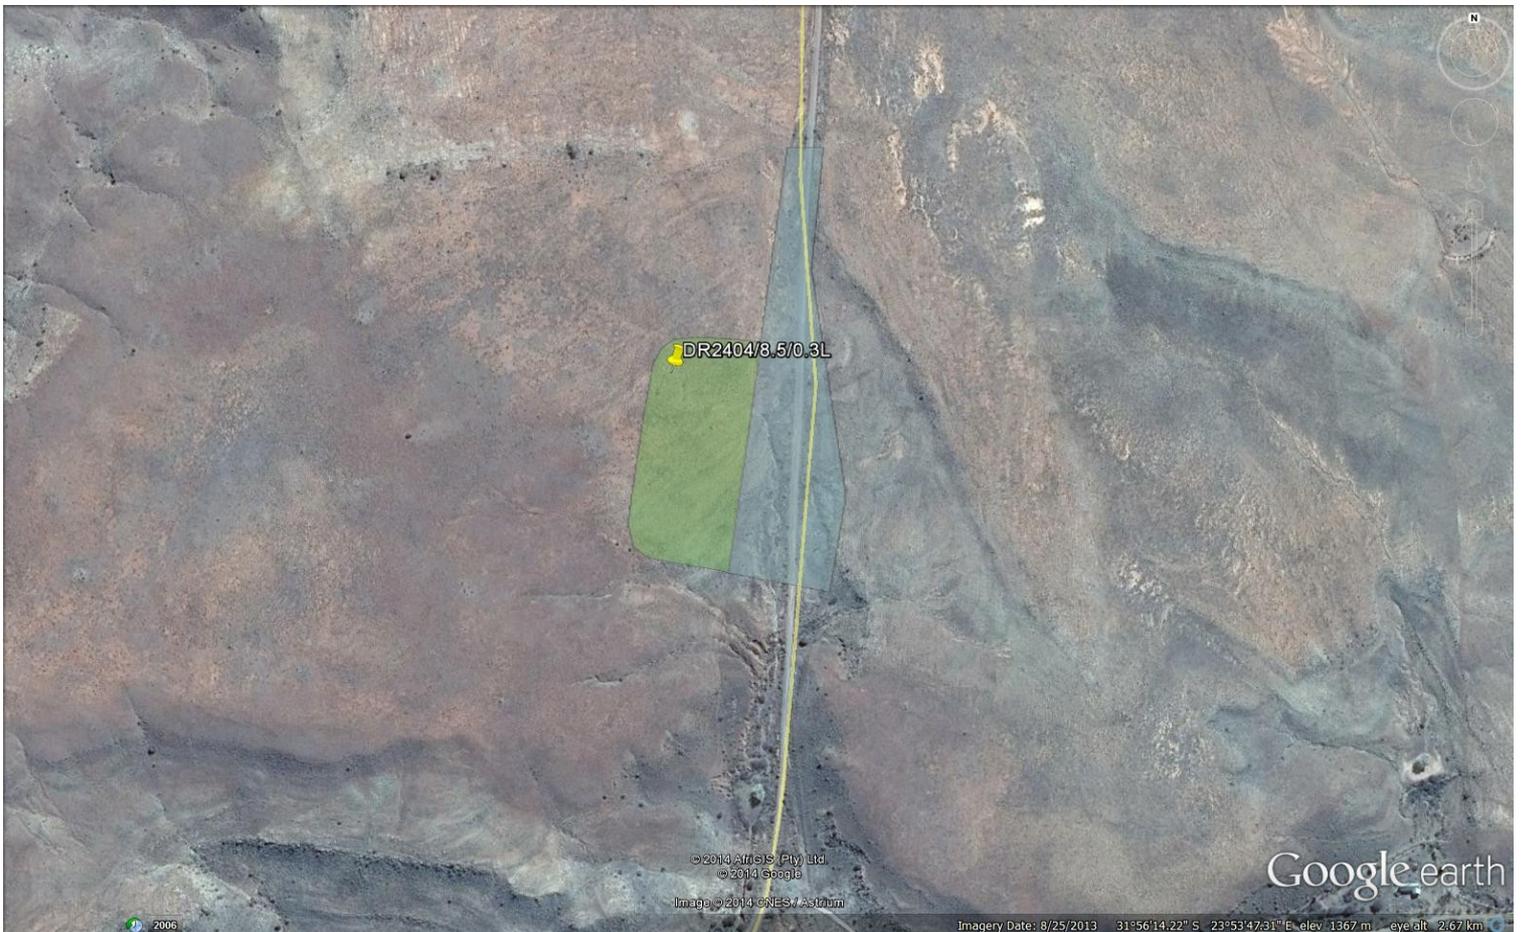
Figure 4: Aerial view of borrow pit and preliminary pit area (Google earth, April 2014)
