**Heritage Management Plan for
Proposed Eskom SOC 765kv
Umfolozi-Thetha transmission
powerline from Umfolozi Substation
to the new Empangeni Substation
in KwaZulu Natal Province.**

Final Report

TITLE:	ARCHAEOLOGICAL AND HERITAGE Phase 2 EMP WALK DOWN REPORT FOR: PROPOSED 765KV UMFOLOZI-THETHA POWERLINE FROM UMFOLOZI SUBSTATION TO EMPANGENI SUBSTATIONS IN KWAZULU NATAL PROVINCE		
PURPOSE OF SCOPE:	The purpose of this document is to describe the cultural values and heritage factors that may be impacted on by the proposed construction of the proposed development. The proposed electrification is located in KwaZulu Natal Province.		
DOCUMENT VERIFICATION			
Signature:		Position:	
Name:		Date:	
Consulted:	Vuledzani Thanyani of Eskom Transmission to review the document. The document also went through Nzumbululo Heritage Solutions Quality Assurance Department for internal review.		
ENDORSED			
Client Project Responsible Officer to sign off.			
Signature		Position	
Name:		Date:

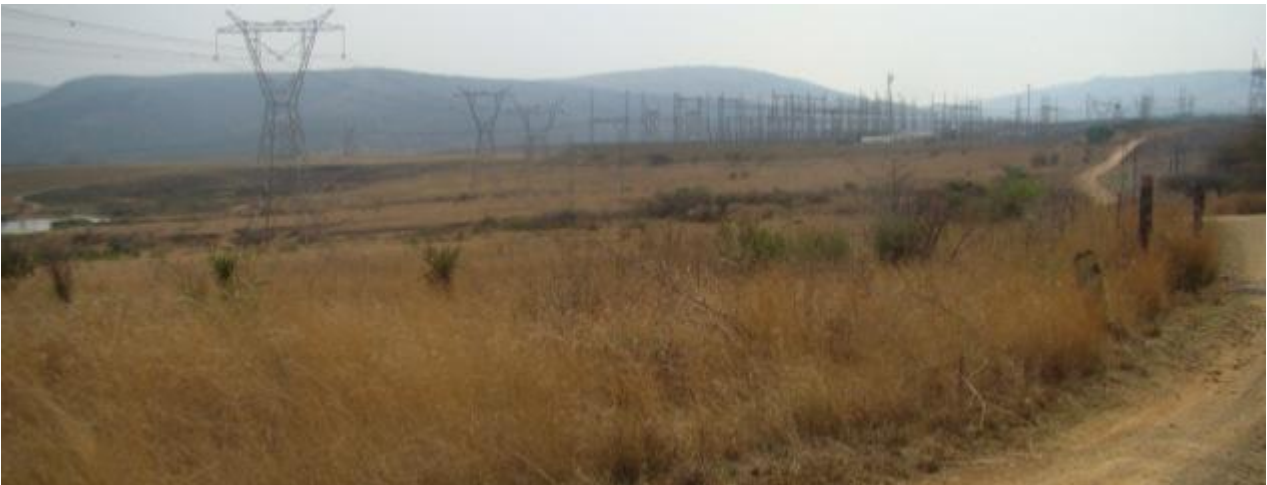
Plate 1: View of Umfolozi Substation where the proposed powerline will T-off.

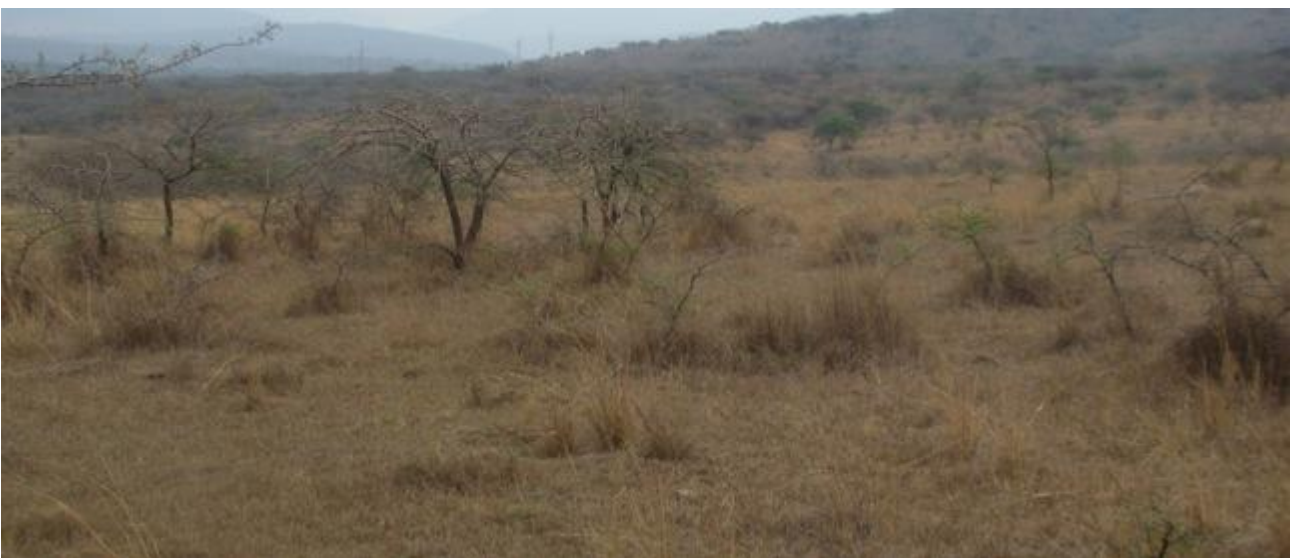
Plate 2: The approved powerline will cut through previously cleared agricultural landscape with secondary vegetation currently used for livestock grazing.

Structures 1 to 20 shown in Figure 2 are all situated on previously degraded and disturbed land portions where high voltage powerlines, railway line, minor reticulation powerlines and railway servitude roads and boundary fence lines already traverses along the powerline route. During the survey and verification exercise, the surveyed Pylon Structures positions 1 to 20 yielded an archaeological site on the direct path and vicinity of the tower positions 5 and 6. The preliminary walk down survey reported one grave at tower 5, but the verification exercise revealed that the entire section from tower 5 to 6 is an archaeological site. The archaeological site was initially not mentioned during the phase 1 HIA and preliminary walk down surveys. The archaeological site is marked by remains of an abandoned homestead that include three circular house foundations, foundation of rectangular stone structure, cattle kraal, characterised by circular stone structures and remains of house foundations and a solitary grave (see Plate 2 images). The centre of the site is located at GPS Coordinates S28° 13' 12.1" and E031° 12' 10.1". Another archaeological site occurs about 50 m from the main site. The site is marked by remains of 4 circular stone structures. The centre of the site is located at GPS Coordinates S28° 13' 11.9" E031° 12' 15.5". The archaeological site between Towers 5 and 6 will be impacted upon during stringing and movement of construction equipment along the powerline route. The team went on to recorded nine graves in the vicinity of tower 10. (The burial ground is part of a broader archaeological settlement site marked with stone enclosures and stone foundation remains (see Plate 4-5). This site has previously been disturbed by Eskom Contractors who used it as either a temporary storage site or construction camp as evidenced by recent remains of cable drums and other litter on site. The new final tower position alignment avoided the site. The archaeological site and associated burial site now fall outside the direct tower development impact zone. However, the area is still prone to disturbance during all stages of the tower development. The survey also recorded a circular stone structure about 40m in diameter and 35cm high and a possible grave near tower 15. There is also a homestead located about 100m from the site. The final tower position alignment moved the tower further away from the stone structure. All the new tower positions were assessed during the survey (See table 2). The survey did not record any new findings on the new tower position within the approved servitude.

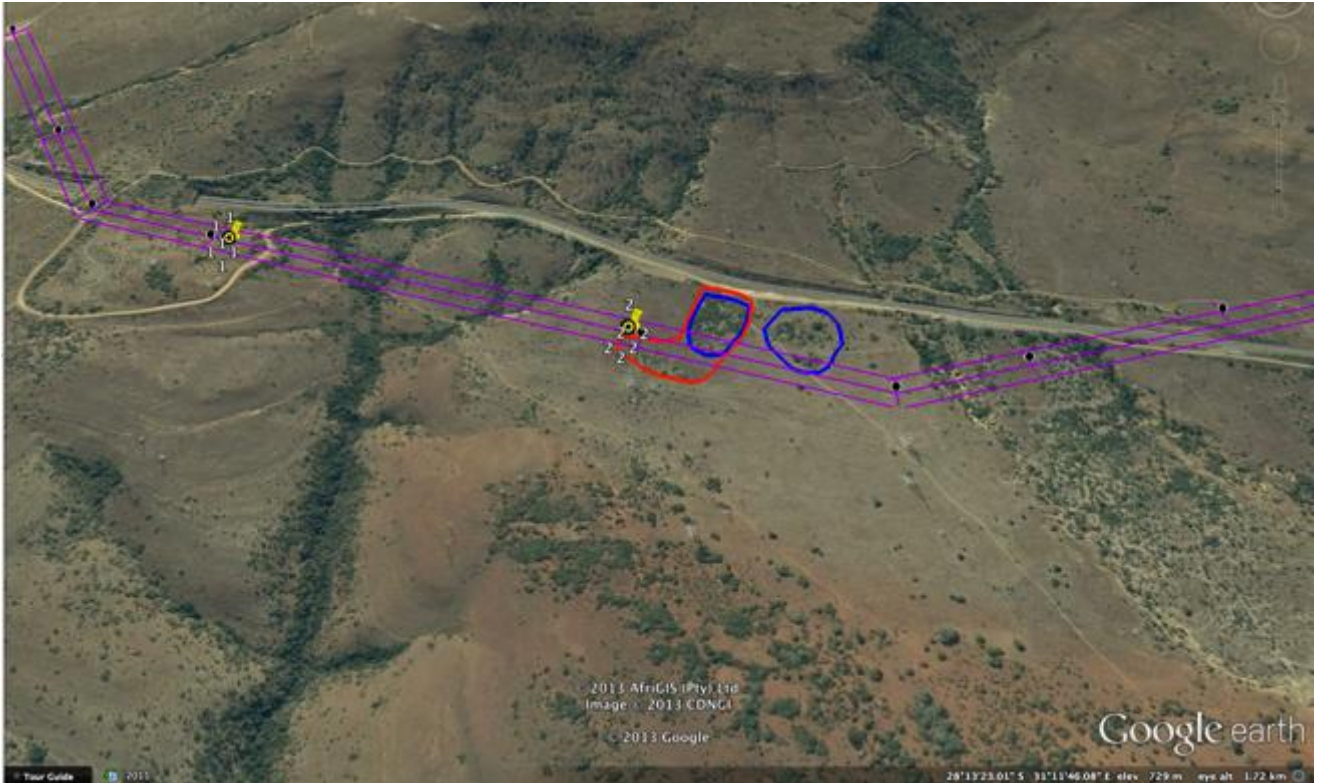
Figure 2: Location of Historic archaeology sites associated with Tower 5 and 6. (Red marks the outer boundary; Blue marks the core of the sites).

Monitoring is required during all stages of construction from excavation for tower foundations, erection of towers and stringing for Towers 5 and 6. Tower 5 is also associated with a grave. The grave should be marked and protected in situ during all construction activities on site. The rubble, litter and cable drum remains recorded in stone walls on the archaeological site near tower 10 should be cleaned up. The site should be protected from any future abuse by contractors when working in the project area. An archaeologist should monitor installation of Tower 10 during foundation excavations, erection and stringing. Although the archaeological stone structure and possible grave on tower 15 is now out of the tower construction impact zone, the site should be clearly marked and should be monitored during stringing. There is a high possibility of the site being interfered with during stringing because heavy construction machinery requires large space to operate. However, in the unlikely event that chance archaeological materials are disturbed at any of the

remaining tower positions in this section, salvage and chance finds procedures should be implemented in line with the project HMP.

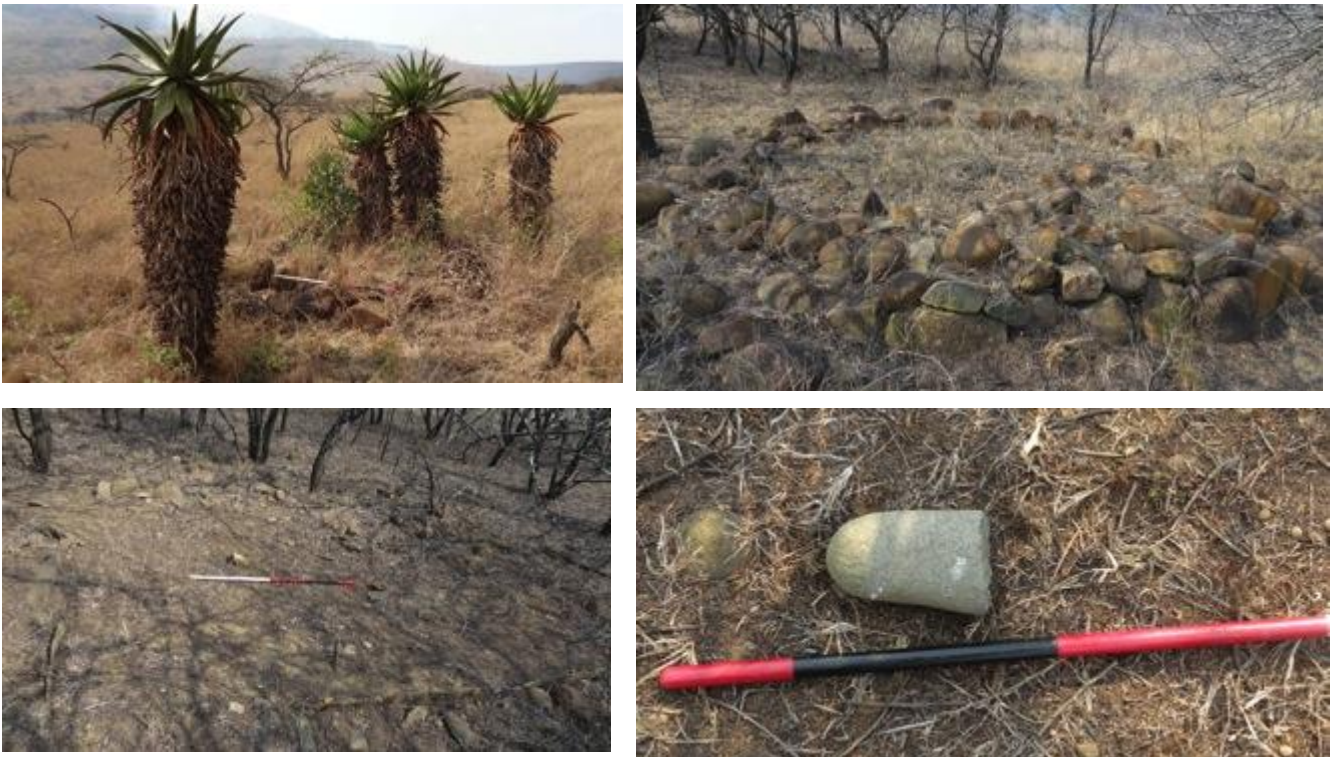
Plate 3: Top Left - Grave situated close to tower 5 position within the historic archaeology site. Top Right – Stone wall remains on site. Bottom Left - Housing remains spread over the site. Bottom Left – artefact remains recorded on site.

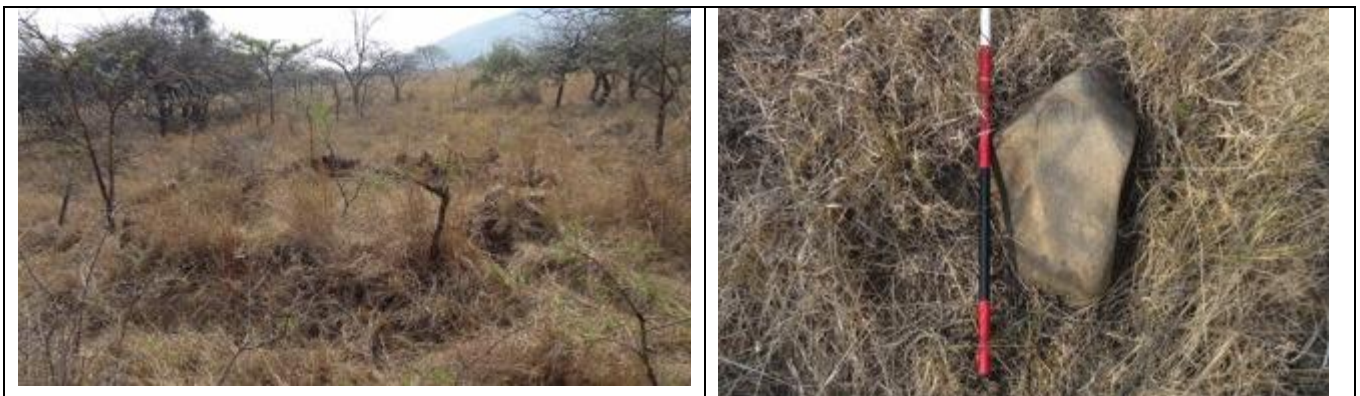
Plate 4: Left - Stone wall feature on Archaeology site 2 situated between Tower 5 and 6. Right – Grinding stone recorded on site 2.

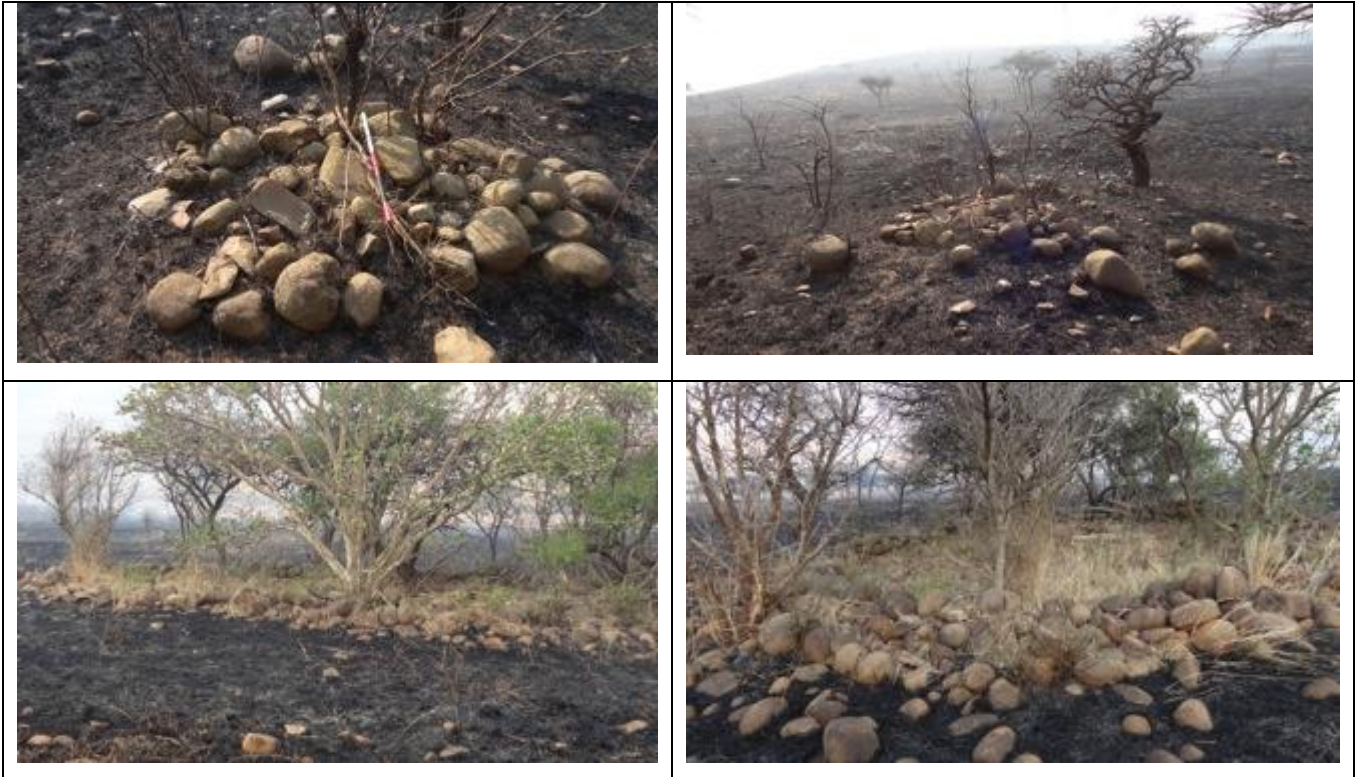
Plate 5: Top L&R – Graves on site associated with Tower 21. Nine graves were recorded on this site. Bottom L&R – Stonewall structure recorded on site. The site is associated with the gravesite previously described.

An archaeologist should monitor installation of Tower 21, 36, 38 and 40 during foundation excavations, erection and stringing. Special emphasis should be placed on tower 40 where an extensive Middle/ Later Stone Age site was recorded in the preliminary walk down survey and confirmed by Nzumbululo Specialists. Although it may be time consuming, the construction team should allow the monitoring archaeologist to conduct extensive search for stone artefacts during excavation for tower foundation. The findings if any should be well documented, classified and tagged. Provision for storage of possible finds should be made with the nearest museum prior to commencement of work. If the excavation yields significant Stone Age tools, further research should be commissioned to salvage the entire site. However, in the unlikely event that chance archaeological materials are disturbed at any of the remaining tower positions in this section, salvage and chance finds procedures should be implemented in line with the project HMP.

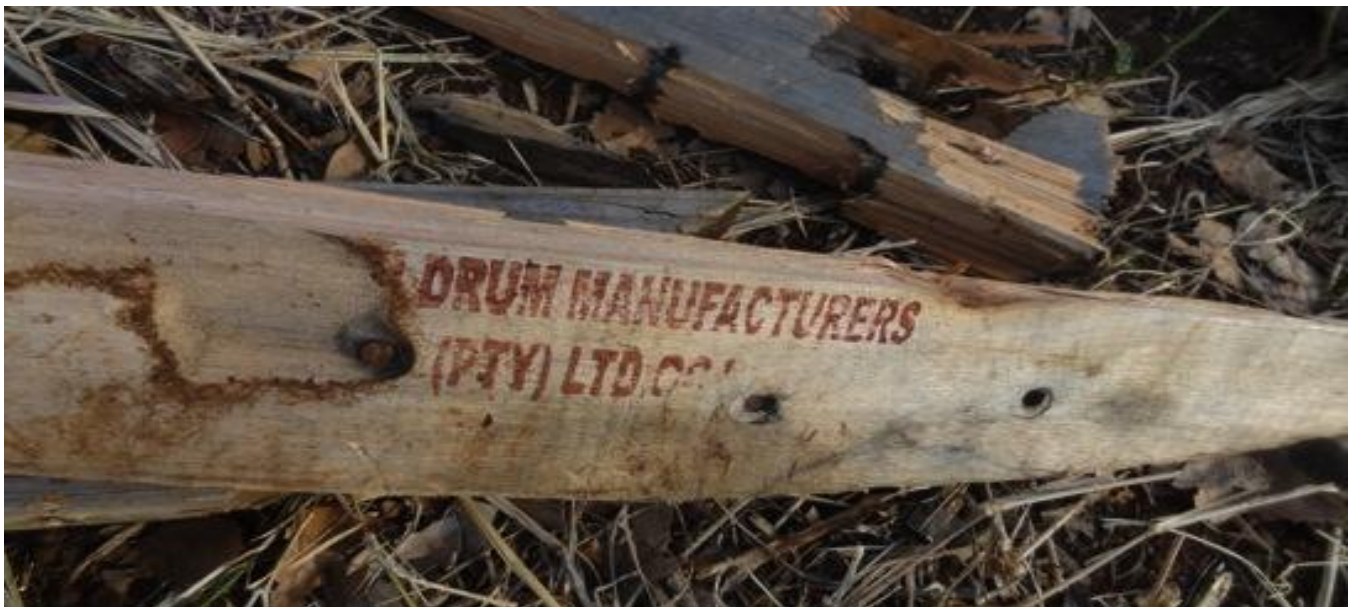
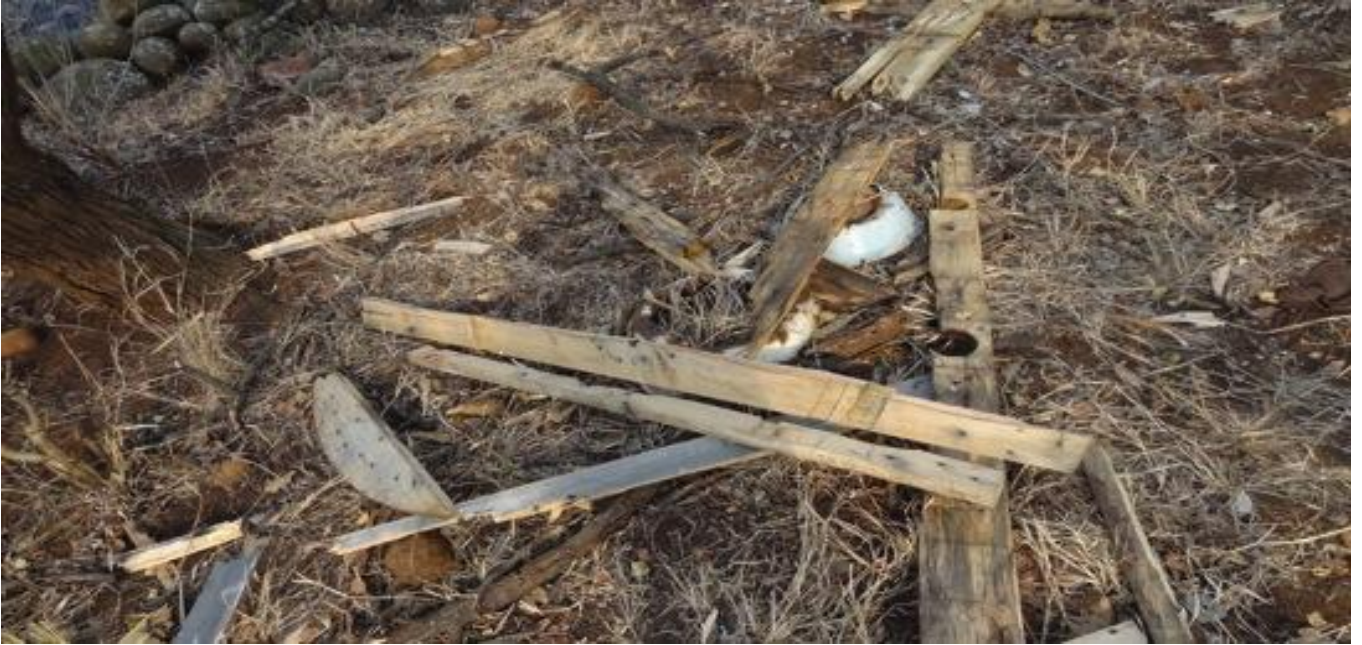
Plate 6: Top & Bottom - rubble and cable drum remains left on archaeological site by previous Eskom Contractors. This site should be cleaned and all rubble and litter removed from area.

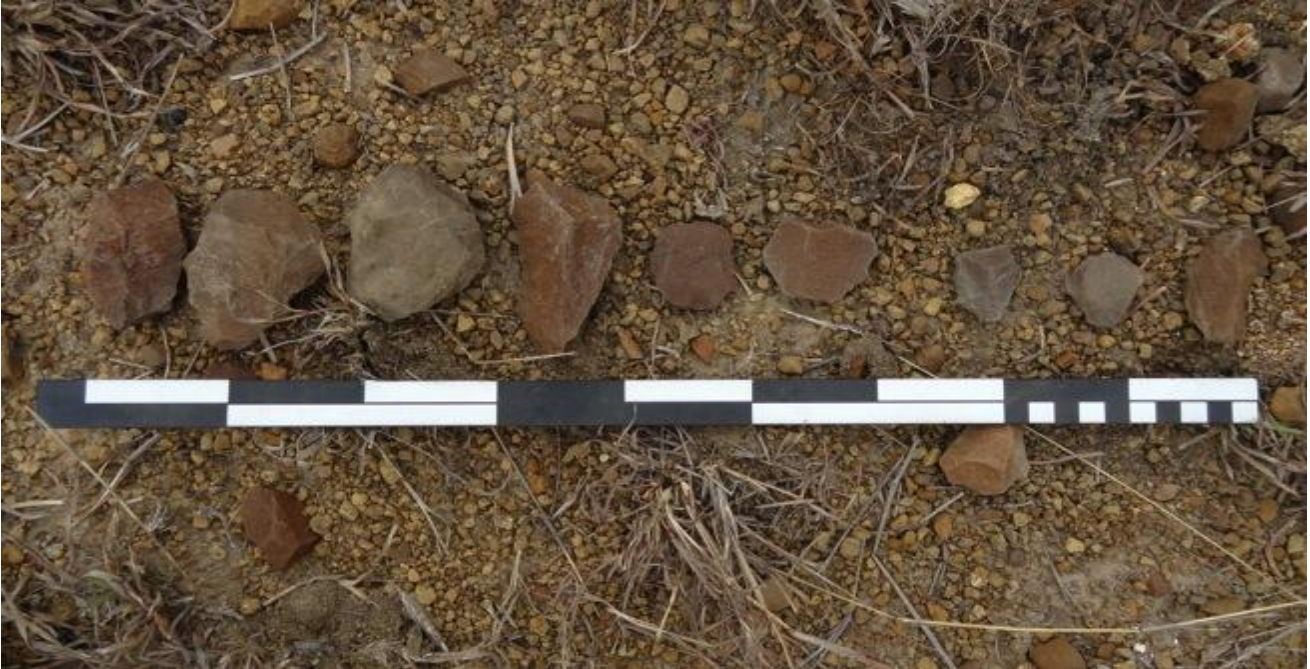
Plate 7: A scatter of Middle Stone Age tools recorded in the vicinity of the powerline route. Such site should not be disturbed during the construction phase since they may be protected by the NHRA, Act 25 of 1999.

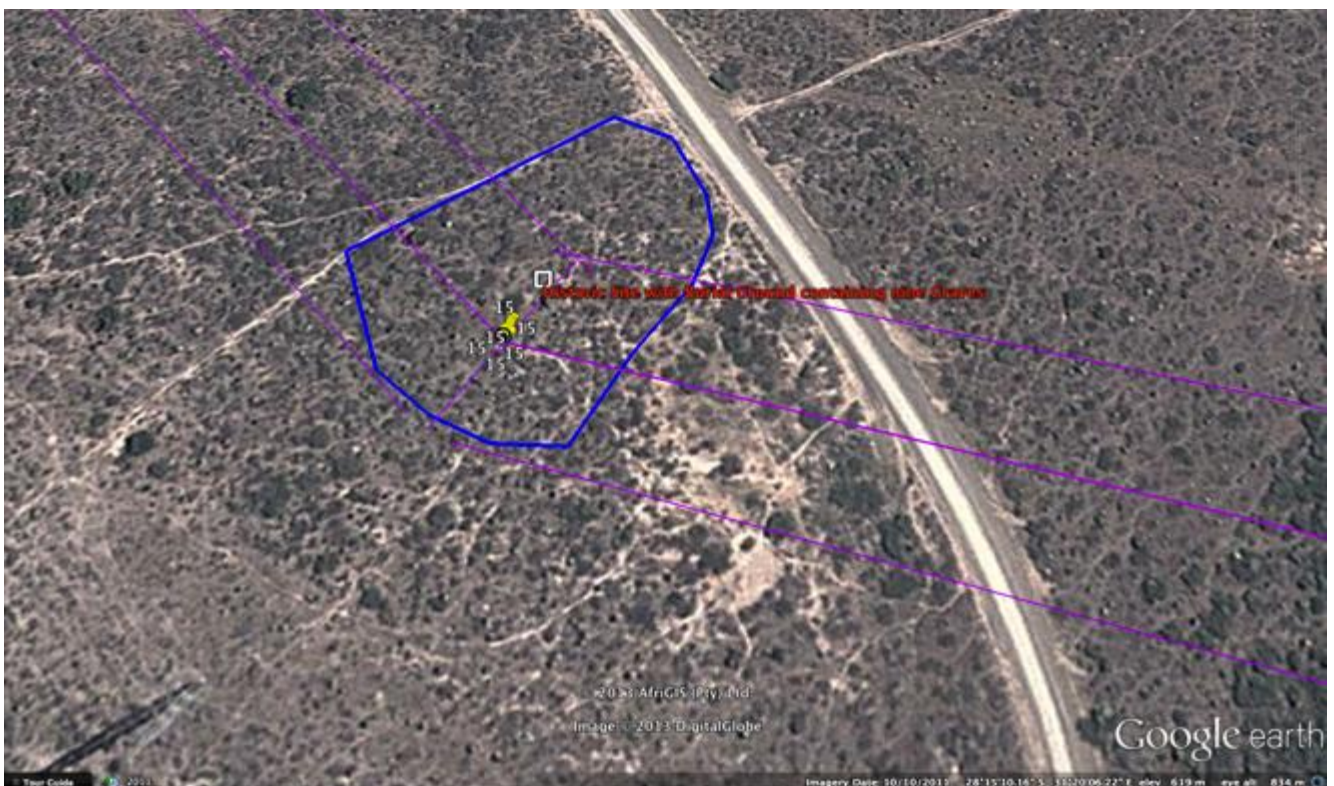
Figure 5: Historic site with a burial ground with nine graves. The site on direct path of Tower 42. The graves therefore should be relocated before construction work begins at Tower 42.

Eskom final tower position could not avoid the burial ground site at tower 42 because it will alter the alignment of the powerline route and it is surrounded by eroded and an existing local road nearby. From a technical point of view the tower position cannot be shifted. As such the nine burials on the direct path of tower 42 should be relocated in accordance with the relevant legislations. An archaeologist should monitor installation of Towers 42 during foundation excavations, erection and stringing to ensure that the solitary burial sites associated with the Mbatha homestead and remains of a historic homestead are not affected during construction and movement of heavy construction machinery. Subject to relocation of the burials, no further mitigation is required prior to construction phase. However, in the unlikely event that chance archaeological materials are disturbed at any of the remaining tower positions in this section, salvage and chance finds procedures should be implemented.

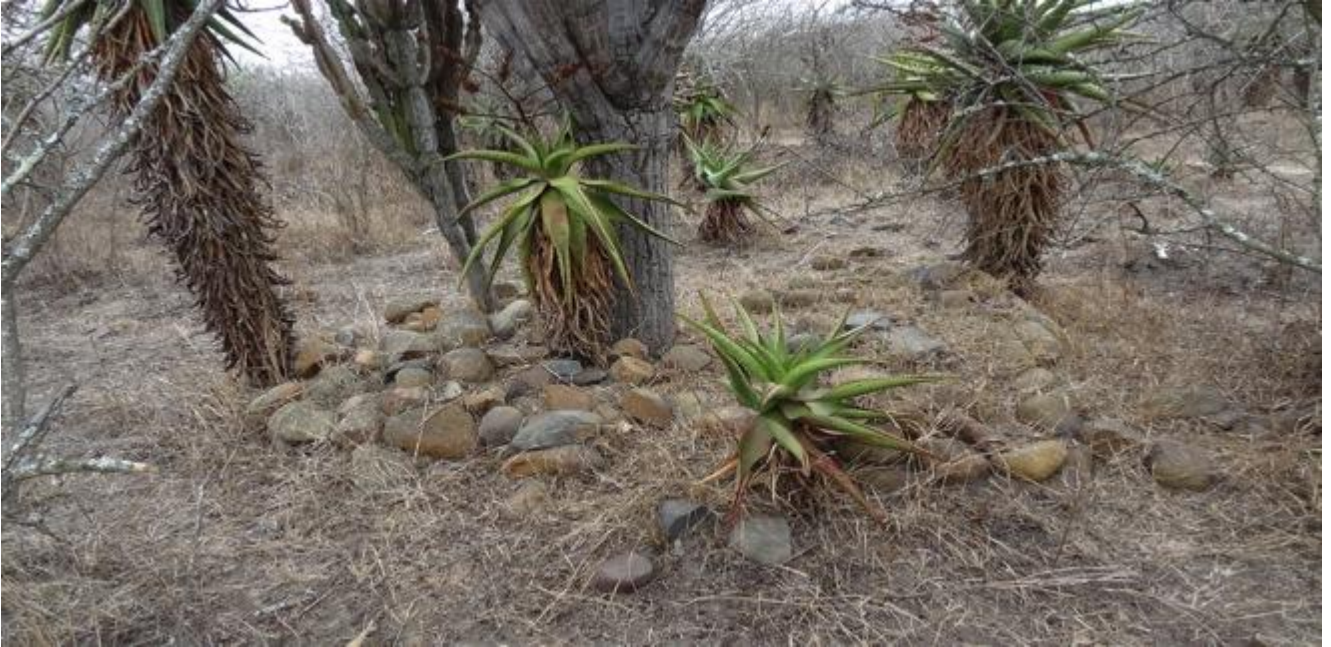
Plate 8: View of nine graves recorded on the direct path of tower 42 Note that the site.

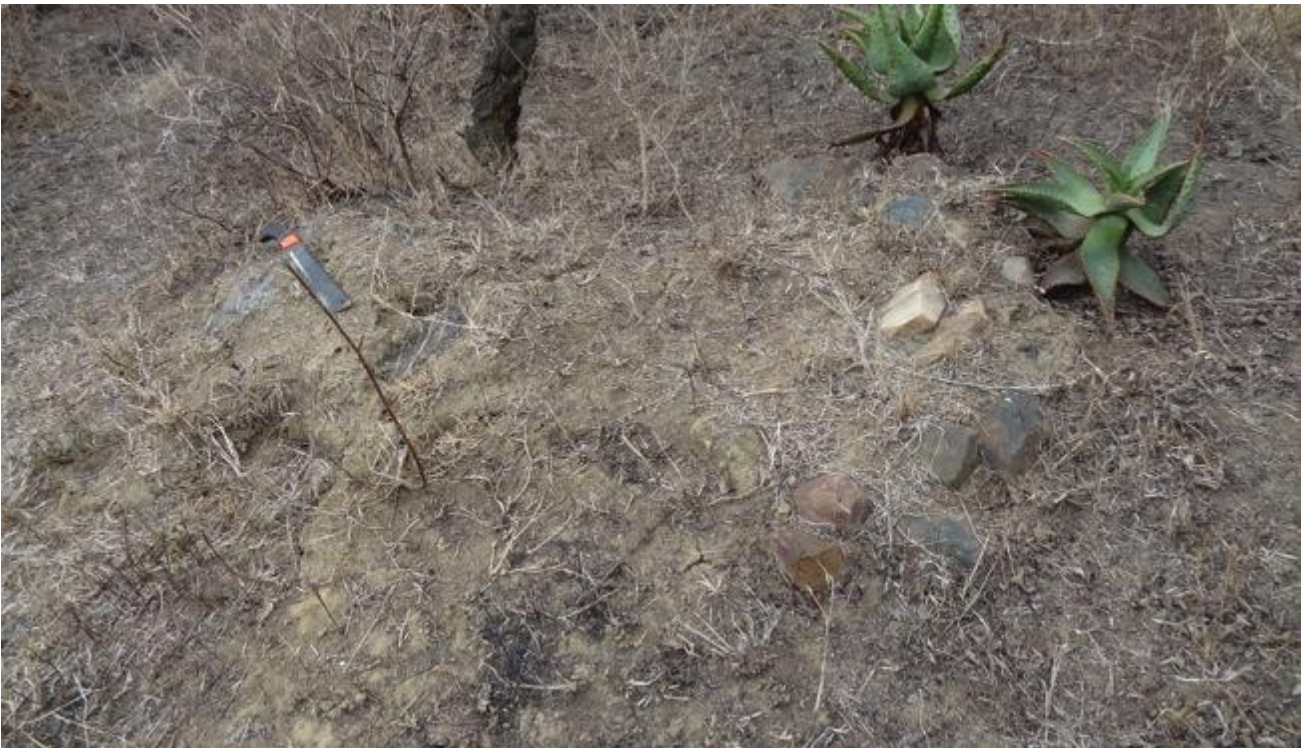
Plate 9: View of burials at tower 42. Note the trees and vegetation growing on the graves, the custodians may have left the area long back.

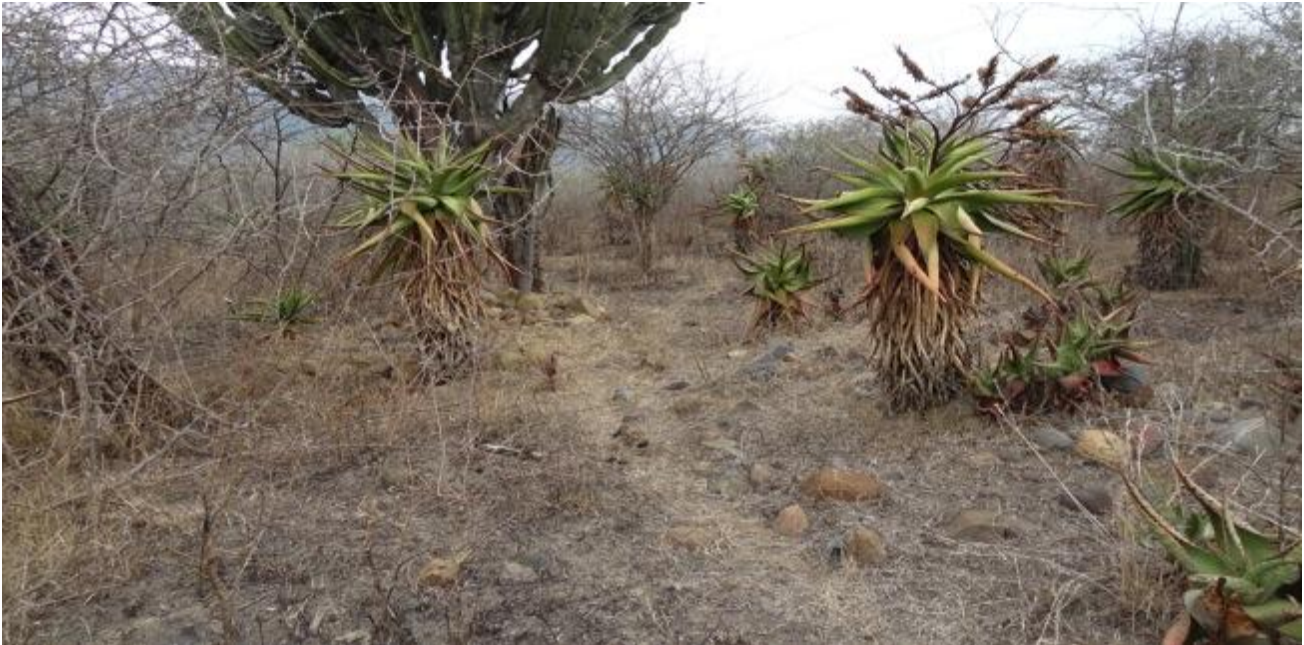
Figure 10: Figure 5: Burial site at tower 42 trees and shrubs have been growing on top of the graves which may suggest that the custodians may be difficult to trace. Note that from a technical point of view the burial cannot be avoided therefore should be relocated.

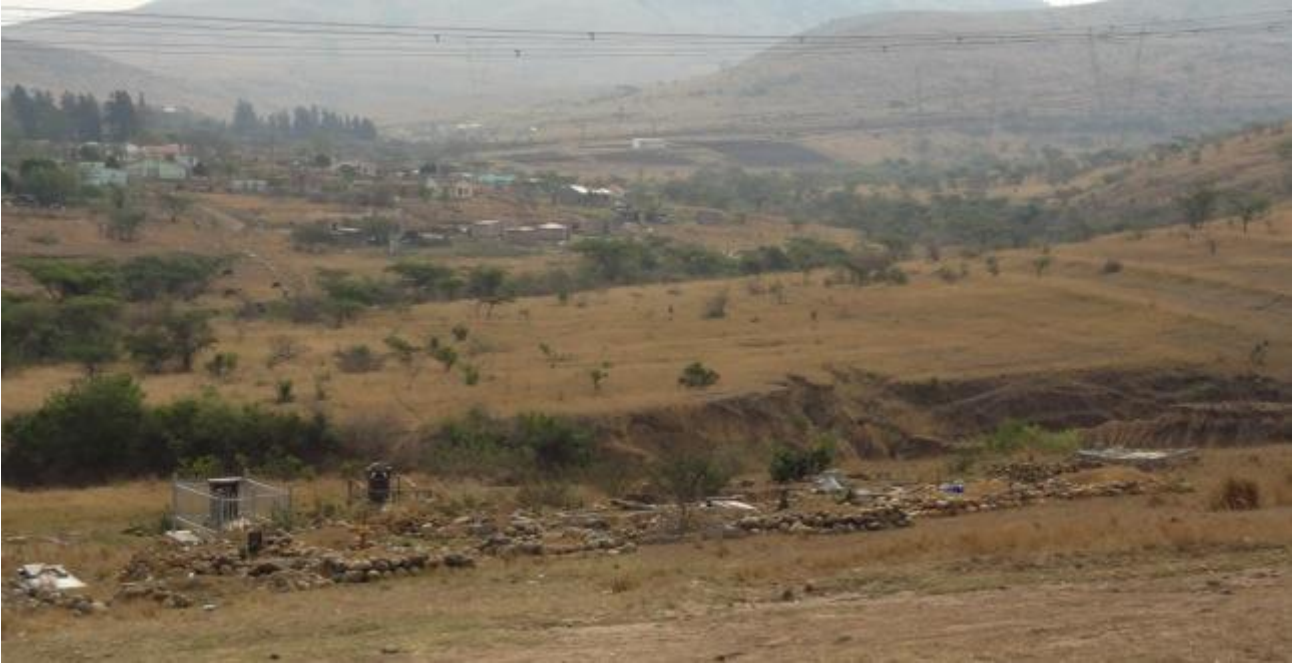
Plate 11: A contemporary cemetery near tower 73 located in the outskirts of Ulundi D .The burial site is significantly away from the impact zone, however the construction team must exercise caution when working near the burial site.

The sites must be monitored during installation of tower 66-67, 72, 73, 74 and 75 to avoid any interference with the contemporary cemetery and burial grounds recorded in the area. The construction team should avoid working near the contemporary cemetery during burial ceremonies. Heavy machinery should not be driven near the contemporary cemetery because they cause vibration, which may disturb the stability of burials and graves especially those with newly installed tombstones.

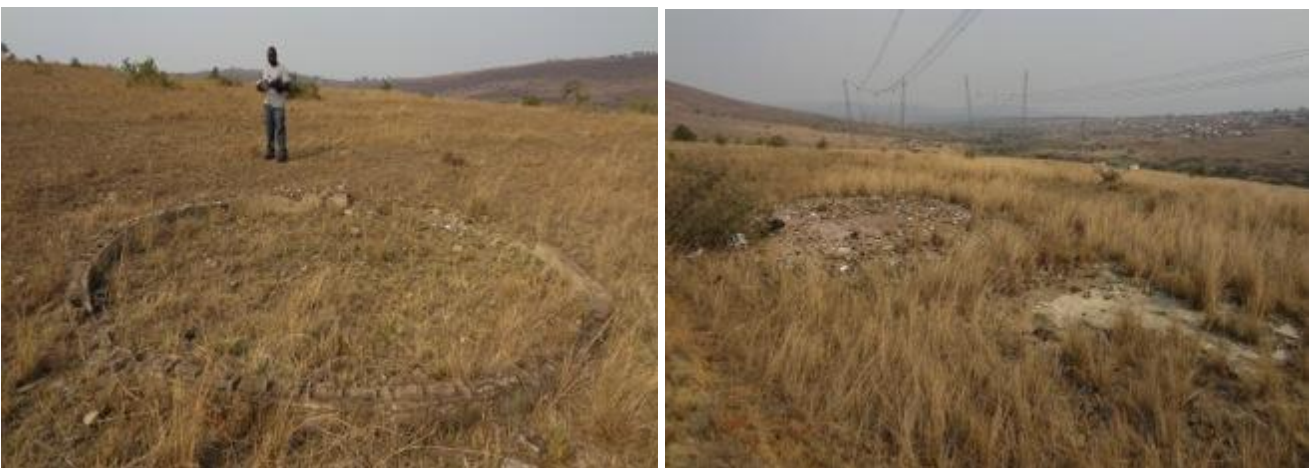
Plate 12: Plate 13: Remains of a historical homestead near the tower 74.

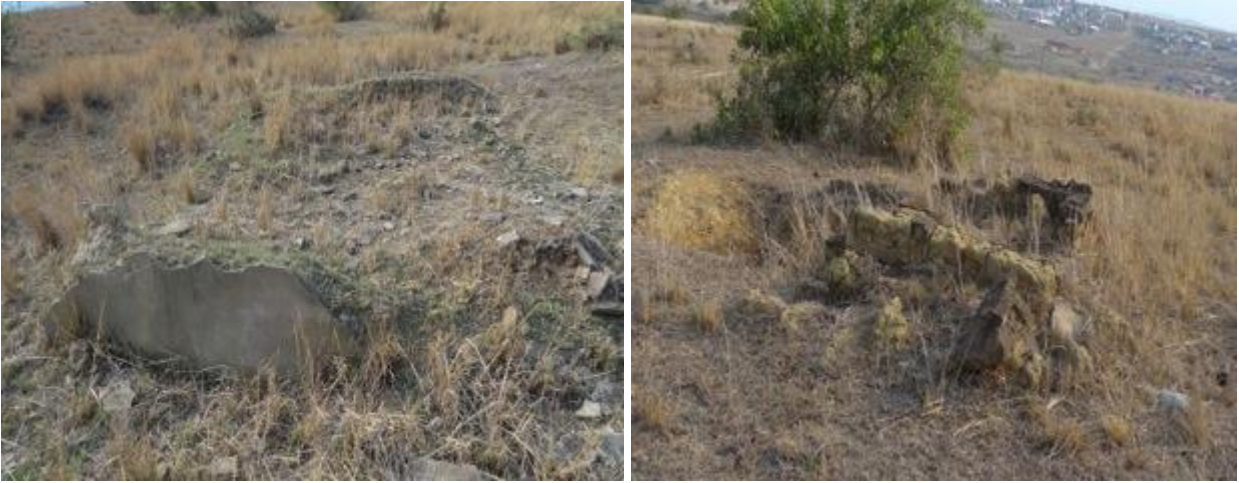
Plate 14 Remains of a historical homestead in the vicinity of tower 75 near Ulundi section D

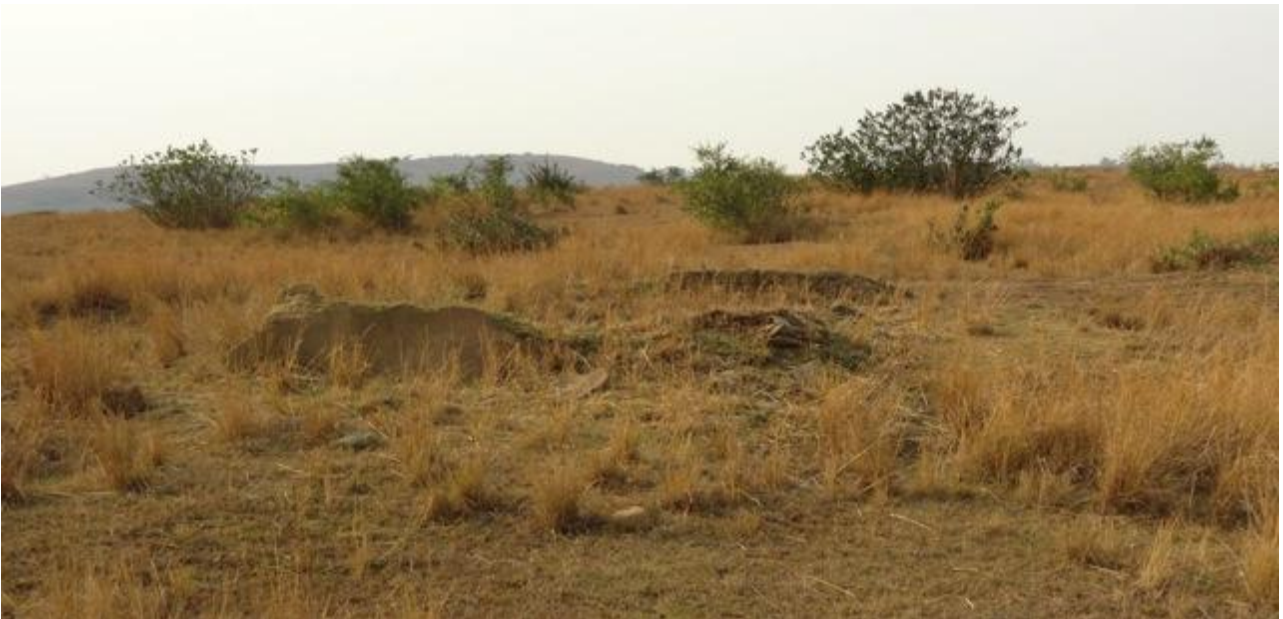
Plate 15: View of remains of a historical homestead located near tower 75. Note that the site is significantly far from the impact zone.

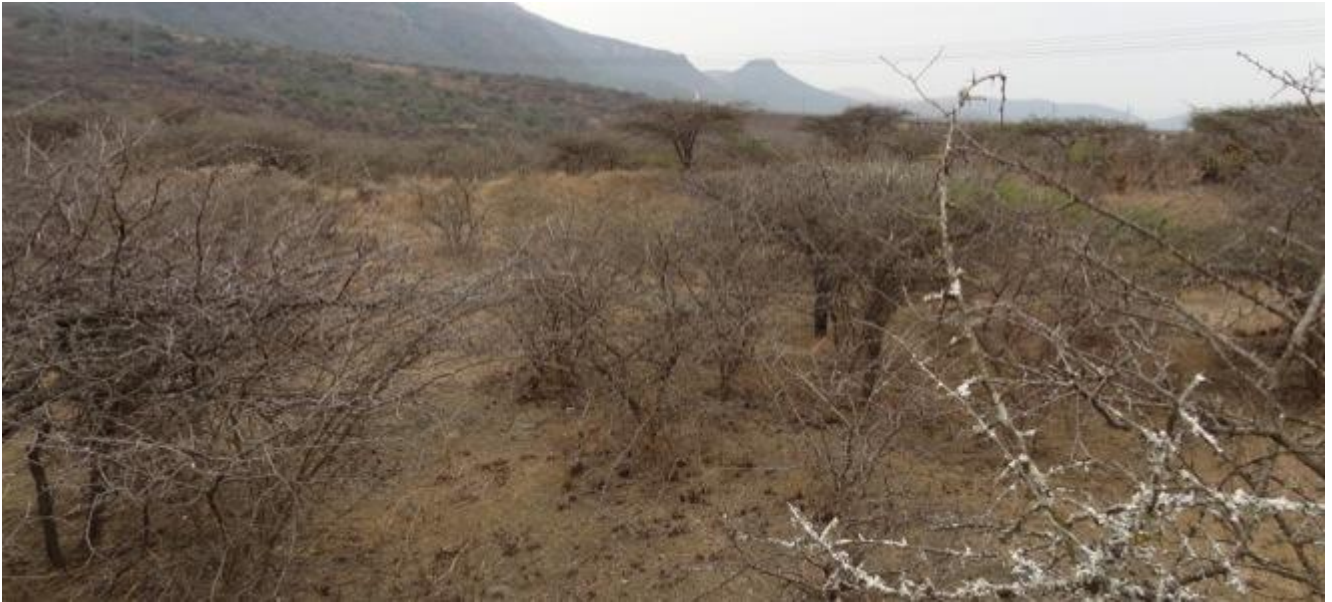
Plate 16: The proposed powerline cuts through sloppy and thickly vegetated areas.

Monitoring is however, required during excavations for tower position 84, 85 and 87. In the unlikely event that chance archaeological materials are disturbed at any of the tower position, salvage and change finds procedures should be implemented. No further mitigation is required prior to construction phase.

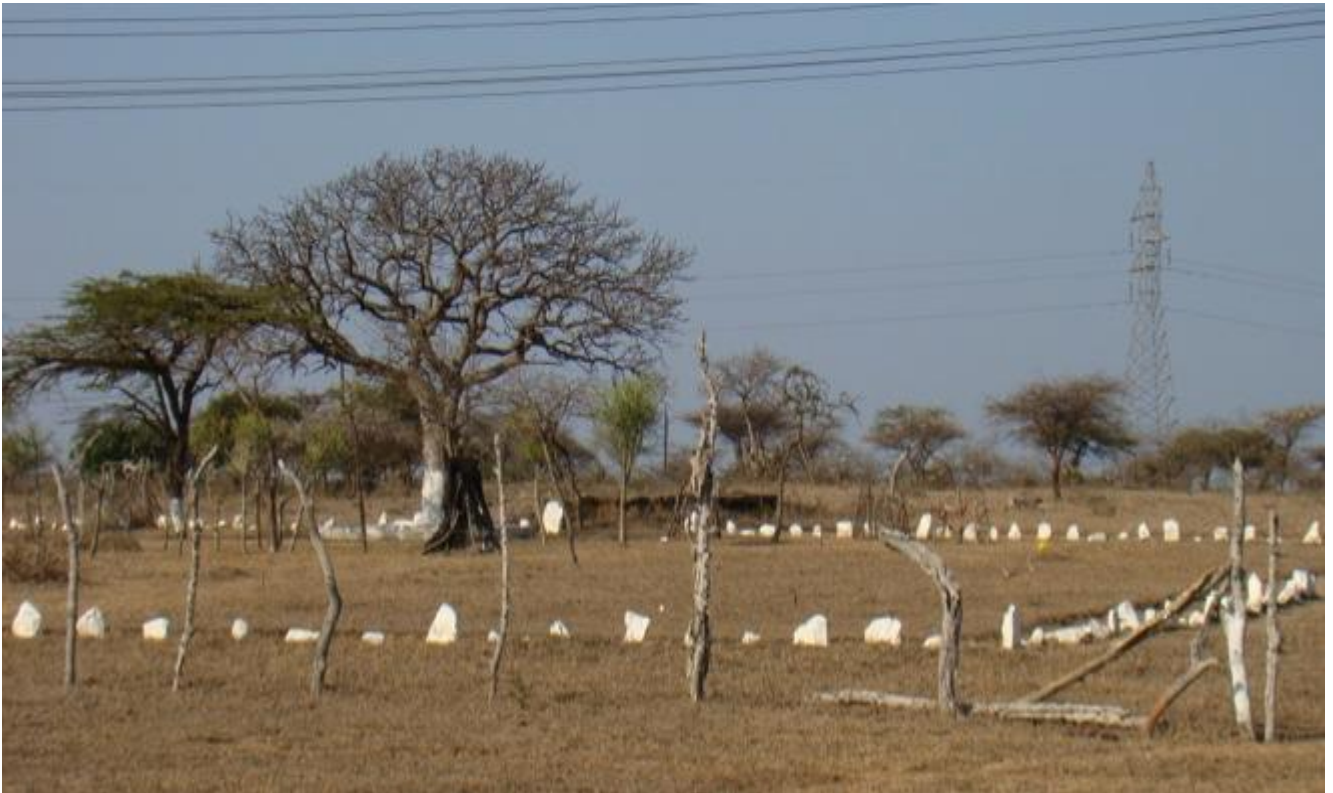
Plate 17: Shembe Church site located in vicinity of powerline development

An archaeologist should monitor installation of Towers 154, 157 and 159 during foundation excavations. These towers locations are associated with archaeological signatures which indicates potential to yield subsurface discernable archaeological remains that may require to be recorded. No further mitigation is required prior to construction phase on other tower positions. However, should chance archaeological materials are disturbed at any of the remaining tower positions in this section, salvage and chance finds procedures should be implemented. The construction team must exercise extreme caution when working near active burial sites and open-air places of worship such as the Shembe Church.

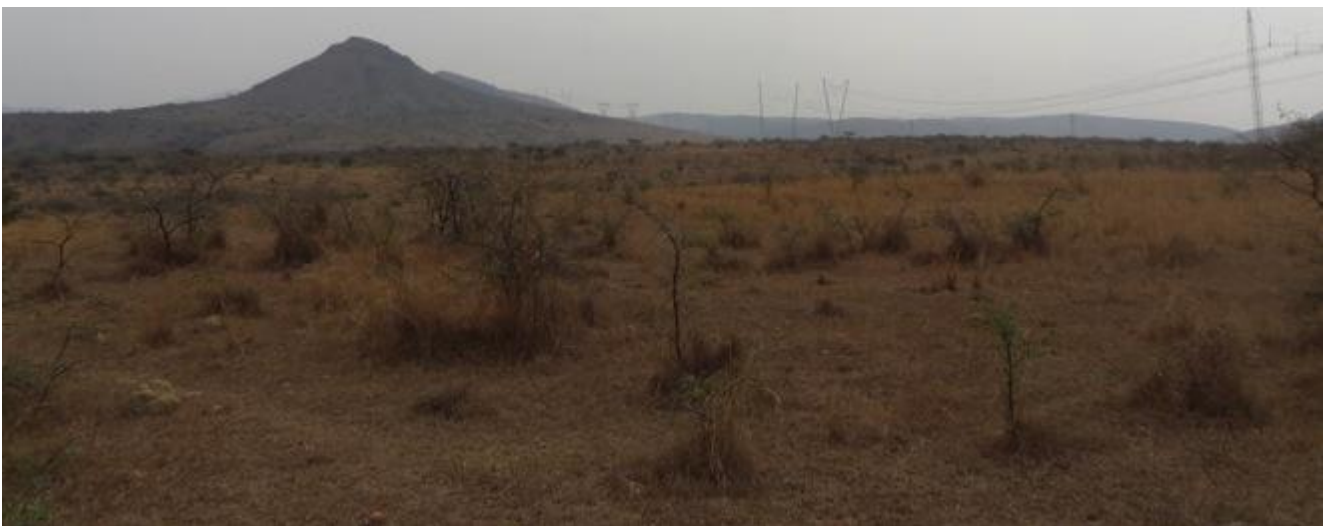
Plate 18. Typical landscape through which the powerline will traverse in section after Ulundi region. The powerline cuts through sloppy area with isolated farm or village settlements, agriculture fields and patches of grazing land.

The construction workers must exercise caution especially during stringing of all towers in this section. Other than generic monitoring, no further mitigation is required prior to construction phase. However, should chance archaeological materials be disturbed at any of the unmonitored tower positions in this section, salvage and chance finds procedures should be implemented.

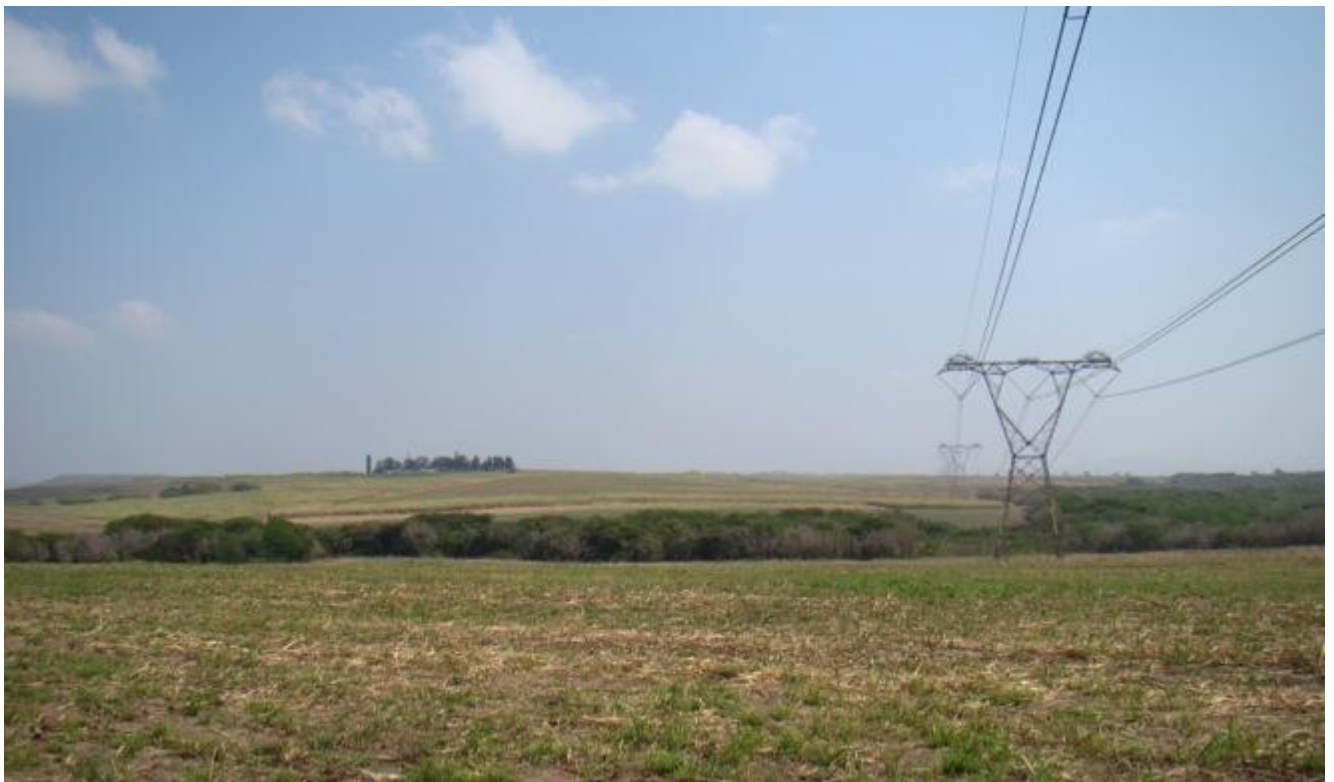
Plate 19: The powerline cuts through sloppy area with isolated farm settlements, agriculture fields and patches of grazing land.

An archaeologist should monitor installation of Towers 214 during foundation excavations. This tower location has potential to yield subsurface discernable archaeological remains that may require to be recorded during construction work. Furthermore, should chance archaeological materials be disturbed at any of the unmonitored tower positions in this section, salvage and chance finds procedures should be implemented.
