# HERITAGE IMPACT ASSESSMENT

14 July 2015

DR 2403 Central Karoo

Beaufort West – Central Karoo Municipality, Western Cape

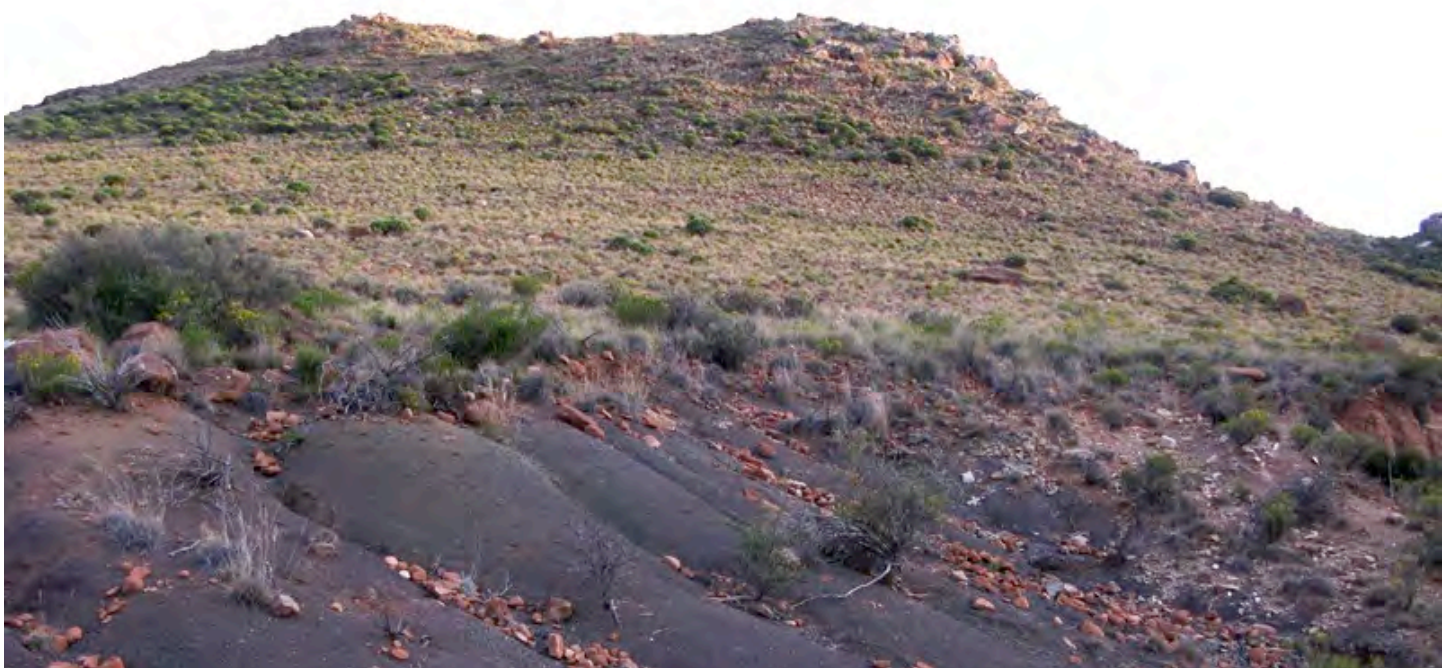
Figure 2: View south-westwards across the DR02403/44.5/0.02R study area (Almond 2015: 4)

Proposal is for an existing borrow pit located along the unsealed DR 2403/44.5/0.02R approximately 33 km southeast of Murraysburg Central Karoo District Municipality. The pit is located on a north-facing slope that extends down to the Buffelrivier. Short grass and koppie surround the borrow pit. Farm Doornboschfontein is in private ownership of Mr J C R van Heerden. Borrow pit co-ordinates are  $32^{\circ} 4'55.19''\text{S}$  and  $24^{\circ} 4'51.76''\text{E}$ .

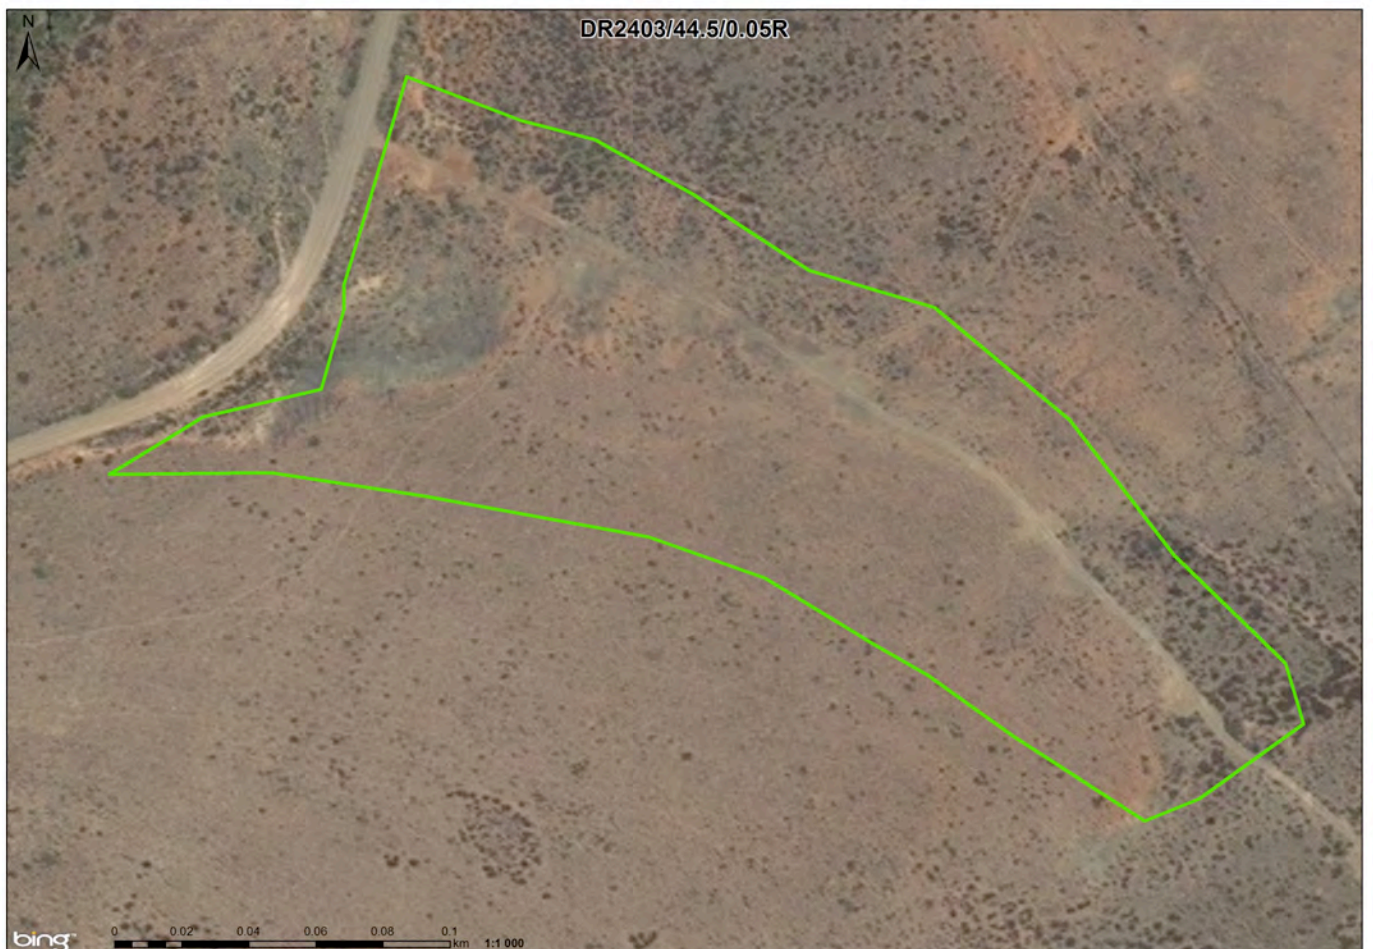
Figure 4: Aerial view of borrow pit and preliminary pit area (Google earth, April 2015)

Summary of borrow pit	
Expropriation area	9000 m <sup>2</sup>
Borrow pit	7 000 m <sup>2</sup>
Maximum depth	1.5 m
Material description	mudrocks of the Balfour Formation (Lower Beaufort Group / Adelaide Subgroup) of Late Permian age.
Proposed usage after rehabilitation	Re-vegetation
Volume of material to be sourced	10 000 m <sup>3</sup>
