ARCHAEOLOGICAL IMPACT ASSESSMENT
OF
THE PROPOSED EXTENSION OF A BORROW PIT IN THE
ROAD RESERVE, BELVEDERE 73, BEAUFORT WEST
MUNICIPALITY, CENTRAL KAROO DISTRICT,
WESTERN CAPE

(Assessment conducted under Section 38 (8) of the National Heritage Resources Act as part
of a Heritage Impact Assessment)

5.2 Borrow pit MR587/27.0/rrR (Vidamemoria pit no. 328)

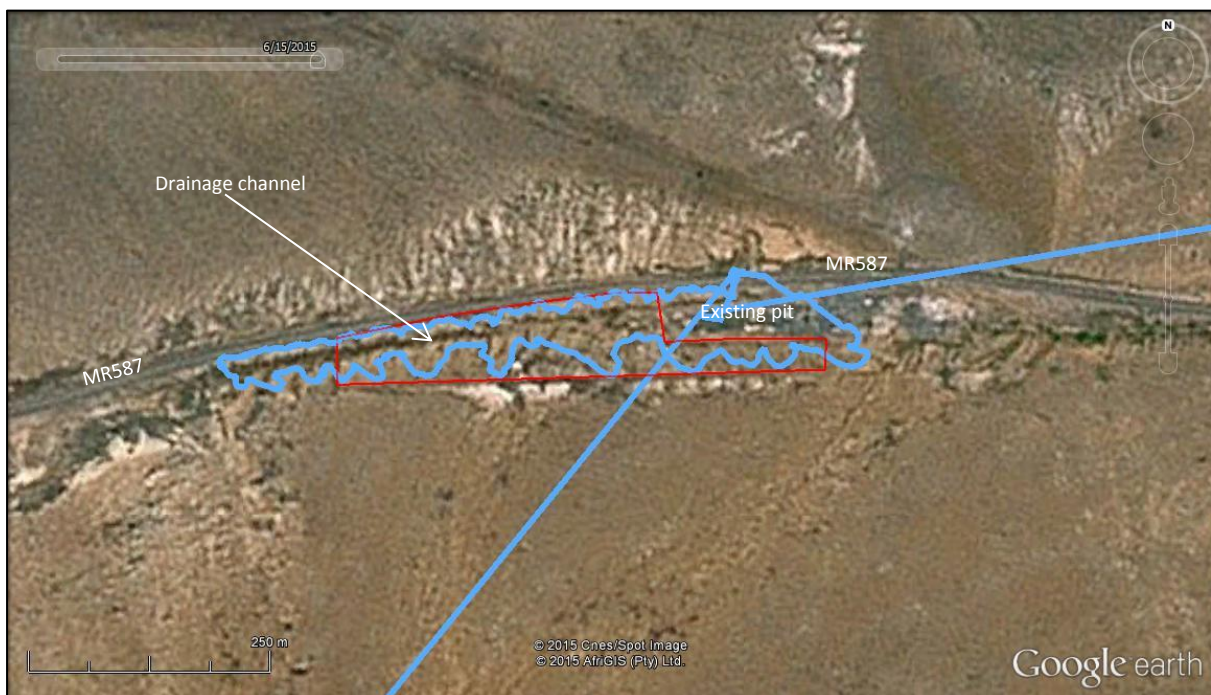
Figure 2: Google earth image showing the proposed borrow pit 328 and tracks of the field survey. The southern boundary lies along a fence line.

Environment: The proposed extension is located within the road reserve immediately south of the east/west aligned MR587 road and lies to the west and southwest of the existing pit (Figures 2, 4 and 5). A fence forms the southern border of the affected area (Figures 2 and 6). Part of the existing pit is filled with water. The area is fairly flat-lying but is largely disturbed by a man-made drainage channel and several roadside drains with berms which dissect the northern half of the proposed extension (Figures 2, 3 to 5, 7 and 8). The southern half of the area also shows signs of disturbance due to runoff from the road and sheet erosion (Figures 6 and 9). The vegetation cover consists of varying densities of low bushes, including *Salsola* sp., and scattered grass (Figures 3 to 9). Colluvial and alluvial surface gravels with calcrete, mudrock and sandstone clasts are visible in the exposed areas between more scattered plants (Figures 3, 4, 6 and 9). The gravels overlie weathered mudrock of the Teekloof Formation, Beaufort Group. Visibility of material on the ground was obviously better where the vegetation was less dense. No dolerite boulders occur in the vicinity of the site investigation area.

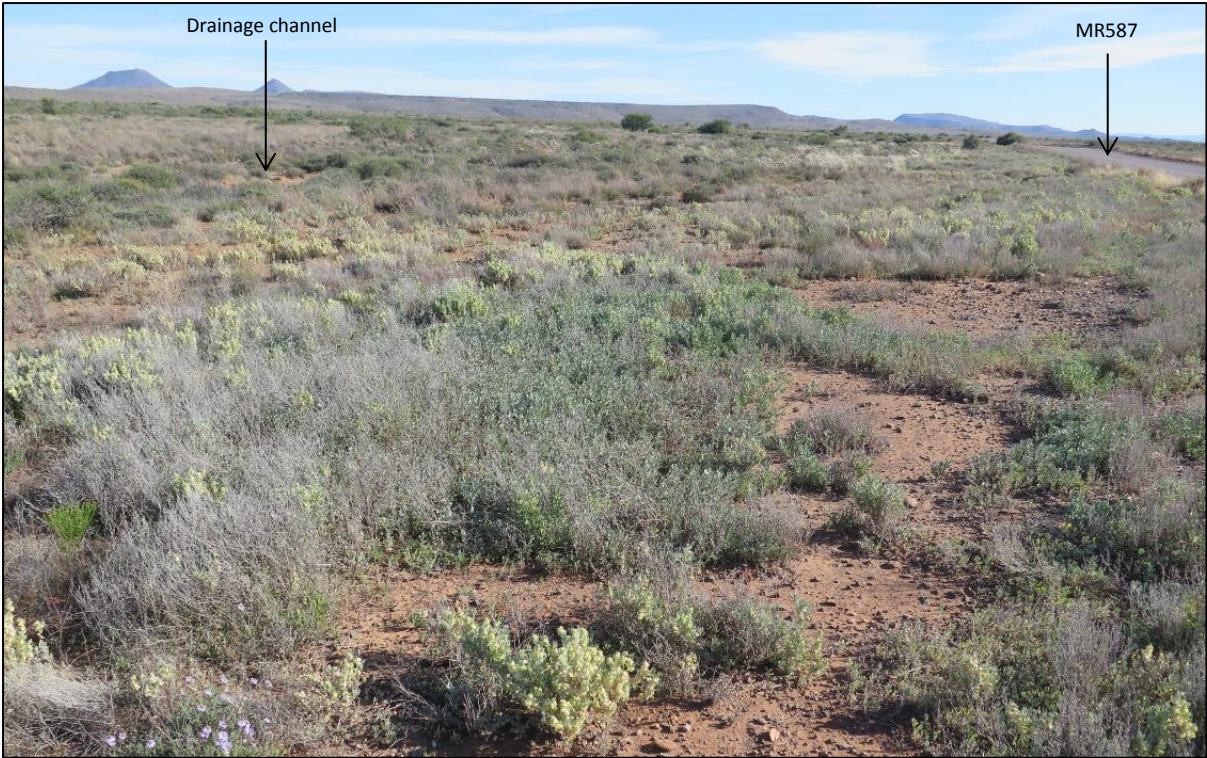
Figure 3: View towards the west. The man-made drainage channel is located in the middle ground and the roadside drains lie between it and the road. The surface gravels are evident in the foreground.

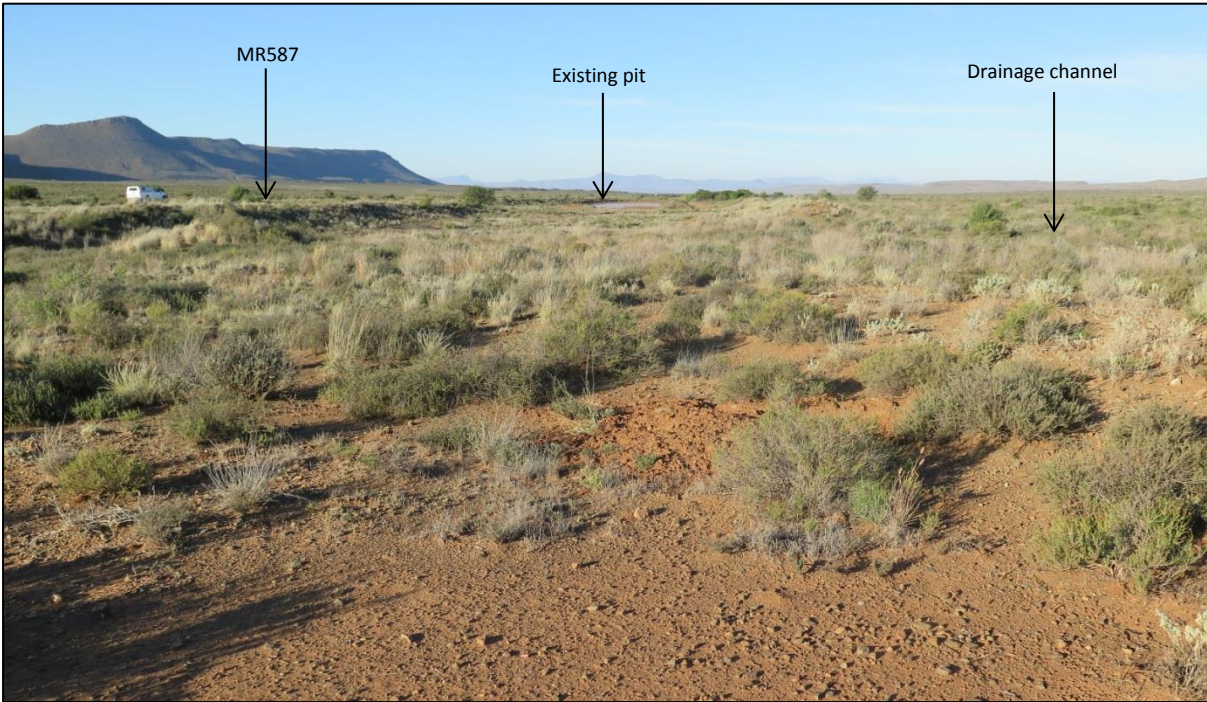
Figure 4: View towards the east showing the gravels in the exposed patches.

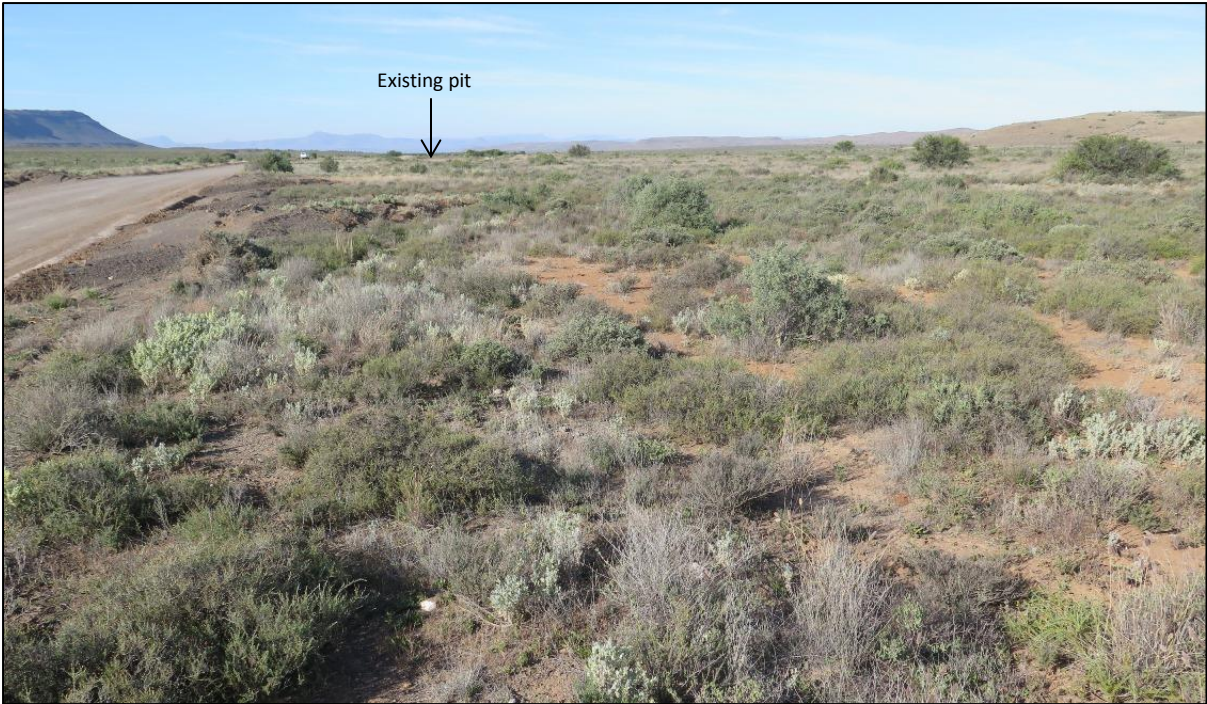
Figure 5: View towards the east from the western part of the affected area. Disturbance due to roadside drains adjacent to the road is visible on the left of the image.

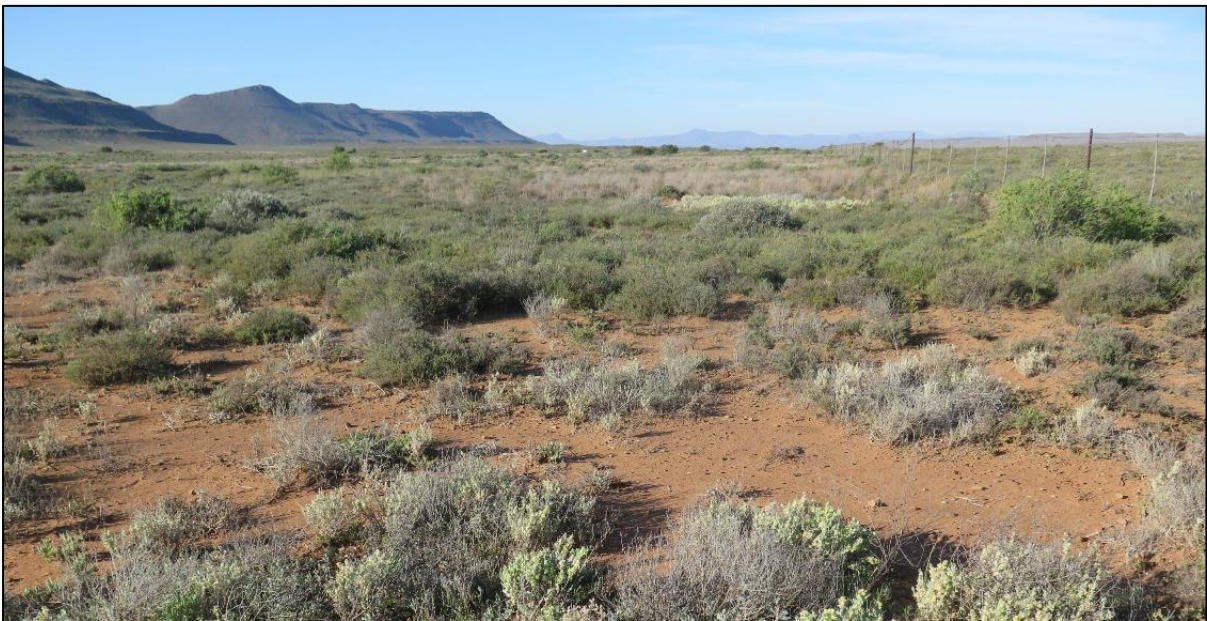
Figure 6: View towards the east of the southern part with the fence visible on the right of the image.

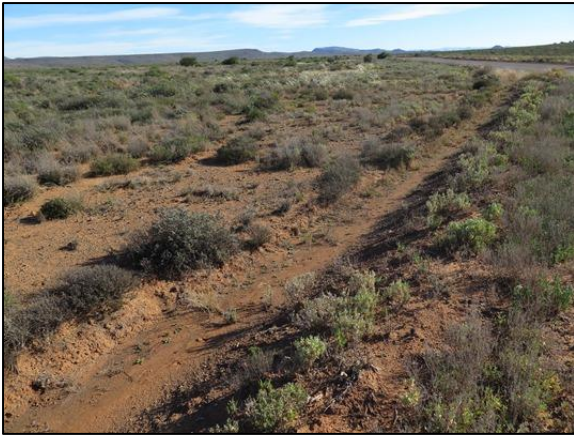
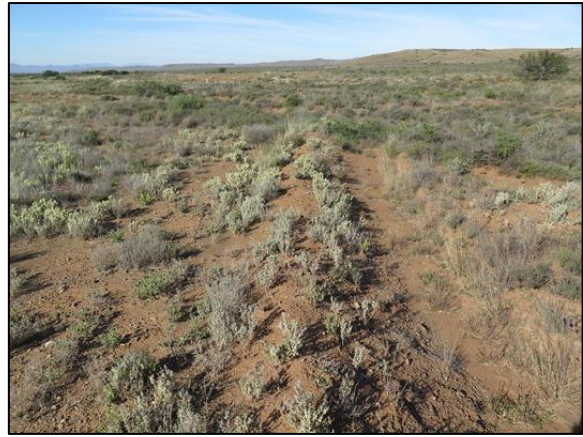
Figure 7: View towards the northwest showing one of the roadside drains with berm.
Figure 8: View towards the southeast along one of the berms.

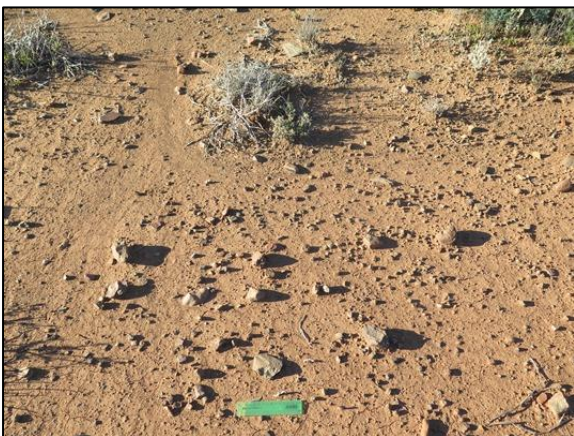
Figure 9: Detail showing evidence of sheet erosion and the down-wasting of artefacts and clasts. The green ruler is about 15cm in length. Figure 10: ESA handaxe, probably of fine-grained sandstone. The scale is in cm.

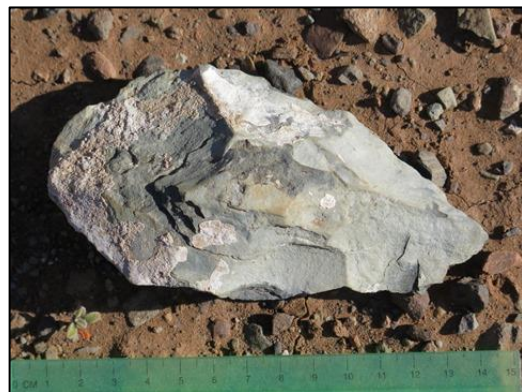
Results of the survey: The survey of the site investigation area revealed about 100 dispersed stone artefacts of various indeterminate ages but probably mostly MSA (Figures 10 to 19). Diagnostic elements included an ESA handaxe (Figure 10) and MSA blades, convergent flakes and cores (e.g. Figures 11 to 16, 18). Some of the artefacts are weathered and patinated (e.g. Figures 12 and 13) so in some cases it is difficult to identify the type of raw material used. It appears that most of the artefacts have been manufactured from local fine-grained sandstone and quartzite from the Beaufort Group (John Almond, pers. comm.), although some hornfels was also used (examples amongst the artefacts in Figures 14 to 16). Some of the hornfels flakes and cores may pertain to the LSA. The artefacts form a patchy background scatter of material on the surface. There is no stratigraphic context and many of the artefacts have been transported by sheet erosion. No other archaeological remains such as organic material, historical remains, graves or rock engravings were observed.

The background surface scatter of isolated stone artefacts, rather than a discrete site, in a disturbed context is considered to be of low archaeological heritage significance. No significant impact on such heritage resources is expected if the proposed extension is developed. No further archaeological studies or mitigation are therefore recommended.

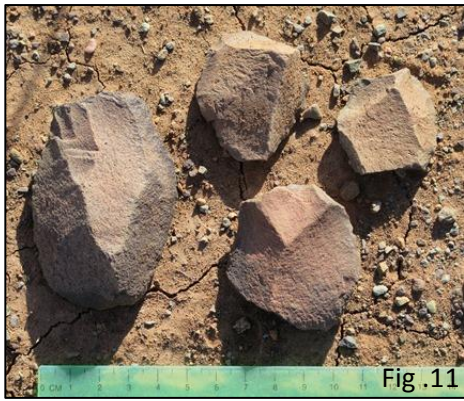
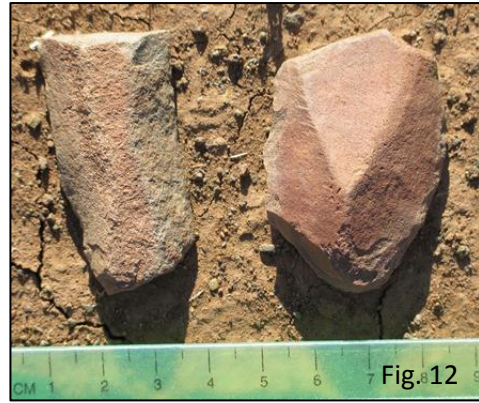
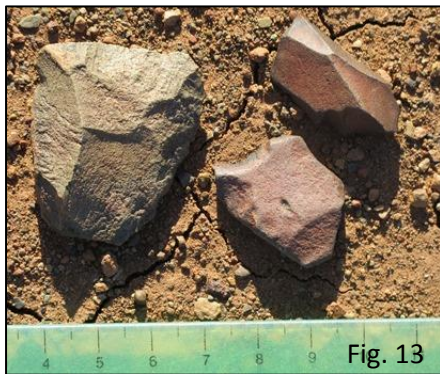
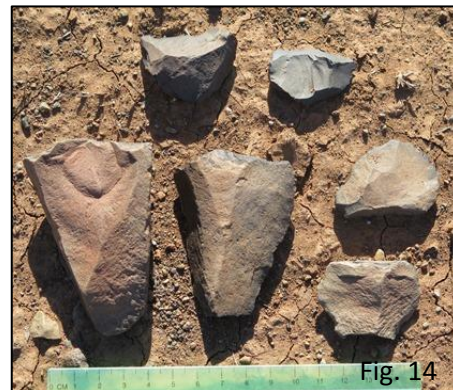
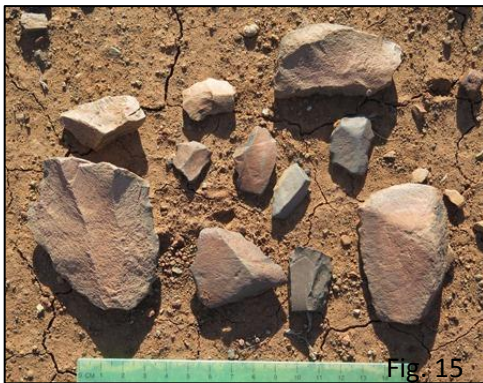
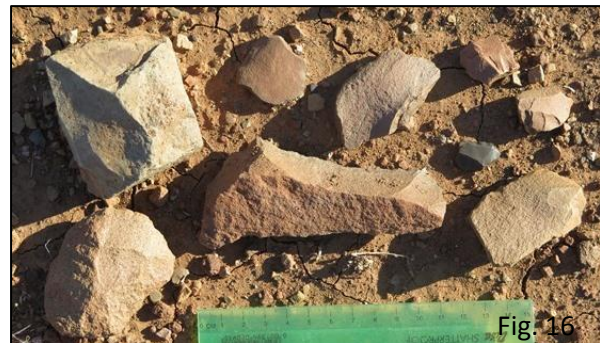
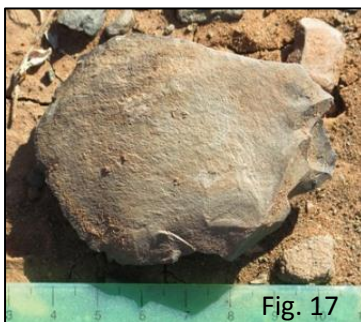
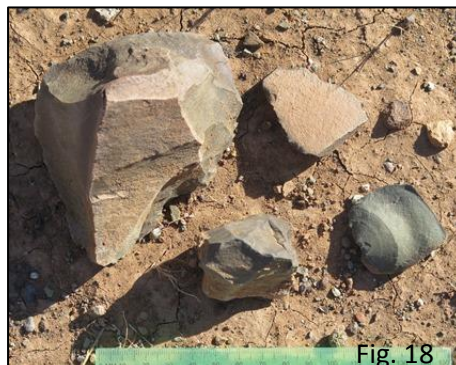
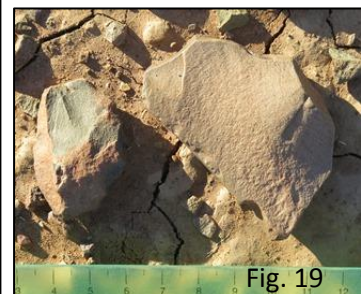
Figures 11 to 19: Examples of the artefacts – cores, chunks, flakes and blades - recorded during the survey. Most are probably of MSA origin and are made of fine-grained local sandstone and quartzite, although hornfels is also present (the small dark grey flakes in Figures 14 to 16). The scale is in cm.
