# HERITAGE IMPACT ASSESSMENT

submitted in terms of section 38(8) of the National Heritage Resources Act

MR 599 Central Karoo

Beaufort West – Central Karoo Municipality, Western Cape

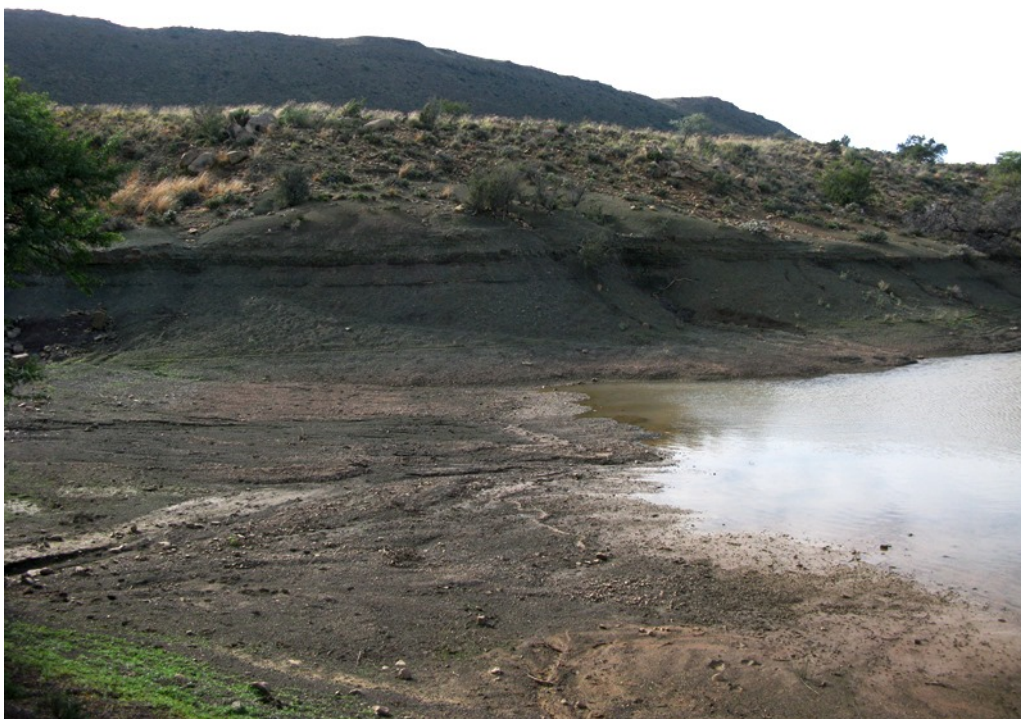
Figure 2: View north-eastwards across the existing MR599/41.0/0.02R (Almond 2015: 4)

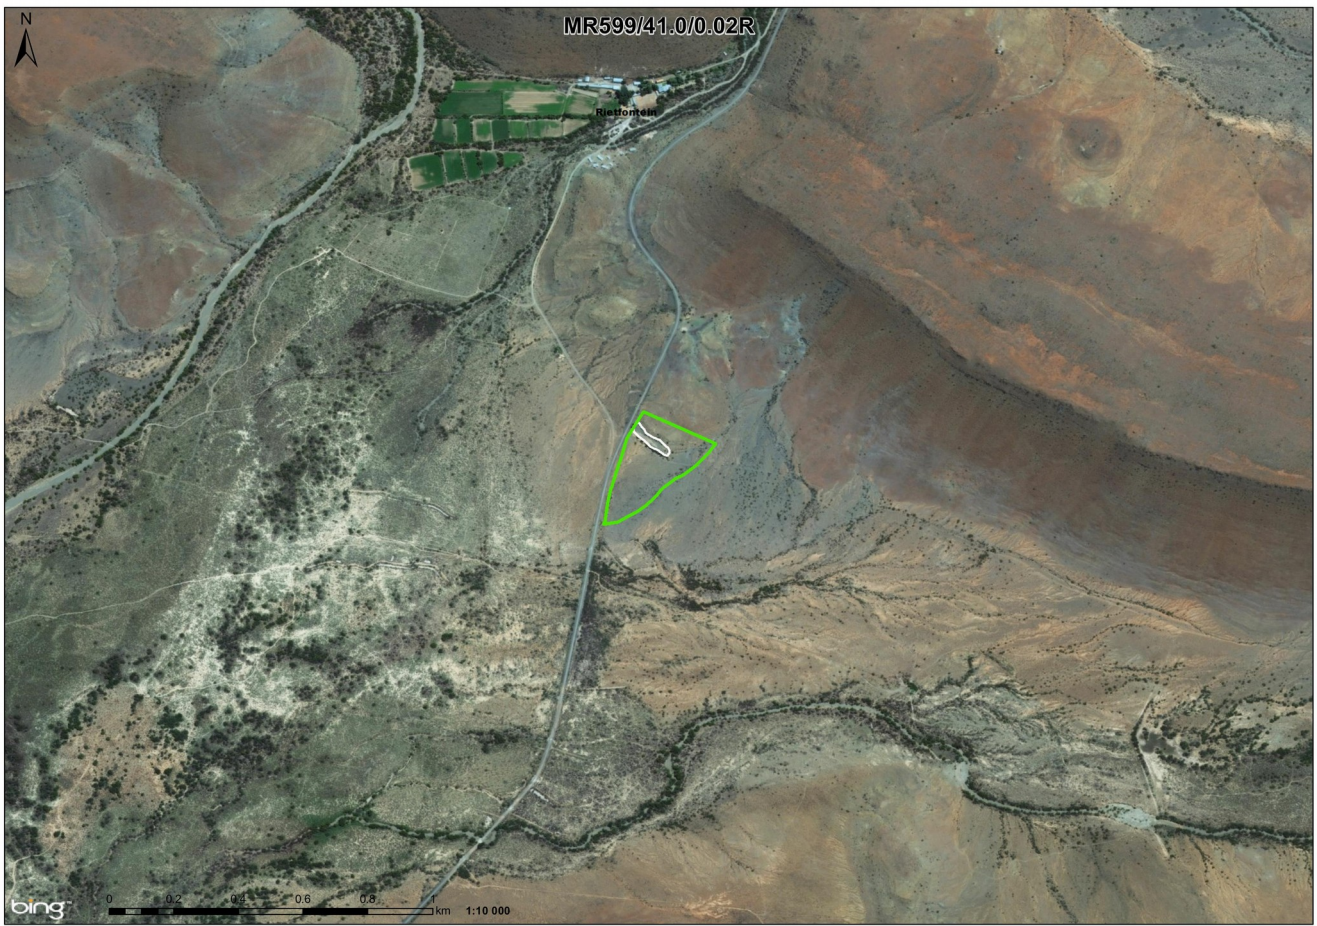
Figure 3: Site context and borrow pit location (Google earth, April 2015)

Proposal is for an extension of an existing borrow pit located along the unsealed MR 599/41.0/0.02R approximately 26 km southwest of Murraysburg, Central Karoo District Municipality. The site lies on the southern foot slopes of a trending ridge and north of a flowing tributary stream. Semi-desert grass and succulents surround the borrow pit. The site is situated on farm Rietfontein in private ownership of Mr Frans van der Ahee. Borrow pit co-ordinates are 32°10'52.97"S, 23°40'16.60"E.

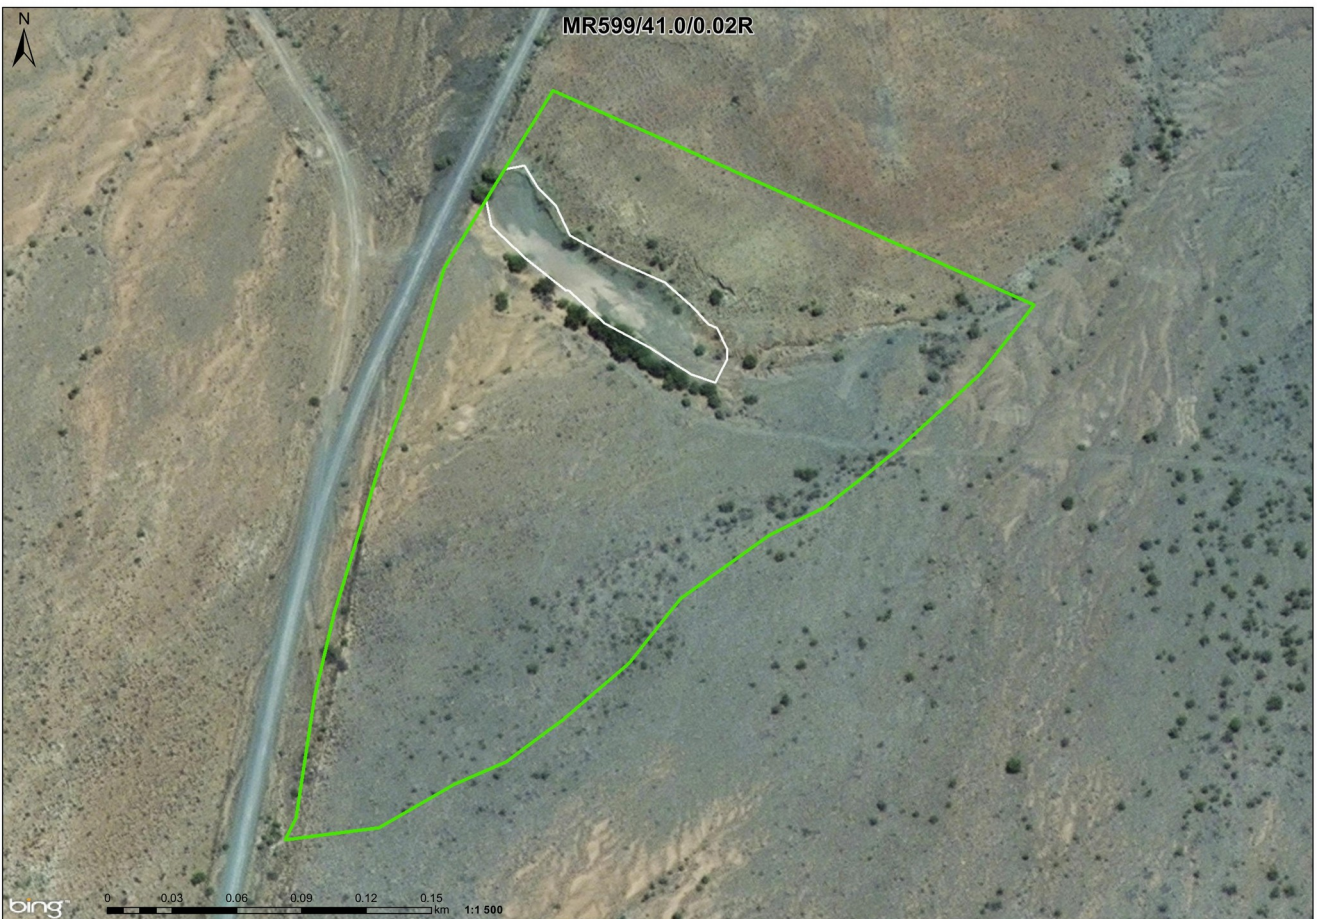
Figure 4: Aerial view of borrow pit and preliminary pit area (Google earth, April 2015)
