**EMERGENCY RISK MITIGATION
POWER PLANT (RMPP) ON LOTS
1854 AND 1795, ALTON,
RICHARDS BAY**

**PRELIMINARY GEOTECHNICAL
INVESTIGATION**

18-3388-01A-GT

September 2020

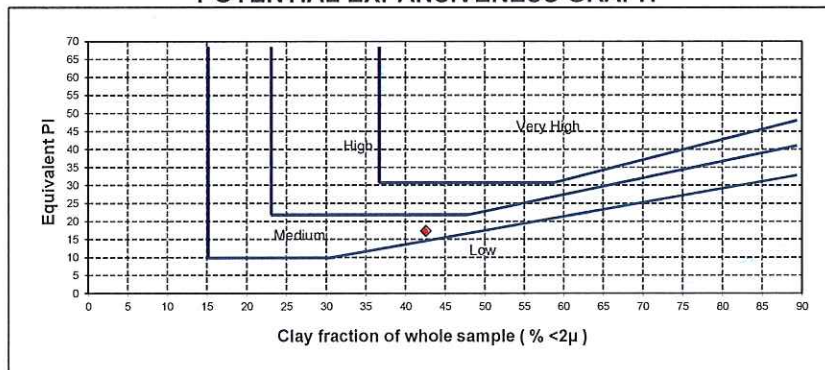
Sample Number : T21560
Field No. : IP10
Sample Description : Dark reddish blotched grey light orange yellowish brown silty CLAY
Equivalent PI : 17 **Clay fraction of whole sample (% <2µ)** : 43

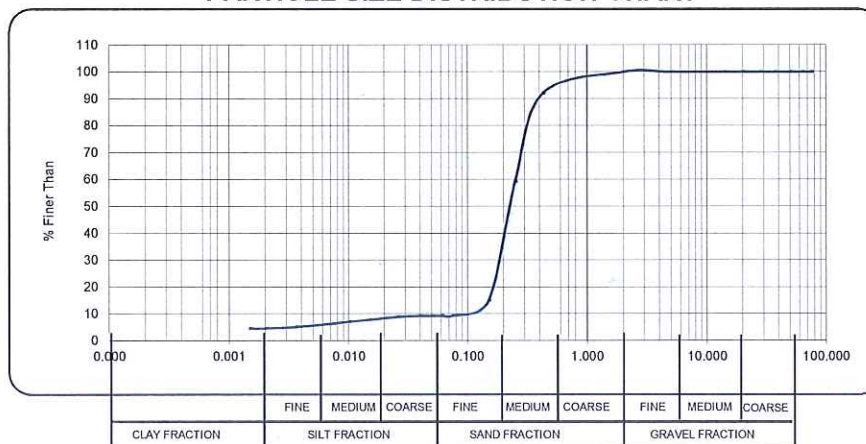
Sample Number : T21561
Field No. : IP12
Sample Description : Dark brown silty SAND
Equivalent PI : NP Clay fraction of whole sample (% <2μ) : 5

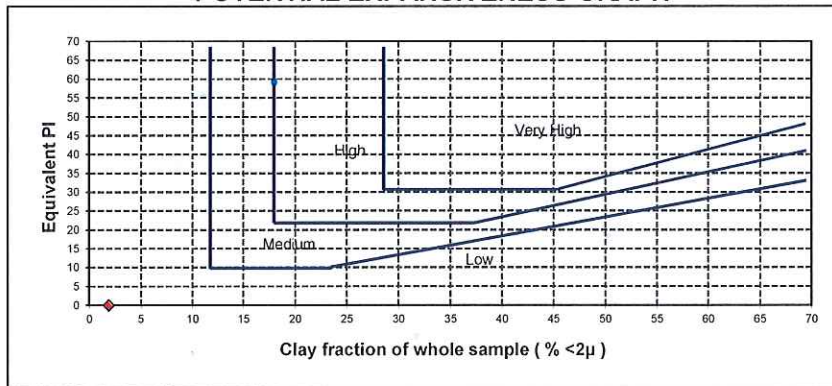
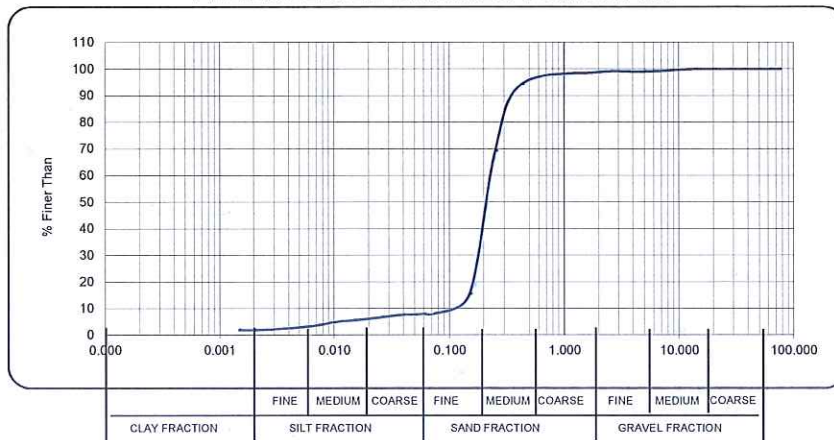
Sample Number : T21562
Field No. : IP19
Sample Description : Light orange yellow silty SAND
Equivalent PI : NP Clay fraction of whole sample (% <2 μ) : 2

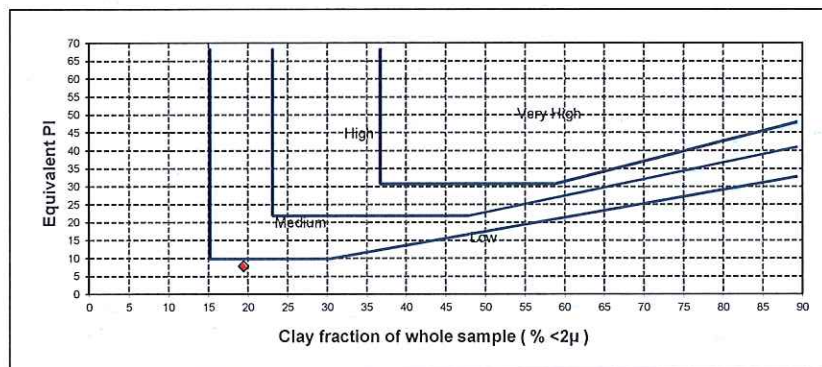
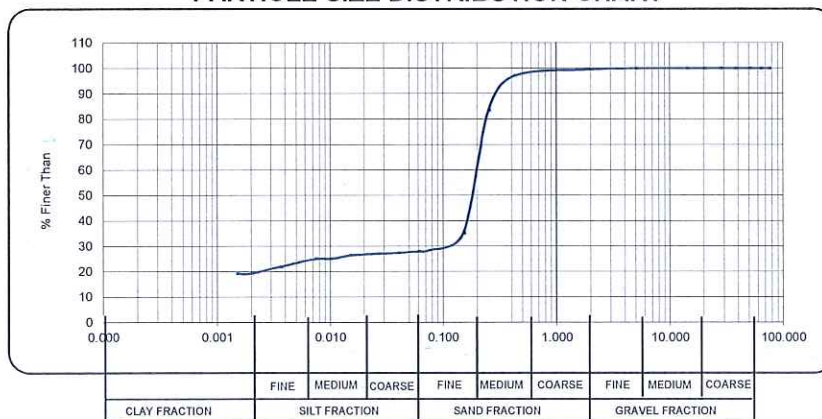
Sample Number : T21704
Field No. : BH1
Sample Description : Light olive reddish brown clayey silty fine SAND
Equivalent PI : 8 Clay fraction of whole sample (% <2µ) : 19

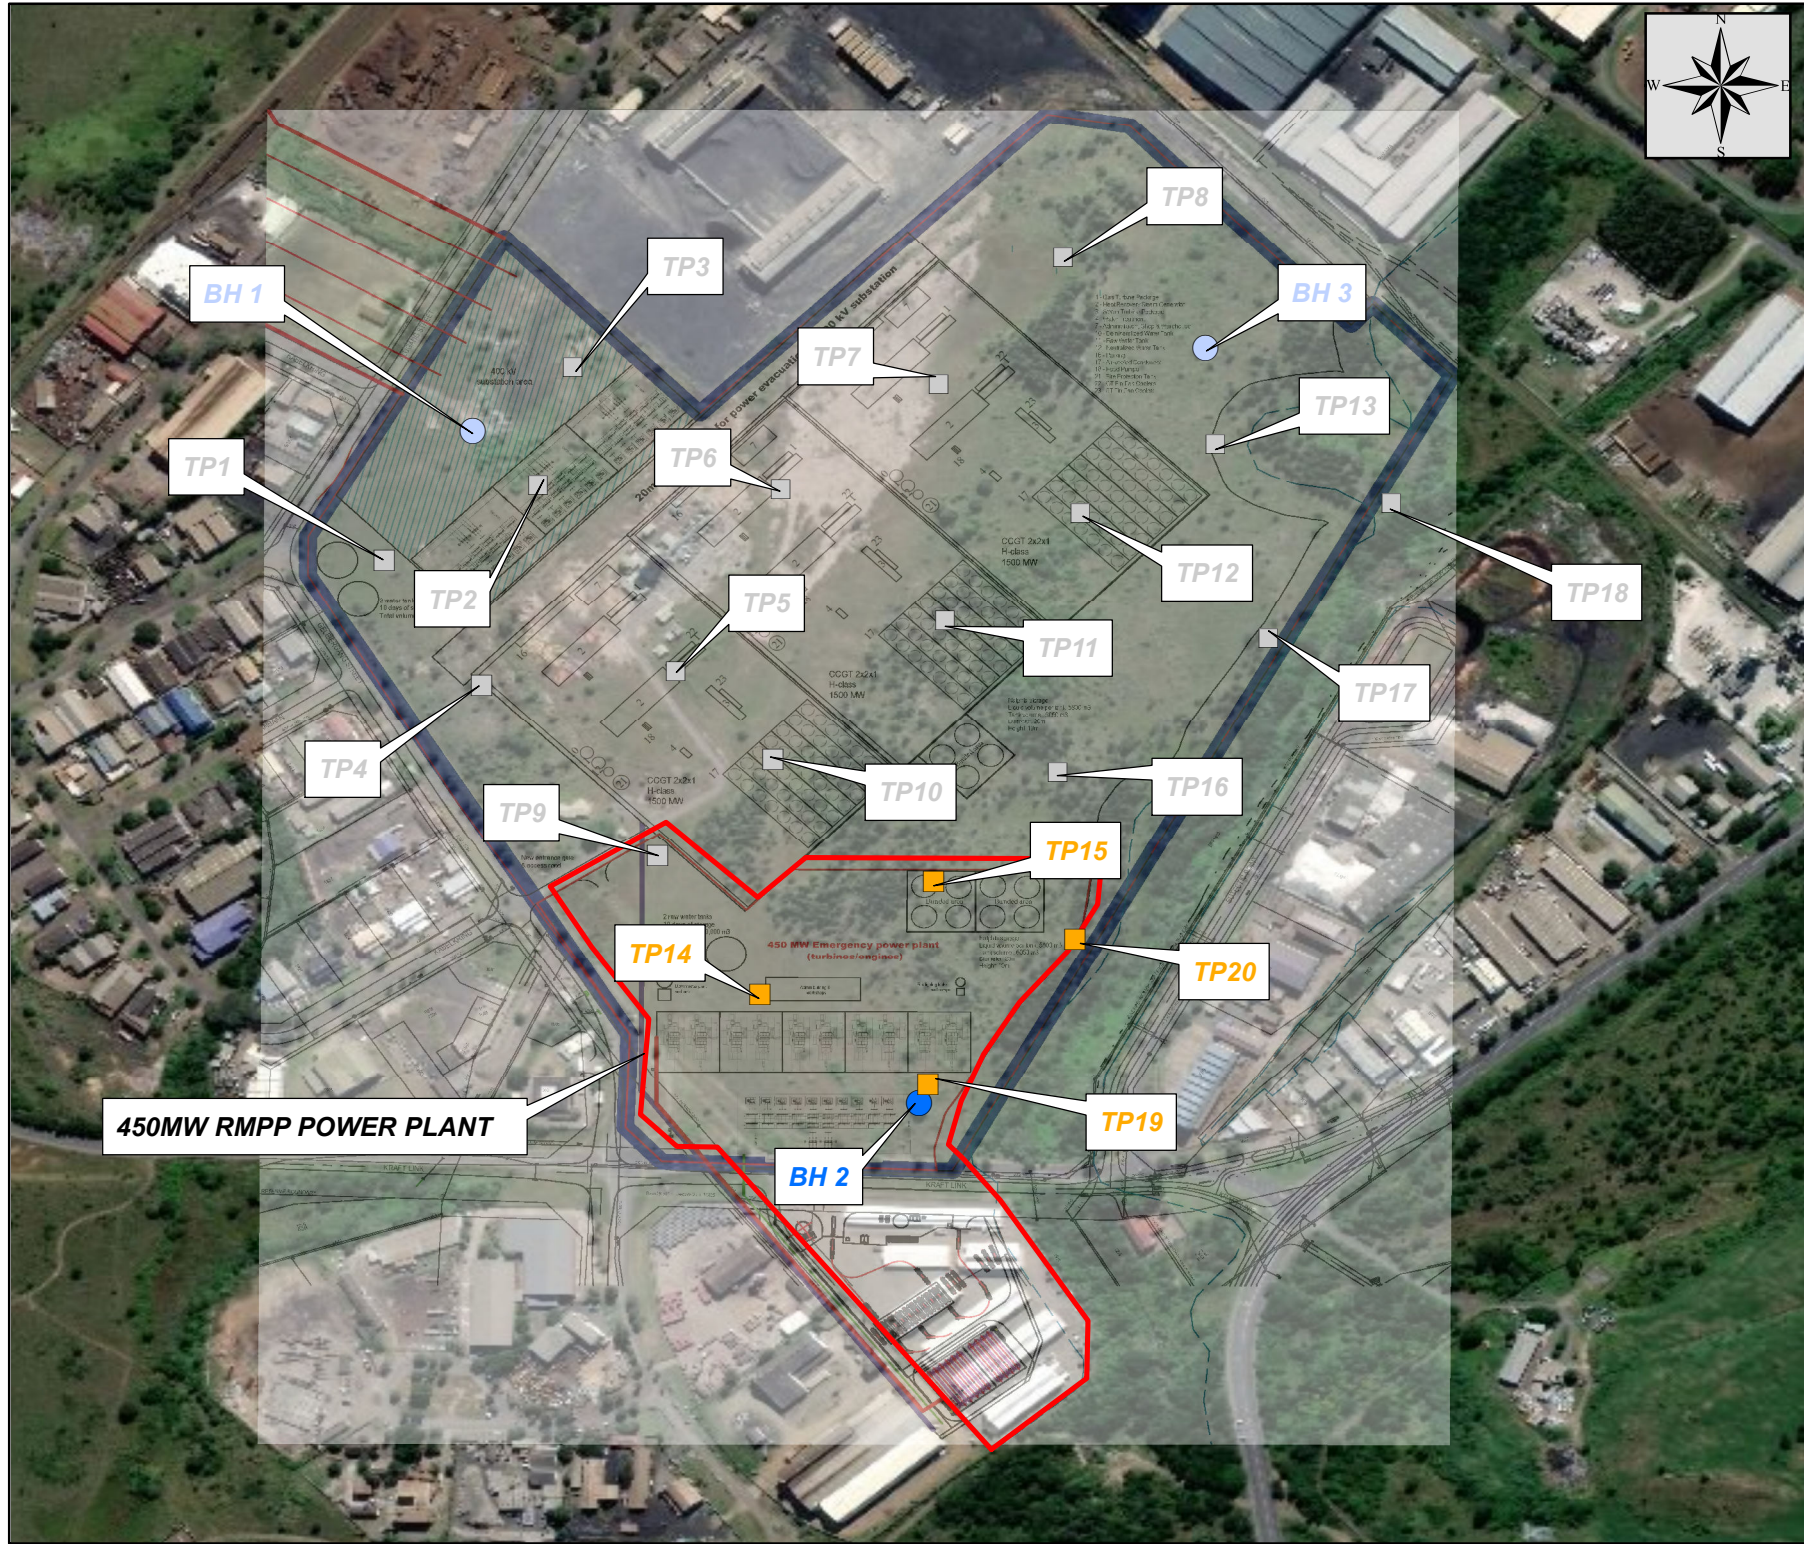
FIGURE NO.
FIGURE 1

The locations of the various in-situ tests in relation to the proposed layout of the 450MW Emergency Risk Mitigation Power Plant (RMPP) Development are indicated on the Geotechnical Site Plan, Drawing No. 18-3388-01A - Figure 1, whilst Drawing No. 18-3388-01A - Figure 2 indicates the locations of the various in-situ tests with the Aerial Imagery of the site.

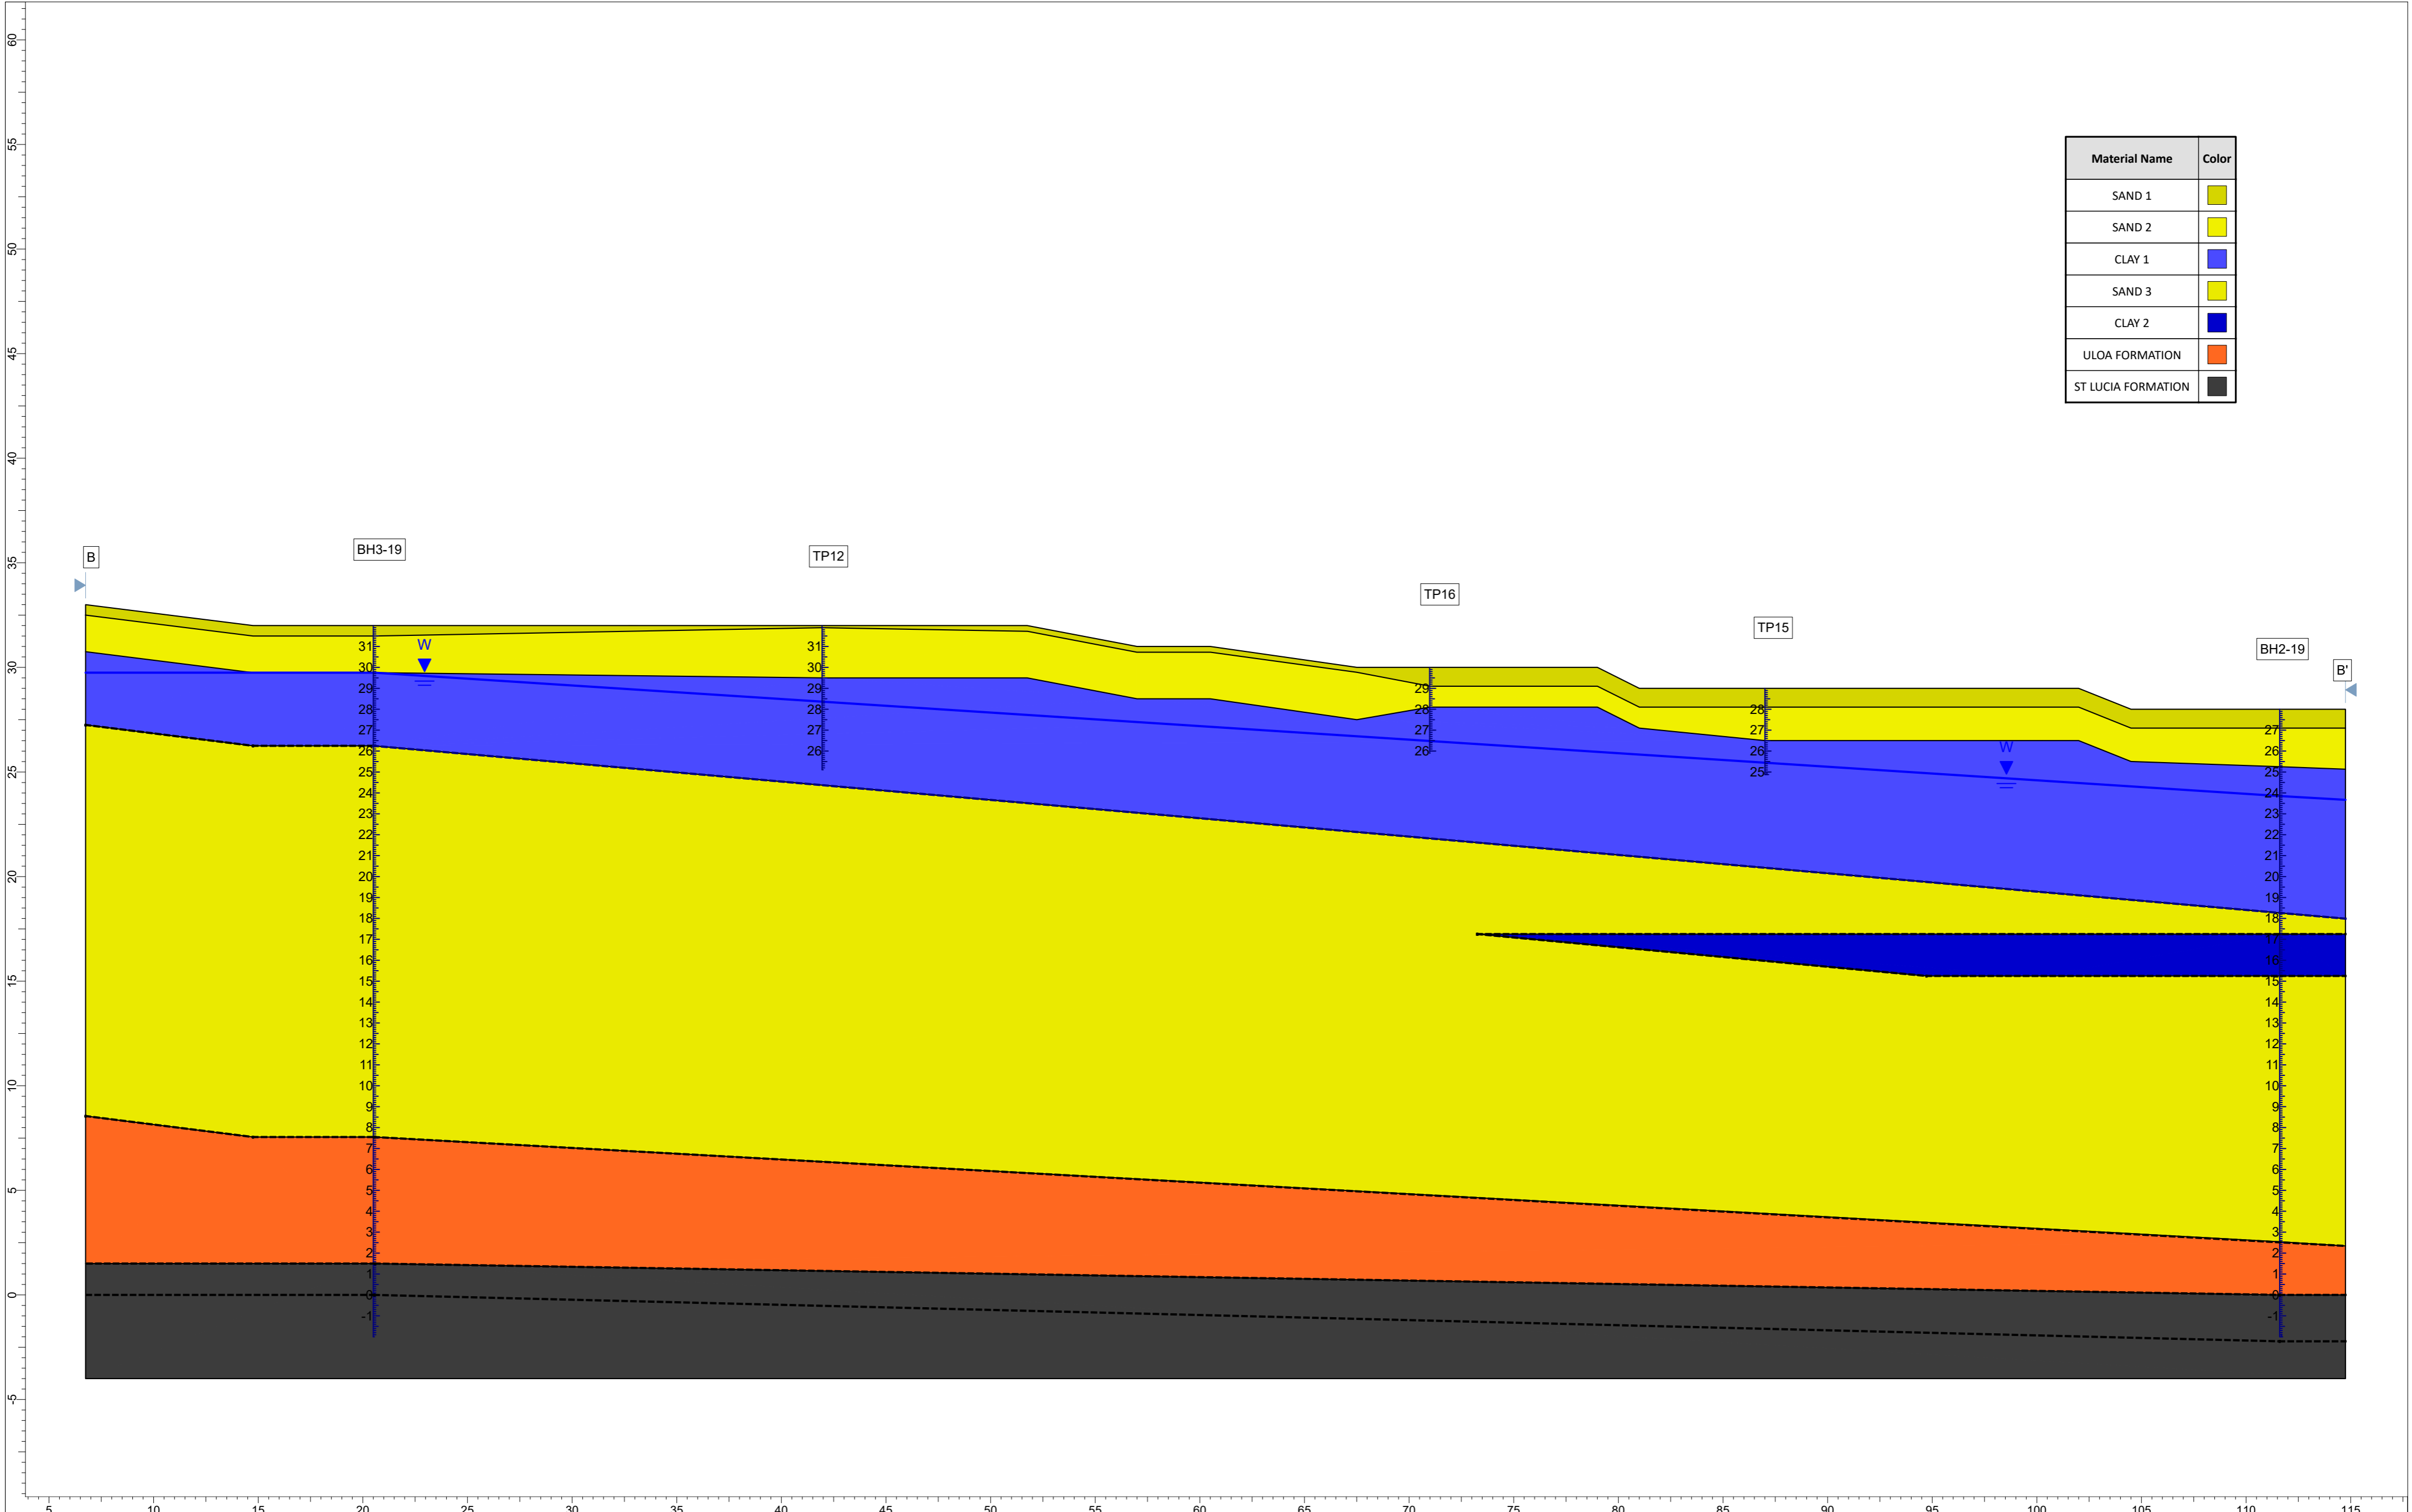
Material Name	Color
SAND 1	Light Yellow
SAND 2	Yellow
CLAY 1	Light Blue
SAND 3	Bright Yellow
CLAY 2	Dark Blue
ULOA FORMATION	Orange
ST LUCIA FORMATION	Dark Grey

In order to provide an indication of the preliminary founding of the proposed structures and the significant influence that reshaping of the existing topography and groundwater elevations will have on a founding assessment, two (2No.) inferred geological cross sections (A – A' and B – B') have been prepared and included in the Drawing Section of this Report.
