HERITAGE STATEMENT

submitted in terms of Section 34 of the NHRA (1999) for

81 ROSE STREET, CAPE TOWN, ERF 1977

Prepared by Rennie Scurr Adendorff Architects on behalf of Brian Green Investments cc

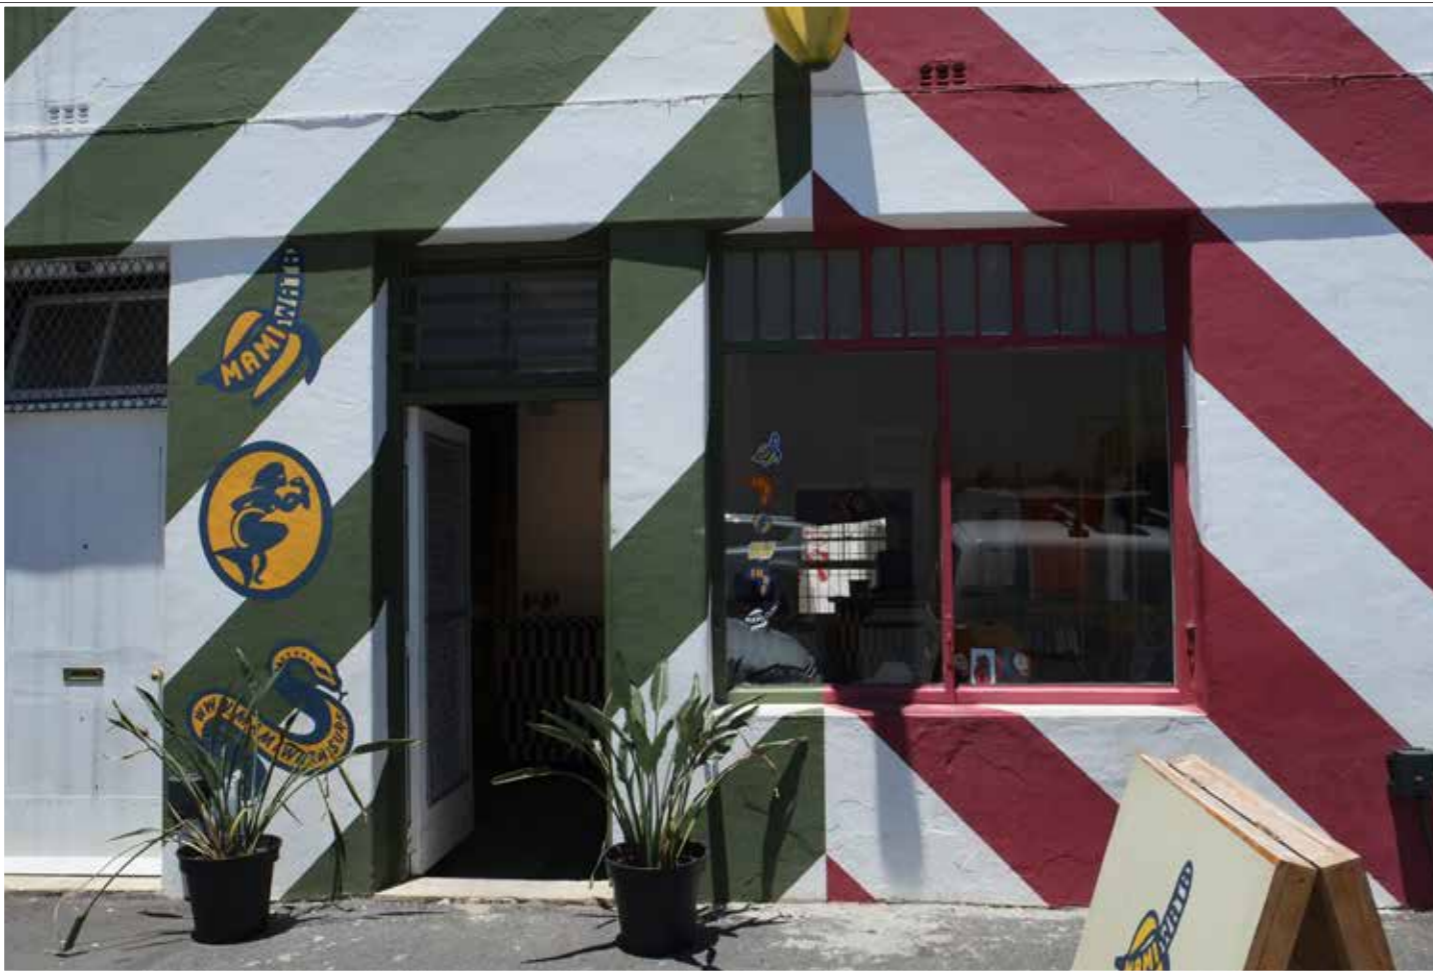
Figure 5. Ground floor: two north entries to front room and non-original window.

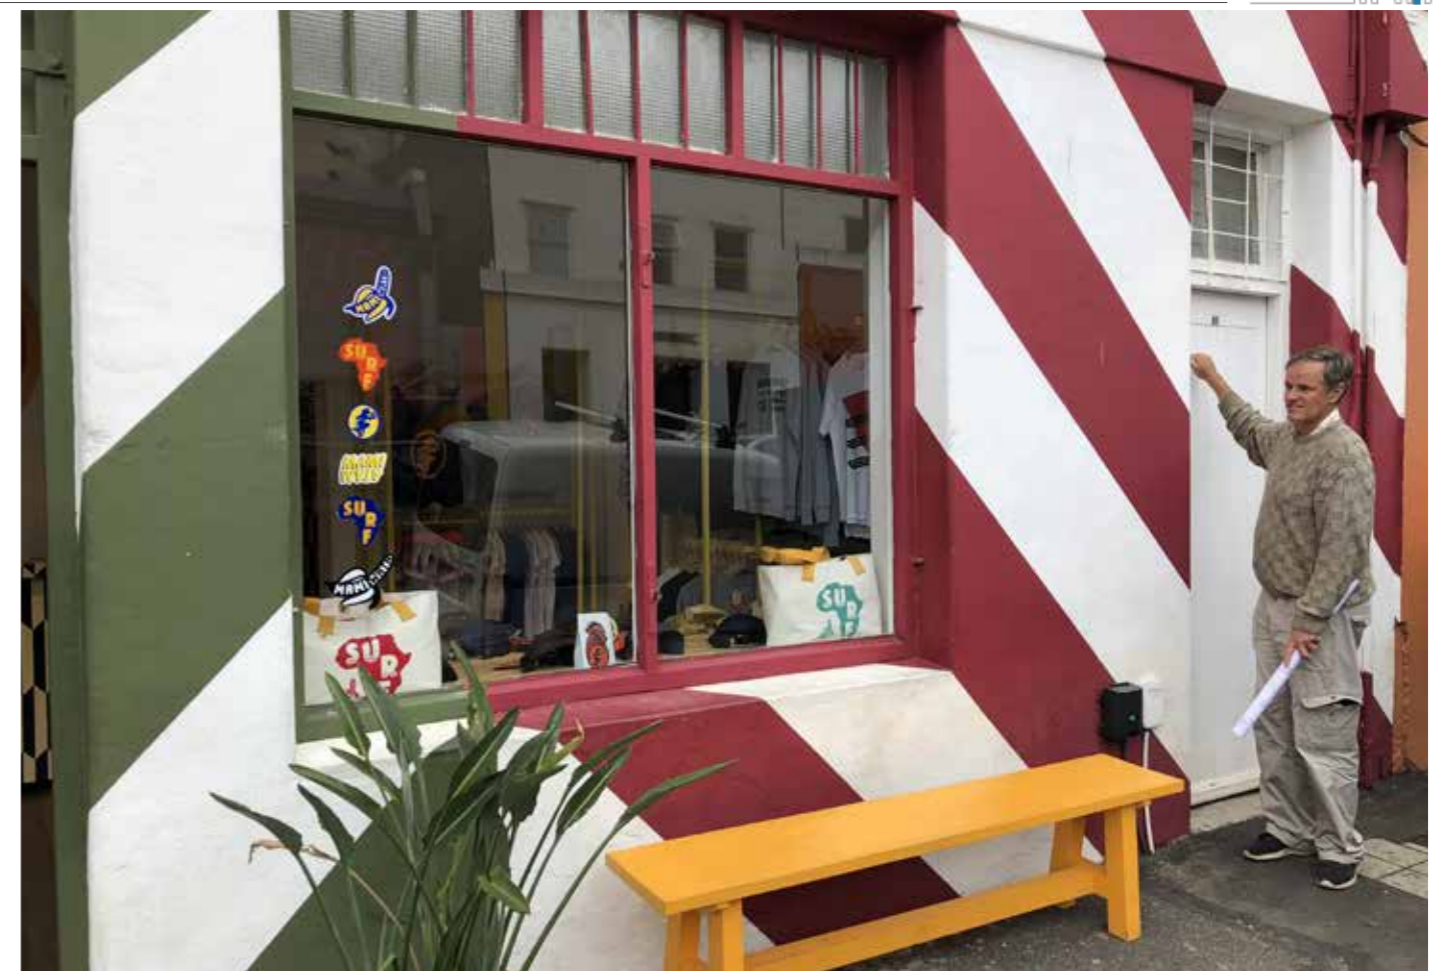
Figure 6. Ground floor window and separate entry to first storey

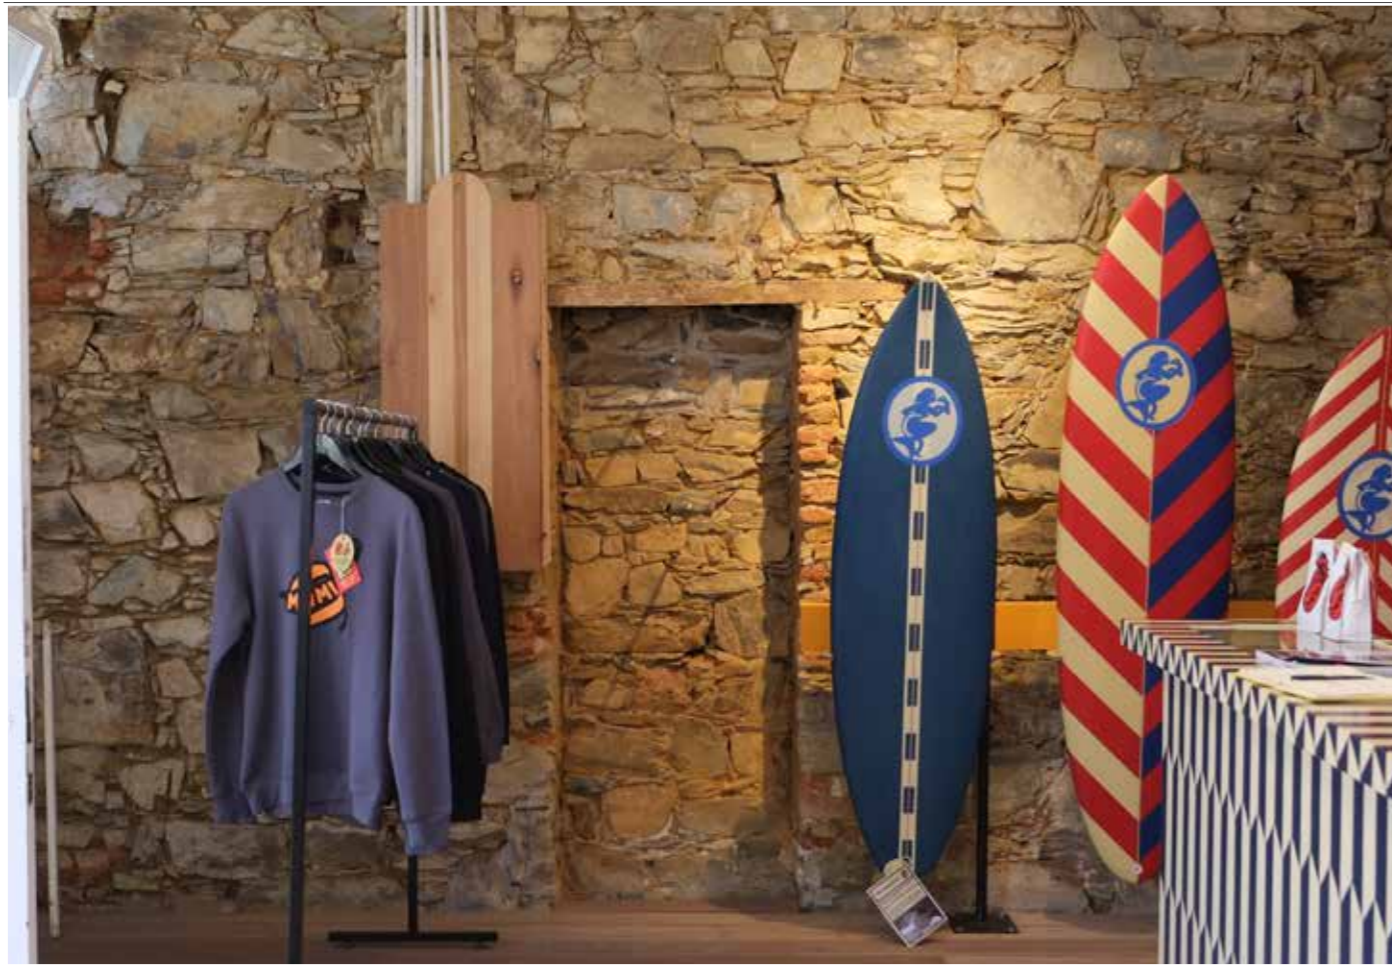
Figure 9. Ground floor front room shared north wall

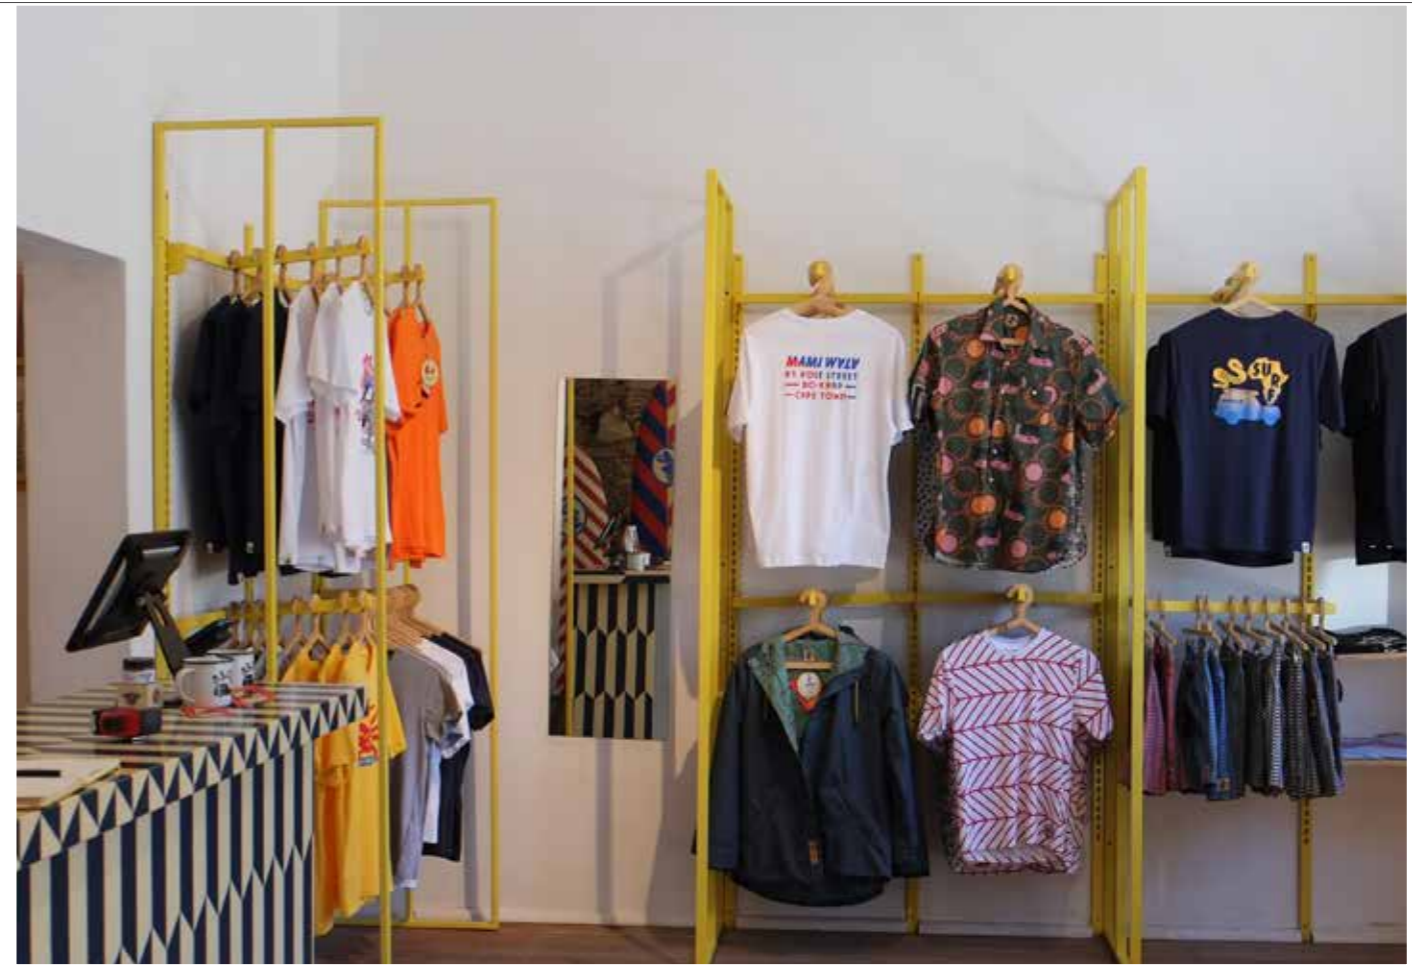
Figure 10. Ground floor front room south wall

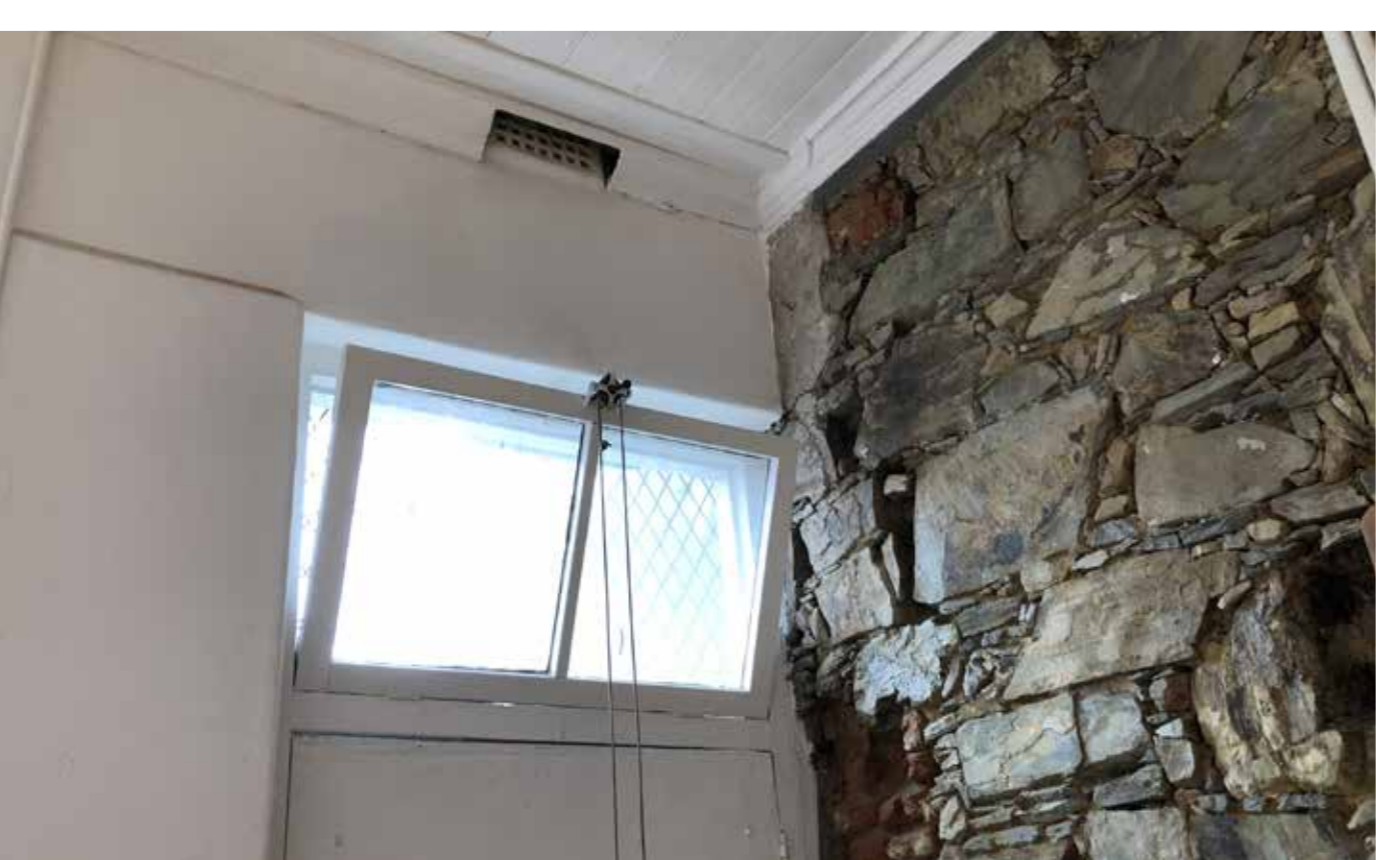
Figure 14. Ground floor north entry showing shared wall and ventilator/ceiling line

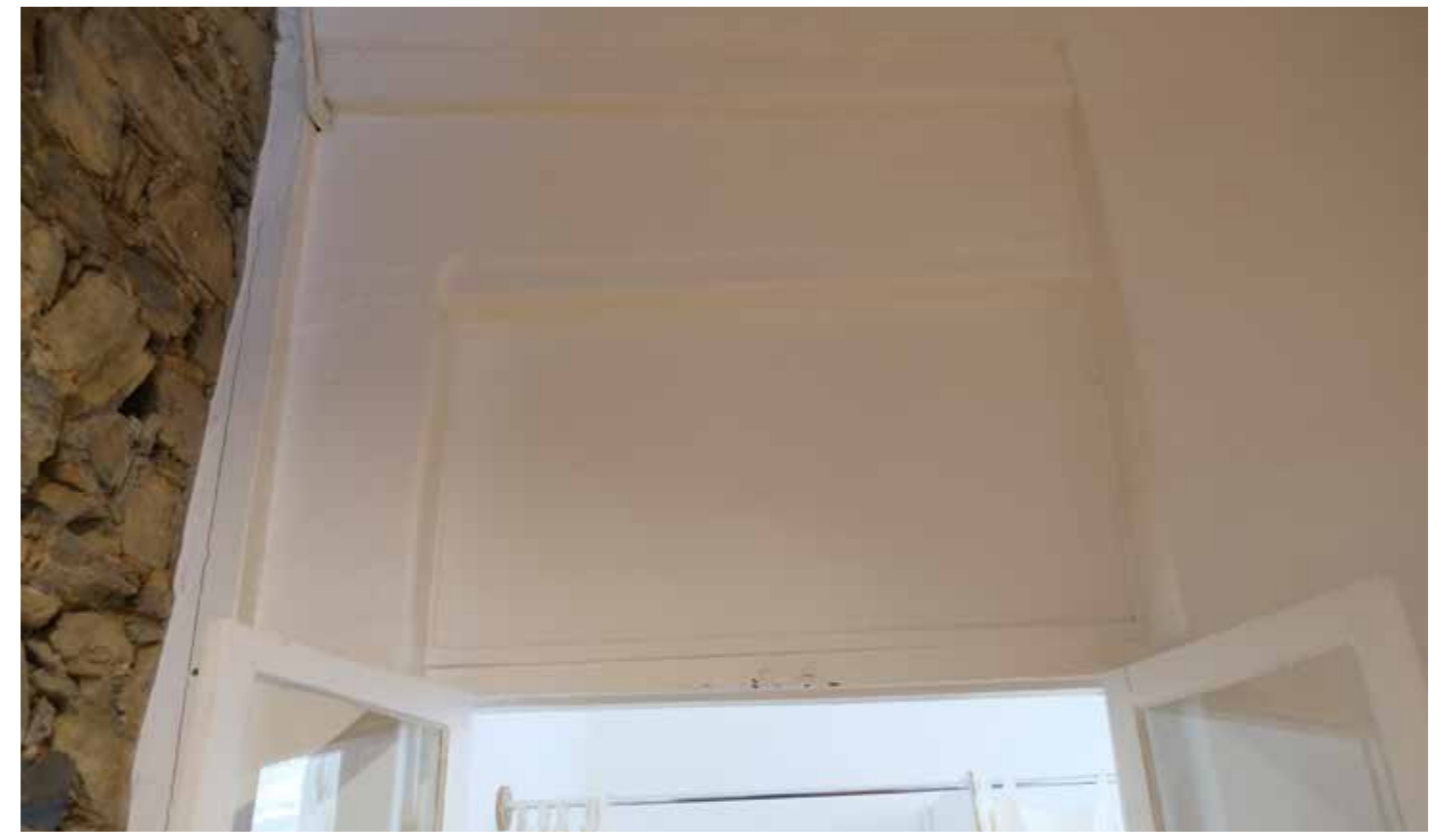
Figure 16. Ground floor, rear door showing layered openings

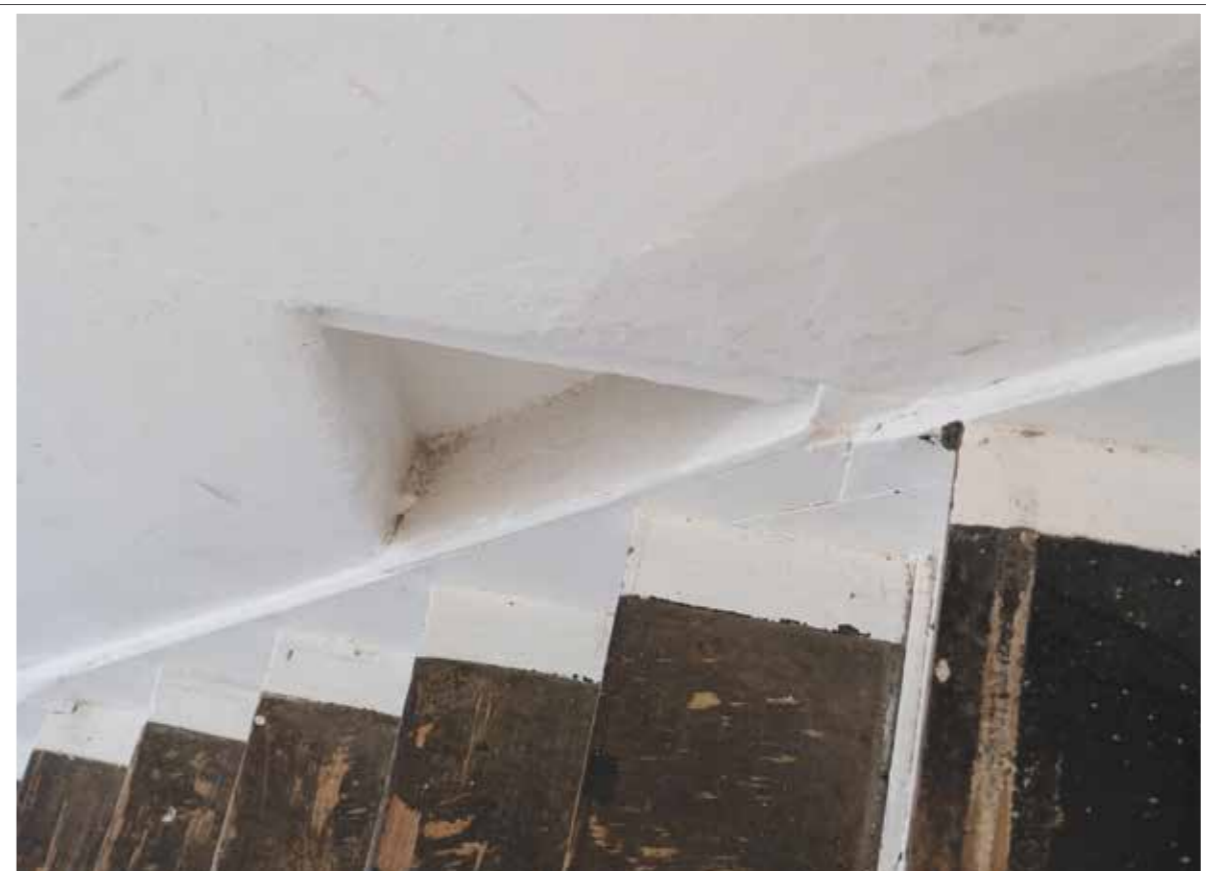
Figure 22. First floor changes to layout (exterior wall removed, slab extended over passage (concrete surface), internal wall added over timber floor)

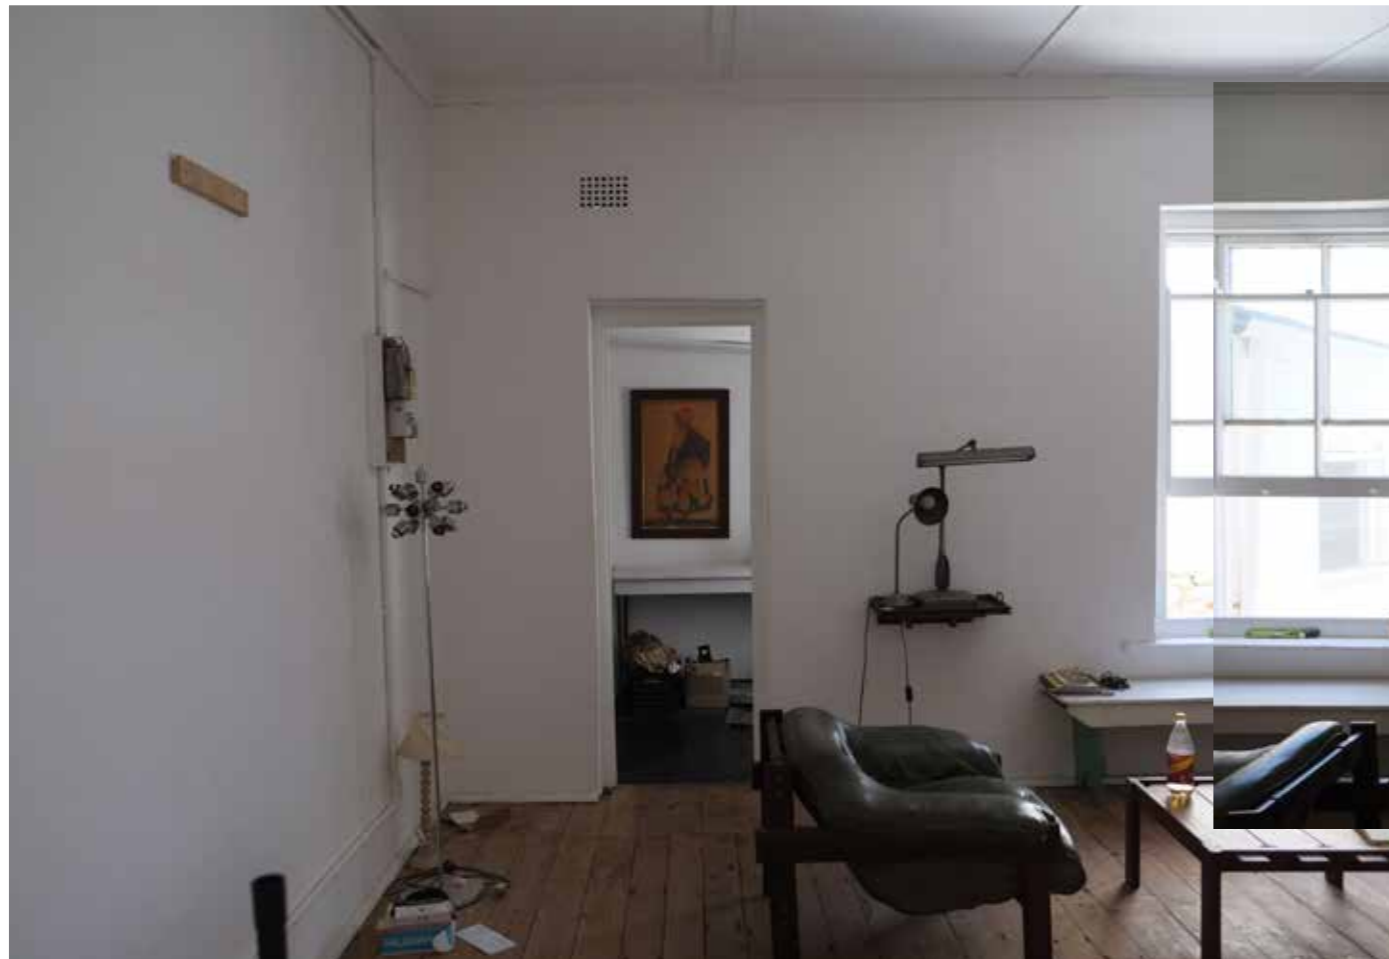
Figure 27. First floor main rear room view to courtyard: access to north side kitchen extension and south side bathroom extension.

- The demolition of courtyard outbuildings to create an open courtyard area does not impact the heritage significance of the building and will enhance usability of the space.
- The replacement of the upstairs timber bathroom with an open terrace is entirely appropriate.

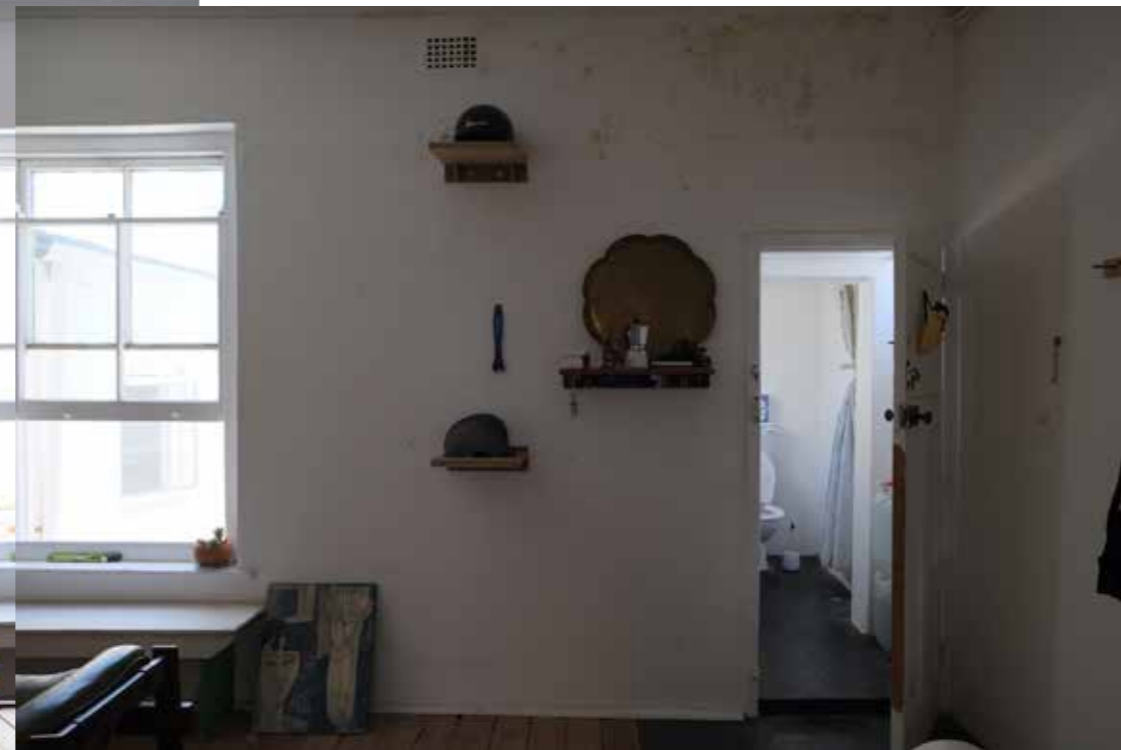
Figure 29. Bathroom

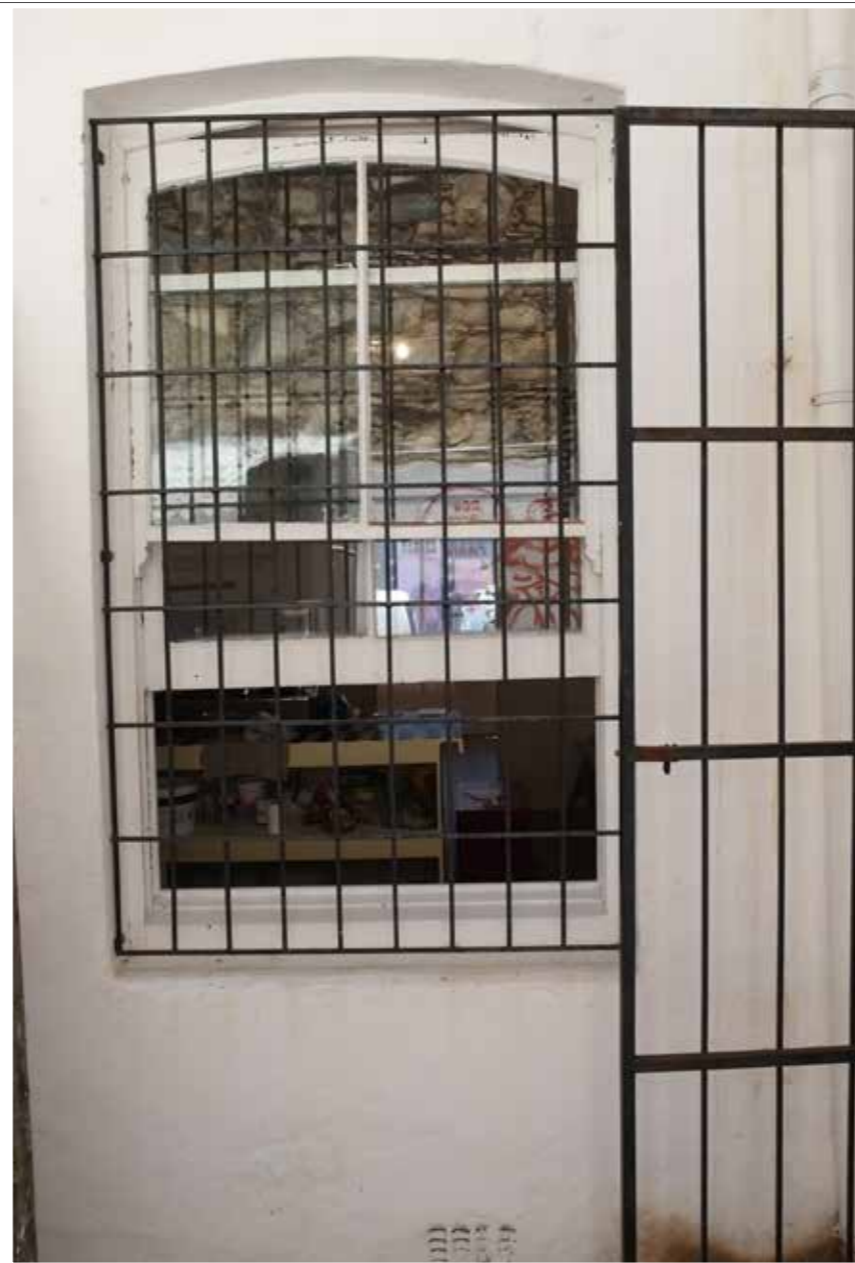
Figure 41. Ground floor rear window: arched top is an indicator of early stone construction (shallow arched stone lintel in place of rare timber). Wide vertical sash window in frame is almost flush with external wall suggesting is early (pre-c1815) Cape Dutch design

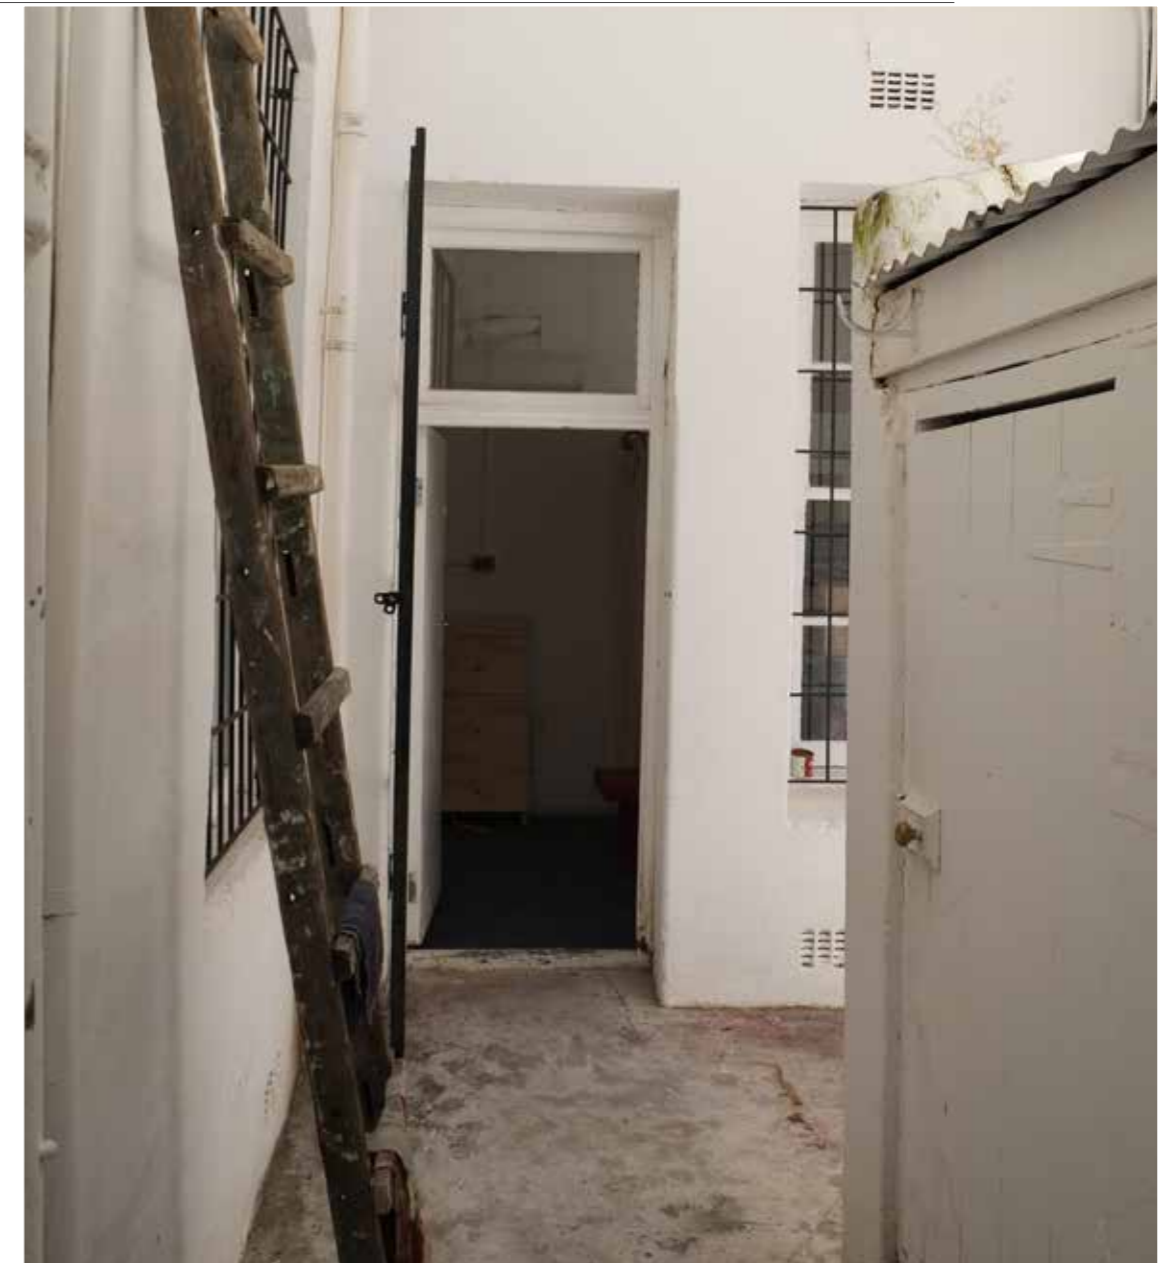
Figure 42. View of rear door from north extension to courtyard, with outbuilding (left). Window (just visible) rebated to internal wall shows the influence of British construction techniques suggesting that the north extension is a later addition

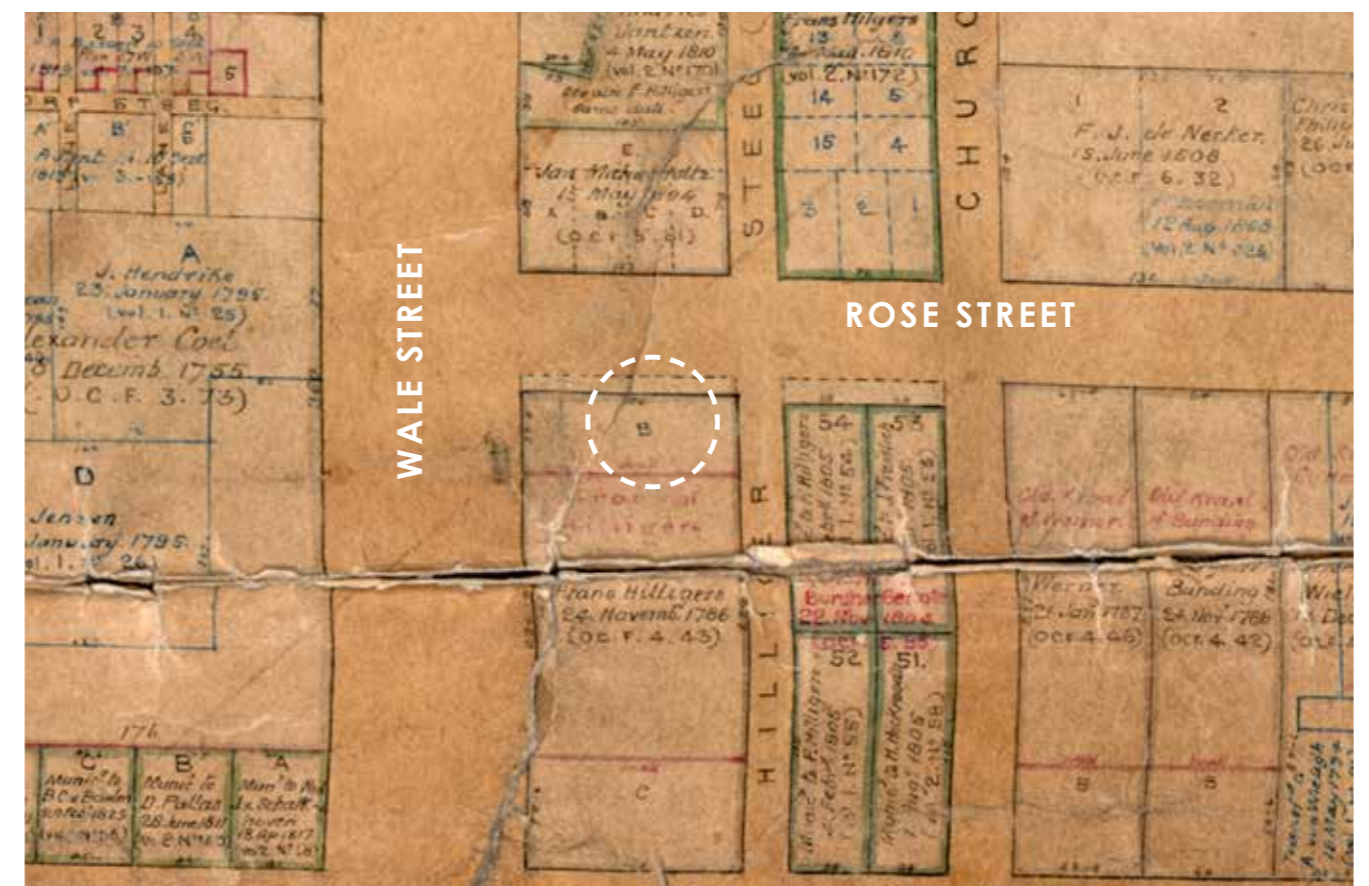
Figure 48. Historic image note “wall”, believed to be the existing shared boundary wall (KAB M4/13)

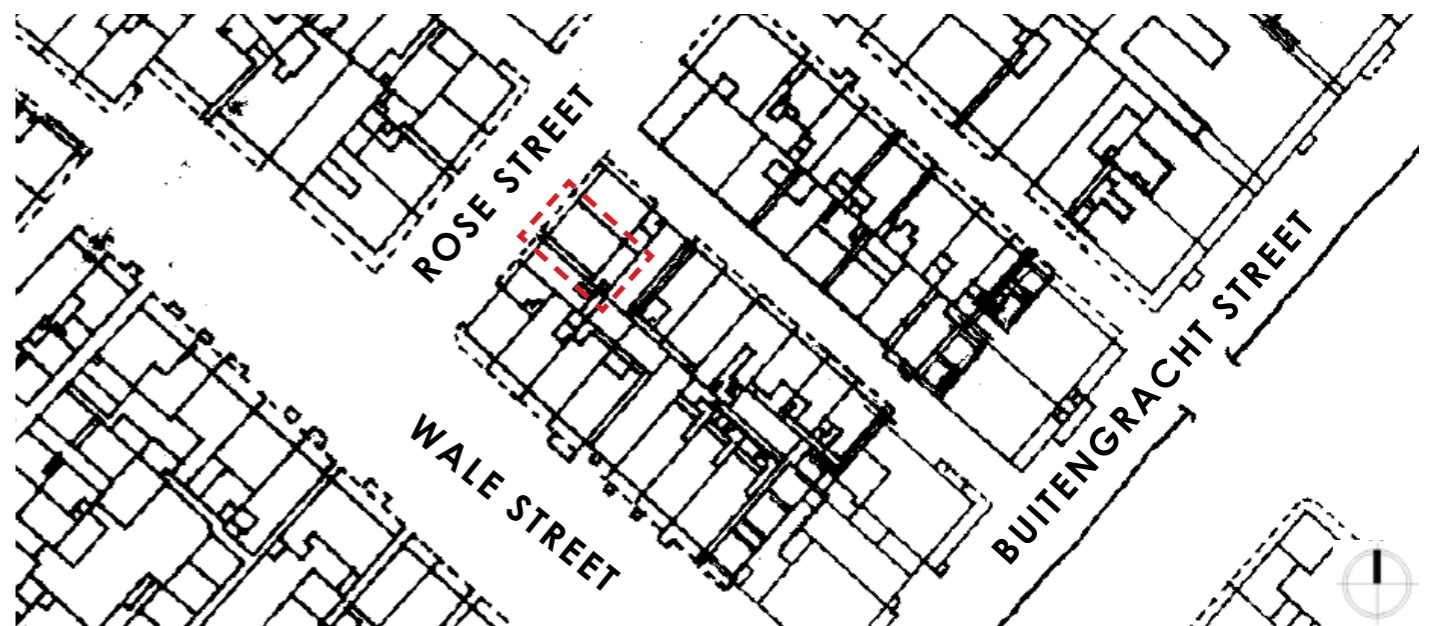
Figure 51. 1860 Snow survey shows site developed with structure of similar form to the existing one. A passageway, closed at the street front, appears to separate it from its south neighbour (CoCT Historical Map Collection)

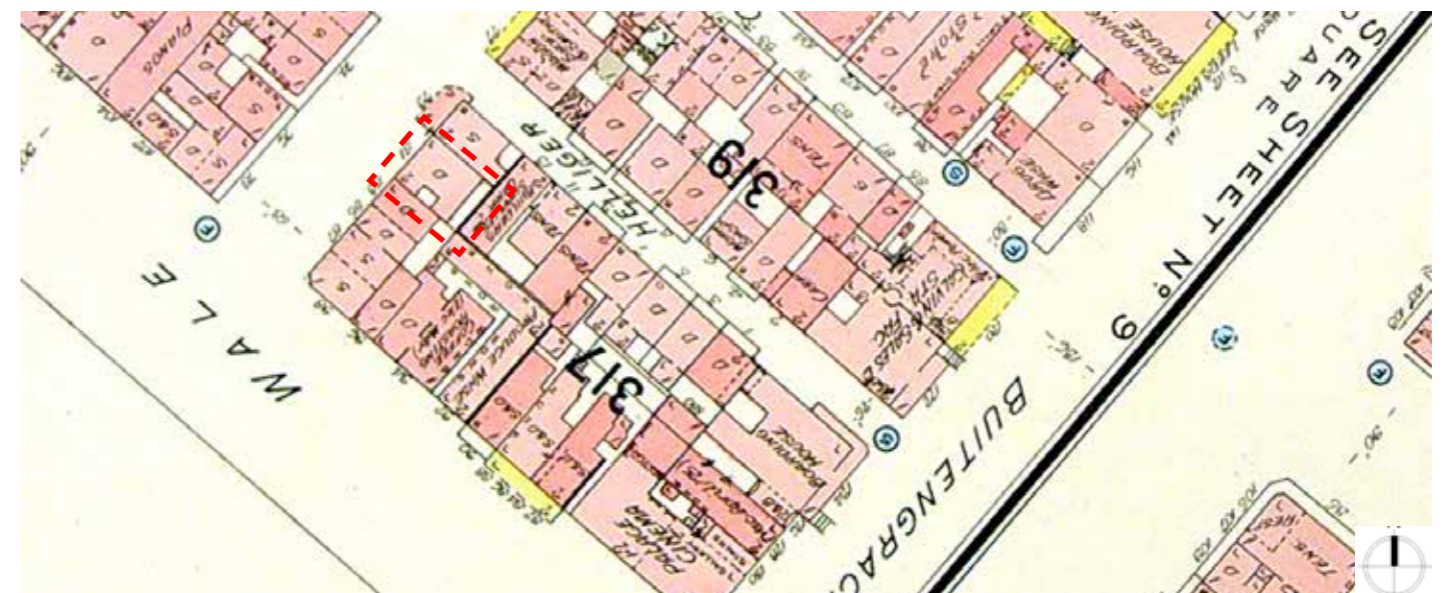
Figure 54. 1925 Goad survey shows site as 2-storey masonry dwelling with metal roof and a rear party wall above 6' high. Open light-well south and unconstructed rear courtyard.

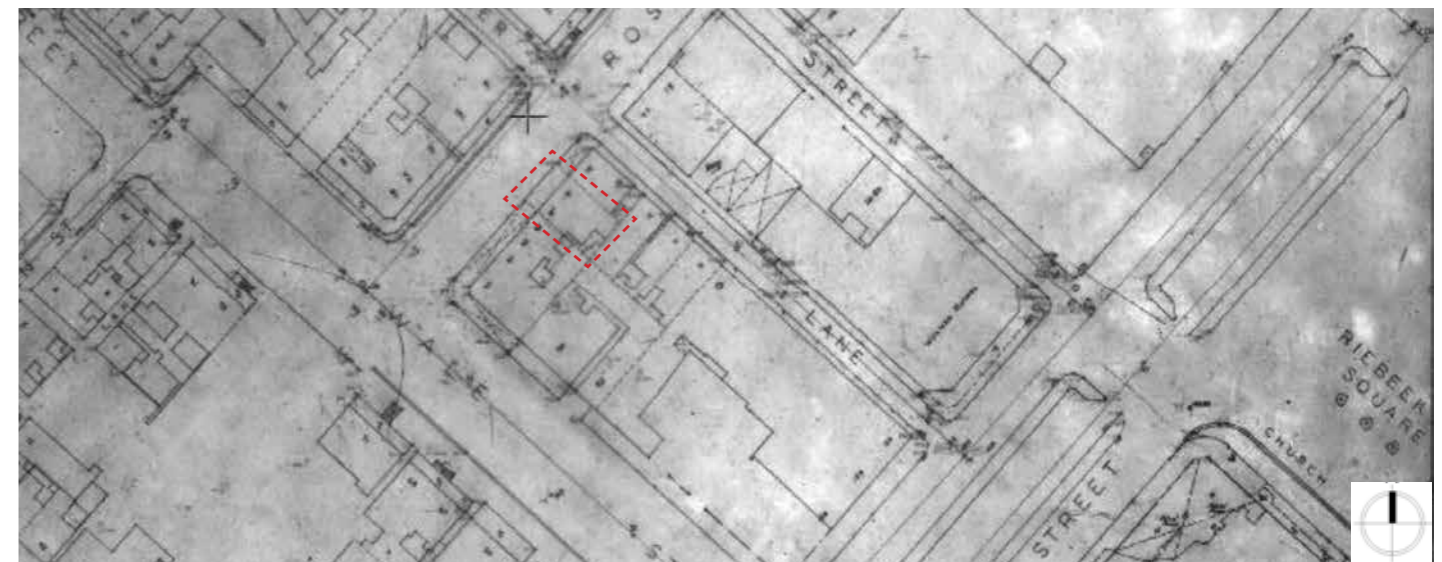
Figure 56. c1944 480 Series survey shows light-well opening, rear north extension and outbuilding (CoCT Historical Imagery)

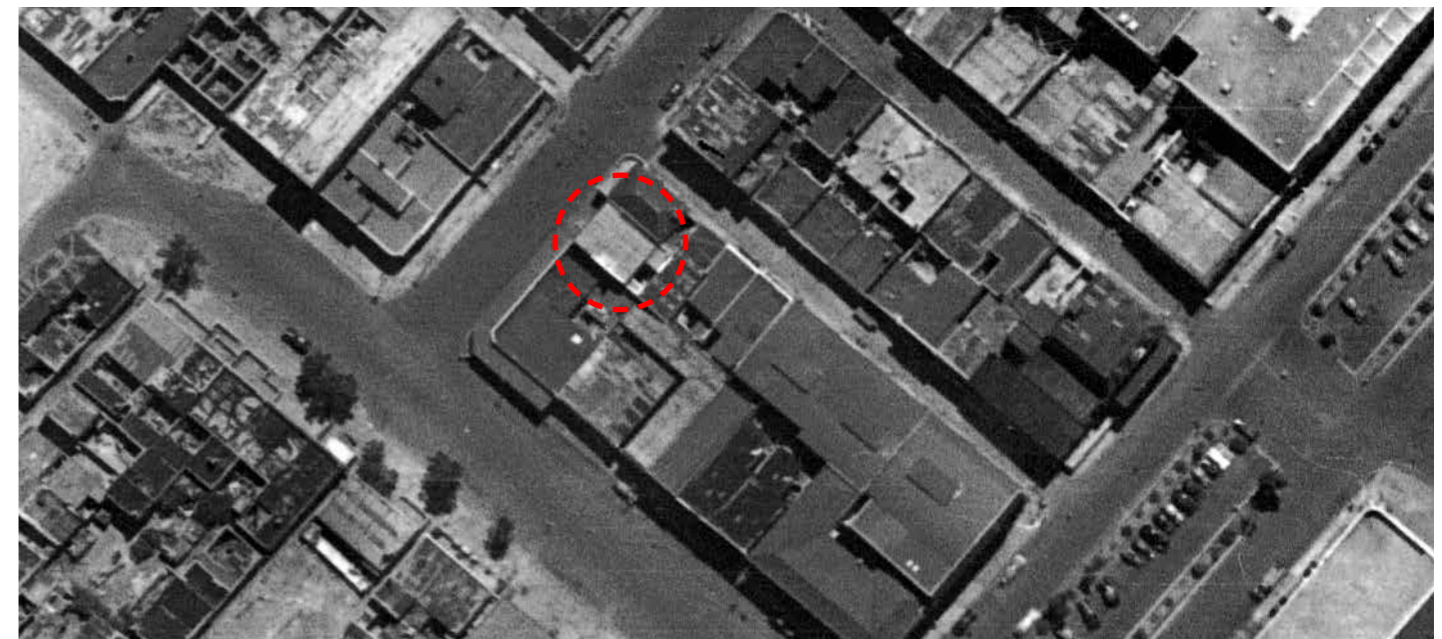
Figure 57. 1945 aerial image light-well enclosed, roofing appears new. Rear outbuildings adjoining east party wall in place. Site circled in red (NGI)
