**ARCHAEOLOGICAL IMPACT ASSESSMENT  
OF THE PROPOSED DEVELOPMENT OF A NEW  
BORROW PIT AT HELPMEKAAR 147 (PTN. 7) AND THE  
EXTENSION OF THREE EXISTING BORROW PITS AT  
MONTAGU FARMS 74, 217 (PTN. 2) & RATELFONTEIN 71,  
MONTAGU AND LANGEBERG DISTRICTS,  
WESTERN CAPE**

(Assessment conducted under Section 38 (8) of the National Heritage Resources Act as part  
of a Heritage Impact Assessment)

**AUGUST 2012**

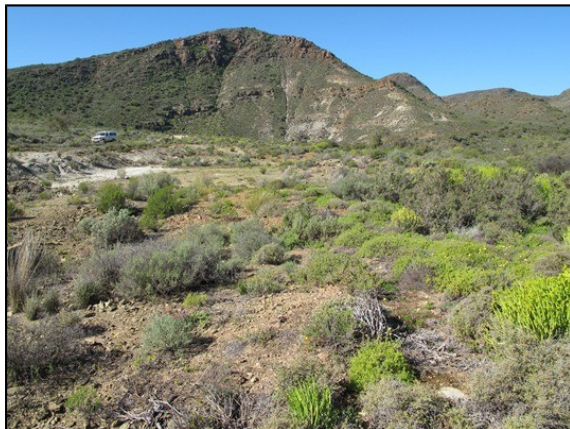
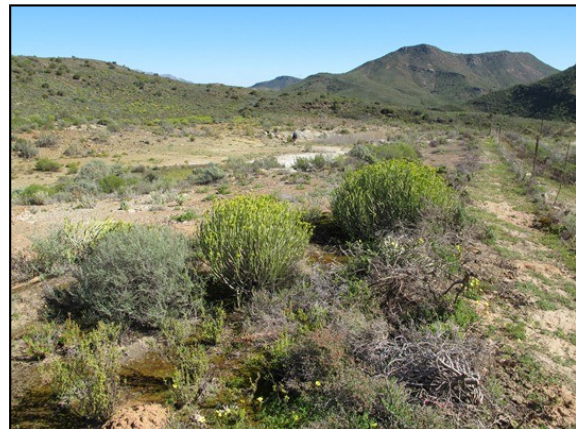
Figures 3 and 4: Pit 92 - view from the western part of the affected area towards the east with the existing pit in the centre of the photo; View of the existing pit towards the west. The photo was taken from the new gate.

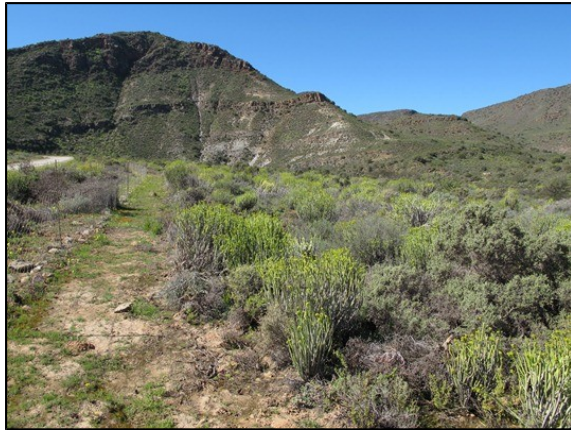
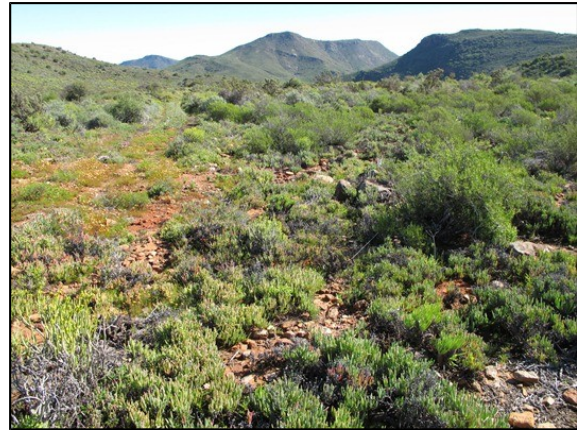
Figures 5 and 6: Pit 92 - view towards the east of the more densely vegetated eastern half; view towards the northwest of the south-eastern portion of the affected area. The 'new' track is visible on the left.

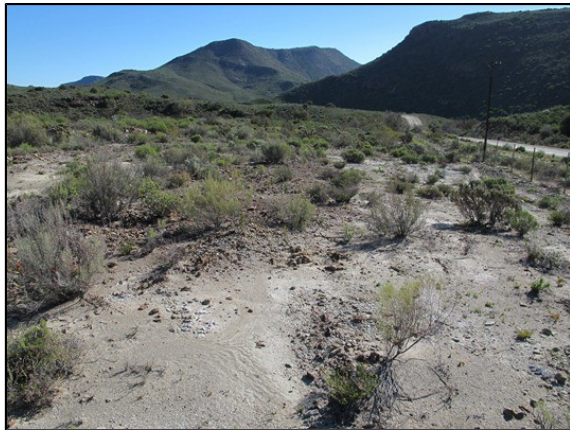
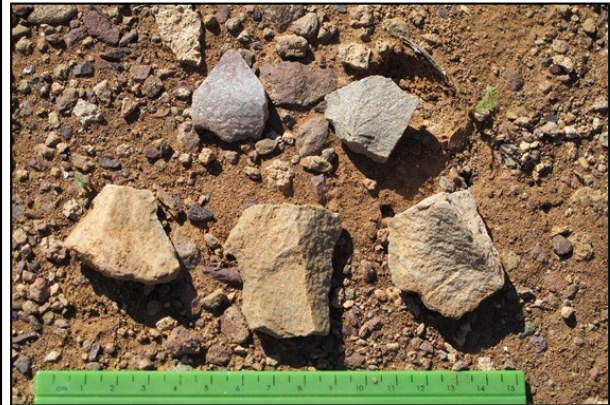
Figures 7 and 8: Pit 92 - view towards the west of the north-western corner of the polygon; a selection of quartzite artefacts. The scale is in cm.

**Results of the survey:** The survey of the proposed extension was undertaken on 19 August 2012. Occasional stone artefacts and a few dispersed small clusters of several artefacts were observed in a handful of places throughout the affected area. The artefacts, all manufactured from quartzite, consist of several flakes, possible blade fragments and chunks (Figures 8, 9, 10 & 11). There are no clearly diagnostic artefacts but some may date to the MSA. There was clear evidence of disturbance by surface run-off (e.g. Figure 11). The archaeological material is thus in a disturbed, secondary context and is considered to be of low archaeological heritage significance.

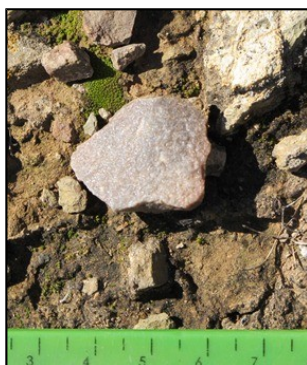
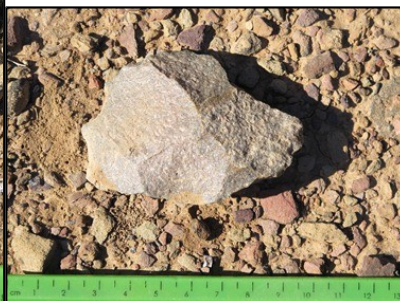
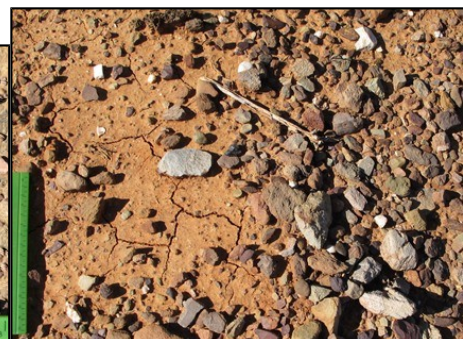
Figures 9, 10 and 11: Pit 92 - quartzite artefacts – small flake; chunk; flake in an area showing surface run-off. The scale is in cm.

The disturbed context and mixing of the stone artefacts at the proposed sites for Pits 92 and 96 indicates that the material is in a secondary context and is therefore of low archaeological heritage significance. No significant impact on such resources is expected if the proposed extensions are developed.

No further archaeological studies or mitigation are recommended for any of the pit sites.

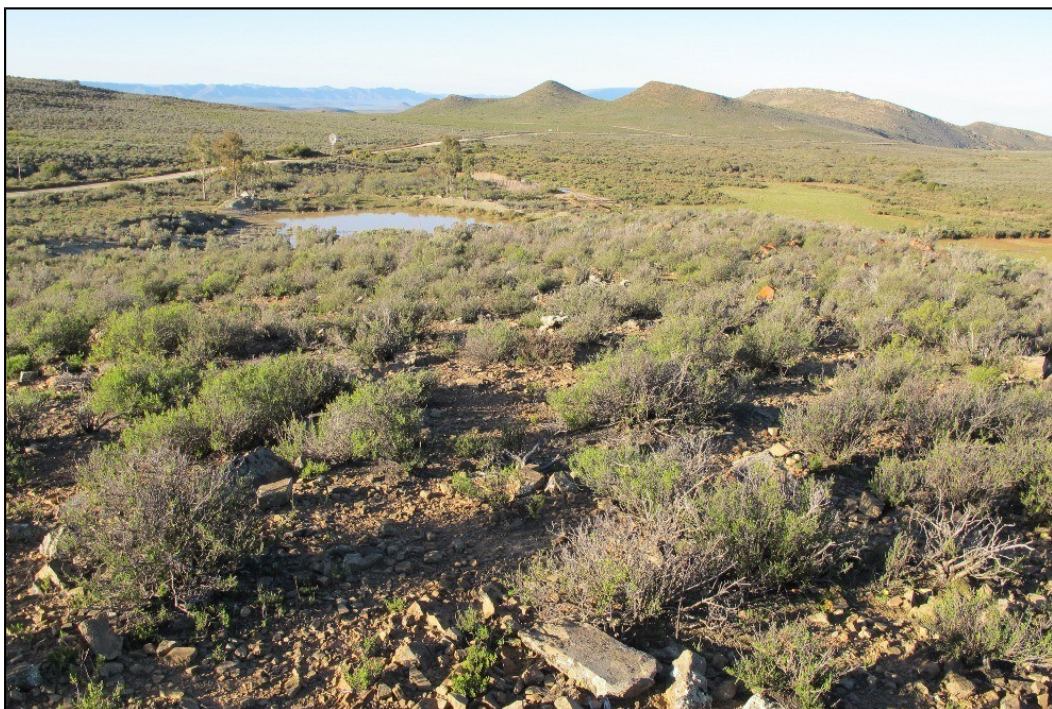
Figure 13: Pit 93 - view towards the northeast showing the existing pit (dam). The photo was taken from the top of the hill. The gravels with larger sandstone blocks are evident in the foreground.

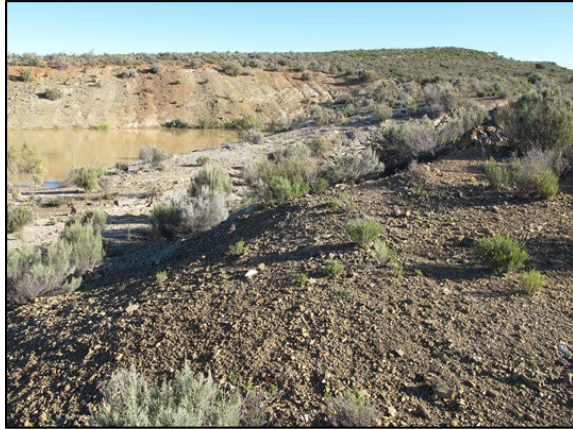
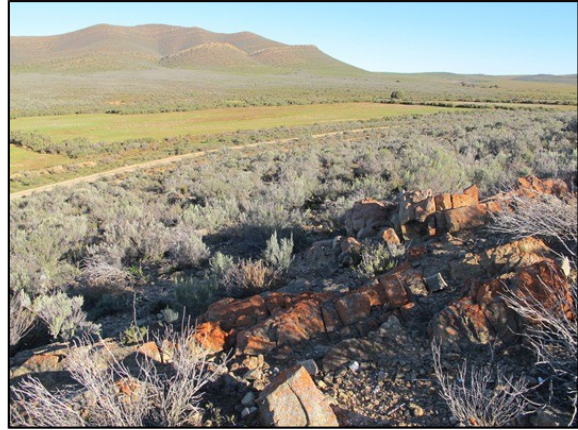
Figures 14 and 15: Pit 93 - view towards the southwest from the western side of the existing pit; view down onto the southeast-facing slope of the affected area from the top of the hill.

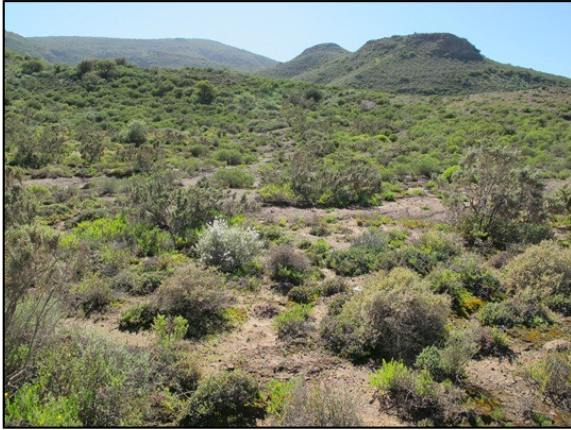
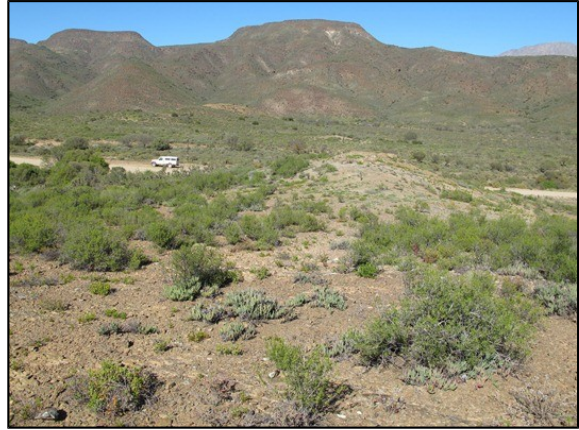
Figures 19 and 20: Pit 96 - view towards the northeast of the koppie with the lower-lying western portion in the foreground; view towards the south taken from the northern part of the affected area.

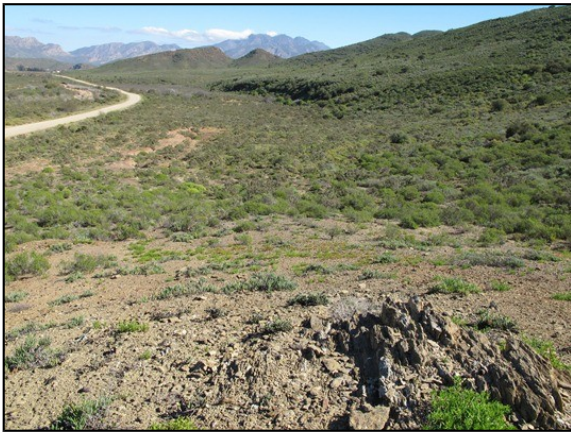
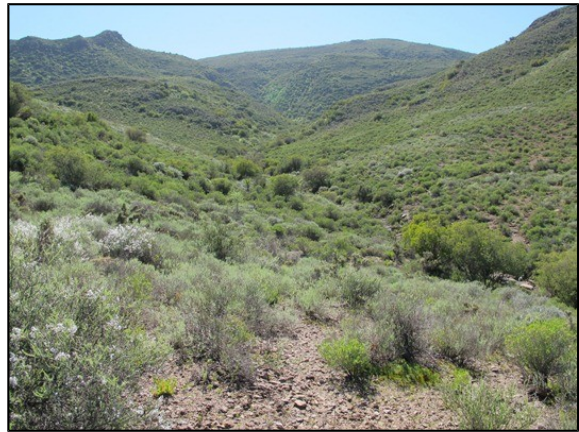
Figures 21 and 22: Pit 96 - view from the top of the hill towards the west, showing the brown area which is badly affected by sheet wash; view towards the north of the eastward-facing slope down to the stream bed.

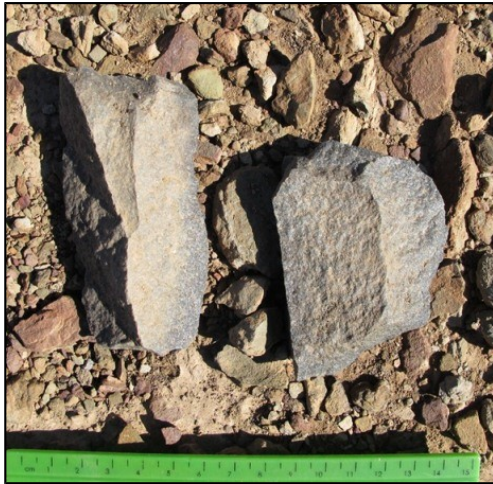
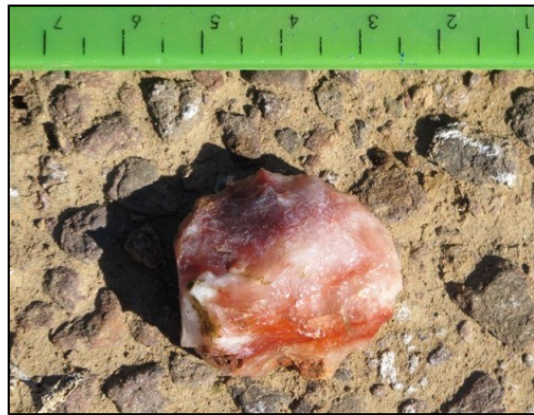
**Results of the survey:** The survey was undertaken on 19 August 2012 and three stone artefacts were observed. Two quartzite flakes (Figure 23) found in close proximity to each other on the north-east facing slope and one small scraper made of milky quartz with impurities (Figure 24) found in the south-western area affected by gully erosion and sheet wash. One of the flakes is clearly a MSA blade and the scraper belongs to the LSA. The fact that the artefacts were found in disturbed, secondary contexts suggests that they are of low archaeological significance.

Figures 23 and 24: Pit 96 - quartzite MSA blade and flake of indeterminate age; quartz LSA scraper.

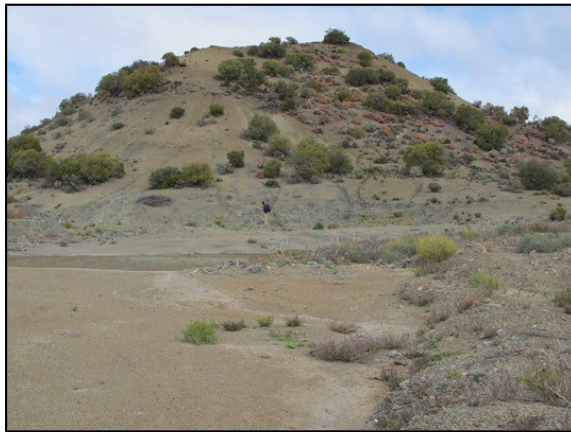
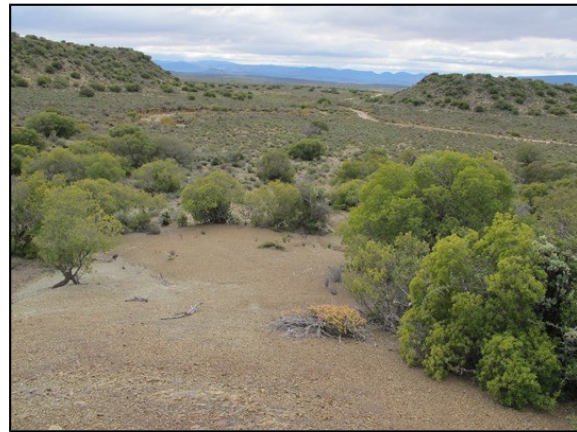
Figures 26 and 27: Pit 100 - view towards the southwest of the existing borrow pit at the foot of the koppie; view towards the north showing the slope and lower ground of the affected area, as well as the stream bed on the left and the main track on the right.

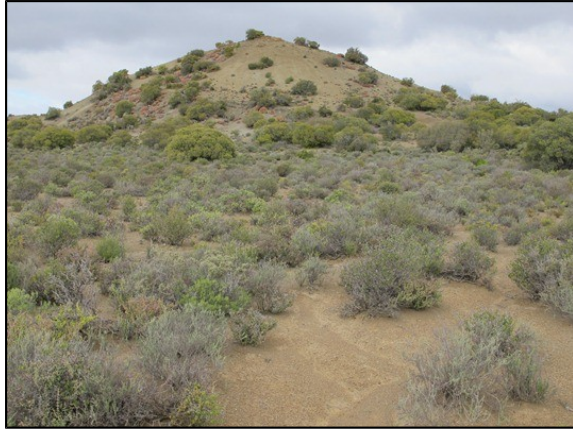
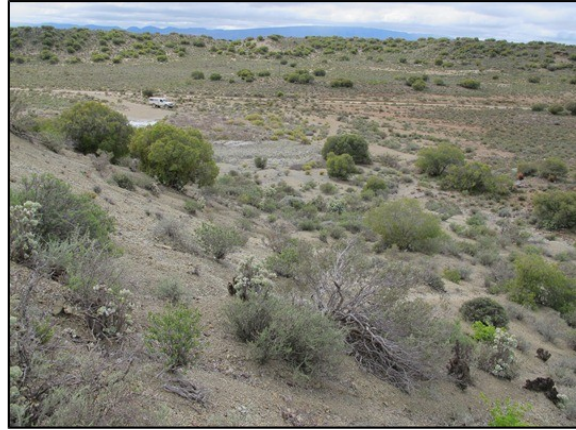
Figures 28 and 29: Pit 100 - view across the lower part of the affected area towards the southwest; view towards the northeast over the eastern part of the affected area. The Anysberg is visible on the horizon.
