# HERITAGE IMPACT ASSESSMENT

29 August 2012

OPO 5960 Cape Winelands

Montagu – Cape Winelands District Municipality, Western Cape

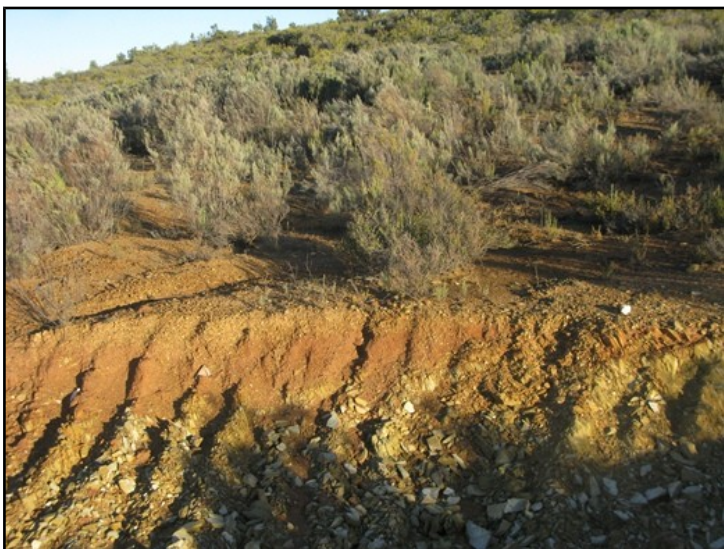
Figure 2: Deposits with fine surface gravels mantling the Bokkeveld Group mudrocks along the southern edge of the pit (Almond 2012: 5)

The small, recently established pit is excavated into mudrocks of the Early Devonian Voorstehoek Formation (Lower Bokkeveld Group). The marine sediments contain sparse moulds of molluscs, trilobites and articulate brachiopods but most specimens are compromised by weathering and tectonic cleavage development, considered to be of low palaeontological sensitivity. Proposed intervention would not result in a detrimental heritage impact, yielding social and economic benefits without a negative impact on heritage resources. No further specialist palaeontological studies or mitigation is recommended and expansion be allowed to proceed.
