HERITAGE IMPACT ASSESSMENT

MR 00374, Central Karoo

Laingsburg – Central Karoo District Municipality, Western Cape

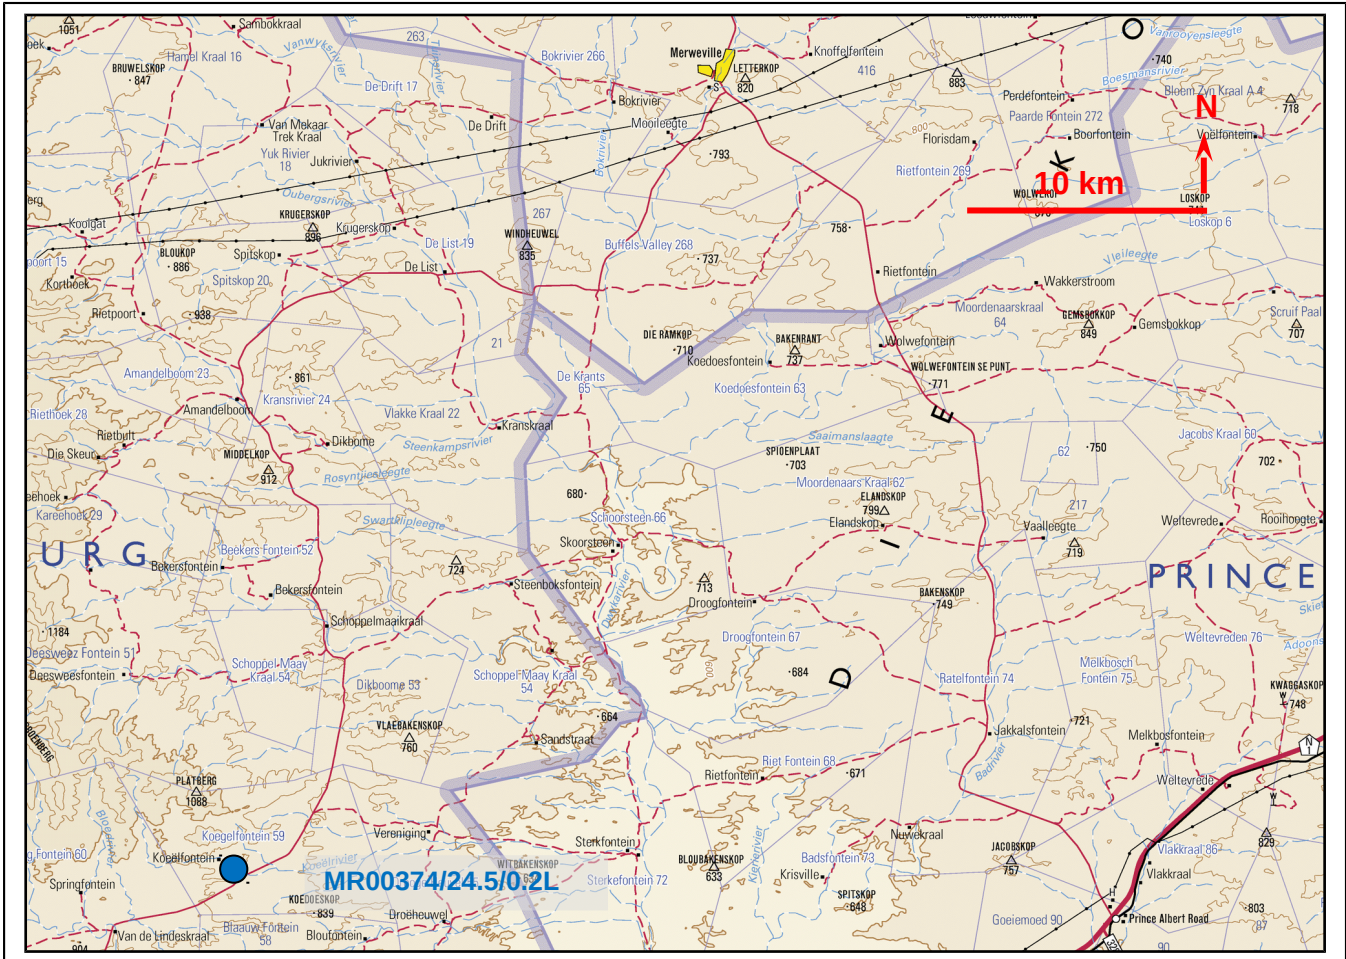
Figure 1: Extract from topographical sheet 3220 Sutherland (extracted Almond 2012: 2)

It is proposed to expand an existing borrow pit for road material along MR374 on the northern side of the DR1334 approximately 49 km north-east of Laingsburg, Central Karoo District Municipality, Western Cape. The existing borrow pit at MR374/24,5/0,2L is located on the south-western margin of an alluvial outwash deposit formed on a pediment crossed by road MR374 between km 24,5 and km 26. The existing pit forms a shallow dam retaining run-off water. Although the rest of the terrain of the proposed expansion is relatively flat-lying, sheet wash from the area to the north-west of the dam drains down a very gentle slope into the existing pit in a south-easterly direction. Vegetation consists of karoo shrubs. Farm Koeëfontein is in private ownership of P.W.Hattingh with borrow pit co-ordinates 32° 58' 10.56" S, 21° 18' 14.04" E

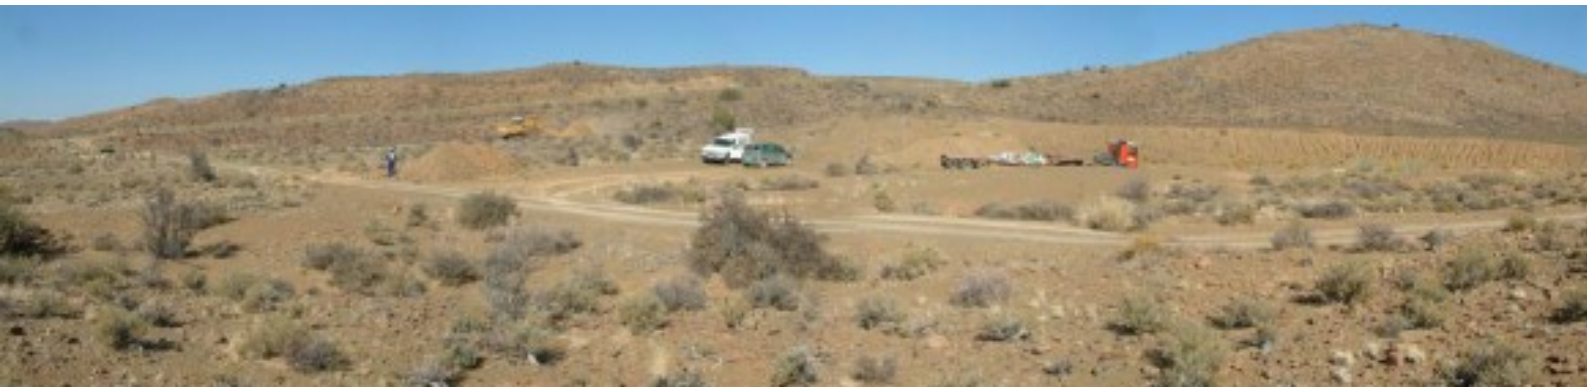
Figure 2: Panorama of entire pit area (2011)

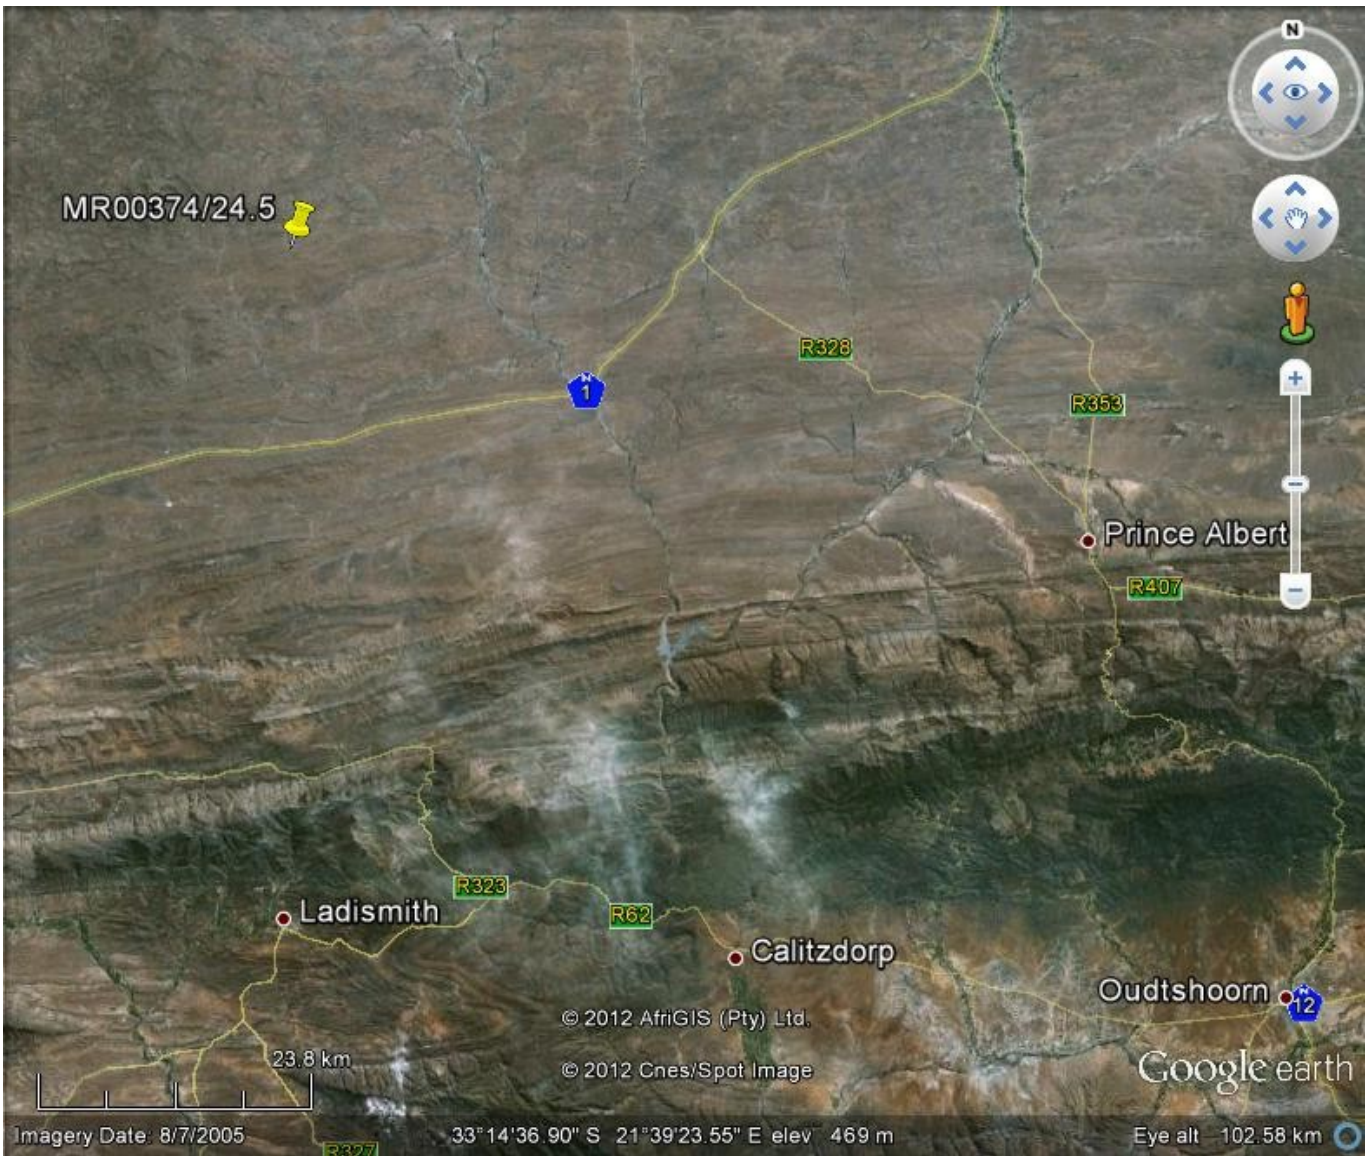
Figure 3: Aerial view of existing borrow pit location (Google earth image, June 2012)

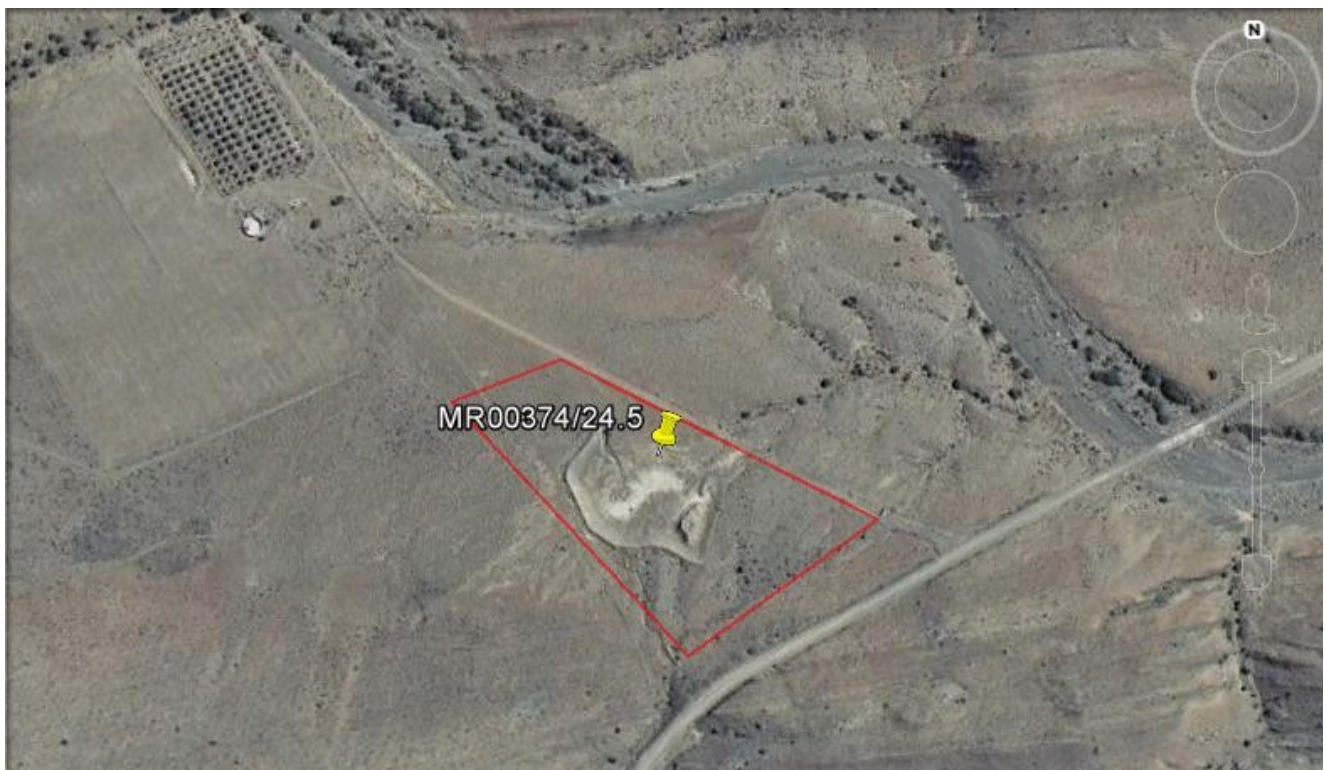
Figure 4: Aerial view of existing borrow pit (Google earth image, June 2012) 3
