**ARCHAEOLOGICAL IMPACT ASSESSMENT
OF PROPOSED BORROW PITS AT SPRINGFONTEIN 60
AND SKOPPELMANSKRAAL 54 AND THE EXTENSION OF
AN EXISTING BORROW PIT AT DIKBOOM 53,
LAINGSBURG DISTRICT, WESTERN CAPE**

(Assessment conducted under Section 38 (8) of the National Heritage Resources Act as part
of a Heritage Impact Assessment)

JUNE 2012

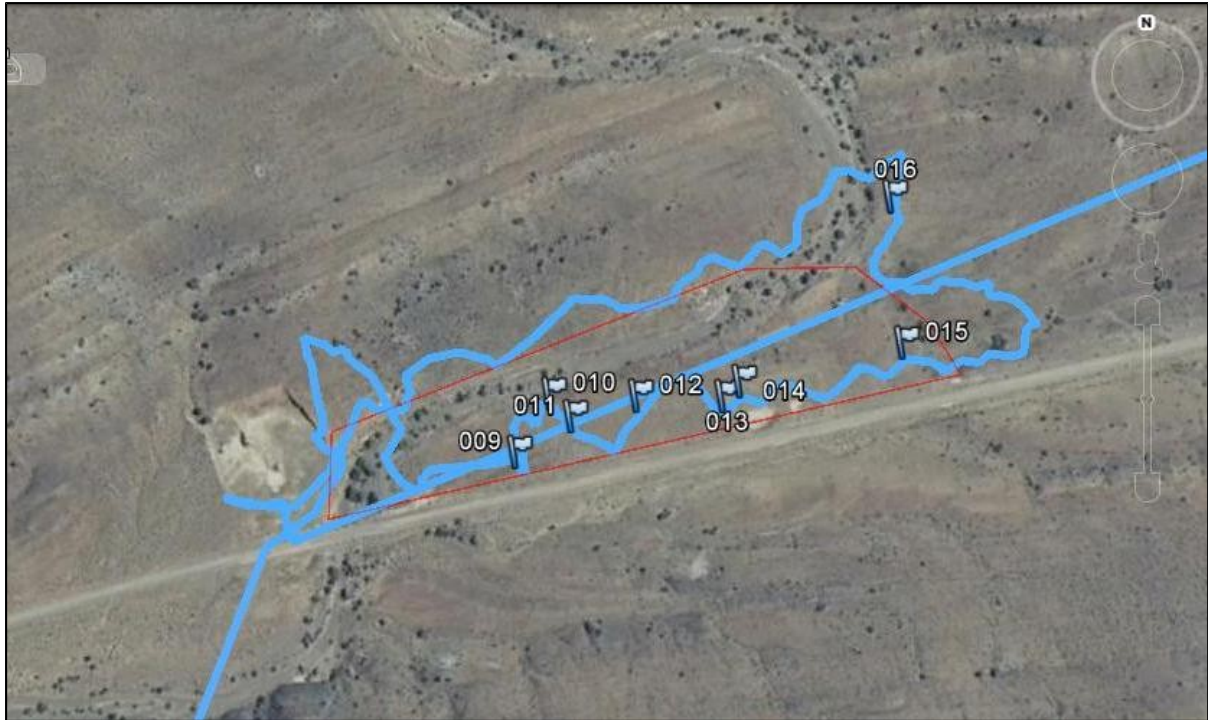
Figure 2: Google earth image showing the proposed borrow Pit 110, waypoints and tracks of the field survey. The small dam to the west of the affected area and the stream bed running through the northern half are evident. The side branch of the stream is close to the south-eastern boundary of the polygon. Please note that the straight blue lines do not indicate survey tracks.

Environment: The proposed borrow pit lies to the east of a small dam on a stream terrace along the MR00374 (Figures 2 & 4). A small stream bed runs in a north-easterly direction through most of the northern half of the affected area (Figure 3), with a side branch of the stream joining it in the south-eastern corner of the polygon. The water courses are obviously areas of disturbance and there is more evidence of sheet wash as the terrain slopes gently to the south and west. The only existing boundary of the proposed pit is the fence and road on the southern side of the area. The side branch of the stream approximately delimits the eastern boundary of the polygon. Alluvium and angular to sub-rounded sandstone gravels overlie mudrocks of the Abrahamskraal Formation of the Lower Beaufort Group. Scree from a small sandstone ridge to the north-west is the source of some of the coarser material. The vegetation consists of scattered karoo bushes and clumps of grass, with larger *Acacia karroo* trees along the stream bed (Figure 3). Archaeological visibility was thus good.

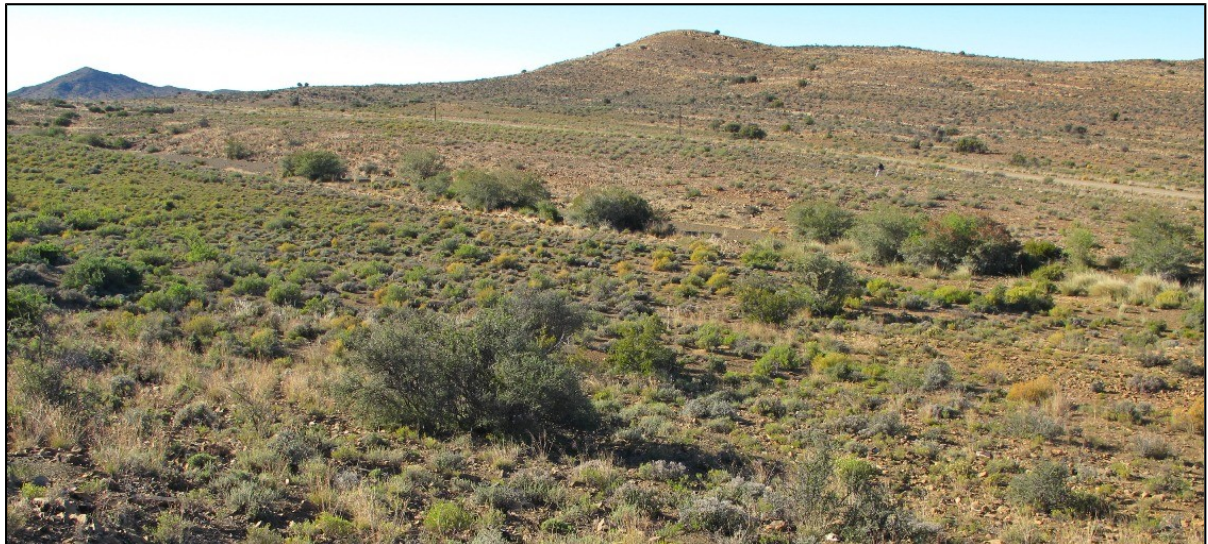
Figure 3: Pit 110 – view towards the south-east. The major part of the proposed borrow pit lies on the terrace between the stream bed and the gravel road in the background of the photo.

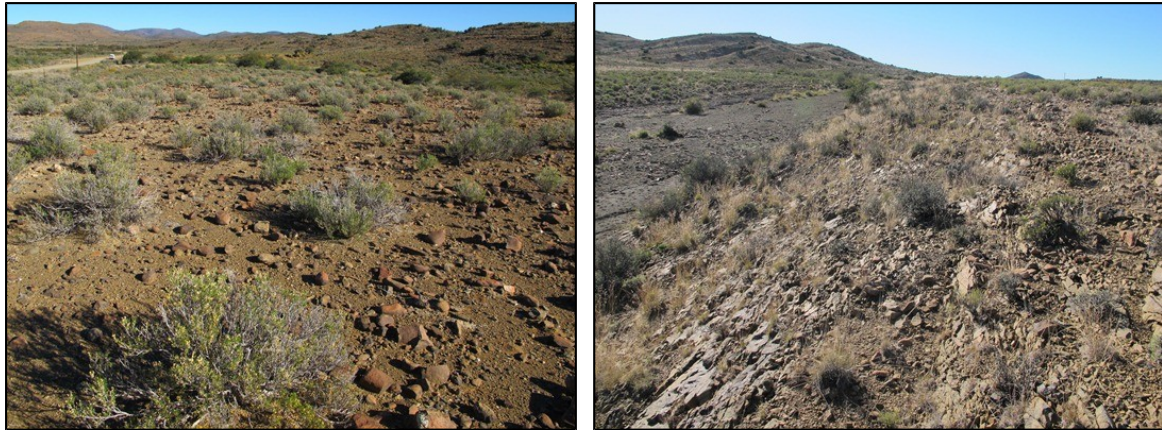
Figures 4 and 5: Pit 110 – view towards the south-west of the terrace where occasional artefacts were observed amongst the sandstone gravels; view towards the north-east of the edge of the terrace incised by the stream.

Results of the survey: A dispersed scatter of a few stone artefacts occurs amongst the sandstone gravels of the terrace mentioned above. Some of them were weathered and patinated. As the immediate area does not seem to have good sources of raw material for the manufacture of artefacts, most of the artefacts observed (Table 1 of the Appendix and Figures 6 to 11) seem to be made of Beaufort Group sandstone, some of it quite crude. Two artefacts made of Matjiesfontein chert – the proximal end of a snapped blade (Figure 6) and the tip of a point (Figure 10) were observed. The diagnostic artefacts such as blades and points appear to belong to the MSA. No dolerite boulders suitable for rock engravings occur in the area. No stone features such as walls or graves were observed.

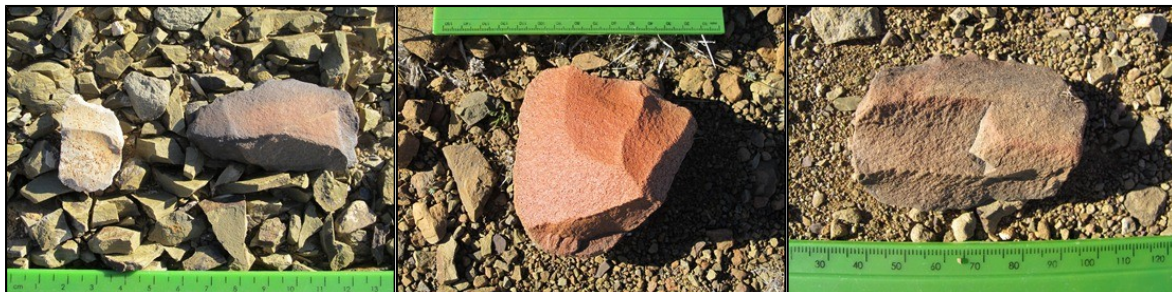
Figures 6, 7 and 8: Pit 110 – the proximal end of a Matjiesfontein chert blade and sandstone point; sandstone chunk; sandstone blade. The scale is in cm.

Most of the artefacts noted in this study came from proposed Pit 110 but, like the proposed extension at Pit 112, all the material was found in a secondary context in areas affected by sheet wash. No rock engravings or stone features such as walls or graves were observed. The archaeological material from these sites is considered to be of low heritage significance and no further archaeological studies or mitigation are recommended.

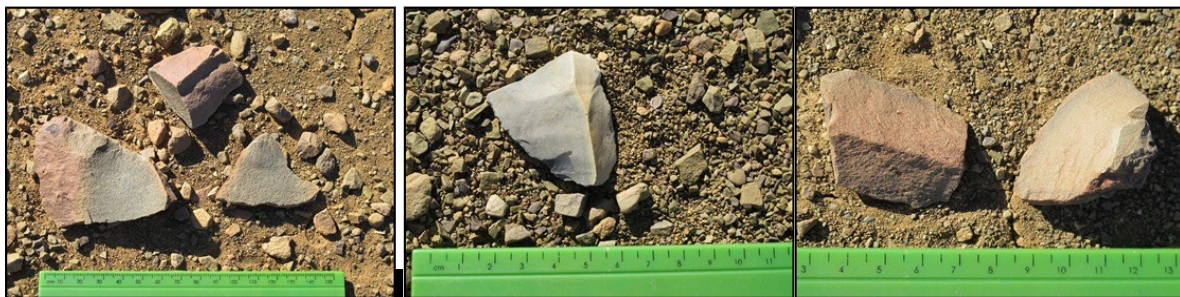
Figures 9, 10 and 11: Pit 110 – sandstone flakes and snapped blade; chert flake; sandstone blade fragment and flake. The scale is in cm.

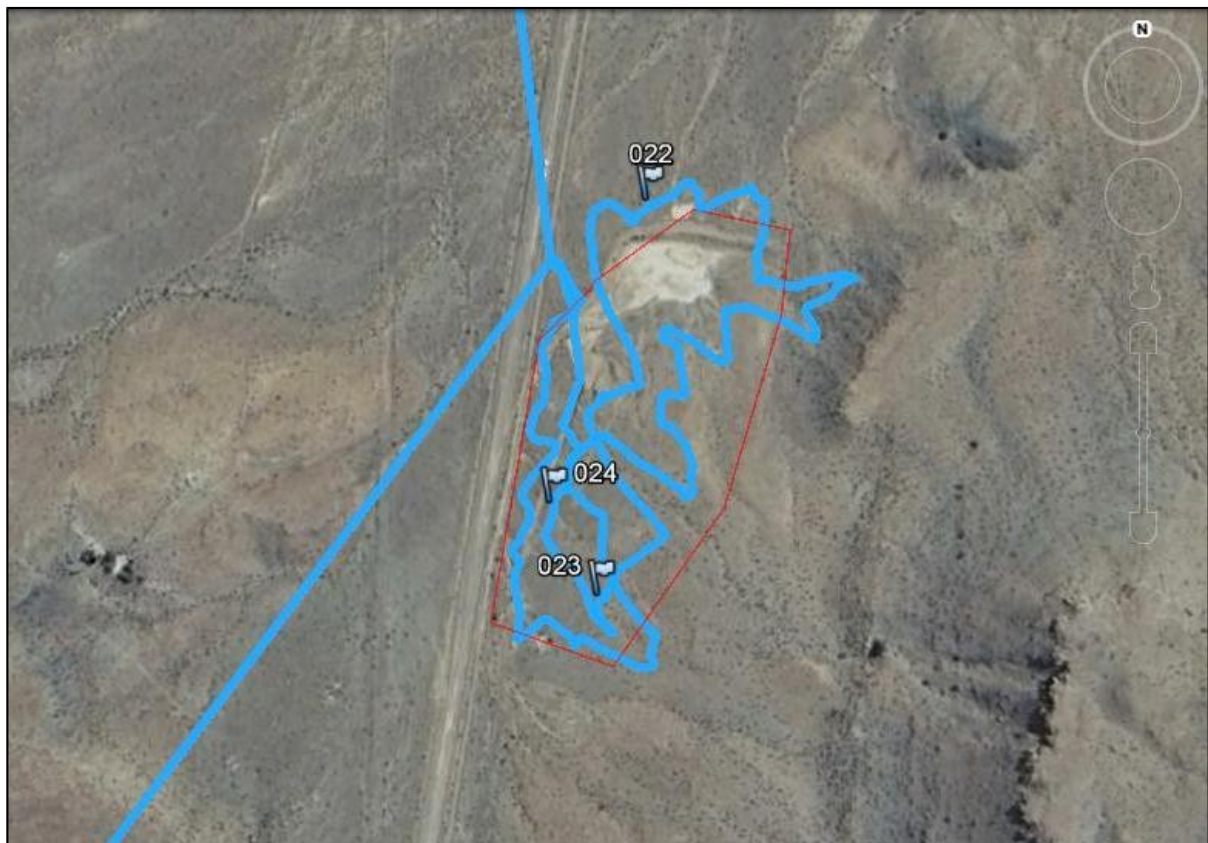
Figure 12: Google earth image showing the proposed extension to borrow pit 112, the tracks and waypoints of the field survey. The western side of the affected area has several channels and small dongas leading water to the existing dam. Please note that the straight blue lines do not indicate survey tracks.

Environment: Pit 112 is the proposed extension of an existing pit which has been converted into a dam (Figures 12 & 15). The affected area lies between the MR00374 to the west and a row of small hills to the east. The northern boundary lies just beyond the dam wall and a pipeline from a sheep trough was taken as the marker for the southern end of the proposed extension. Alluvium overlies Abrahamskraal Formation mudrock over most of the site (Figure 13). An apron of scree of angular to sub-rounded sandstone blocks and chunks overlies the alluvium at the foot of the small hills (Figure 14). Several channels and erosion gullies (dongas) occur in the western part and there is evidence of sheet wash over a large section of the affected area. The vegetation consists of scattered clumps of grass and small karoo bushes so the visibility of archaeological material on the ground was good.

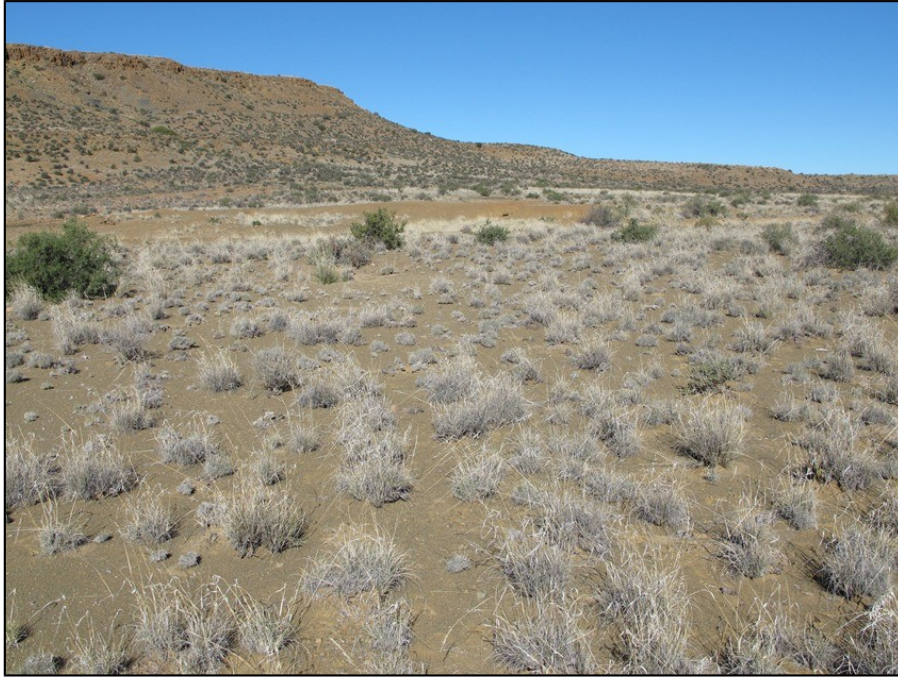
Figure 13: Pit 112 – view towards the south-east over the alluvium of the southern half of the affected area. The patch devoid of vegetation in the middle ground indicates the southern extremity of the existing borrow pit.

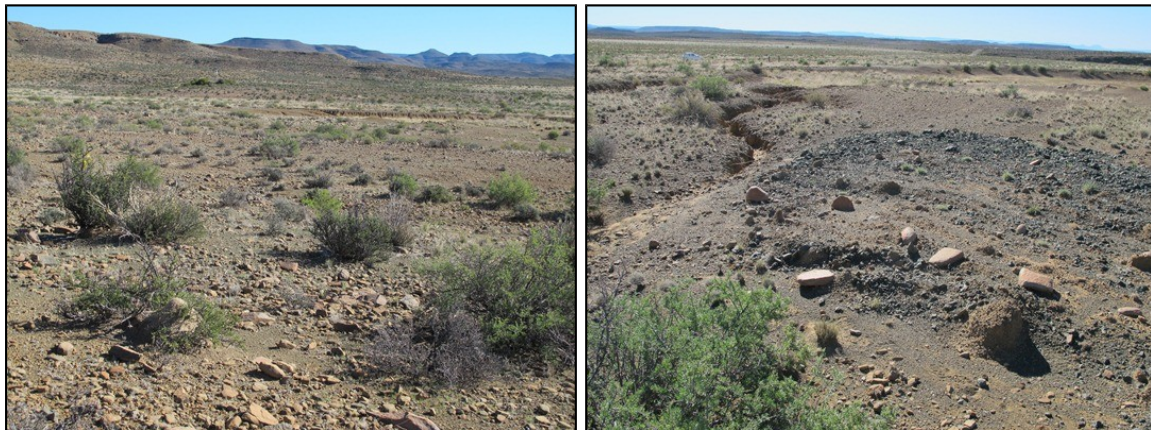
Figures 14 and 15: Pit 112 – view towards the south-west over most of the eastern and central parts of the affected area taken from the slope close to the north-eastern corner of the polygon; view towards the north showing dongas, a geotechnical test pit and the existing borrow pit converted into a dam.

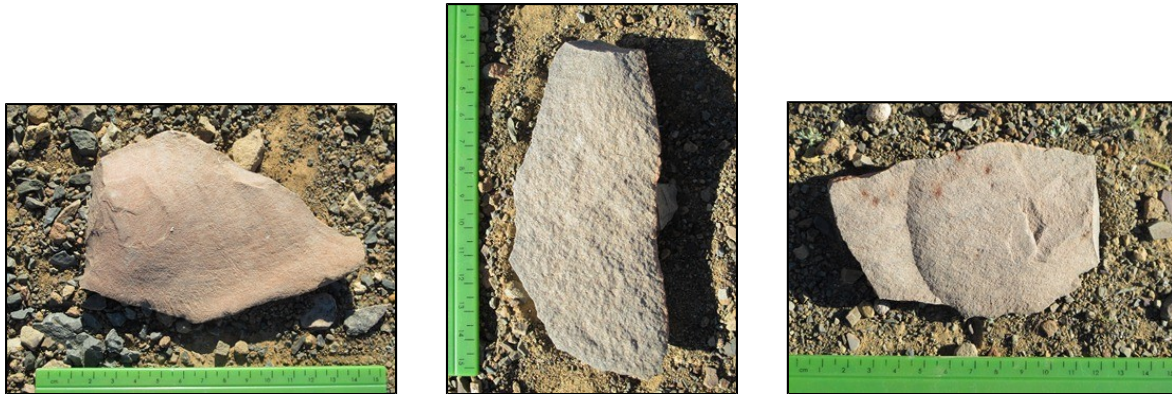
Results of the survey: Three isolated, large sandstone flakes of indeterminate age were the only artefacts observed (Table 2 in the Appendix and Figures 16 to 18). Given the evidence of sheet erosion, it is likely that they were brought in from elsewhere. No dolerite boulders suitable for rock engravings occur in the area. No stone features such as walls or graves were observed.

Figures 16, 17 and 18: Pit 112 – sandstone flakes. The ruler is about 15 cm in length.

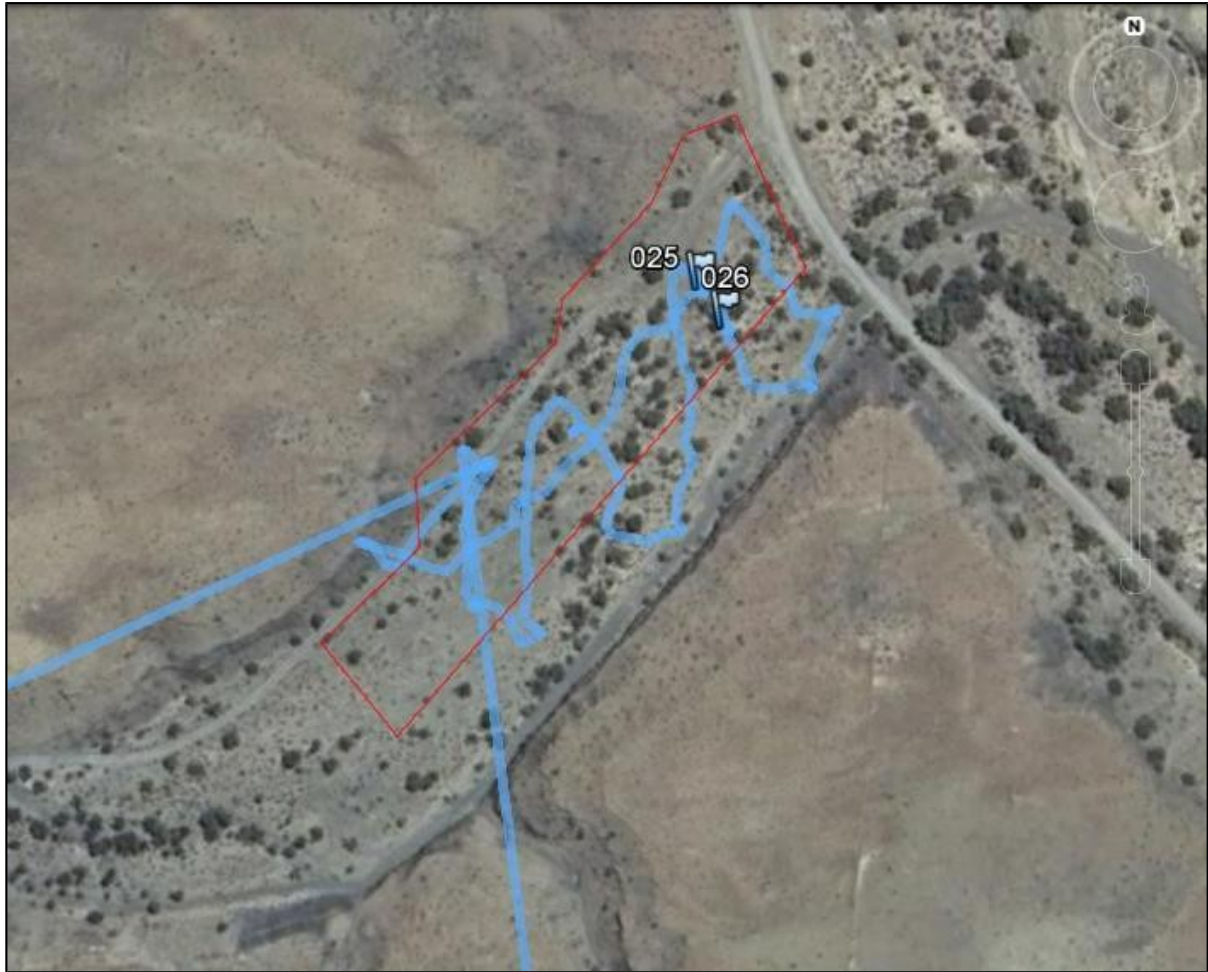
Figure 19: Google earth image showing proposed Pit 113, the tracks and waypoints of the field survey. Please note that the polygon provided is slightly displaced as the site report shows the affected area as lying between the track and stream bed. Also note that the straight blue lines do not indicate survey tracks. The vegetation appears to have become denser since the satellite image was taken.

Environment: The proposed borrow pit is roughly rectangular in shape and is aligned in a north-east to south-west direction (Figure 19). Boundaries are formed by the MR00374 to the north-east, the farm track to the north-west and a stream and cliff to the south-east. There is no obvious boundary for the south-western end of the polygon. The whole area lies on a river alluvial floodplain with coarse gravels containing blocks of sandstone and quartzite (Figures 20, 22 & 23). A good section through the mudrocks and sandstones of the Abrahamskraal Formation is evident in the cliff face (Figure 21). The density of the vegetation varies across the site and affects archaeological visibility. This ranged from good to poor. Concentrations of *Acacia karroo* occur in the central part (Figure 21) whereas lower, more scattered *Lycium sp.* and kraalbos (*Galenia africana*) are predominant in the rest. Dead branches also obscured the ground in some areas.

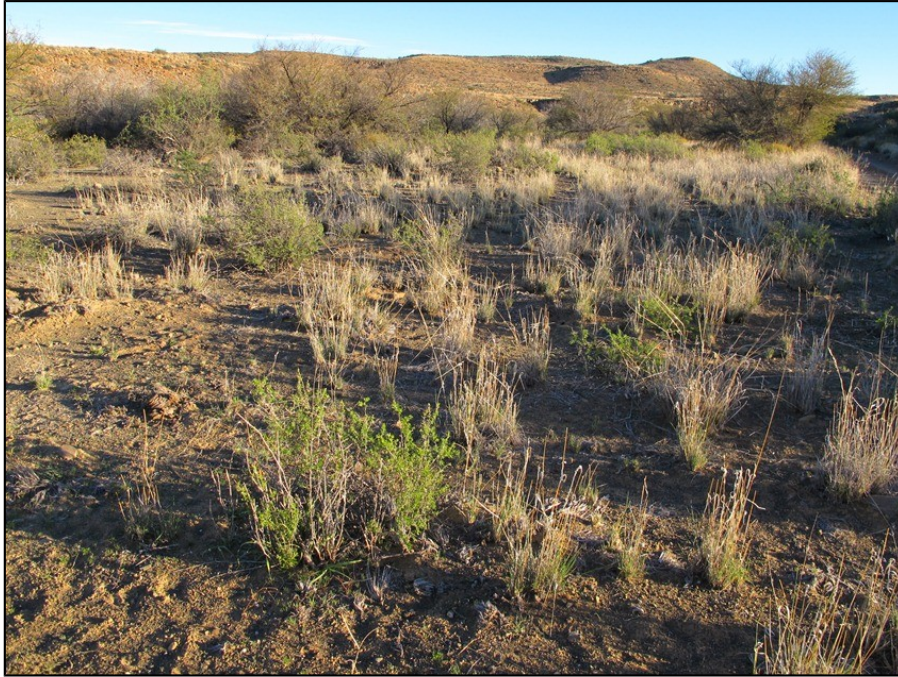
Figure 20: Pit 113 – view towards the south-west taken from the north-east corner of the affected area. The central area has denser vegetation consisting of *Acacia karroo*.

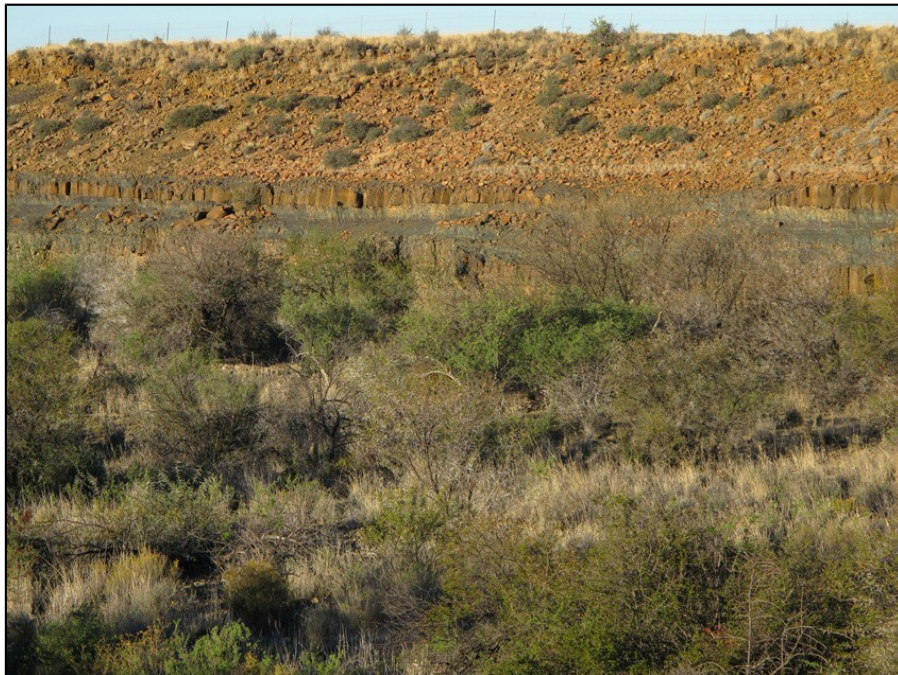
Figure 21: Pit 113 – view over the central part of the proposed pit area towards the stream and cliff to the south-east. Archaeological visibility was poor in this area.

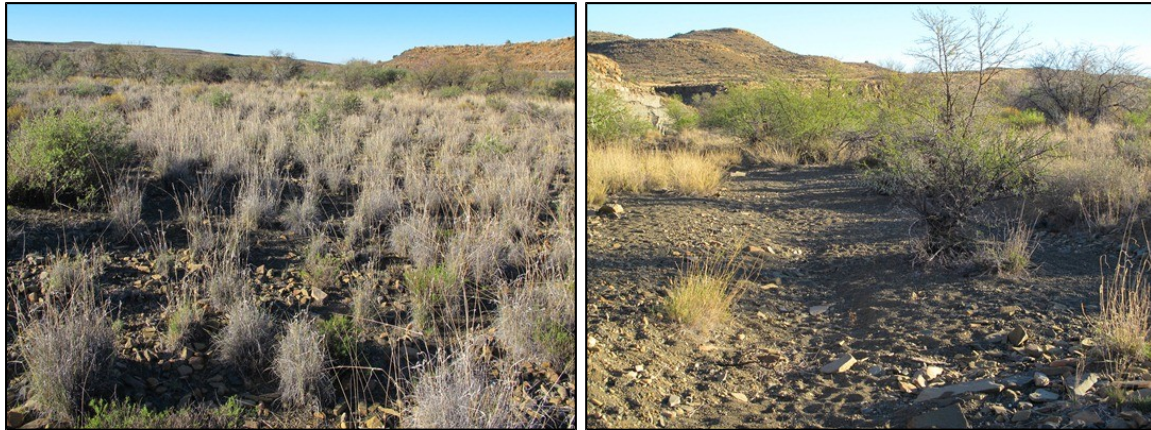
Figures 22 and 23: Pit 113 – view towards the north-east from the south-eastern part of the site; view towards the south-east from the stream bed at the foot of the cliff.

Results of the survey: A survey of the affected area was undertaken although it was clear that nothing found would be in a primary context. The landowner, Mr Hans Botes, commented that this area is regularly flooded and this was apparent on the ground. Besides flooding, many aardvark holes and other signs of disturbance were observed. The two waypoints (Figure 19) indicate two sandstone flakes of doubtful anthropogenic origin. They are fairly fresh-looking and are probably the result of boulders being hit while transported by water. No dolerite boulders suitable for rock engravings occur in the area. No stone features such as walls or graves were observed. This proposed pit site is therefore regarded as having no archaeological material.
