**Phase 1 Heritage Impact Assessment of a proposed new
subsurface water pipeline between the Van Wyksvlei
reservoir and Saaipoort, near Carnarvon, NC
Province.**

Report prepared for
MDA Environmental Consultants
by
L. Rossouw
Archaeological Impacts Unit
National Museum Bloemfontein

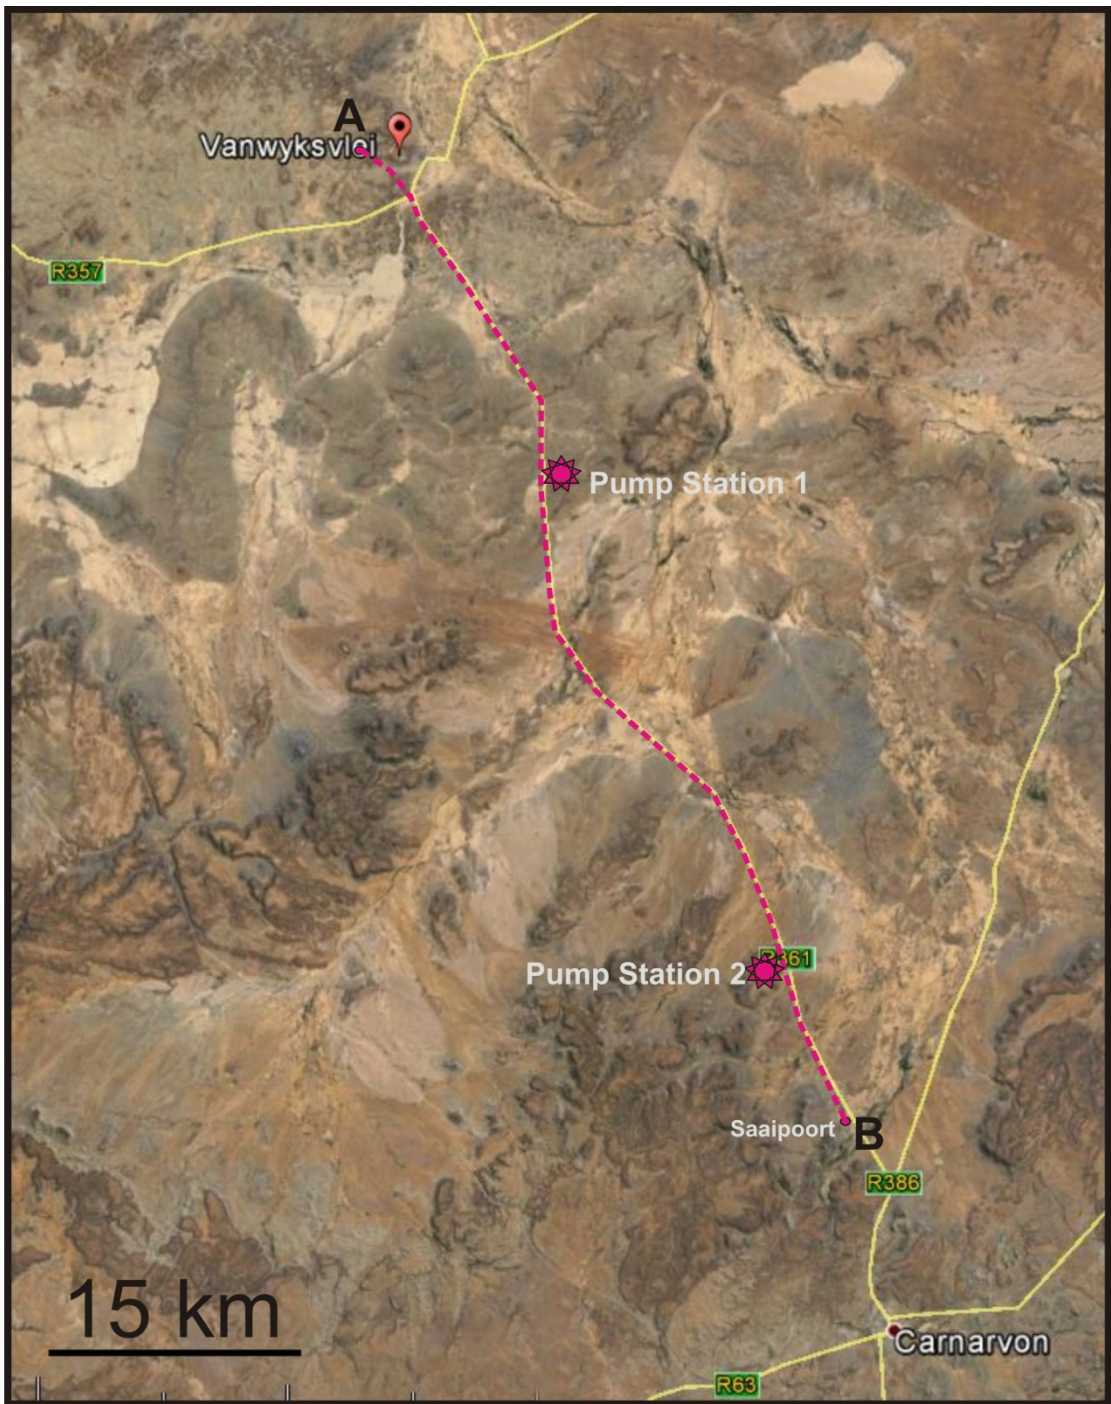
Figure1. Layout and aerial view of the proposed new pipeline.

A Phase 1 heritage impact assessment was carried out the construction of a proposed new water pipeline between Van Wyksvlei and Saaipoort near Carnarvon in the Northern Cape Province (**Fig. 1**).

Pipeline coordinates (**Fig. 1 & 2**):

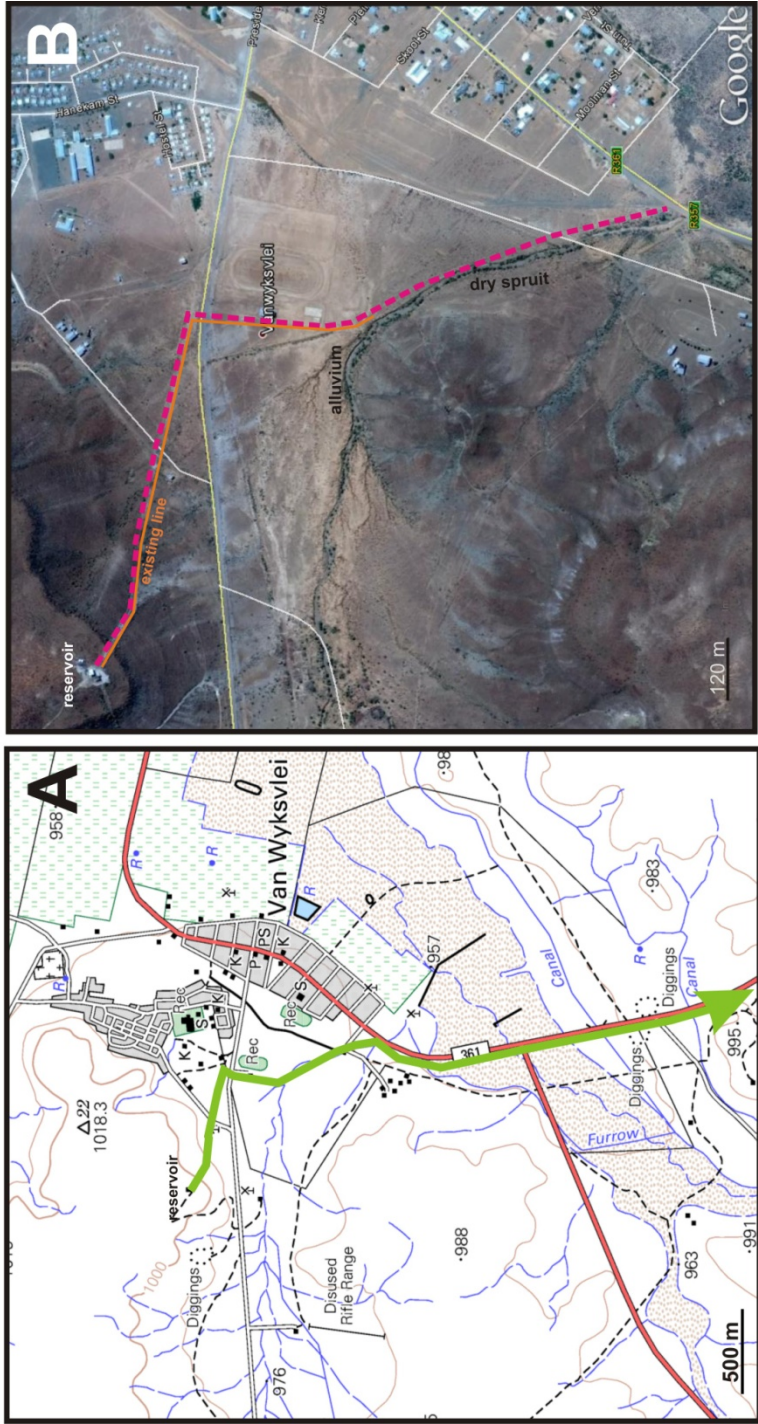
Figure 2. (A) Layout of the proposed pipeline section between the Van Wyksvlei reservoir and the R361 road (portion of 1:50 000 scale topographic map 3021BD Van Wyksvlei); (B) Aerial view of the proposed pipeline section between the Van Wyksvlei reservoir and the R361 road.

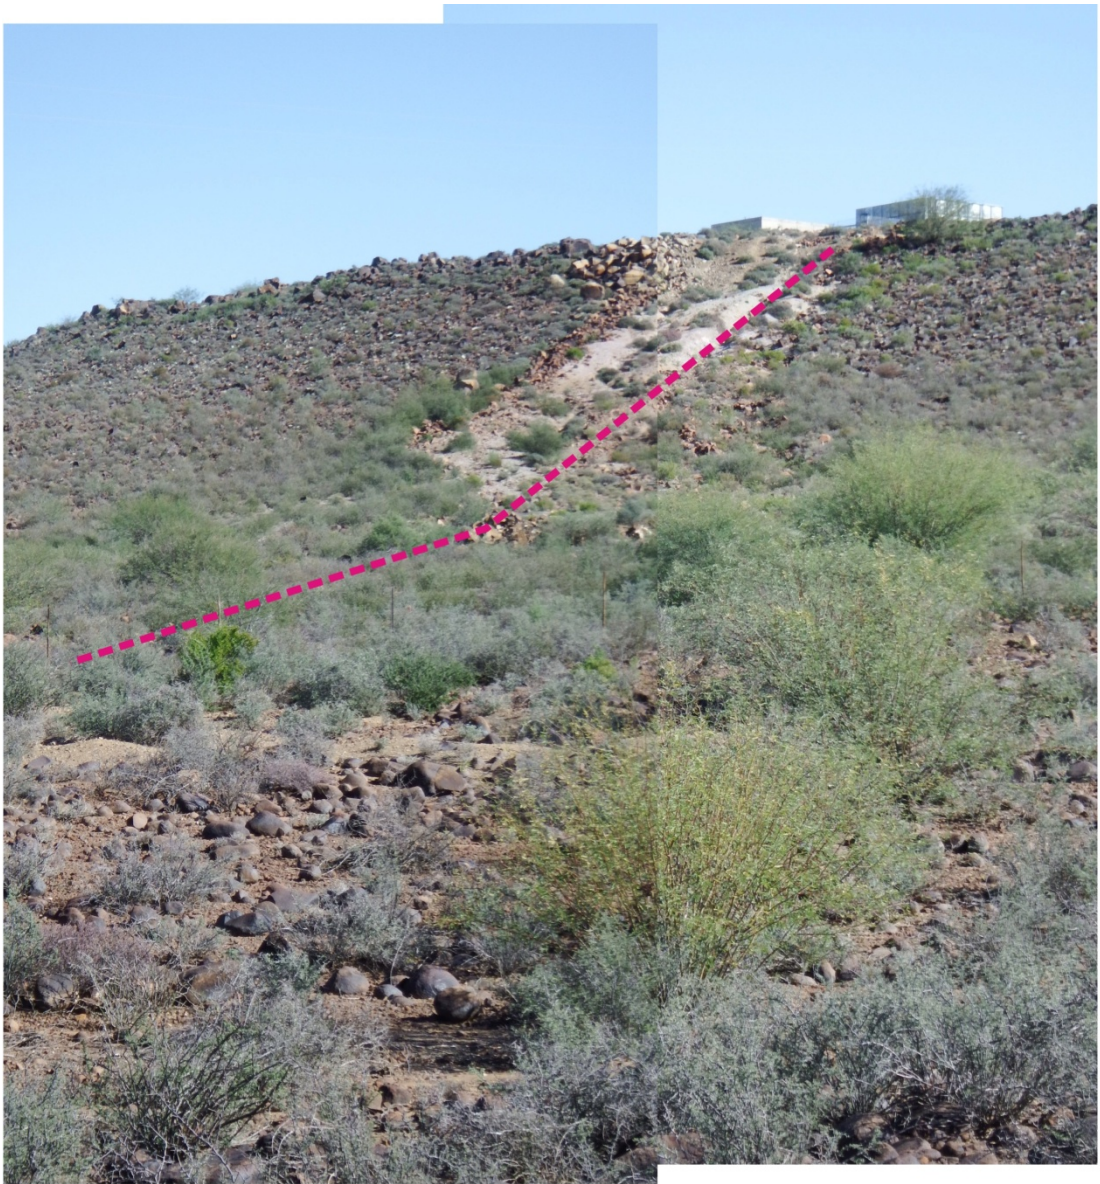
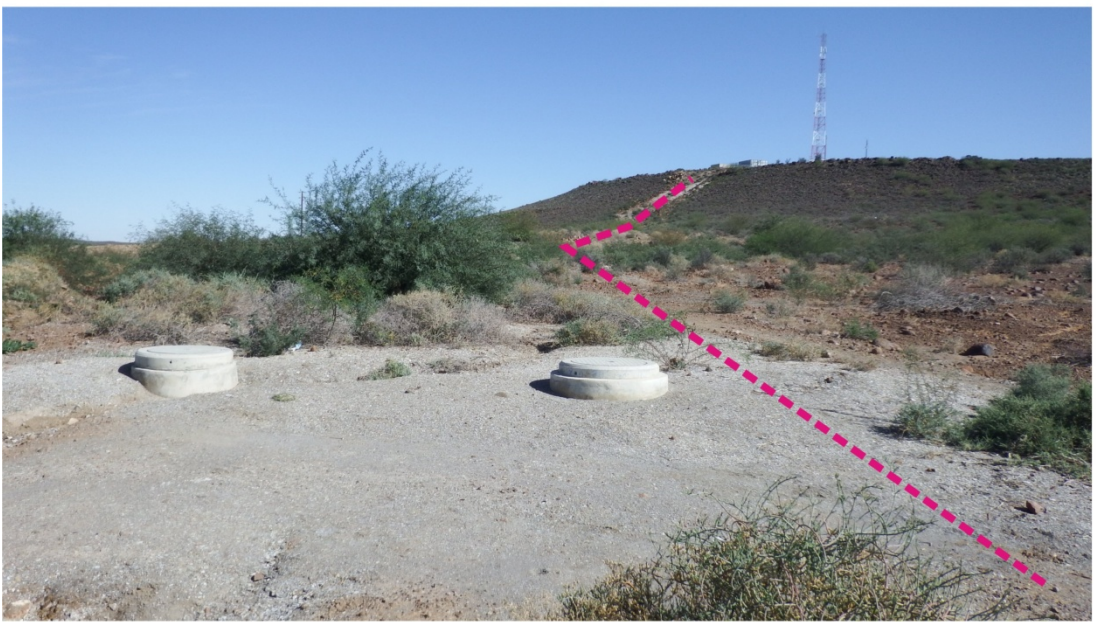
Figure 3. Looking north towards the Van Wyksvlei reservoir. The proposed new route is marked in red.

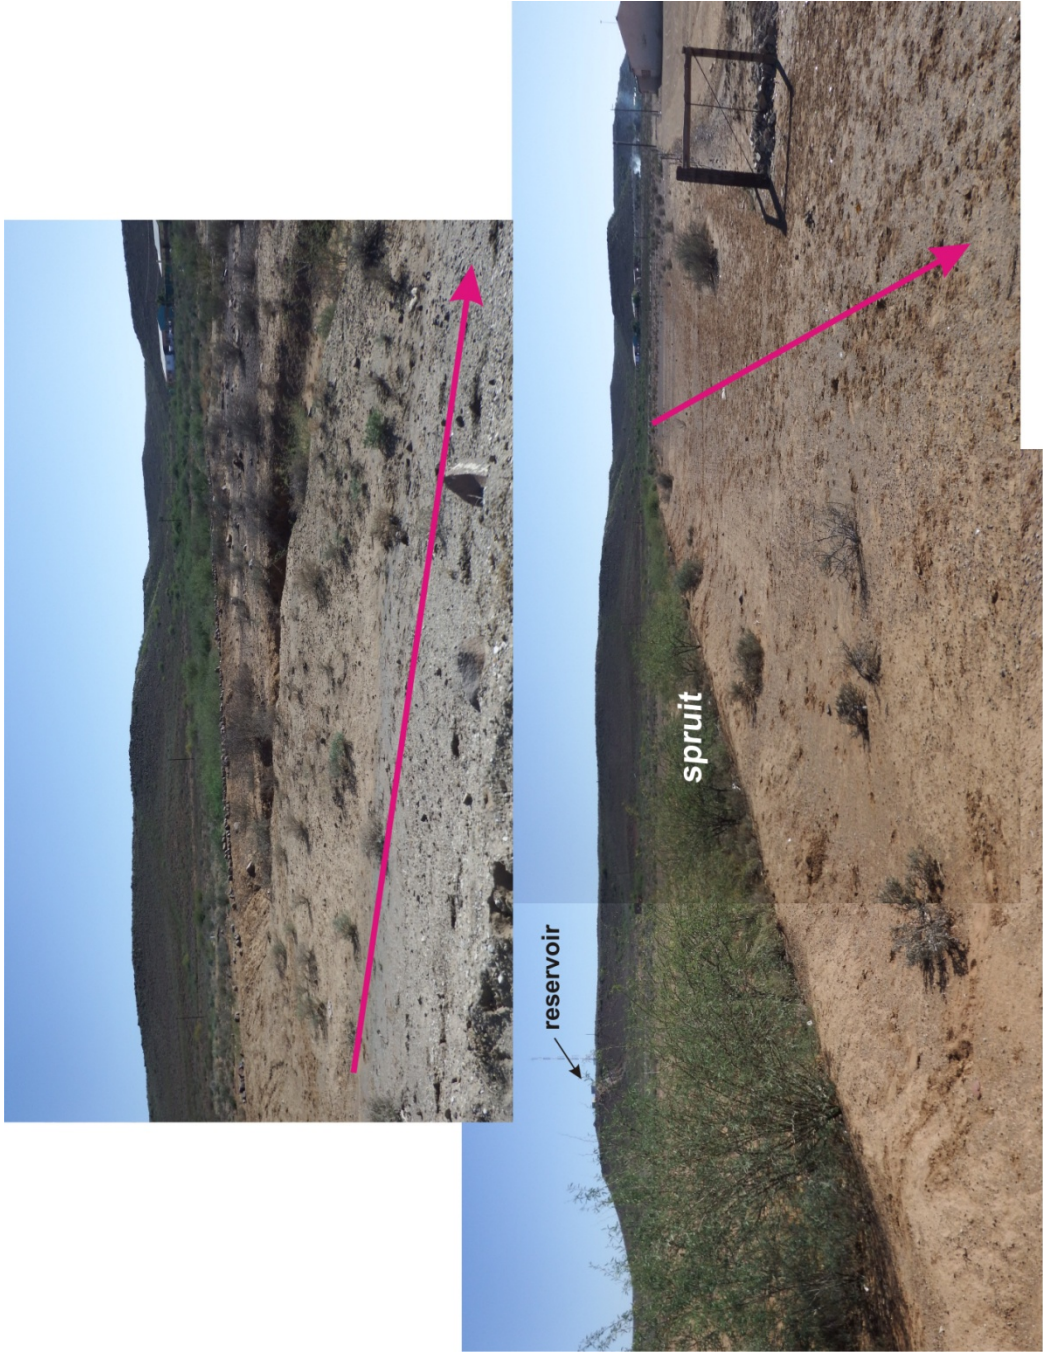
Figure 4. The proposed route crosses degraded open veld (top) and then flanks a dry spruit west of the town before it joins up with the R361.

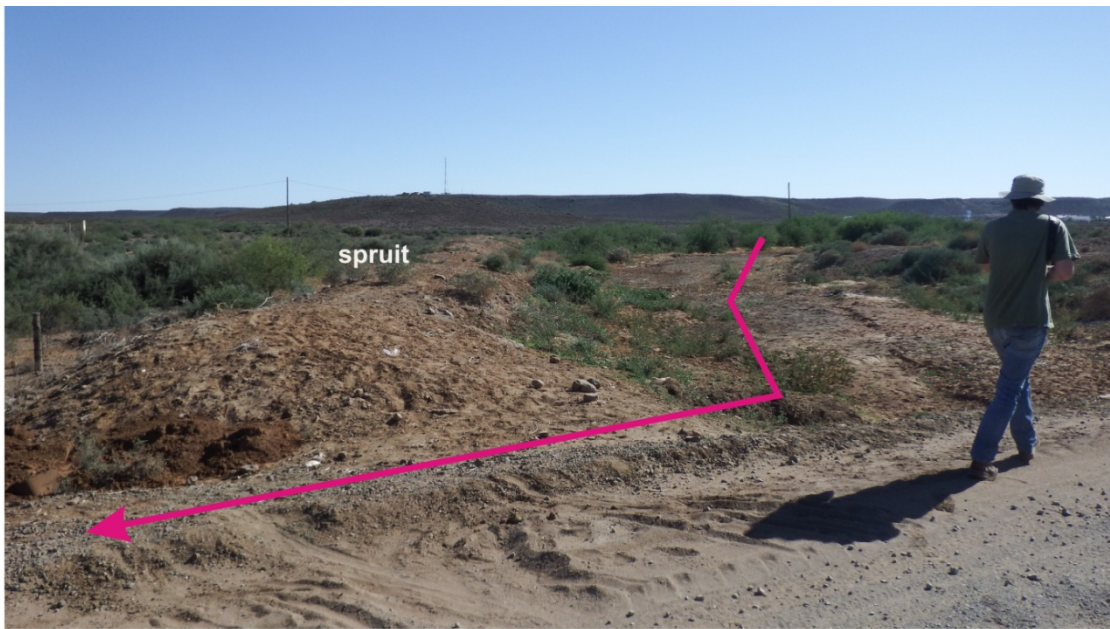
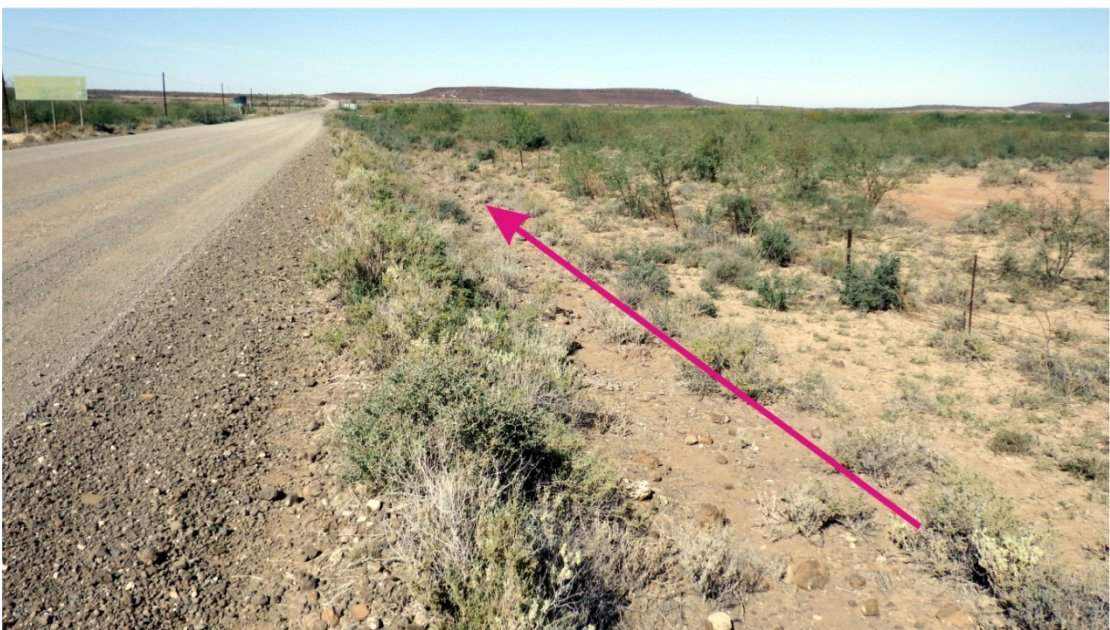
Figure 5. Junction where the proposed pipeline route joins the R361 (top) where after it turns south to follow the R361 along the road reserve (bottom).

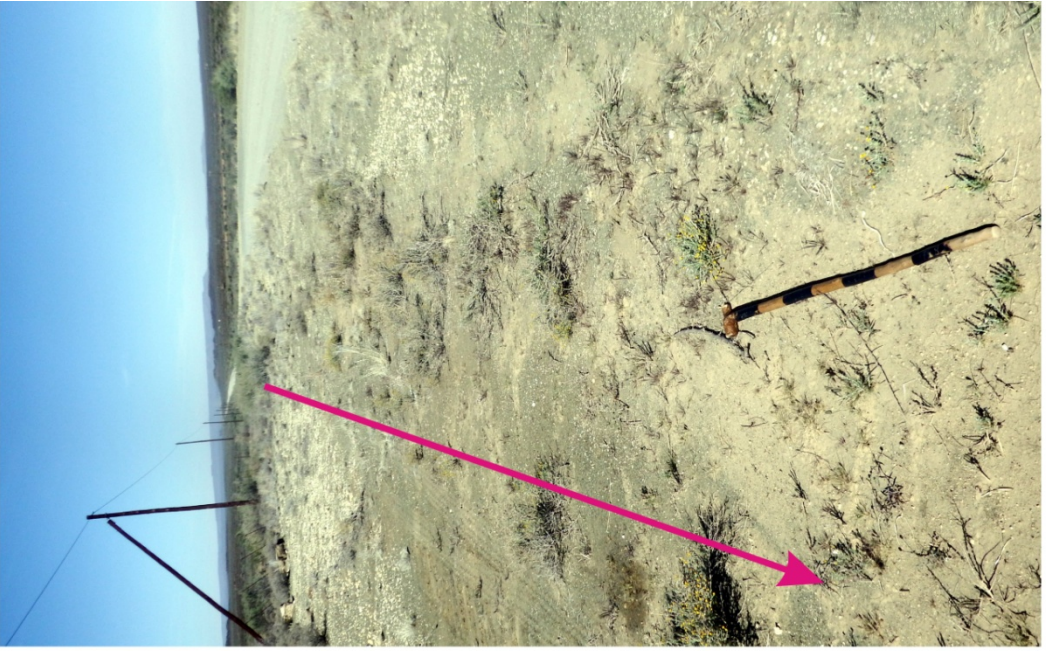
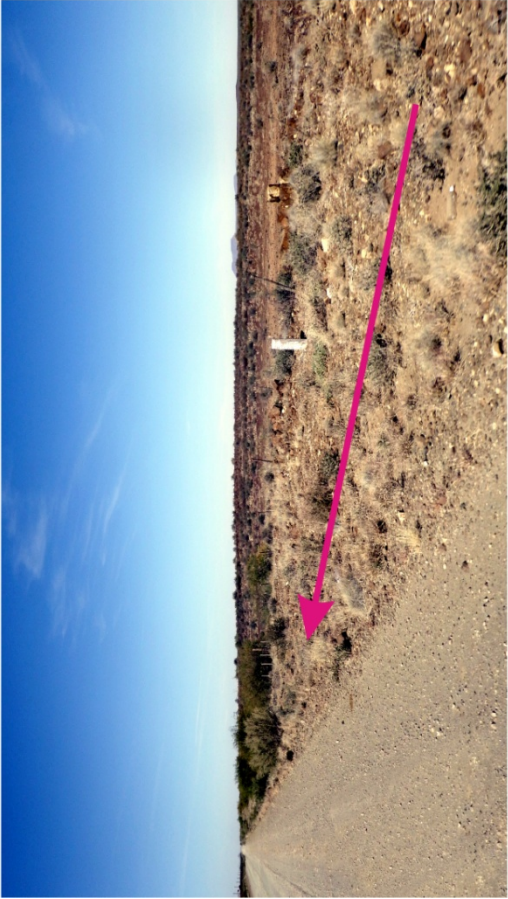
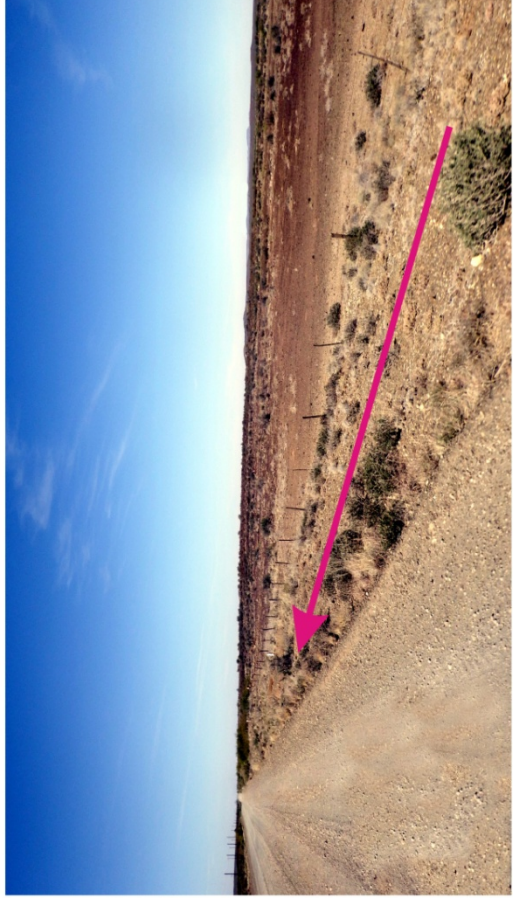
Figure 6. General view of the proposed footprint at different points along the R361

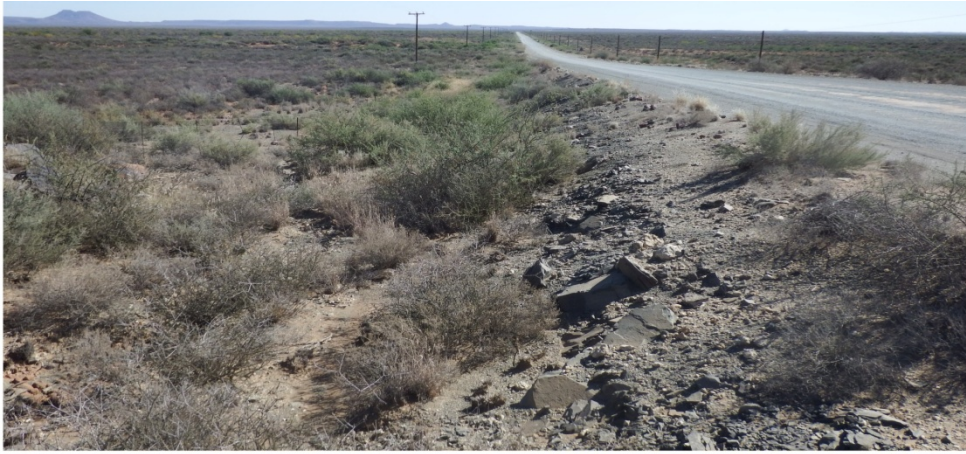
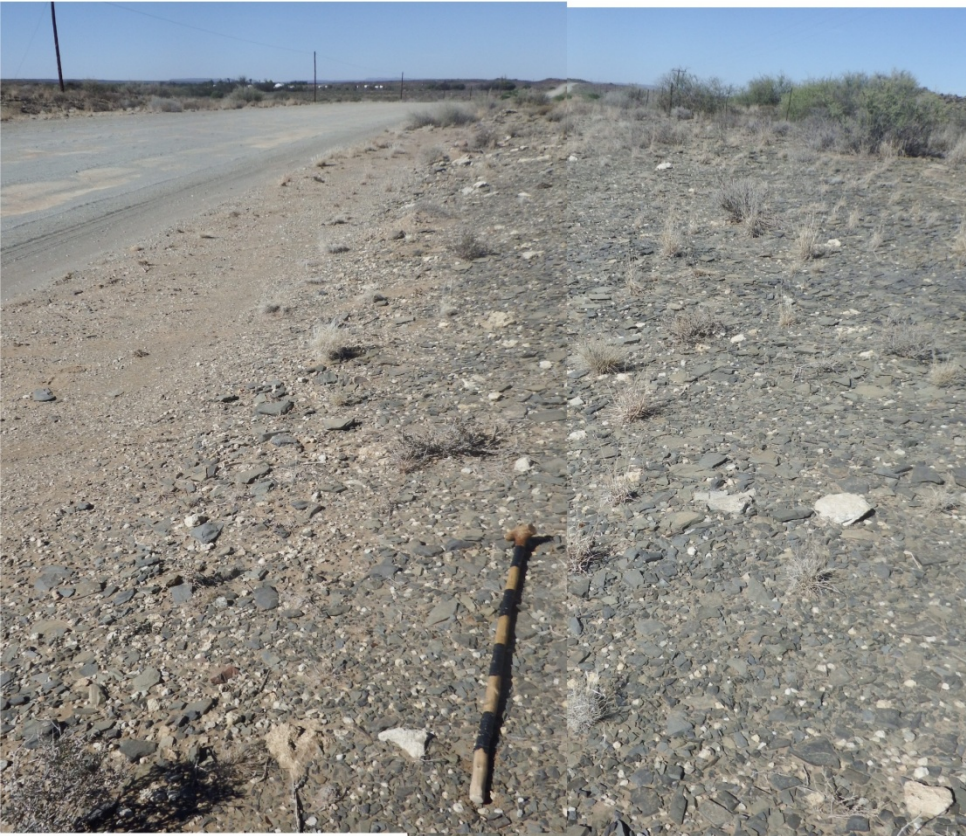
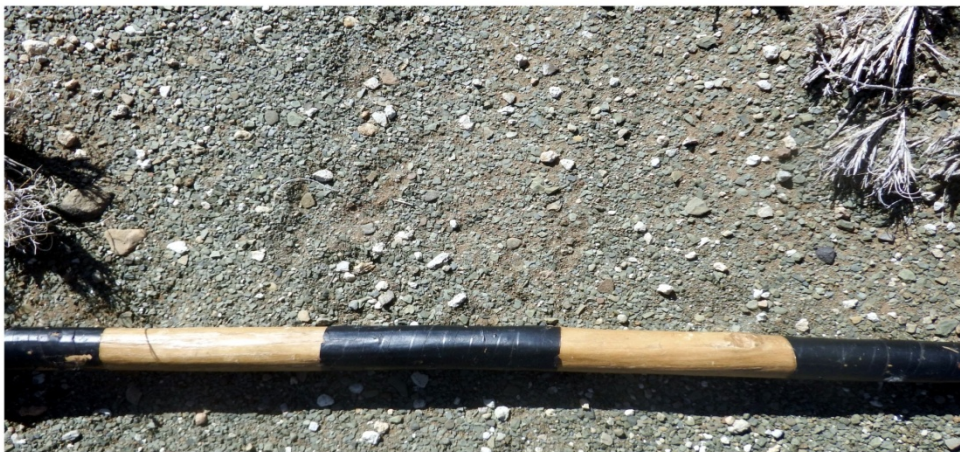
Figure 7. General view of the proposed pipeline route along the R361. The road has largely been constructed using locally available bedrock sediments (Ecca shales) for raw material (center and bottom).
Scale 1 = 10 cm.

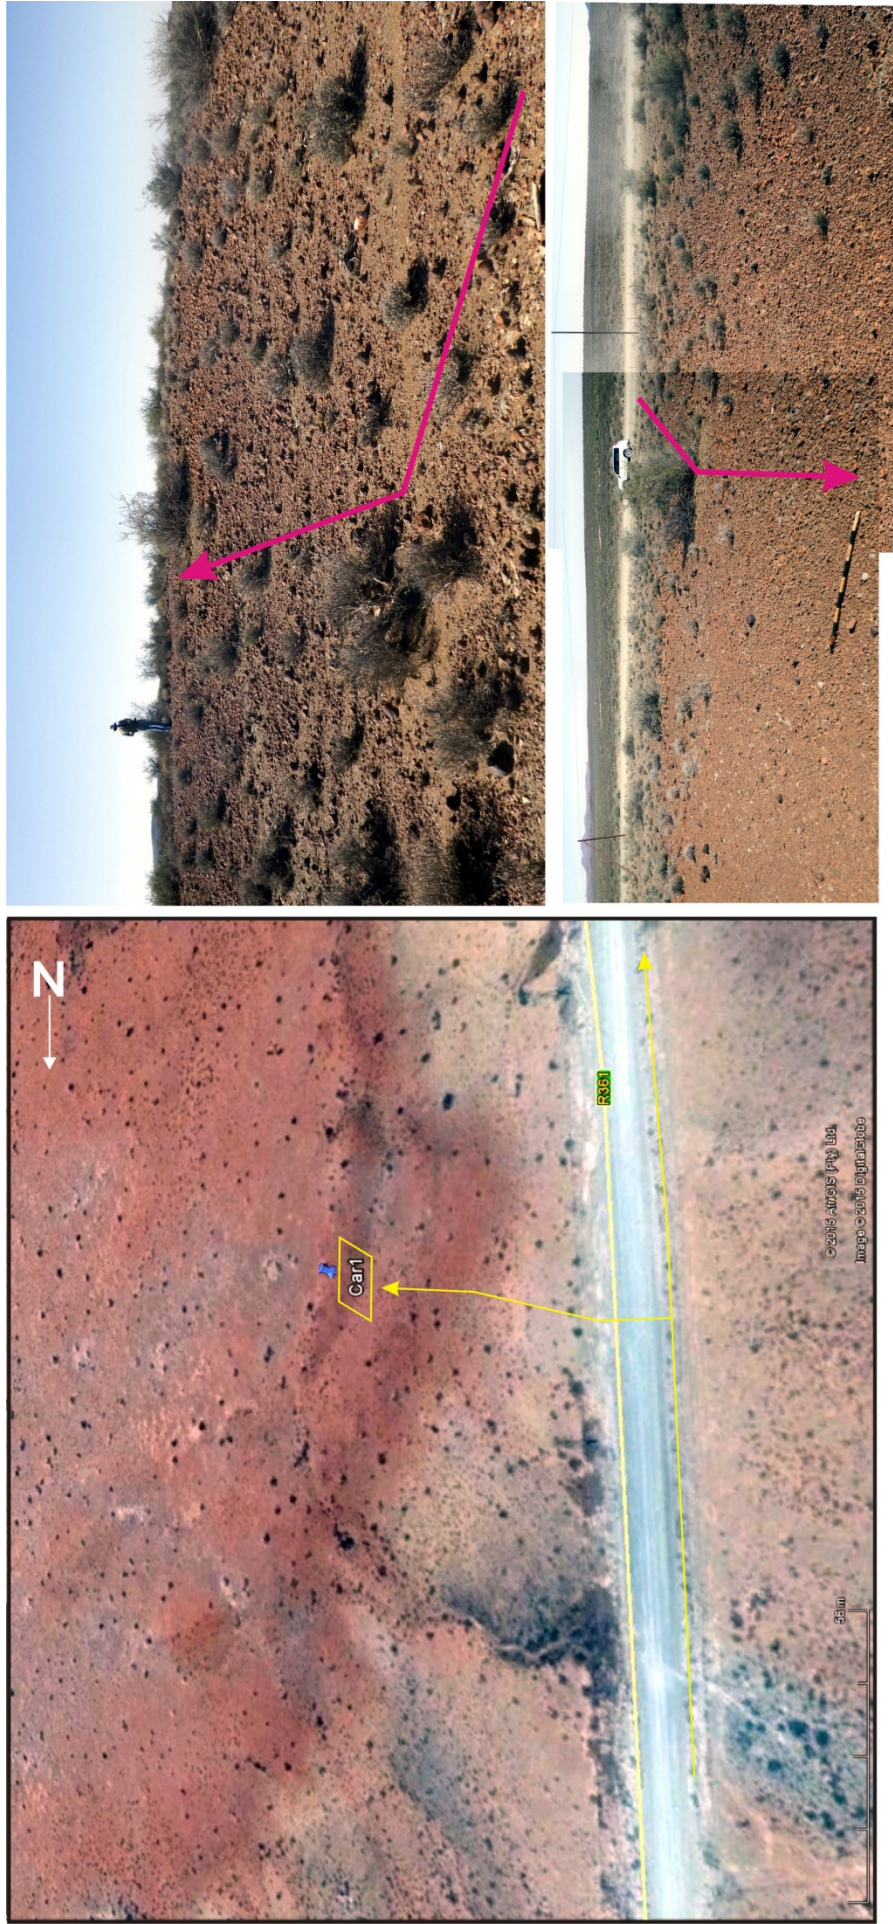
A foot survey of the site revealed no evidence of *in situ* Stone Age archaeological material, rock engraving sites, prehistoric structures, graves or historical buildings older than 60 years within the boundary of the footprint. The site is rated Generally Protected C (GP.C)

Figure 8. Aerial view of the proposed Pumpstation 1 site (left) and general view of the area, looking east-southeast (top right) and west towards the R361 (bottom right).

The proposed new subsurface water pipeline route will run within the road reserve of the R361 between two existing reservoirs from Van Wyksvlei to Saaipoort, located about 12 km north of Carnarvon. The town of Van Wyksvlei was founded in 1882 and named after a farmer by the name of Van Wyk. Carnarvon was laid out in 1860 on the farms *Harmsfontein* and *Schietfontein*, which belonged to the Rhenish Missionary Society and was named after the British Colonial Secretary, the Earl of Carnarvon, Henry Howard Molyneux Herbert in 1874. It became a municipality in 1882 (Rosenthal 1967). The footprint is located next to an existing pipeline route that traverses the townlands, bordering a dry spruit west of Van Wyksvlei to join the R361 road that goes to Carnarvon (**Fig. 2 - 5**). From here the pipeline will run to Saaipoort within the road reserve of the R361 (**Fig. 6 & 7**). Two new pump stations will be placed on high ground on Karoo dolerite outcrop along the route (**Fig. 8 & 9**)

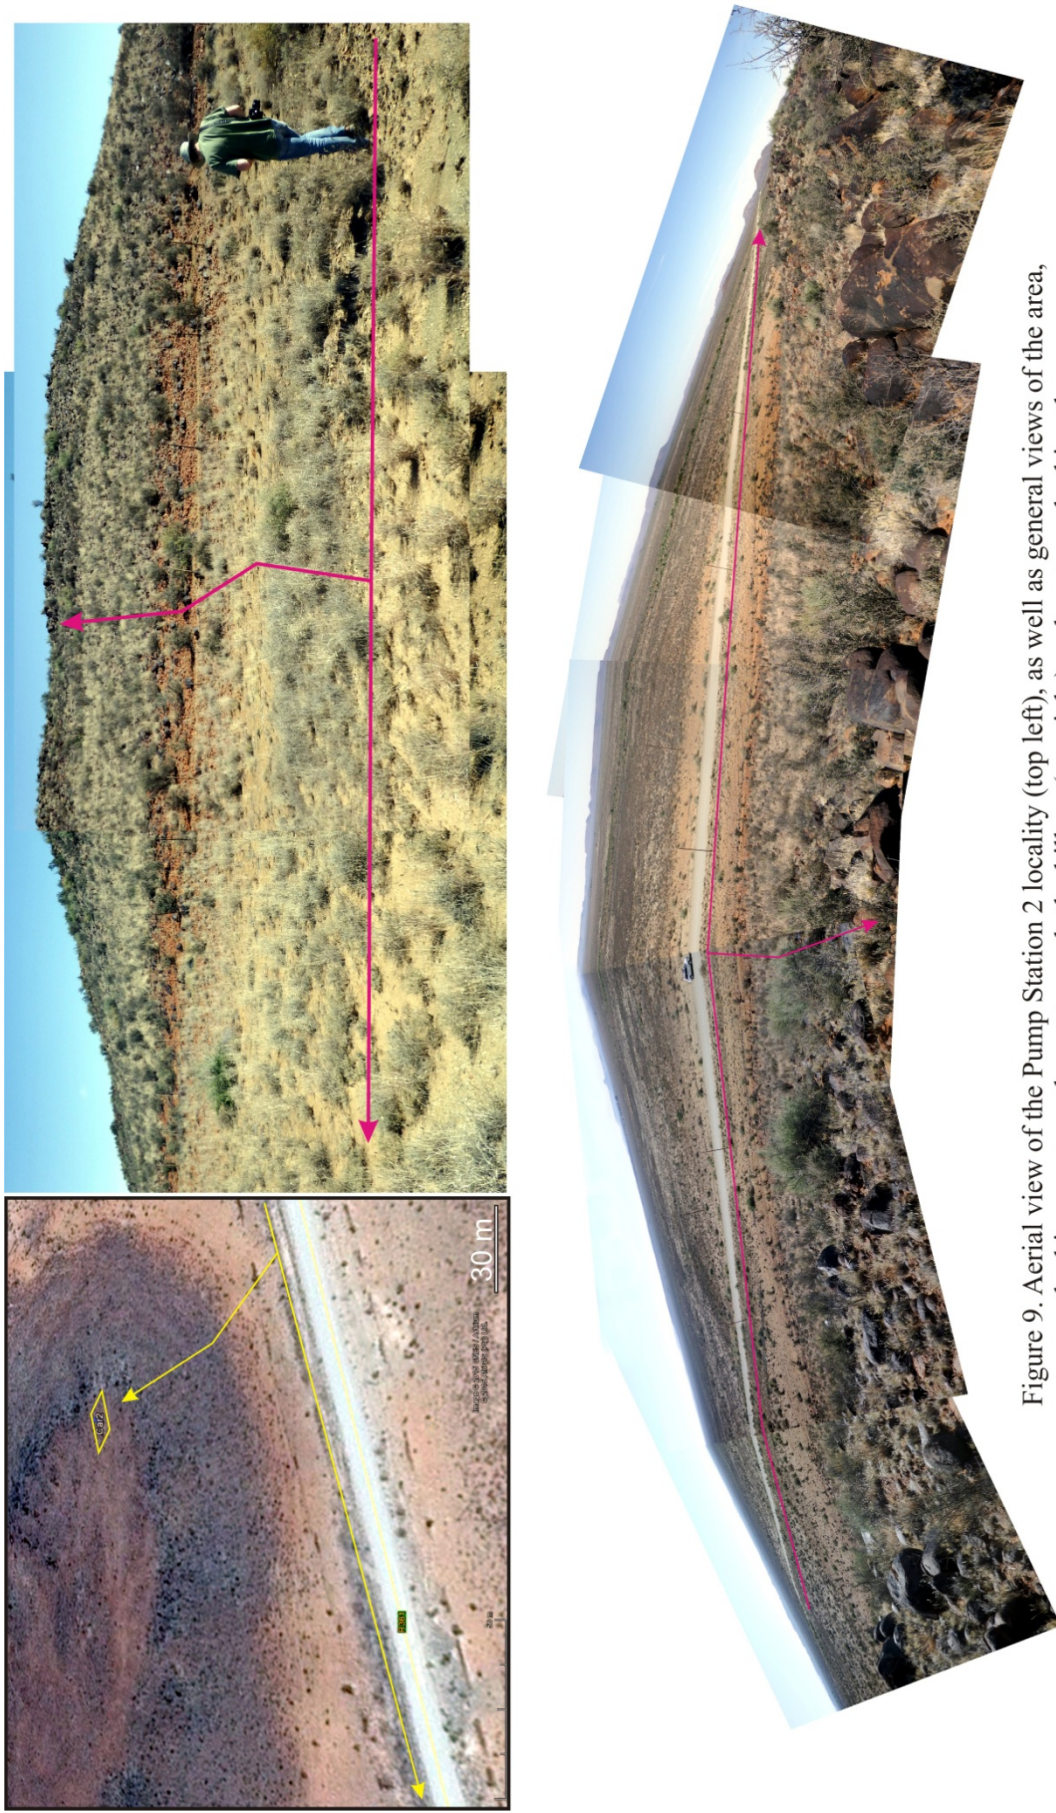
Figure 9. Aerial view of the Pump Station 2 locality (top left), as well as general views of the area, looking west-southwest towards the hilltop (top right) and east overlooking the plain below the site (bottom).

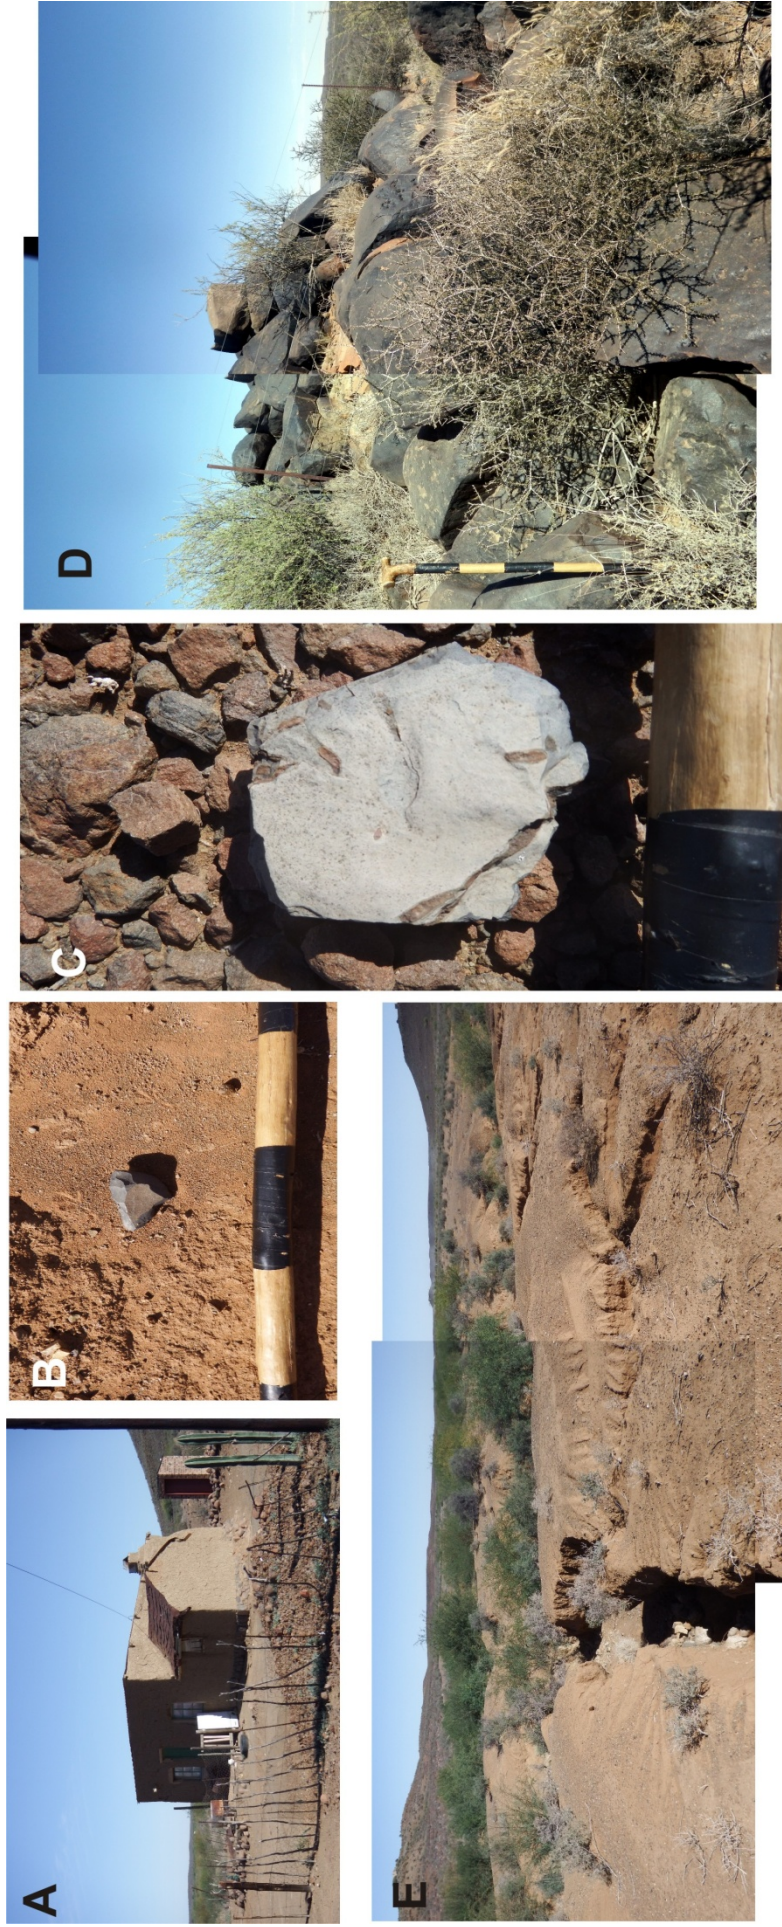
Except for a house (that is still in use) situated next to the existing pipeline route below the reservoir (**Fig. 11 & Fig. 12 no. 1**), as well as a few isolated, informal stone tools recorded on alluvial sediments derived from a nearby dry spruit (**Fig. 11 & Fig. 12 no. 2**), no evidence was found of *in situ* Stone Age archaeological material, rock engraving sites, prehistoric structures, graves or historical buildings older than 60 years within the boundary of the footprint area along the section. The section is rated Generally Protected C (GP.C)

Figure 11. Relevant features recorded within the vicinity of the proposed pipeline route during the field assessment: (A) house and yard still in use; (B) isolated flake made from hornfels; (C) shale fragment with evidence of trace fossils; (D) small dolerite outcrop next to the R361 with no sign of engravings ($30^{\circ}41'33.91''S$ $22^{\circ}1'15.85''E$); (E) dry spruit at the Van Wyksvlei townlands with well-developed alluvial overburden. Scale 1 = 10 cm.

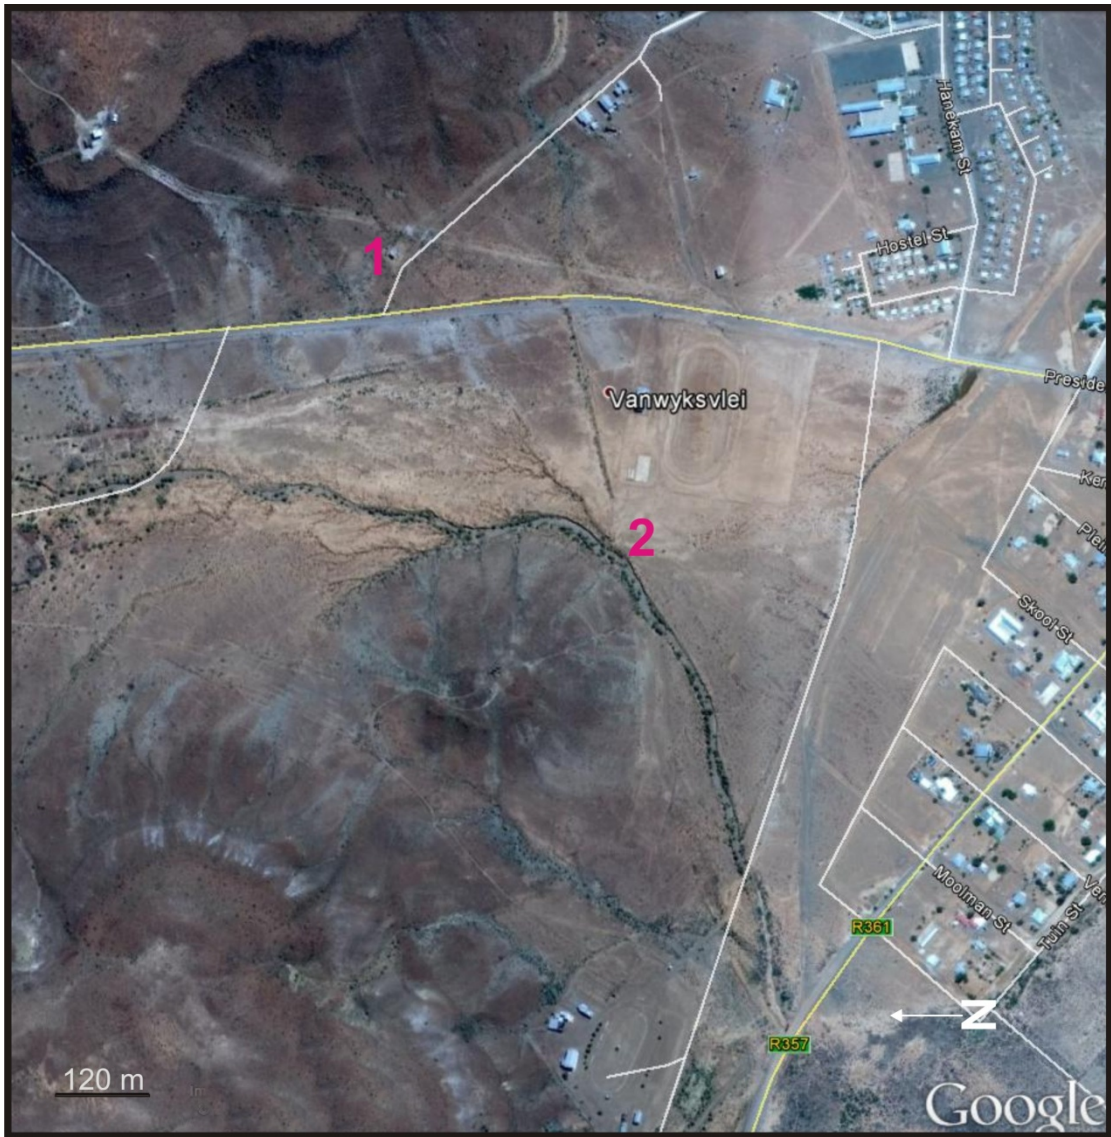
Figure 12. Aerial view and location of the house (1) and isolated stone tool find (2) recorded in the vicinity of the proposed pipeline route.

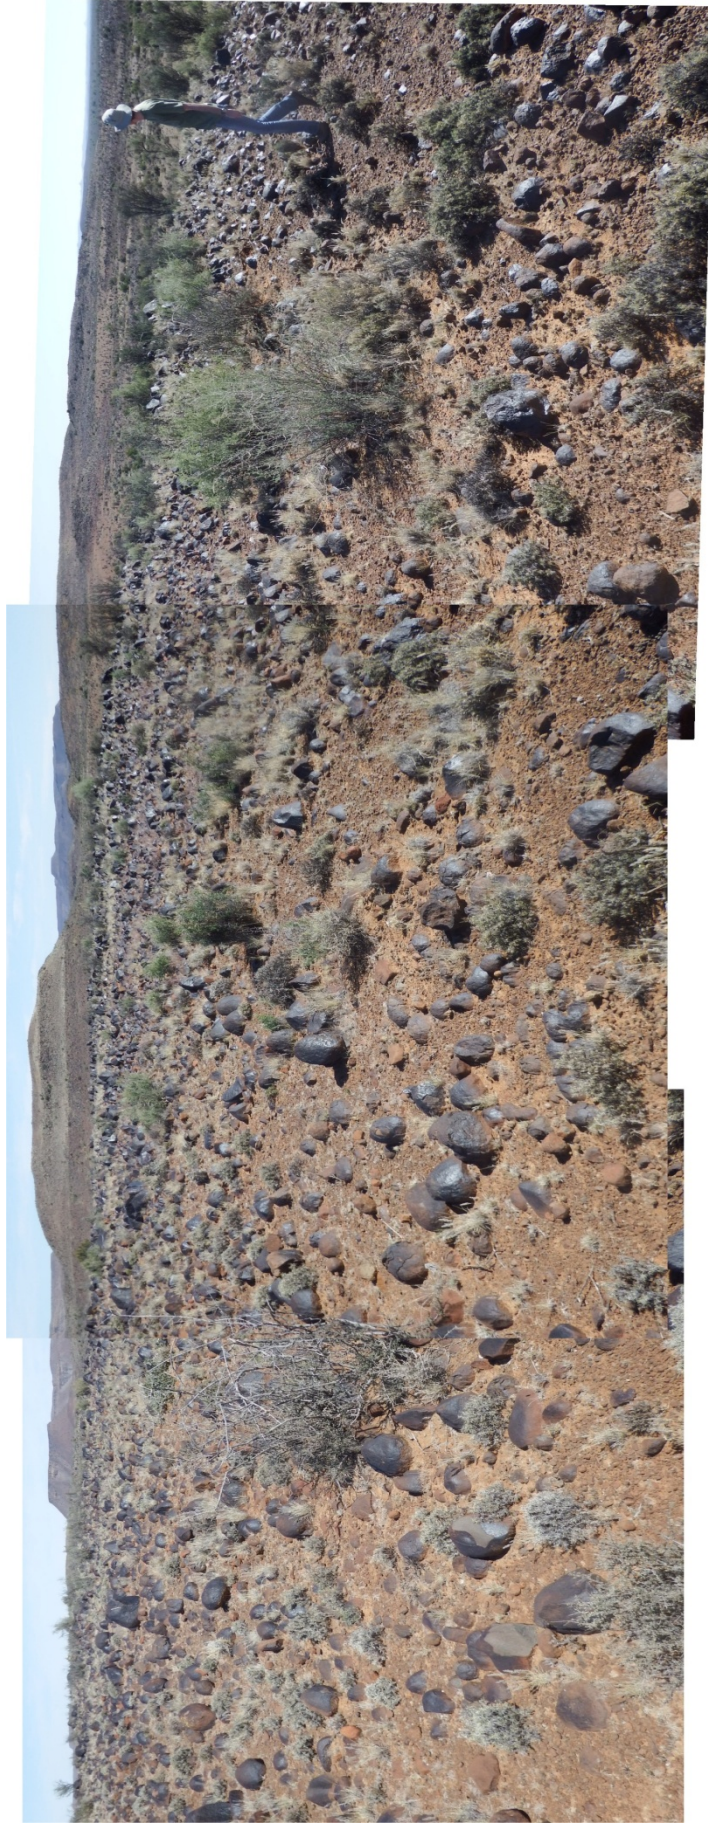
Three isolated OES fragments, two weathered microliths and faint traces of several engraved lines were recorded at three different localities, south of the affected area, which may suggest that human occupation in the area was most likely of an ephemeral nature. (**Fig. 13 - 16**). The engraved markings of several short horizontal lines, were found on one dolerite boulder, about 40m to the south-west of the affected area. No other rock engravings could be found within a 50 m radius of the proposed pump station site. Construction of the proposed pump station will not impact on the stone tool and engraving locality. The site is rated Generally Protected C (GP.C)

Figure 13. Boulder-strewn terrain at the Pump Station locality, looking west.

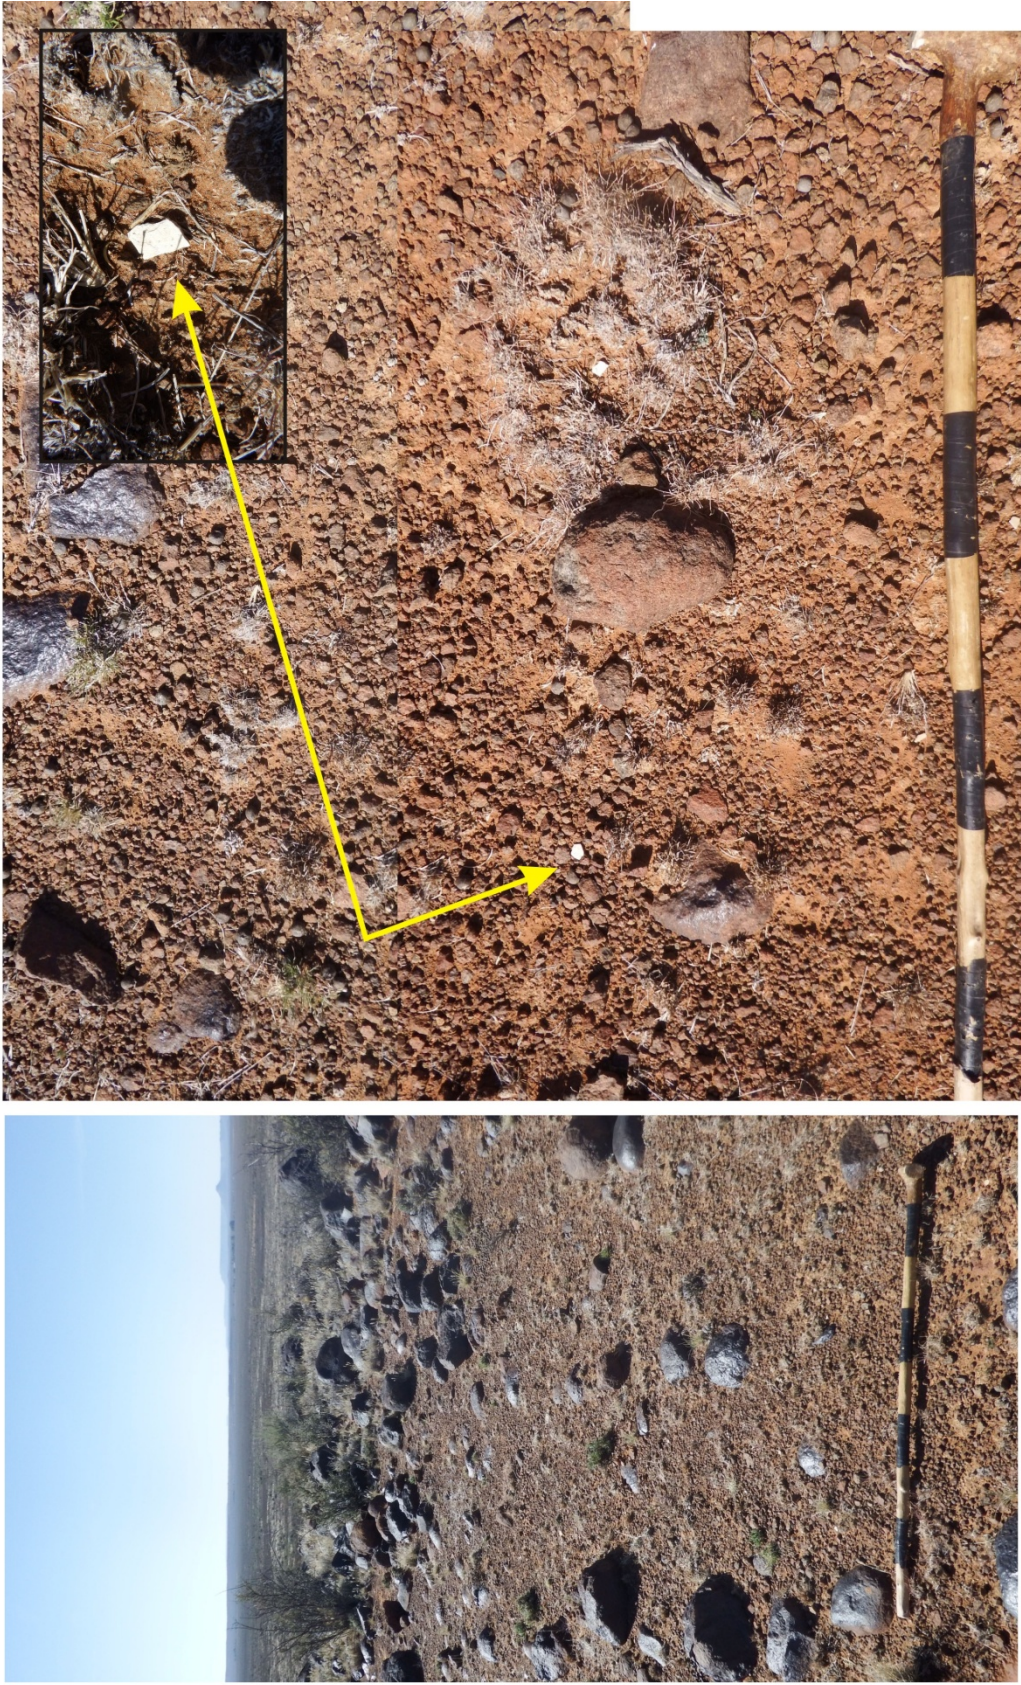
Figure. 14. The proposed new Pump Station 2 facility, looking east (left) and isolated OES fragments recorded nearby (right). Scale 1 = 10 cm).
