**Phase 1 Heritage Impact Assessment of a proposed new
subsurface water pipeline between the Van Wyksvlei
reservoir and Saaipoort, near Carnarvon, NC
Province.**

Report prepared for
MDA Environmental Consultants
by
L. Rossouw
Archaeological Impacts Unit
National Museum Bloemfontein

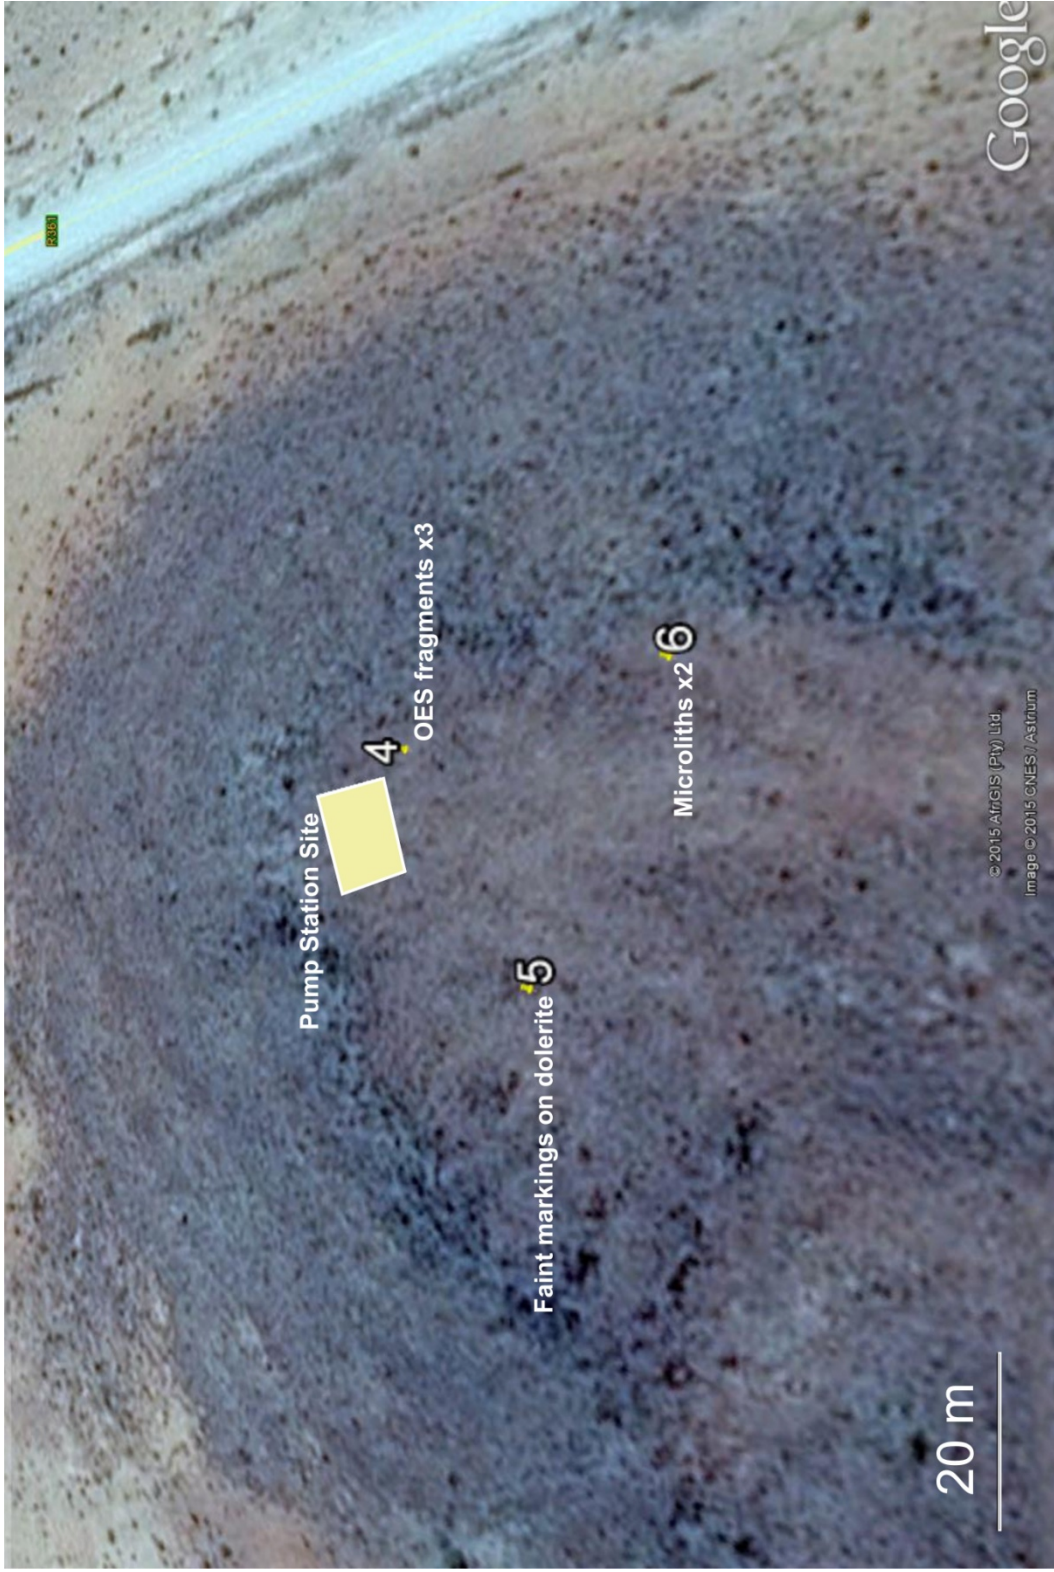
Three isolated OES fragments, two weathered microliths and faint traces of several engraved lines were recorded at three different localities, south of the affected area, which may suggest that human occupation in the area was most likely of an ephemeral nature. (**Fig. 13 - 16**). The engraved markings of several short horizontal lines, were found on one dolerite boulder, about 40m to the south-west of the affected area. No other rock engravings could be found within a 50 m radius of the proposed pump station site. Construction of the proposed pump station will not impact on the stone tool and engraving locality. The site is rated Generally Protected C (GP.C)

Figure 1.5. Location of features identified near the Pump Station 2 site.

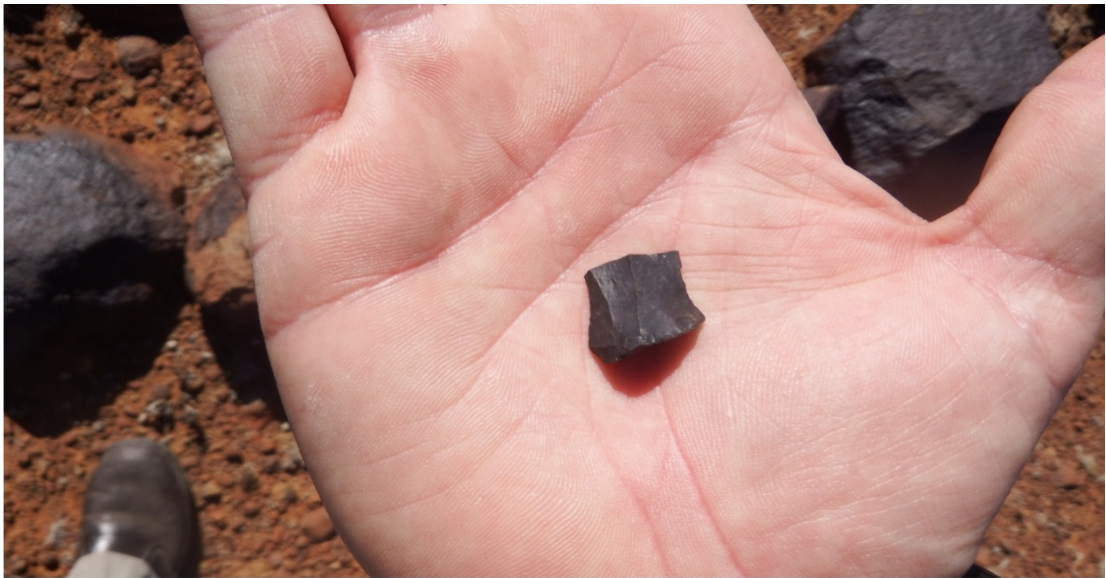
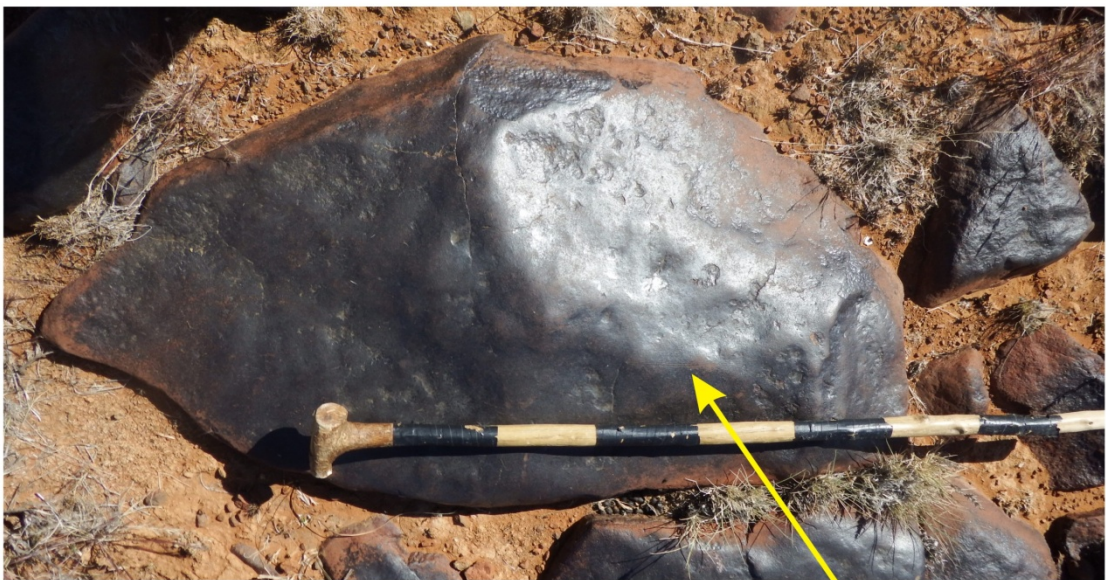
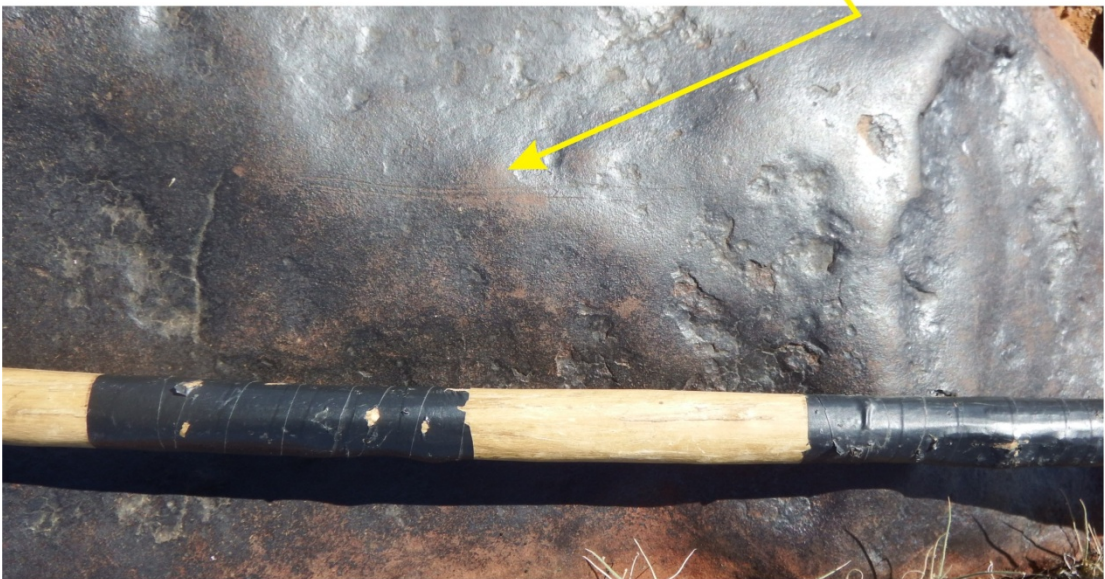
Figure 16. A small core/debitage waste product made from hornfels (top) and faint markings on one dolerite boulder (Center and bottom) located near the proposed Pump Station 2 site.
Scale 1= 10 cm.
