**A PHASE 1 ARCHAEOLOGICAL IMPACT ASSESSMENT (AIA) FOR THE PROPOSED UPGRADE AND MAINTENANCE OF NATIONAL ROADS R335 & R342 BETWEEN ADDO AND PATERSON, SARAH BAARTMAN DISTRICT MUNICIPALITY, EASTERN CAPE PROVINCE.**

**Date:** February 2018

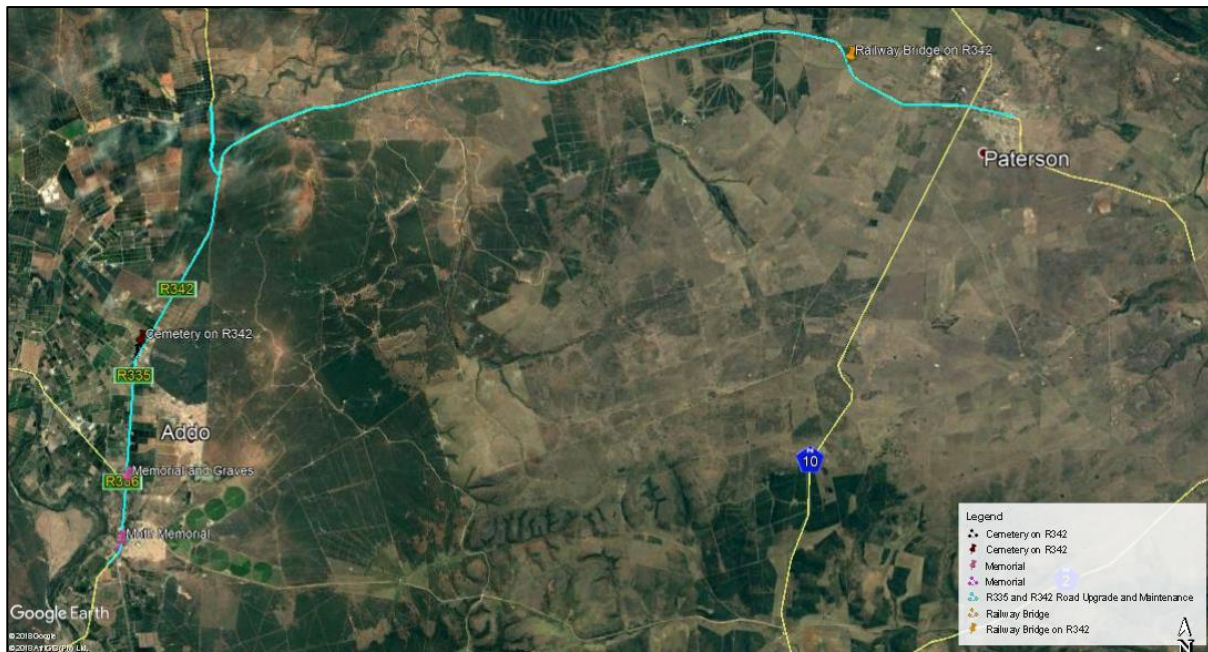
**Figure 3. View of the National Roads R335 and R342 proposed for upgrade and maintenance showing the location of protected heritage resources and the railway bridge documented along the route.**

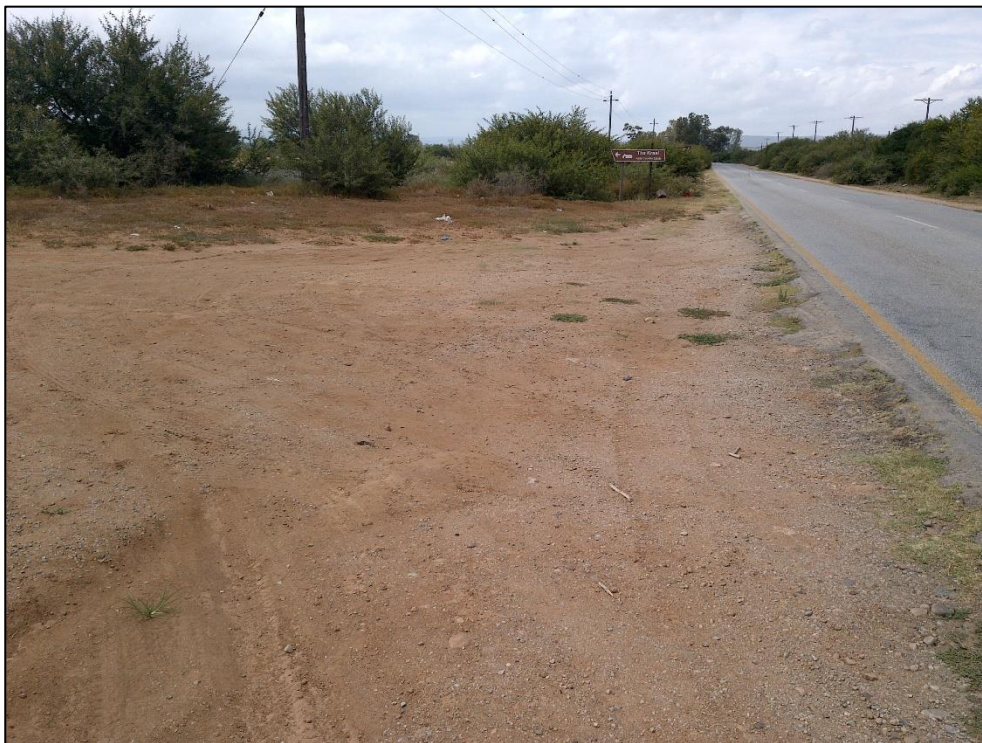
**Figure 4. View of the road reserve proposed for upgrade (km 0.5– km 12) facing north towards Addo Town.**

The portion proposed for road upgrade, km 0.5 – km 12, from the south of Addo Town runs through Addo Town to the Langbos turn-off, is heavily disturbed by previous construction activities (Figures 4 - 12). These activities include the construction and continued maintenance of the existing road, entrances to properties, the development of Addo Town and associated infrastructure, as well as the railway line that cuts across the road.

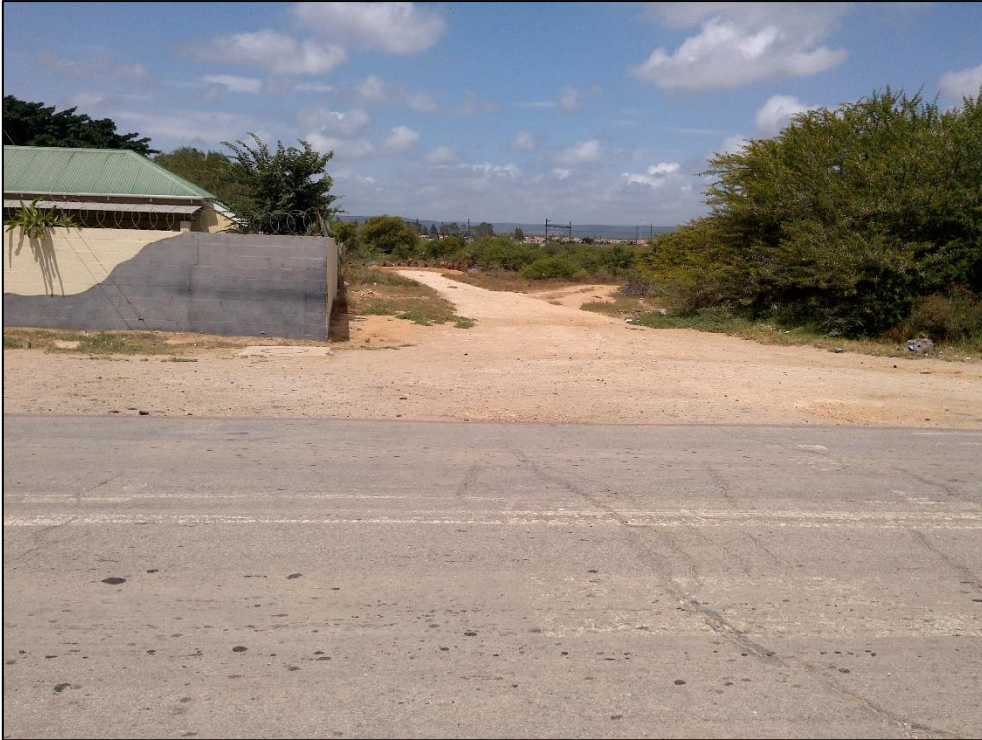
**Figure 7. View of the area proposed for upgrade of the pedestrian walkways into Valencia Township (km 0.5 – km 12).**

The pedestrian walkway and road to Nomathamsanqa Township has recently been upgraded (Figure 11). The current pedestrian walkway to Valencia Township is a path through the thicket vegetation (Figure 7).

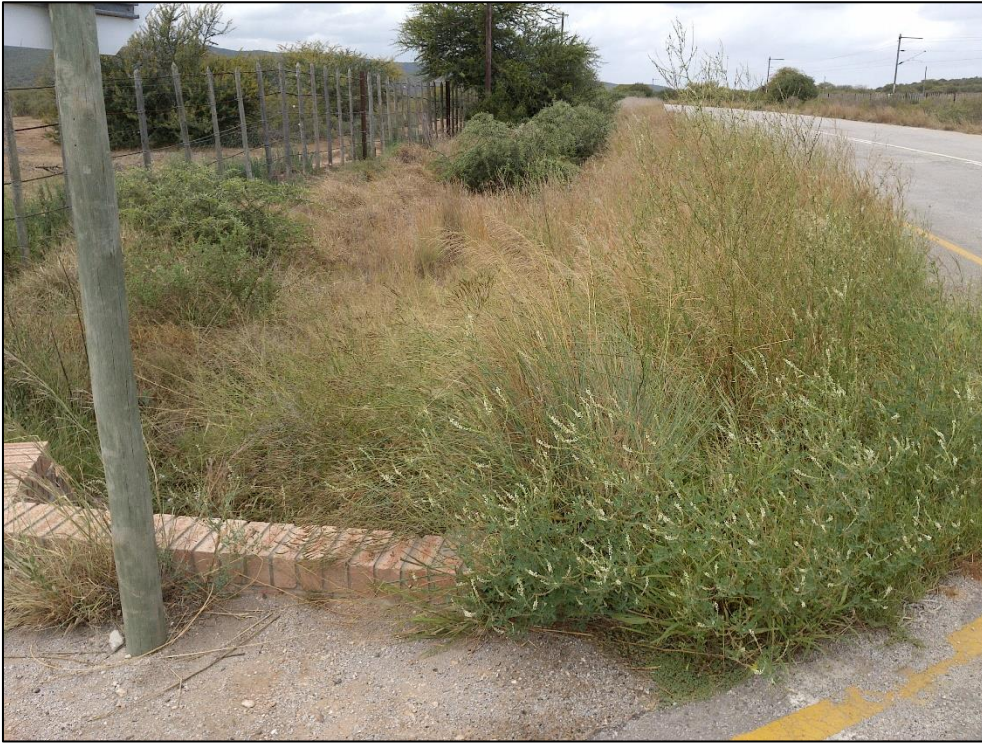
**Figure 13. View of the dense vegetation cover and culvert situated within the road reserve area proposed for maintenance (km 12–km 37) facing north.**

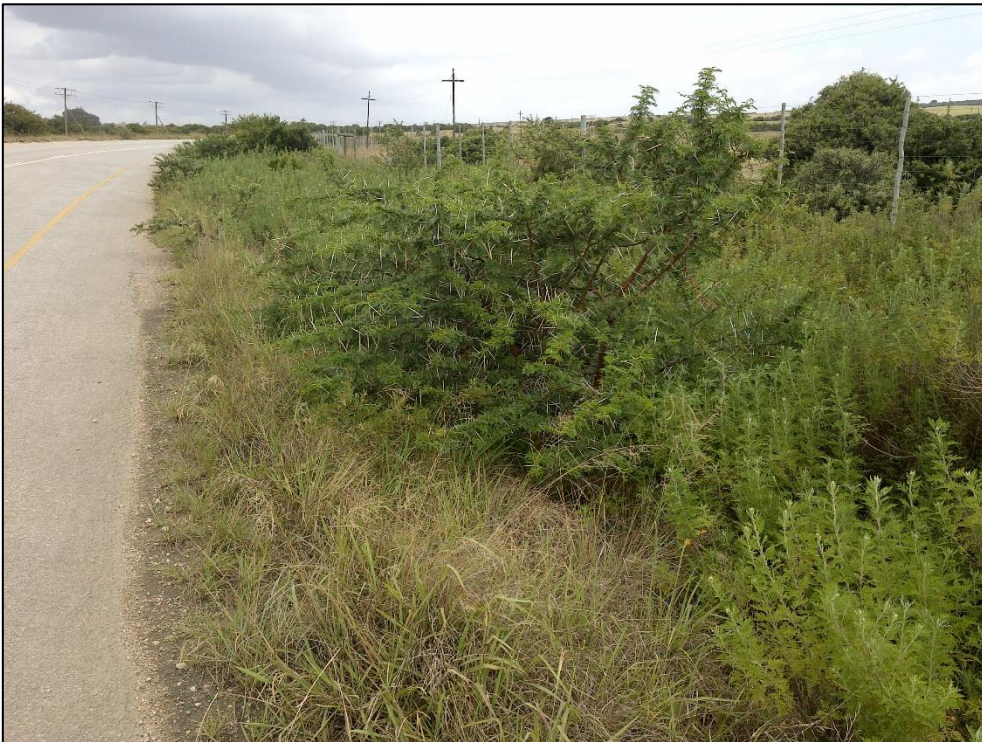
**Figure 14. View of the dense vegetation cover within the road reserve area proposed for maintenance (km 12–km 37) facing north.**

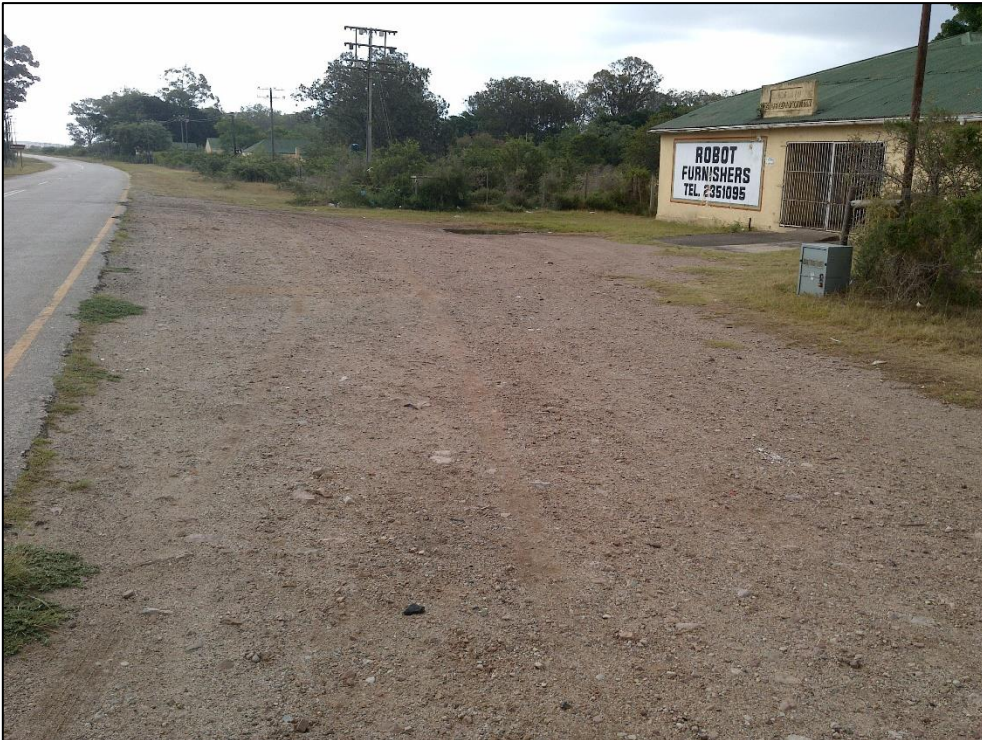
**Figure 16. View of the historical buildings situated near Paterson (km 12 – km 37).**

No archaeological heritage remains were identified along the route, however, several other protected heritage resources were identified along the route. However, historical buildings are located near the town of Paterson (Figures 16-17). It is unlikely that these buildings will be negatively affected by the road maintenance activities.

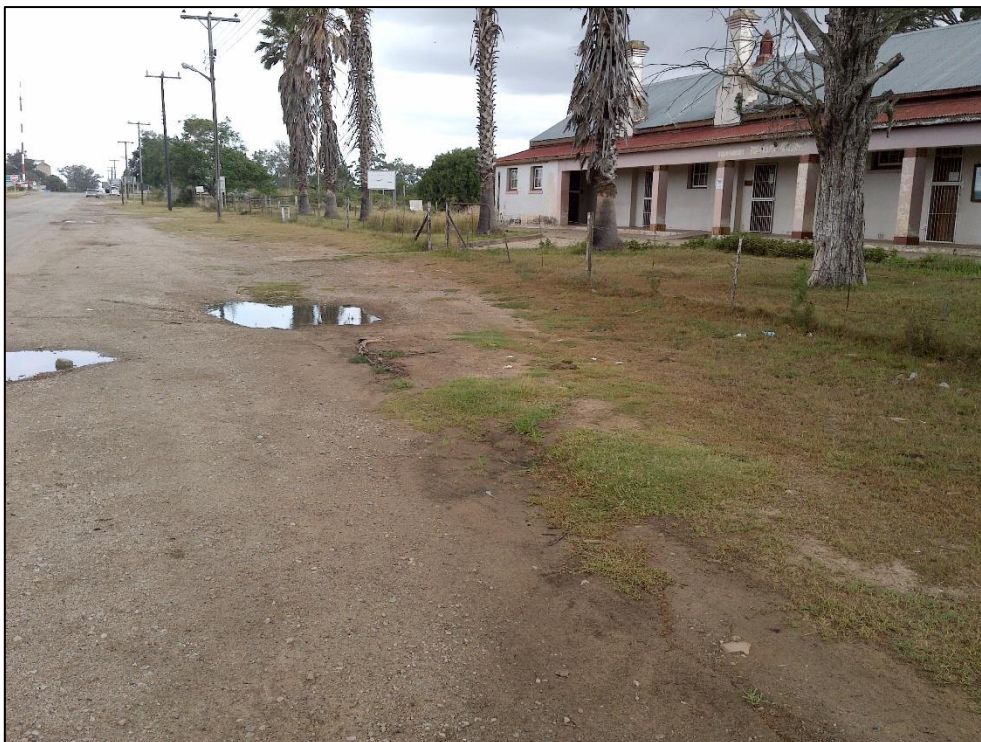
**Figure 17. View of the historical buildings situated near Paterson (km 12 – km 37).**

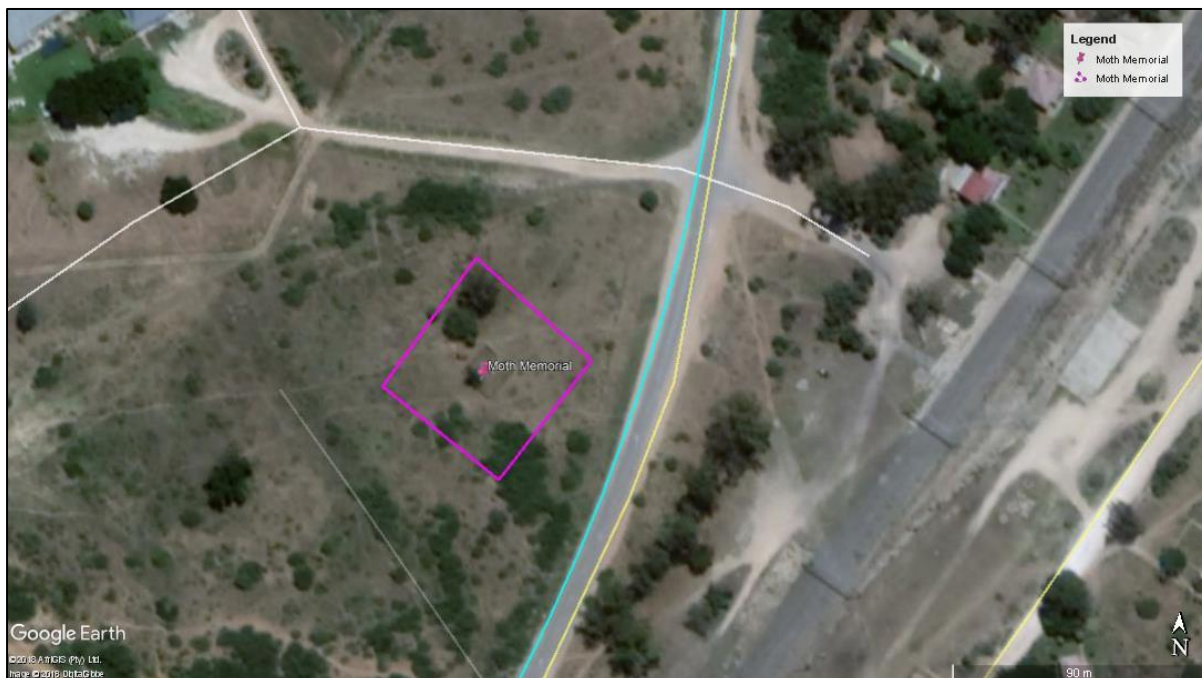
**Figure 18. Location of the Moth Remembrance Memorial south of Addo town showing the 20 m boundary where no construction activities should occur.**

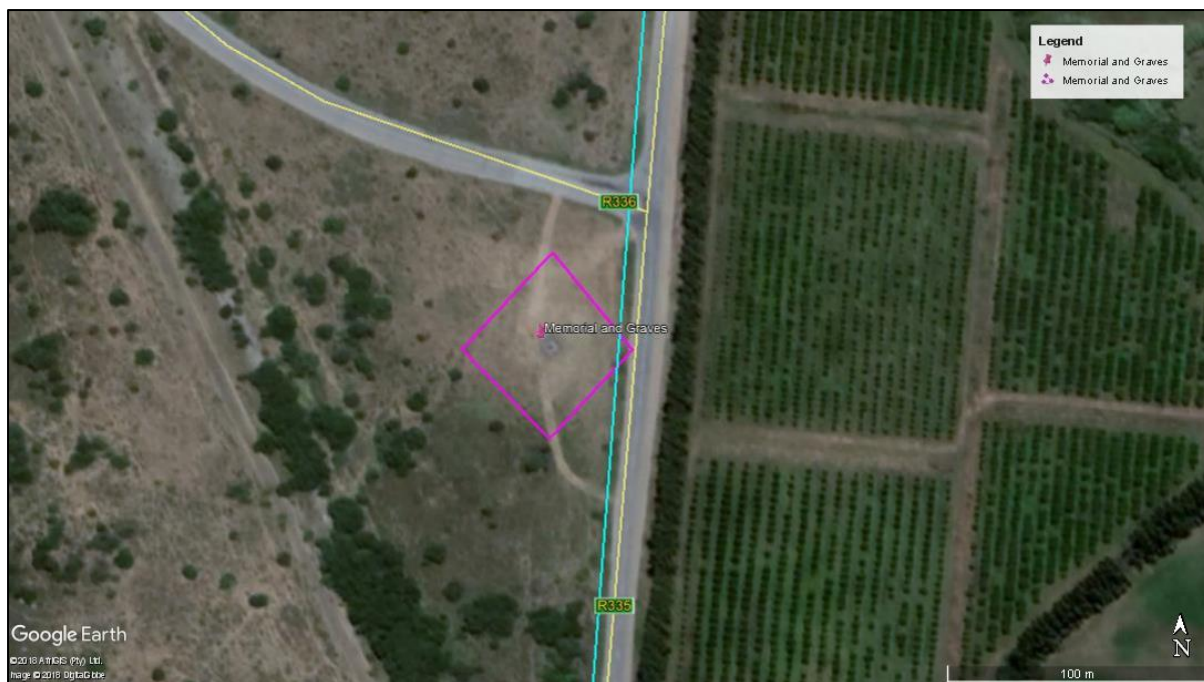
**Figure 21. Location of the Struggle associated Memorial and two graves at the corner of the R335 and R336 north of Addo Town showing the 20 m boundary where no construction activities should occur.**

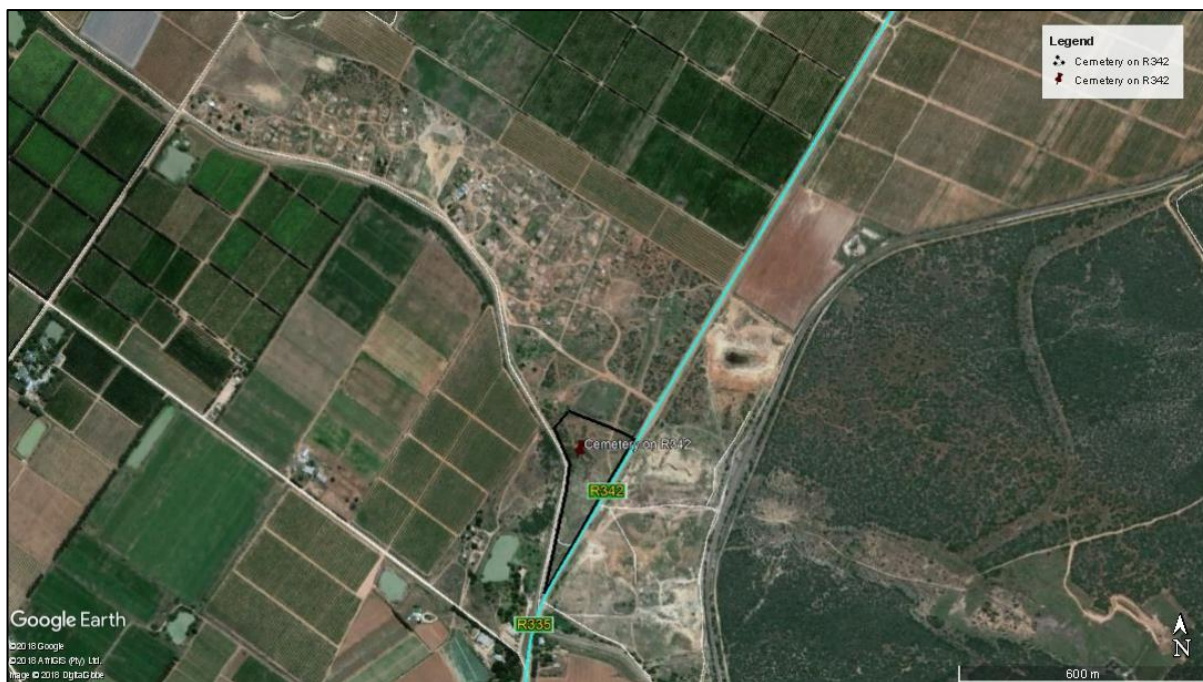
The cemetery is not clearly fenced, although remnants of previous fencing is visible. There is a possibility that if not mitigated effectively damage could be caused to the burials and graves situated near to the road. A fence should be erected to clearly demarcate the extent of the cemetery before development continues. It is suggested that no construction activities occur on the left side of the road for the extent of the cemetery and that the widening of the road is conducted on the right-hand-side of the road.

**Figure 26. Location of the Cemetery situated next to the R342 situated near the Langbos Township between Addo Town and the Addo Elephant National Park turn-off.**

The burials and graves are visible from the boundary of the road reserve. It is possible if not mitigated adequately that some of the burials and graves may be negatively affected. It is recommended that construction activities for the road upgrade extent to the right-hand-side of the road and that a fence be established to demarcate the cemetery area.

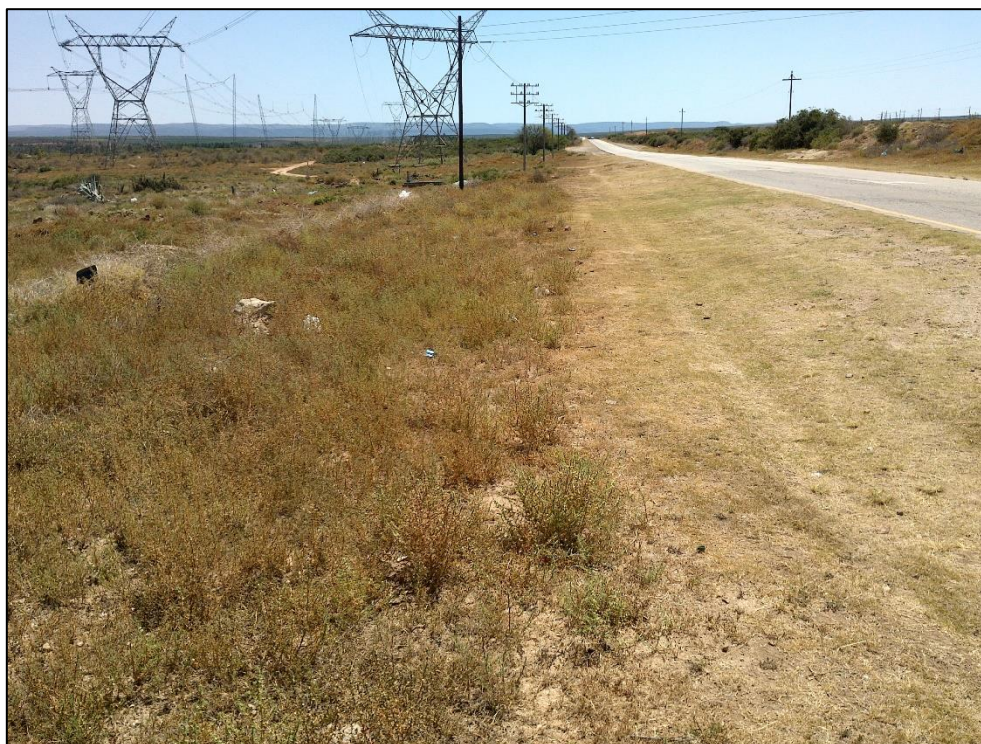
**Figure 27. View of the graves in proximity to the road and road reserve.**

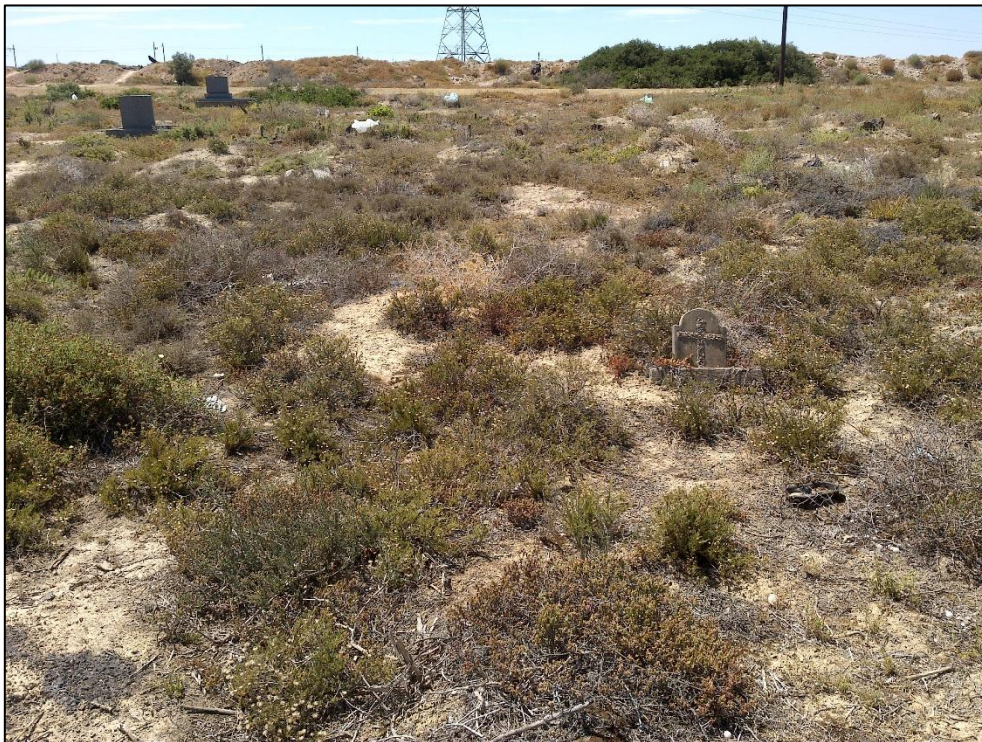
**Figure 28. View facing towards the road showing the more formerly established graves, a headstone and the almost invisible heaps representing graves.**

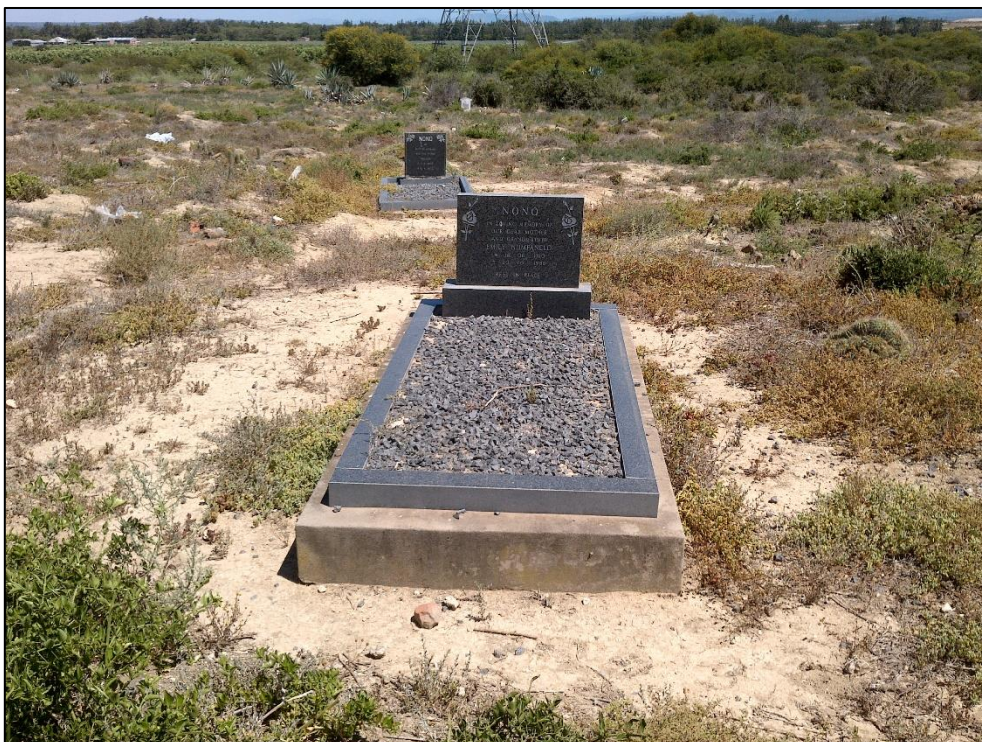
**Figure 29. View of the more formerly established graves.**

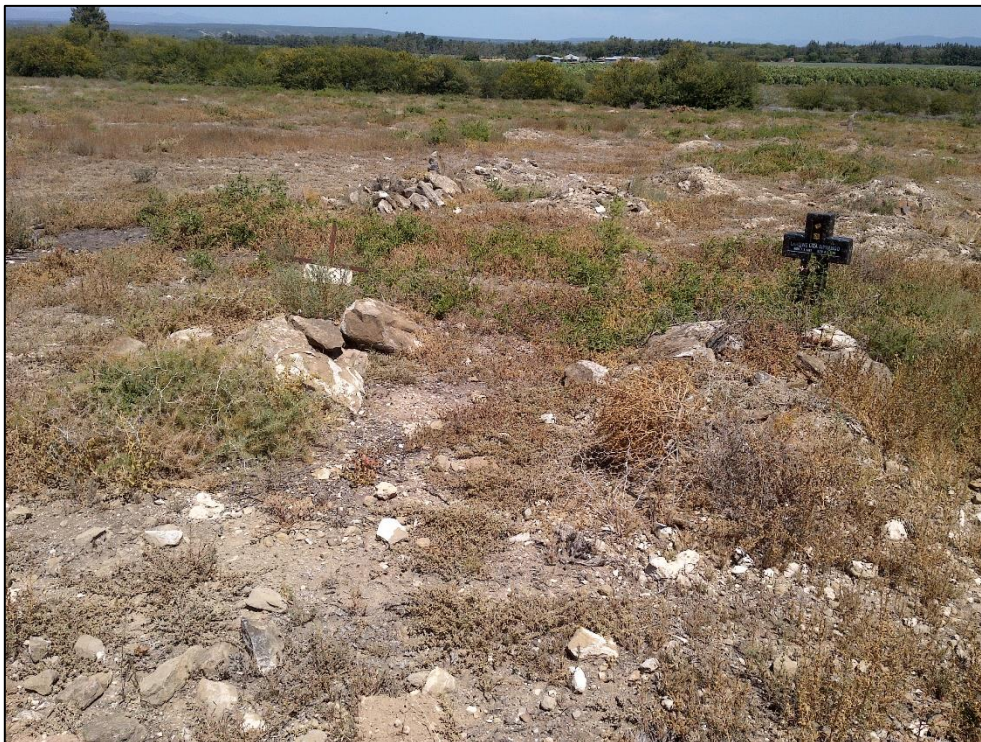
Figure 30. View of the stone packed graves.

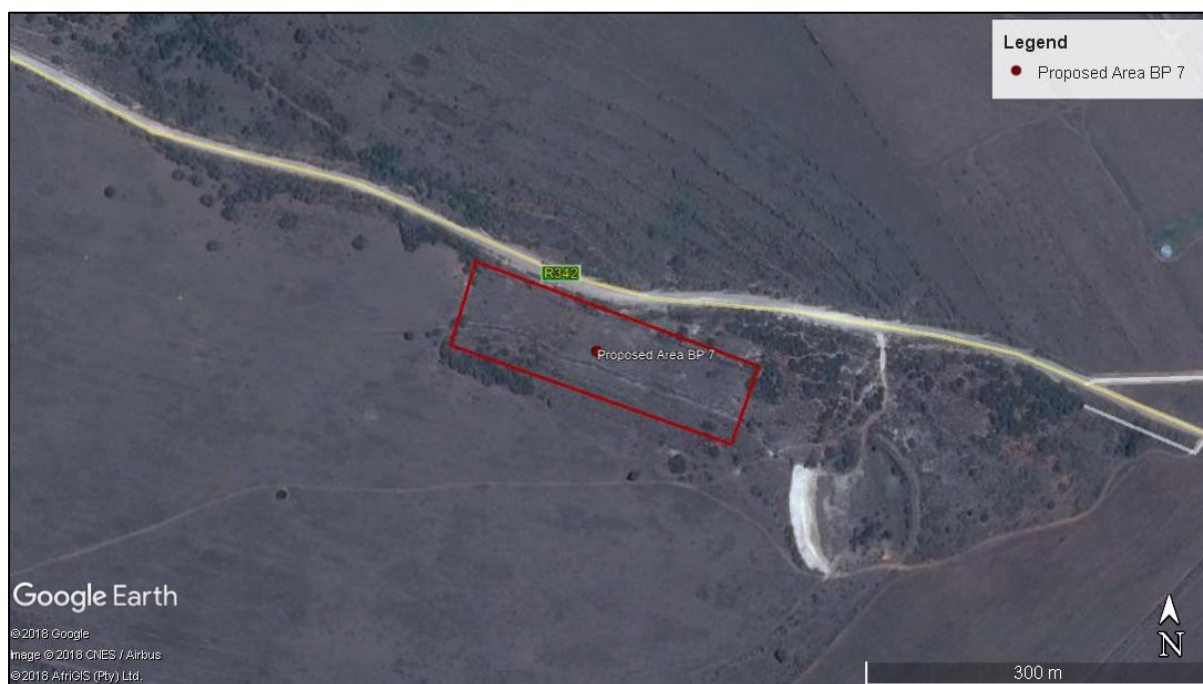
Figure 31. Aerial view showing the boundary of Borrow Pit 7 (BP7).

Borrow Pit 7 (BP 7) (Figure 31) is located on the southern side of the R342 on Farm Goedgemoed situated between the town of Paterson to the west and Shamwari Private Game Reserve to the east (Figures 33-35). The area is mostly rural and is dominated by agricultural, dairy and private game reserve activities. Several stone artefact scatters were identified within the proposed borrow pit (Figures 36-41). These occurred mostly from the centre to the north of the area. Isolated scatters were indented along the southern boundary area. The artefacts included some Later Stone Age and Middle Stone Age artefacts manufactured on a quartzite raw material. The artefacts were made up mostly of flakes, chunks and cores, no formal tools were observed.

It is unlikely that the stone artefact surface scatters that occur on the exposed surface areas are positioned *in situ*; however, stone artefacts may occur between 50 – 80 cm below the surface. The area is considered as having a low archaeological significance, although the recommendations must be noted for mitigation in the case where concentrations of stone artefacts and associated material and human remains may be uncovered during the mining activities.

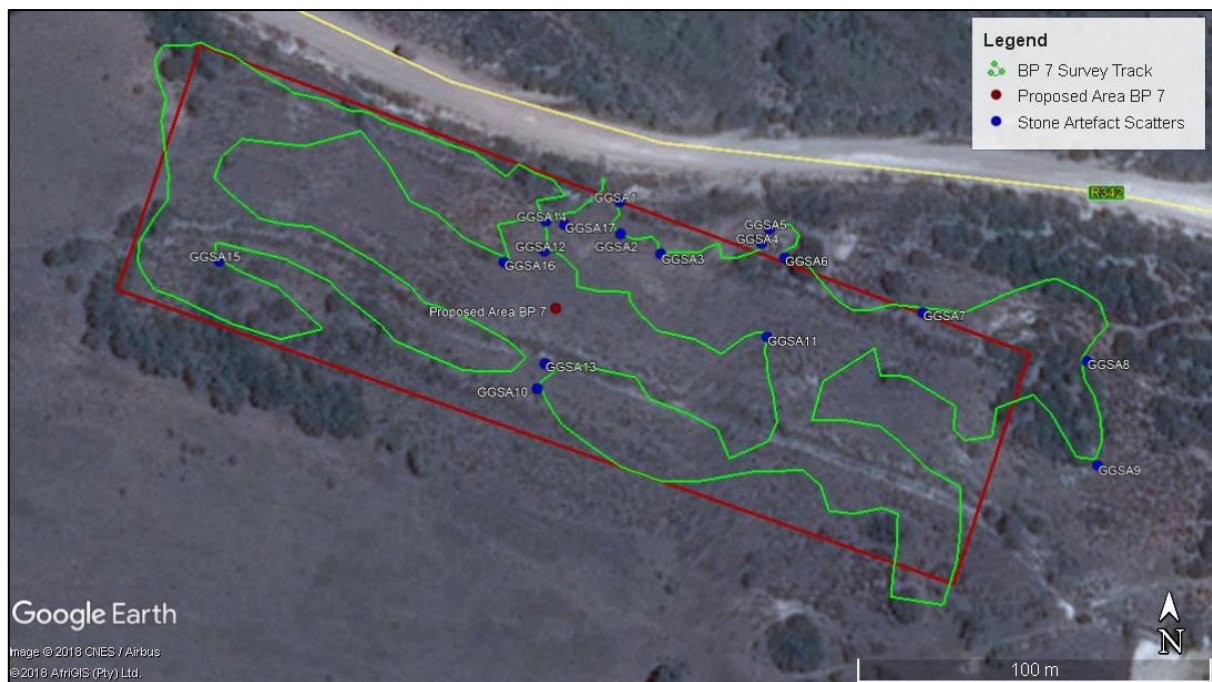
**Figure 32. Aerial view of the boundary of Borrow Pit 7 (BP7) showing the survey tracks and stone artefact scatters documented within the area.**

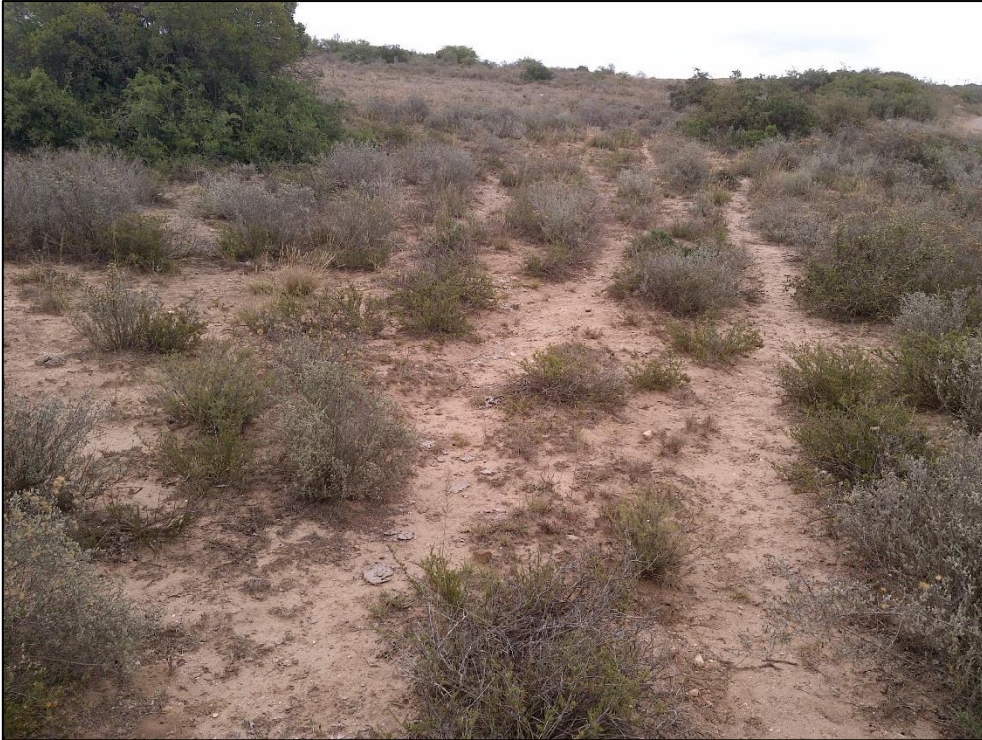
**Figure 35. View of the exposed surface areas along the northern boundary where a large portion of stone artefacts were observed.**

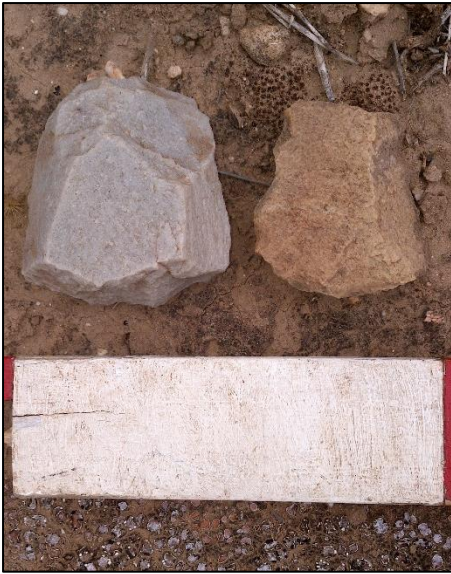
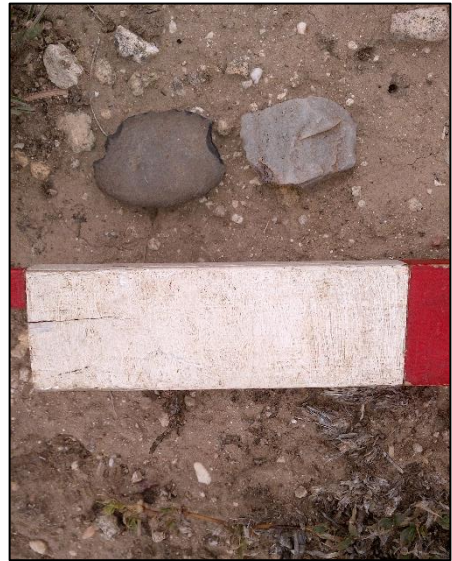
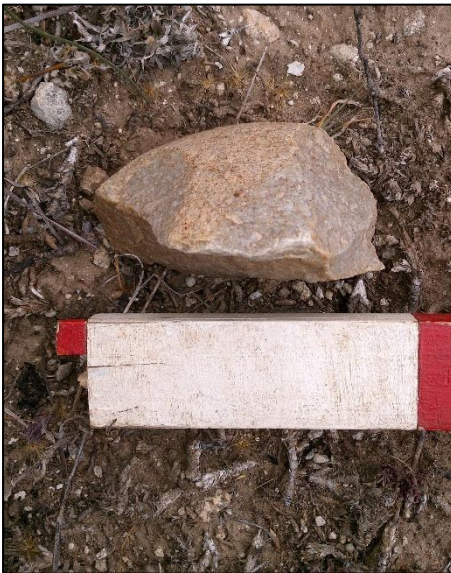
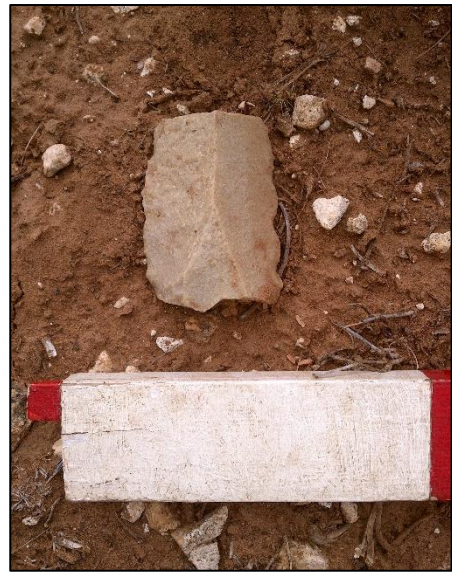
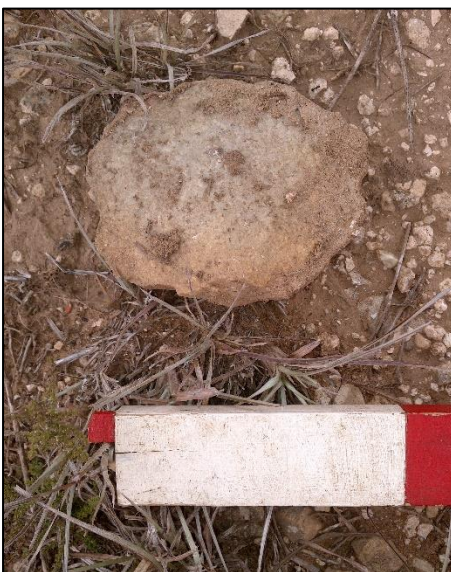
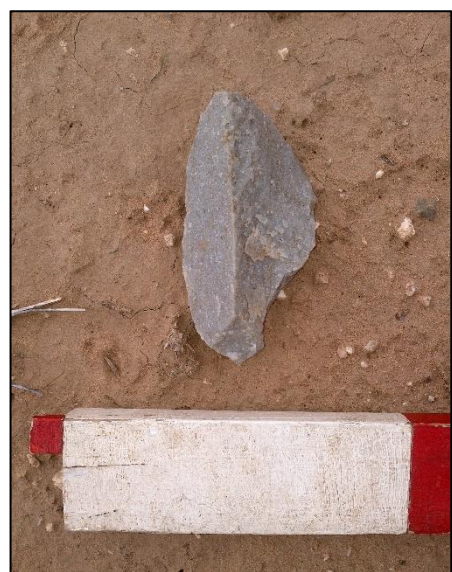
**Figures 36-41. Examples of stone artefacts identified within the proposed Borrow Pit (BP7) area.**

Several stone artefact scatters were identified within the proposed borrow pit. These occurred mostly from the centre to the north of the area. Isolated scatters were identified along the southern boundary area. The artefacts included some Later Stone Age and Middle Stone Age artefacts manufactured on a quartzite raw material. The artefacts were made up mostly of flakes, chunks and cores, no formal tools were observed.

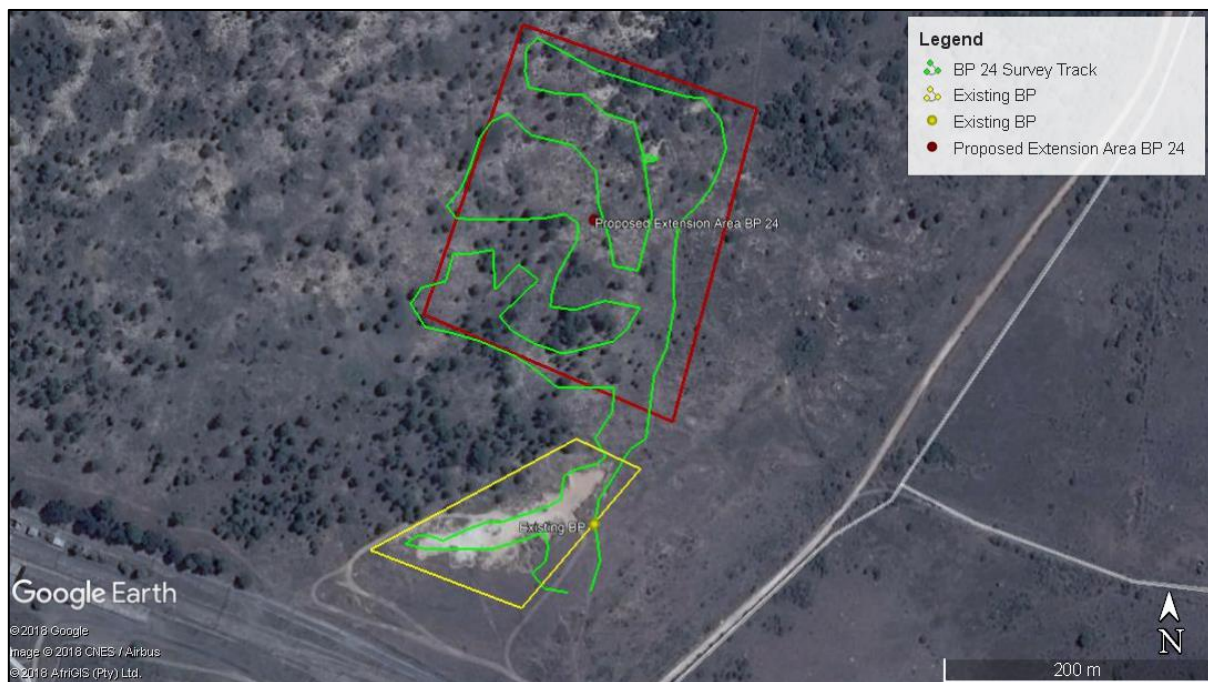
**Figure 42. Aerial view of the boundary of Borrow Pit 24 (BP24) and the existing borrow pit situated to the south of BP24 showing the survey tracks.**

Borrow Pit 24 (BP 24) (Figure 42) is located north on the Farm De Bruyn's Kraal 113 (Dufisani Land Trust Property) just north of the town of Paterson. The area is largely made up of vegetated and semi-vegetated Holocene river sand dunes and pine trees (Figures 43-46).

No archaeological heritage remains, features, or sites were observed within the proposed borrow pit area, however, stone artefacts may occur between 50 – 80 cm below the surface. The area is considered as having a low archaeological significance, although the recommendations must be noted for mitigation in the case where concentrations of stone artefacts and associated material and human remains may be uncovered during the mining activities.

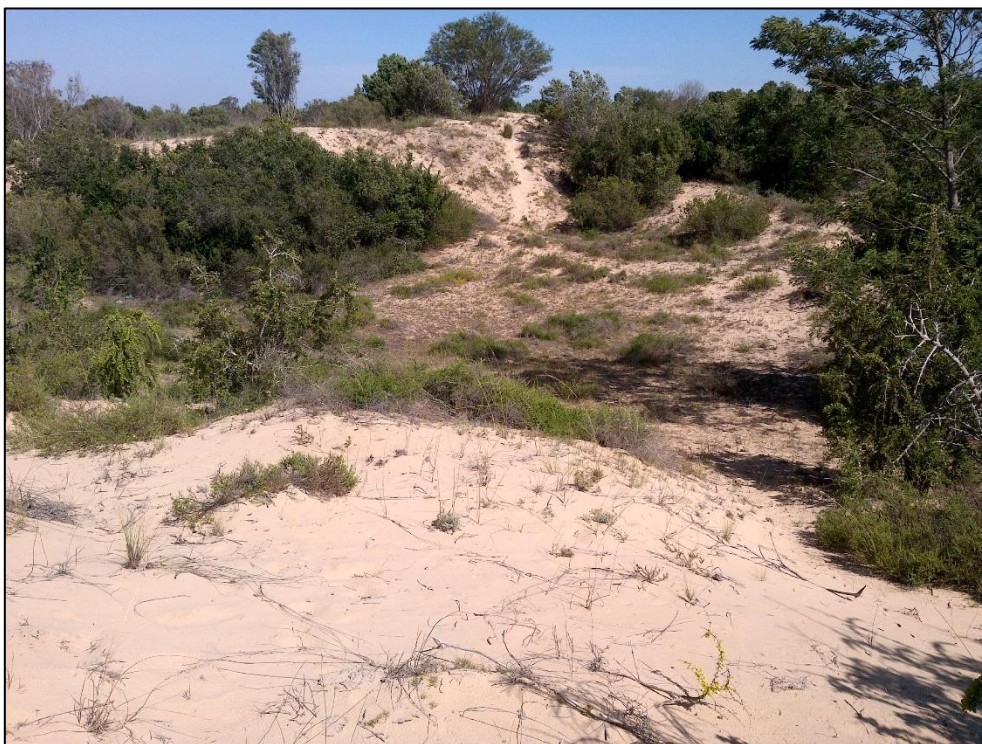
**Figure 46. Exposed surface areas allowed for the investigation of archaeological remains.**

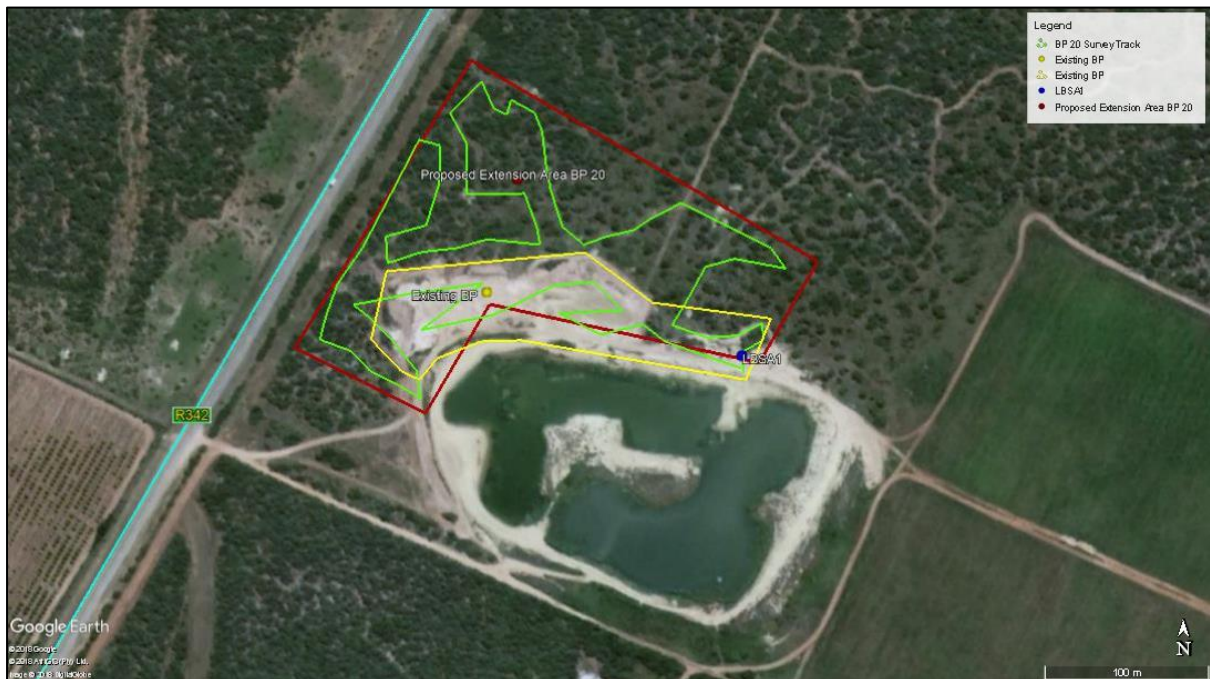
**Figure 47. Aerial view of the boundary of Borrow Pit 20 (BP20) showing the survey tracks and stone artefact scatter documented within the area.**

No archaeological heritage remains, features, or sites were observed within the proposed borrow pit area, however, stone artefacts may occur between 50 – 80 cm below the surface. The area is considered as having a low archaeological significance, although the recommendations must be noted for mitigation in the case where concentrations of stone artefacts and associated material and human remains may be uncovered during the mining activities.

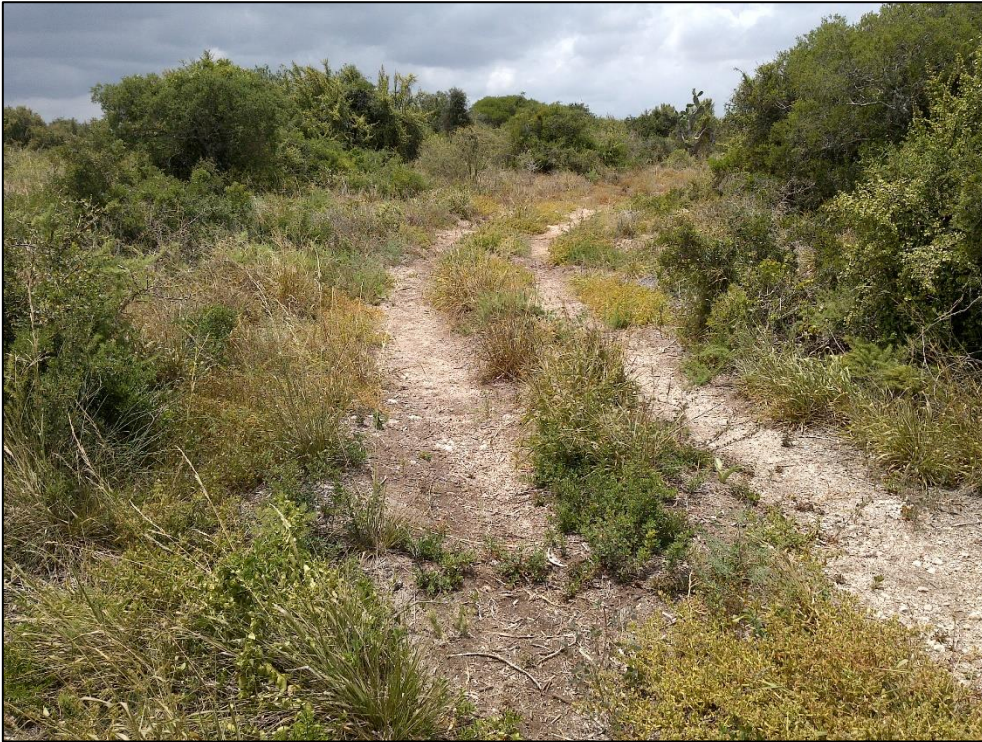
The proposed area was densely vegetated that limited archaeological visibility (Figures 48-50). Some test pits had been dug to assess the quality of the material to mined, these areas were investigated for possible exposure of archaeological resources, however, none were observed.

**Figure 50. Example of a surface exposed area that allowed for archaeological investigation.**

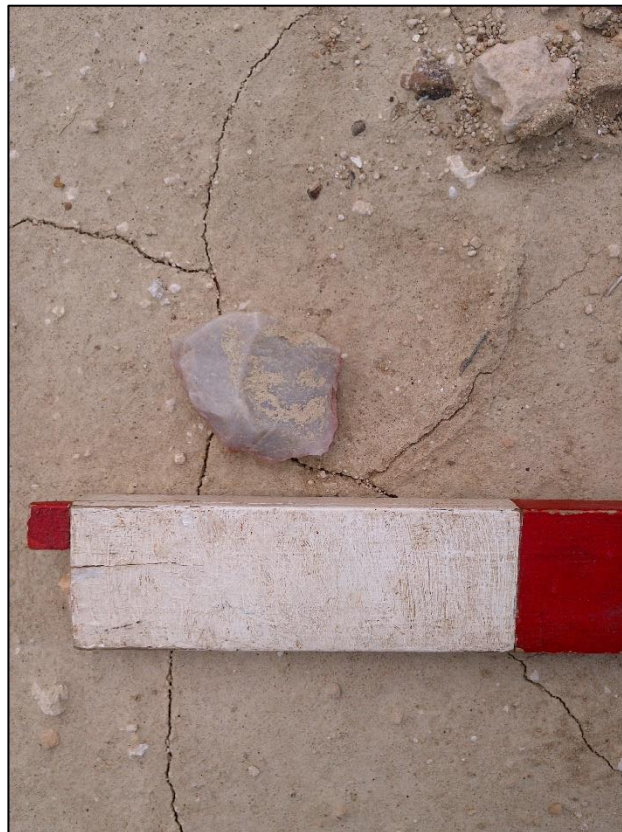
**Figure 51. Example of the stone artefact identified on the boundary of the existing borrow pit area.**

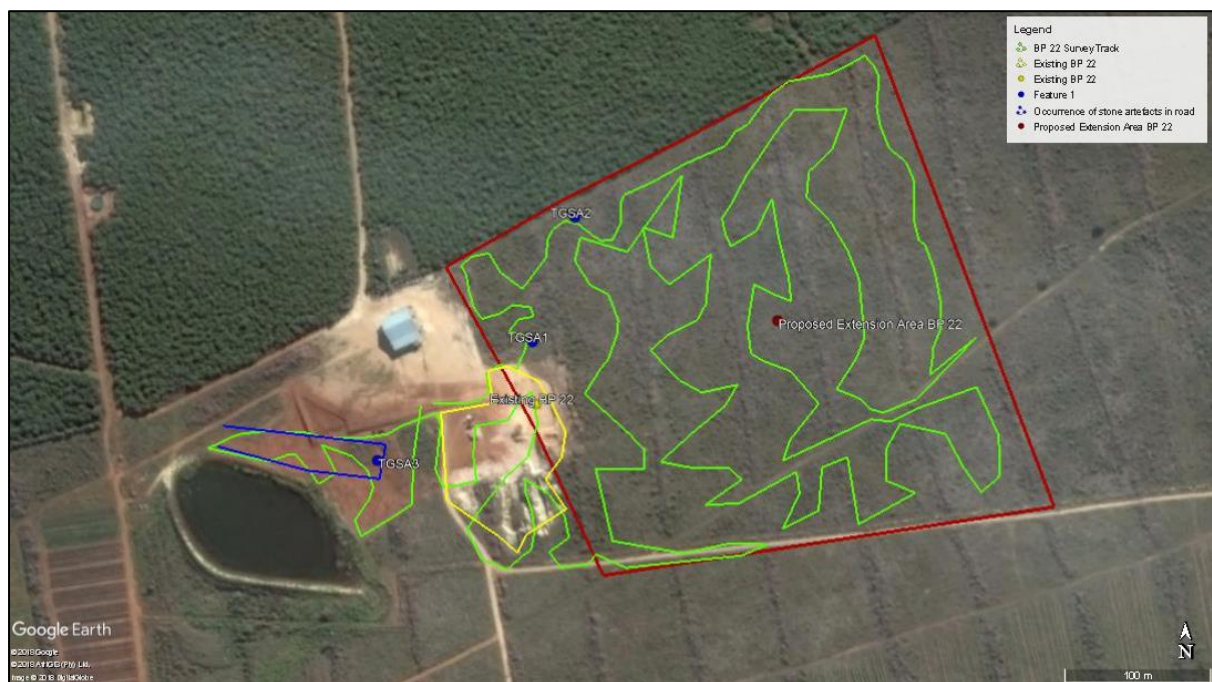
**Figure 52. Aerial view of the boundary of Borrow Pit 22 (BP22) showing the existing borrow pit area, survey tracks and stone artefact scatters documented within the area.**

Borrow Pit 22 (BP 22) (Figure 52) is located on the Farm Tregaron 2, 3 km south east of the village of Enon at the foot of the Suurberg Mountains. The area is mostly rural and is dominated by citrus and other agricultural activities. Two Middle Stone Age stone artefacts (flakes) manufactured on a quartzite raw material was identified in the north-western boundary corner of the proposed borrow pit. Stone artefacts were more easily observed along the gravel access road to the proposed borrow pit area (Figures 58-59).

The area is considered as having a low archaeological significance, although the recommendations must be noted for mitigation in the case where concentrations of stone artefacts and associated material and human remains may be uncovered during the mining activities.

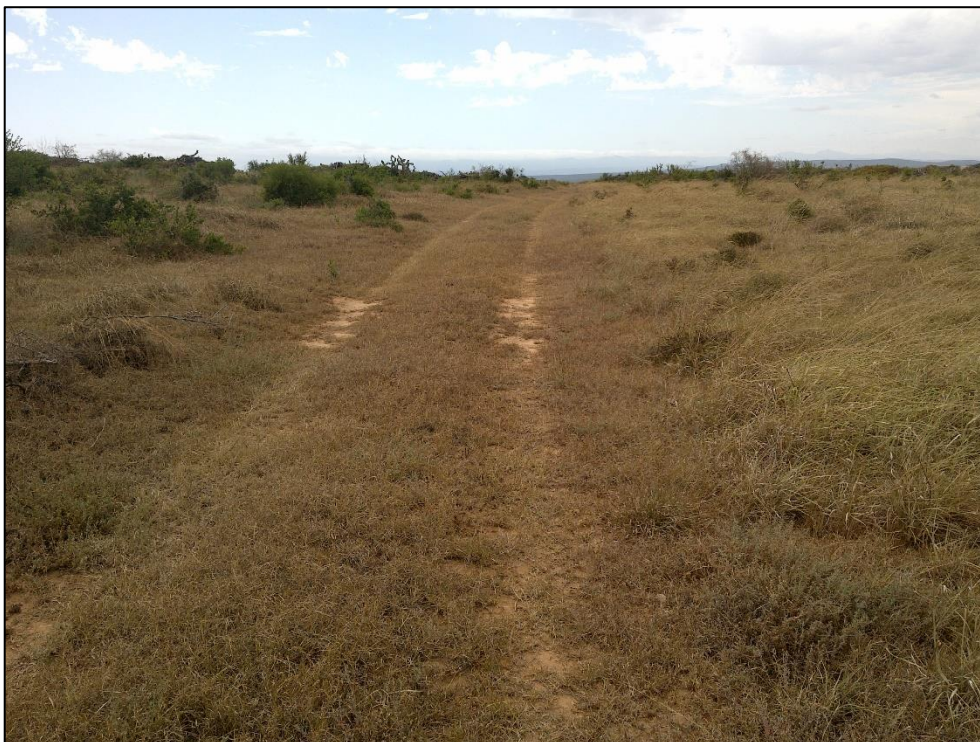
**Figure 57. View of the surface exposed internal gravel road that allowed for archaeological investigation.**

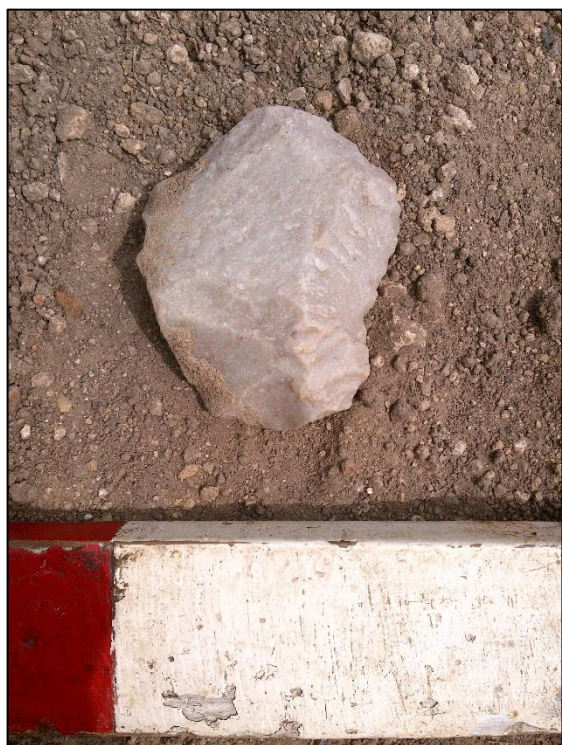
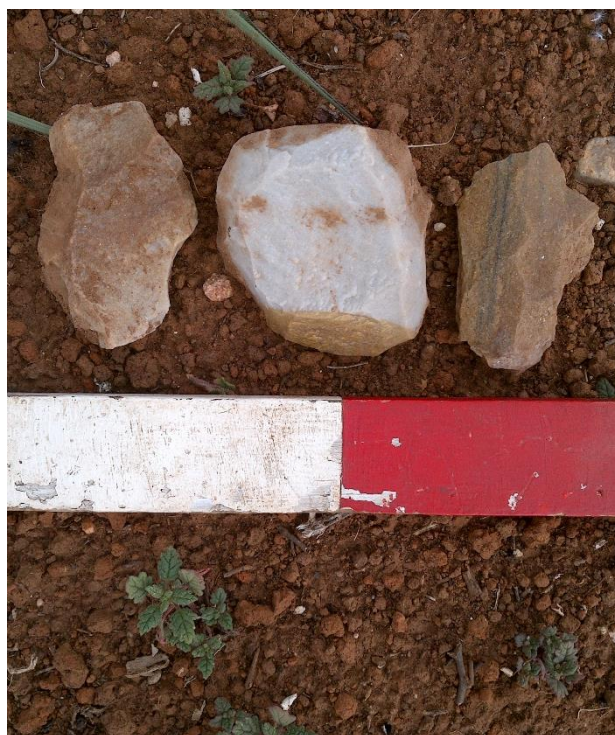
**Figures 58-59. Examples of stone artefacts identified within the proposed Borrow Pit 22 (BP22) area.**

Two Middle Stone Age stone artefacts (flakes) manufactured on a quartzite raw material was identified in the north-western boundary corner of the proposed borrow pit. Stone artefacts were more easily observed along the gravel access road to the proposed borrow pit area.
