**A PHASE 1 ARCHAEOLOGICAL IMPACT ASSESSMENT (AIA) FOR THE PROPOSED UPGRADE AND MAINTENANCE OF NATIONAL ROADS R335 & R342 BETWEEN ADDO AND PATERSON, SARAH BAARTMAN DISTRICT MUNICIPALITY, EASTERN CAPE PROVINCE.**

**Date:** February 2018

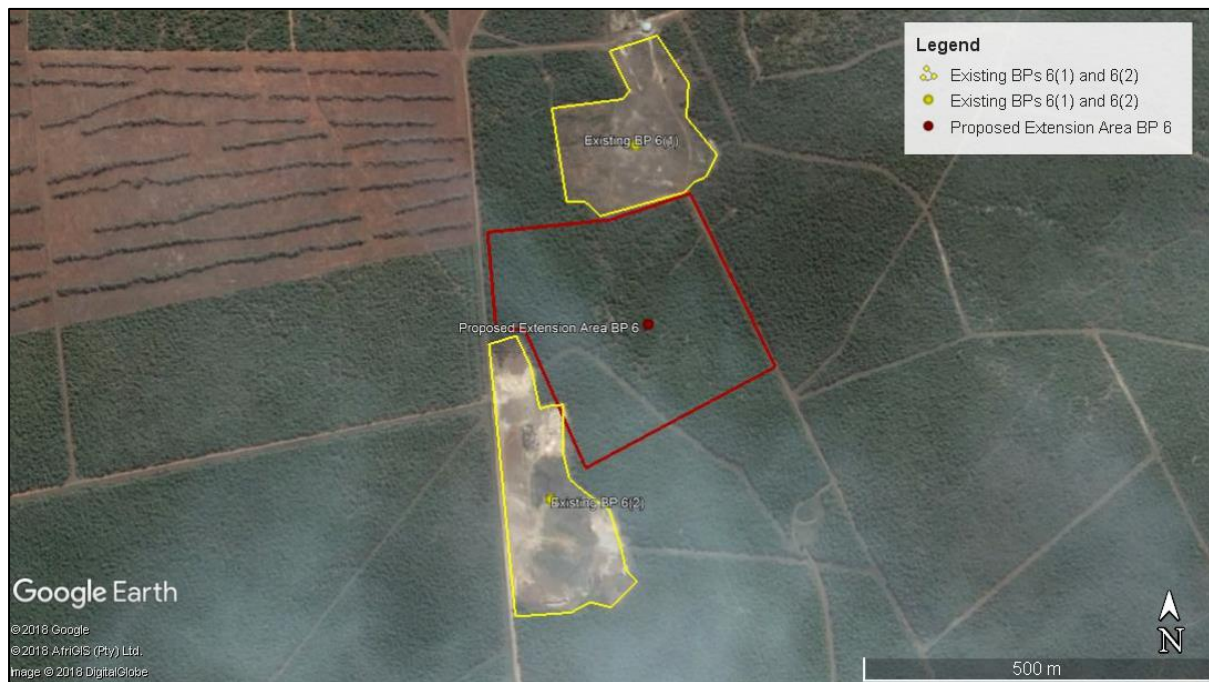
**Figure 60. Aerial view showing the boundary of Borrow Pit 6 (BP6) and existing borrow pits to the north and south of the proposed area.**

No archaeological heritage remains, features, or sites were observed within the proposed borrow pit area, however, stone artefacts may occur between 50 – 80 cm below the surface. However, taking into consideration the archaeological findings in Booth (2017), as mentioned in the previous section, it is possible that archaeological remains will be uncovered during the bush clearing and excavation.

The area is considered as having a low archaeological significance, although the recommendations must be noted for mitigation in the case where concentrations of stone artefacts and associated material and human remains may be uncovered during the mining activities.

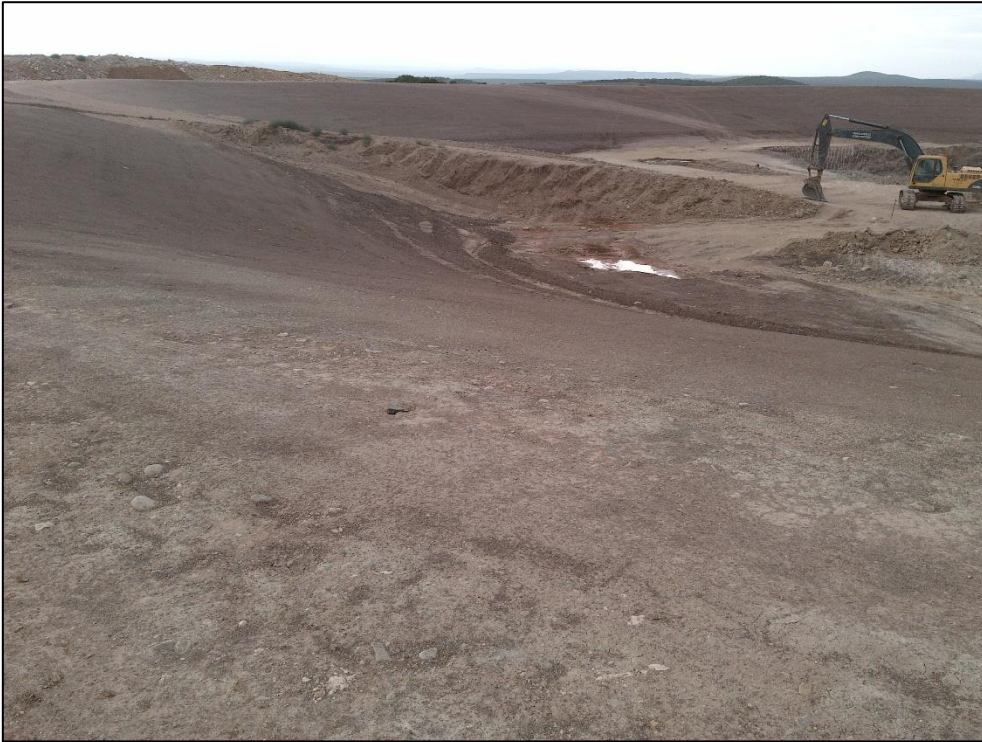
**Figure 61. View of the existing borrow pit / mining activity (Existing BP6 [1], Fig 60) situated north of the proposed Borrow Pit 6 (BP6) area.**

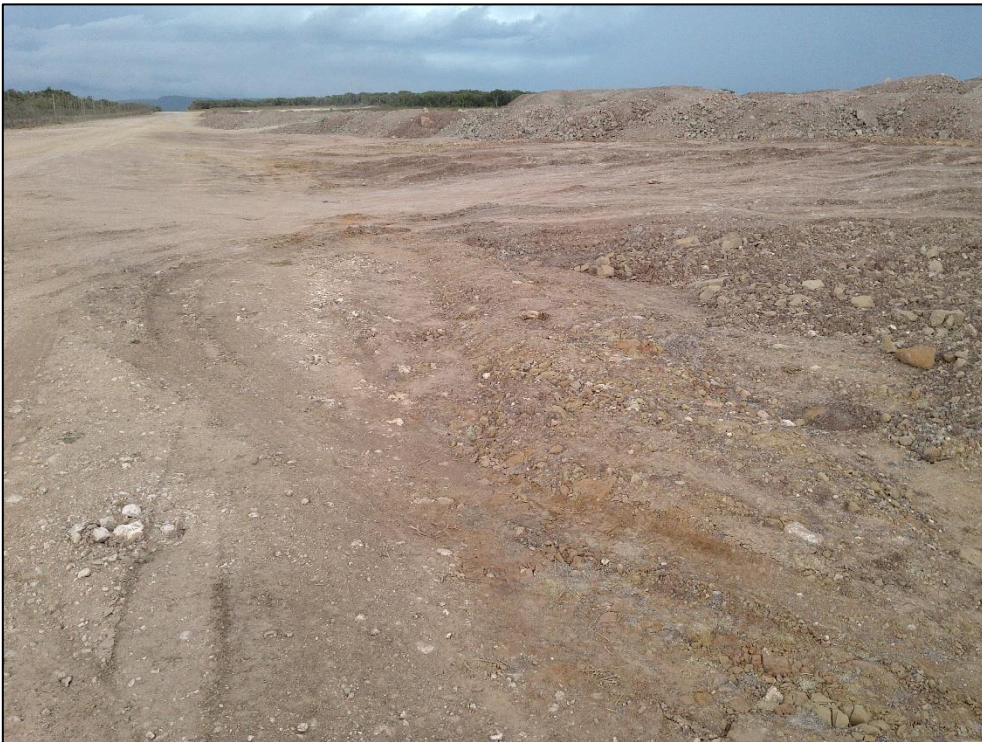
**Figure 62. View of the existing borrow pit / mining activity (Existing BP6 [2], Fig 60) situated south of the proposed Borrow Pit 6 (BP6) area.**

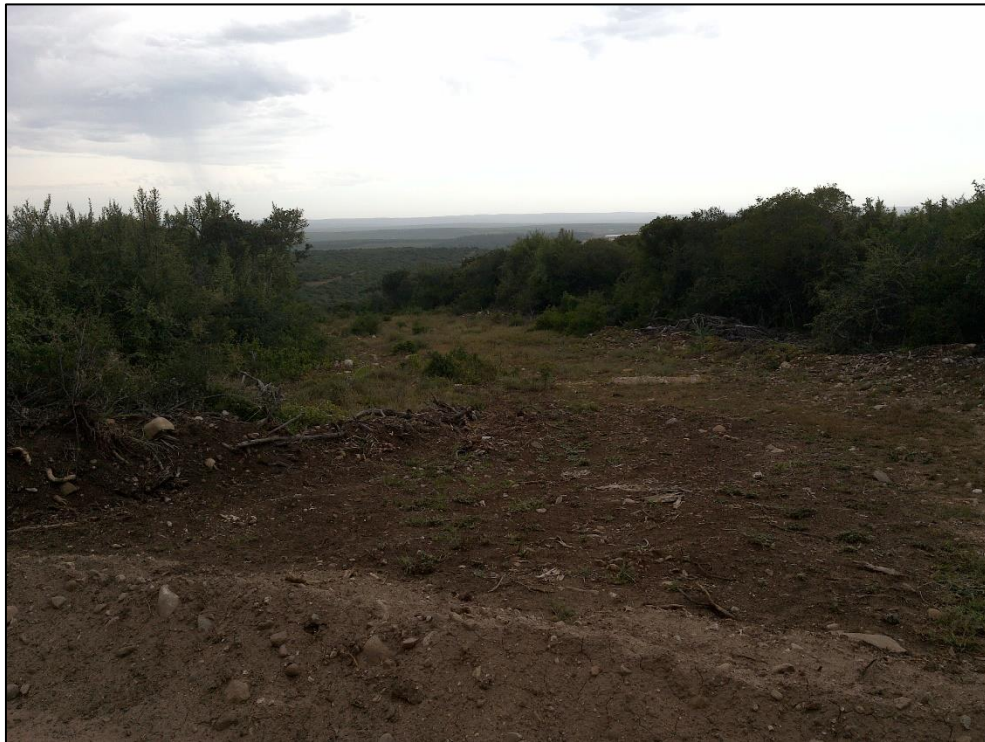
Borrow Pit 6 (BP 6) (Figure 60) is located on the Farm Swanepoelshoek 104, situated about 6 km from BP 22 and 10.5 km south-east of the village of Enon at the foot of the Suurberg Mountains. The area is rural and is dominated by citrus and other agricultural activities. The proposed area is surrounded by existing mining activities immediately to the north and south (Figures 61-62). The area is covered in dense Sundays Valley Thicket vegetation, however, the internal gravel roads and some bush clearing allowed for archaeological investigation (Figures 63-64).

**Figure 64. View of the general landscape showing the densely vegetated Sundays River Valley Thicket and areas of bush clearing that allowed for archaeological investigation.**
