**ARCHAEOLOGICAL IMPACT ASSESSMENT
OF A PROPOSED BORROW PIT ON OUDEKRAAL
AND THE PROPOSED EXTENSION OF A BORROW PIT ON
MELKHOUTRIVIER 492, OVERBERG DISTRICT,
WESTERN CAPE**

(Assessment conducted under Section 38 (8) of the National Heritage Resources Act as part
of a Heritage Impact Assessment)

JUNE 2012

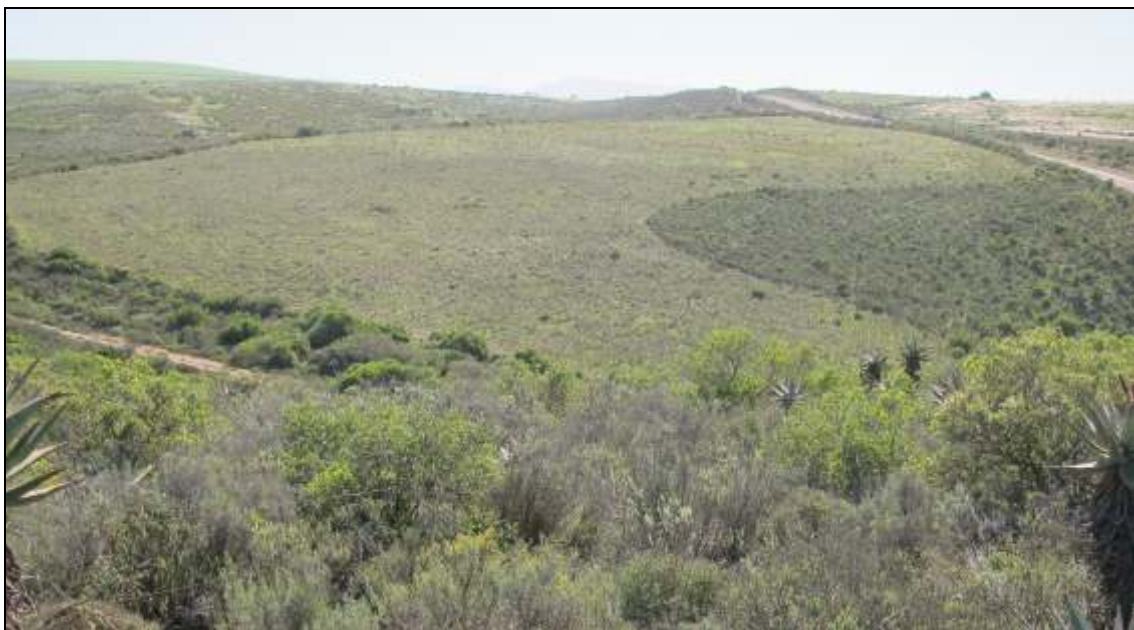
Figure 3: Pit 74 – view towards the north taken from a hill to the south of the affected area. The MR268 and road cutting with alluvial gravel-capped pediment are visible in the top right corner.

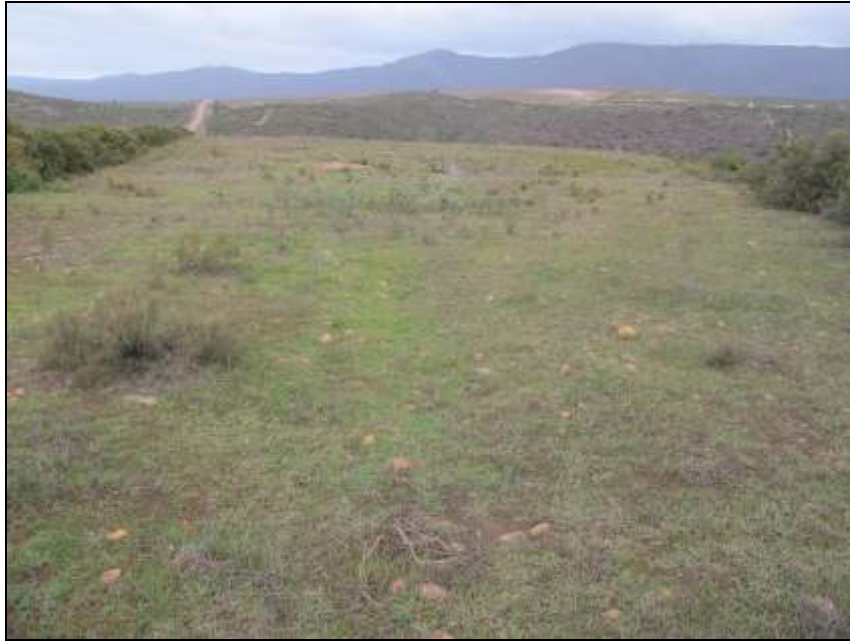
Figure 4: Pit 74 – view towards the south showing the ploughed Tertiary alluvial gravels.

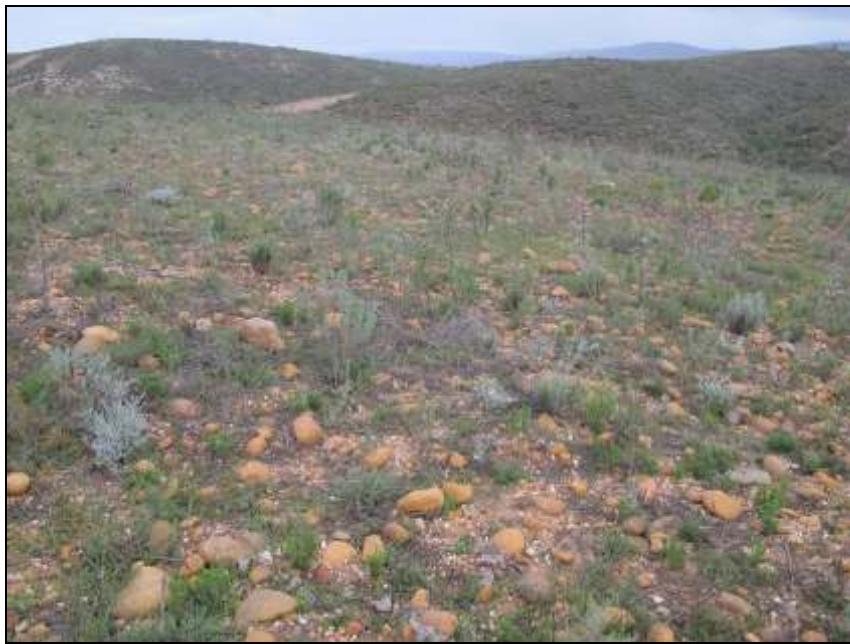
Figure 5: Pit 74 – detail of one of the areas with a denser concentration of quartzite cobbles and blocks, with occasional quartz chunks. View towards the south-east.

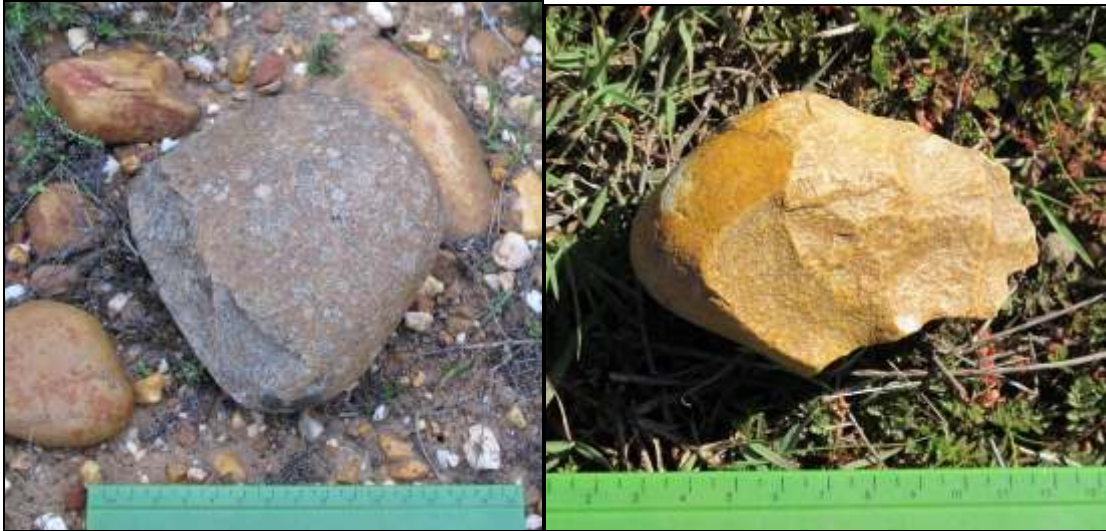
Results of the survey: Although there was a fairly dense scatter of quartzite cobbles across most of the affected area, very few flaked cobbles and artefacts were observed (see Table 1 of the Appendix and Figures 6 to 8). Early Stone Age (ESA) affiliation seems most likely for some of these artefacts.

Figures 6 and 7: Pit 74 – flaked quartzite cobble; bifacially flaked quartzite piece, probably ESA. The scale is in cm.

Only a few quartzite artefacts were found amongst the cobbles of the ploughed Tertiary alluvial gravels of proposed Pit 74. This was perhaps surprising given the availability of suitable raw material in the area and would thus indicate a generally low density of archaeological material in the immediate area. At the proposed Pit 75 extension only three artefacts were observed in a disturbed context. The sparse material at both sites was in a secondary context and are therefore of low archaeological heritage significance. No significant impact on such resources is expected if the proposed pit and extension of the existing borrow pit are developed. No further archaeological studies or mitigation are recommended.

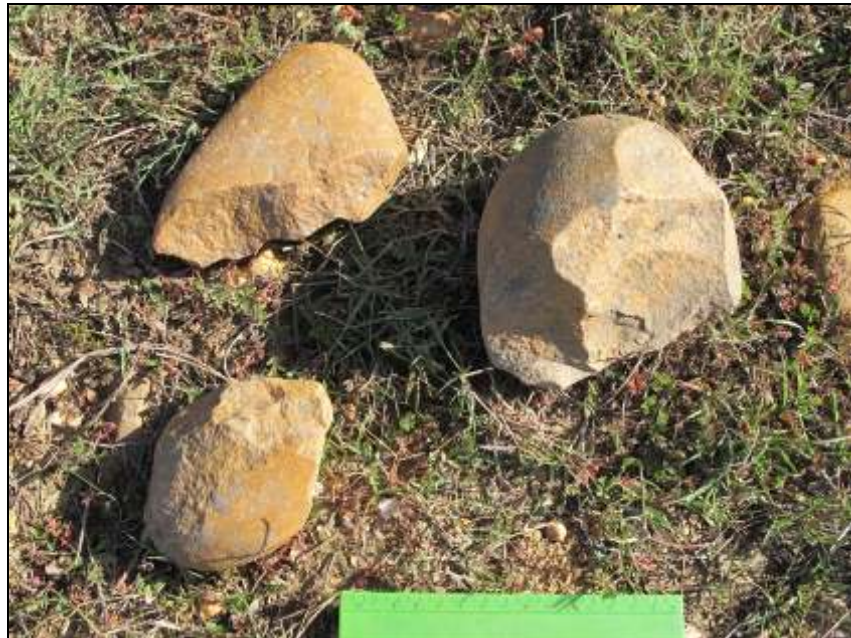
Figure 8: Pit 74 – quartzite core with other flaked cobbles. The ruler is about 15 cm in length.

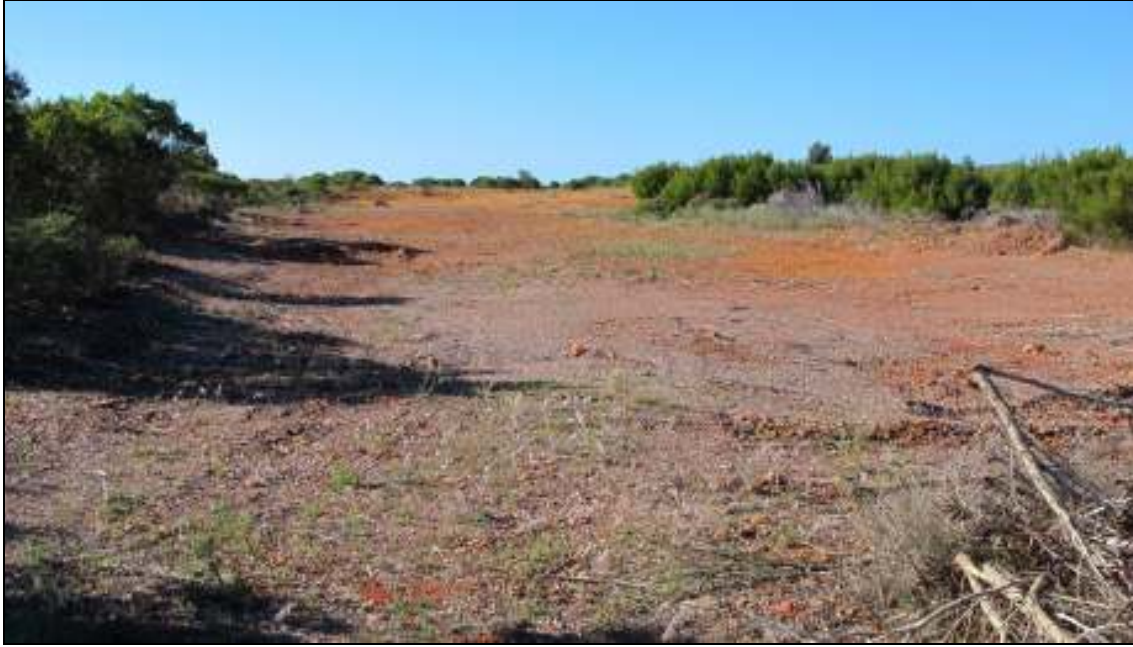
Environment: Pit 75 is the proposed extension to an existing, un-authorised borrow pit which is orientated in an east-west direction on relatively flat-lying terrain which slopes very gently to the west (Figures 9 and 10). The area to the south and west of the existing pit has clearly been disturbed by ploughing in the past and has since been re-vegetated by grass and invasive rooikrans (*Acacia cyclops*) shrubs (Figure 11). The areas to the north and east of the existing quarry have dense coastal fynbos vegetation which was difficult to walk through (Figures 14 and 15) and archaeological visibility on the ground was poor. Where grass and invasive shrubs were present, the surface of ferricrete gravels was clearly visible (Figure 12). The gravels, of alluvial and colluvial terrace origin, consist of sub-rounded to sub-angular clasts of Table Mountain sandstone and quartzite, as well as silcrete and vein quartz. The sandstone has been heavily impregnated with iron and manganese. Excavated holes and heaps of gravel have been left on the northern side of the existing pit (Figure 13). There are no boundary fences delimiting the proposed extension. Access for the extension will be through an existing gate and farm track.

Figure 10: View towards the east across the existing Pit 75. The area to the right of the pit, i.e. to the south, is covered by grass and *Acacia cyclops* shrubs whereas the area to the left (the north) and the east of the excavation is covered by dense coastal fynbos vegetation. The ferricrete gravels are evident.

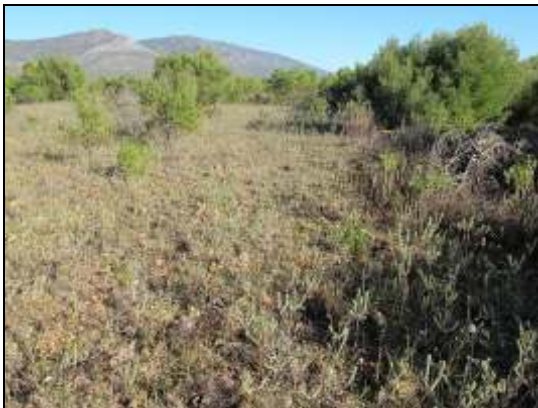
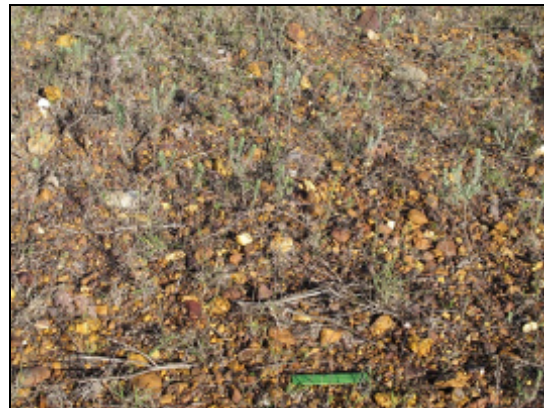
Figures 11 and 12: Pit 75 – looking towards the west in the southern area with its covering of grass and *Acacia cyclops*; detail of the ferricrete gravels. The ruler is about 15 cm in length.

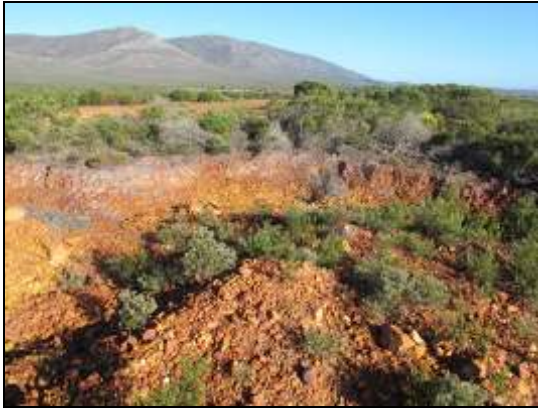
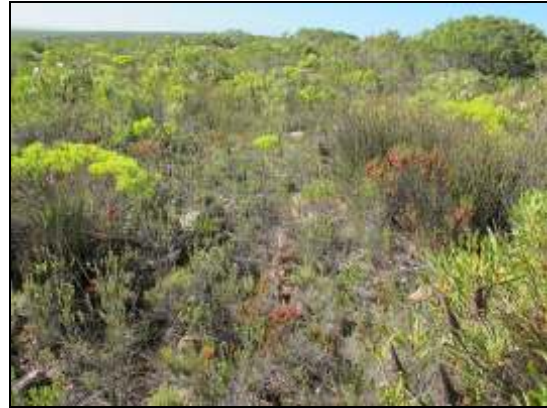
Figures 13 and 14: Pit 75 – view towards the west of the excavated holes and heaps of gravel in the northern part; view towards the east of the dense coastal fynbos.

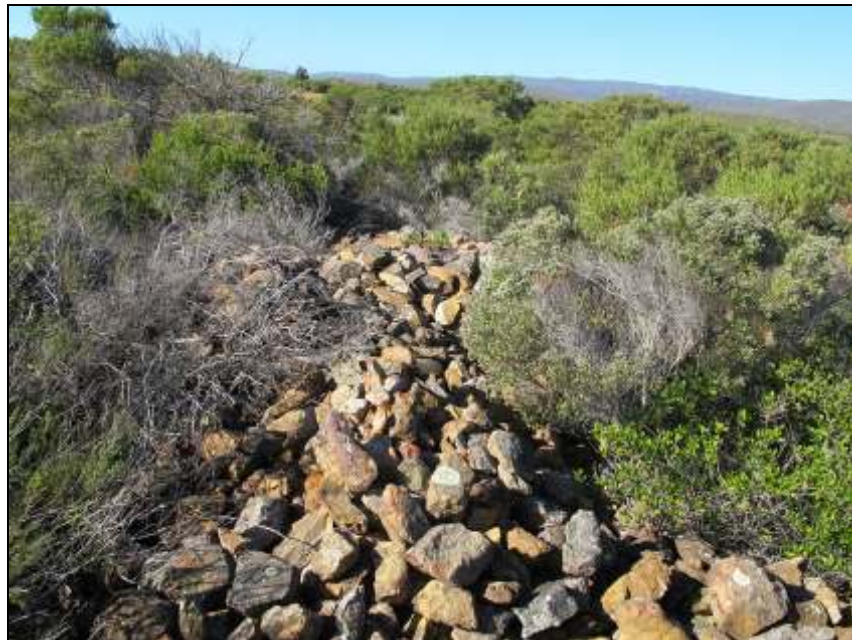
Results of the survey: During the survey, heaps of sandstone and quartzite blocks were observed amongst the fynbos bushes and shrubs in the northern part of the affected area (Figure 15). The blocks had obviously been removed from the disturbed area prior to ploughing in the past. The heaps were examined but no flaked blocks or artefacts were observed. The only artefacts found were an isolated quartzite core, chunk and flaked piece of indeterminate age which were found in the disturbed southern area (see Table 2 of the Appendix and Figures 16 to 18). Nothing was observed on the ground in the northern or eastern parts surveyed and it is not expected that the distribution of archaeological material would be any denser in the area not covered in the easternmost part of the site.

Figure 15: Pit 75 – one of the heaps of quartzite and sandstone blocks observed amongst coastal fynbos shrubs in the northern part of the affected area.

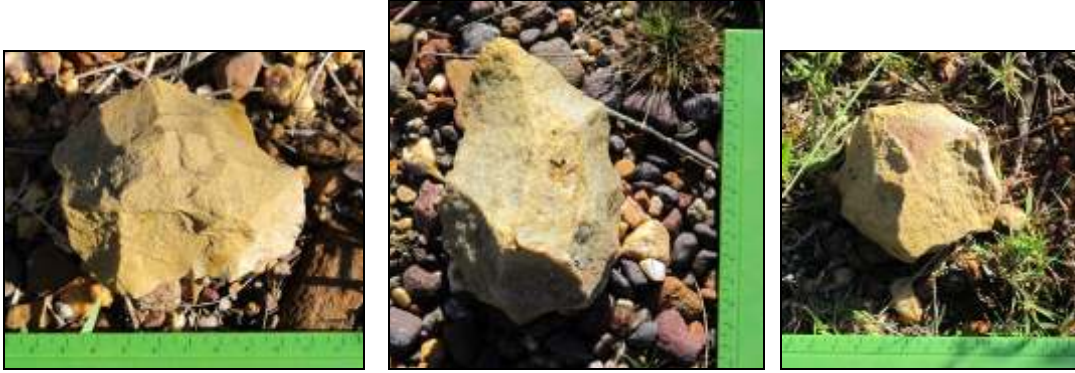
Figures 16 to 18: Pit 75 – the quartzite artefacts observed. The scale is in cm.
