HERITAGE IMPACT ASSESSMENT

submitted in terms of section 38(8) of the National Heritage Resources Act

27 June 2012

MR 00268 Malgas, Swellendam
Malgas, Swellendam - Overberg District Municipality, Western Cape

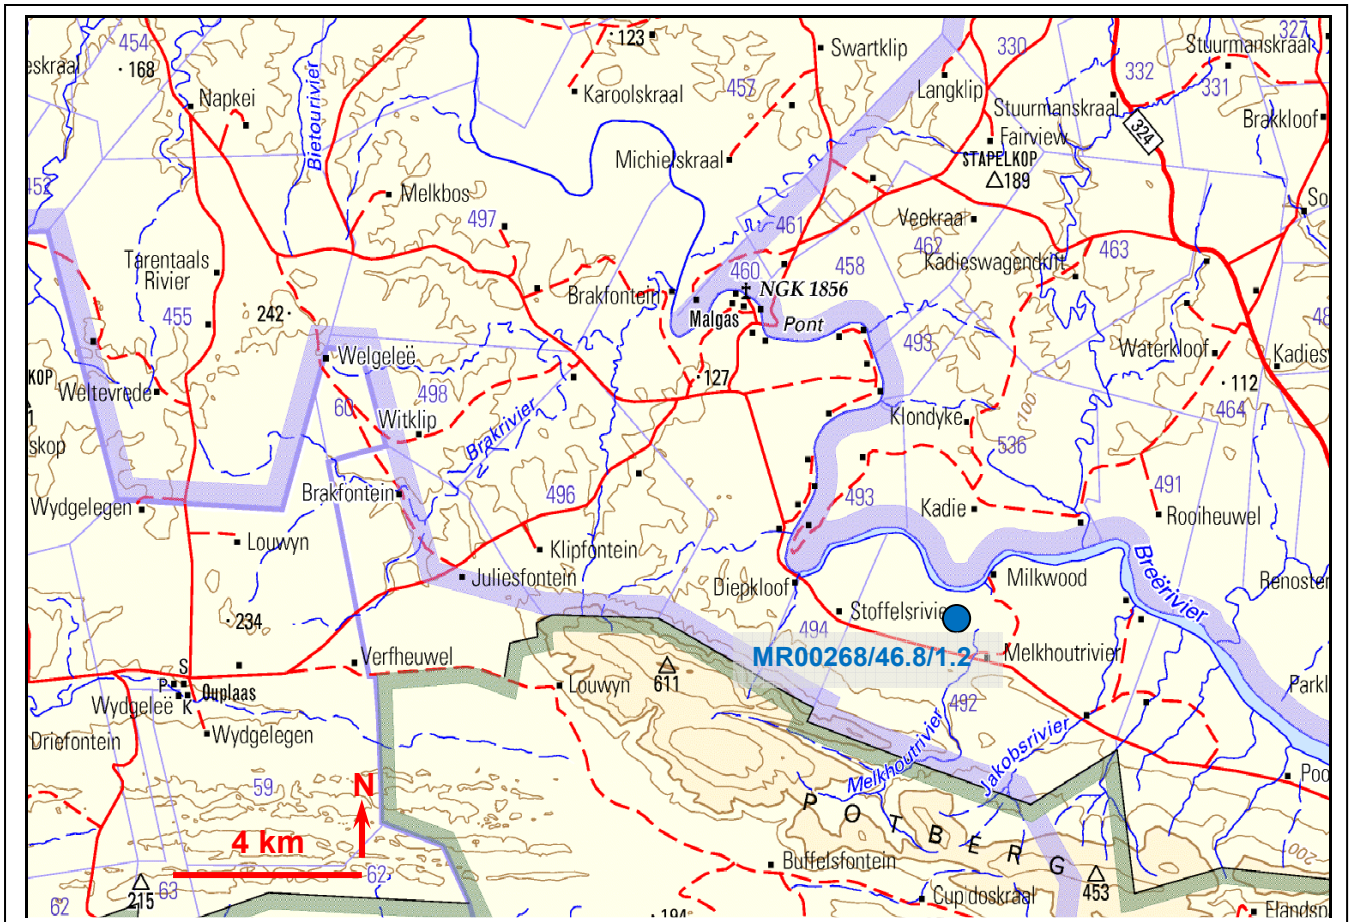
Figure 1: Extract from topographical sheet 3429 Riversdale (extracted Almond 2012: 2)

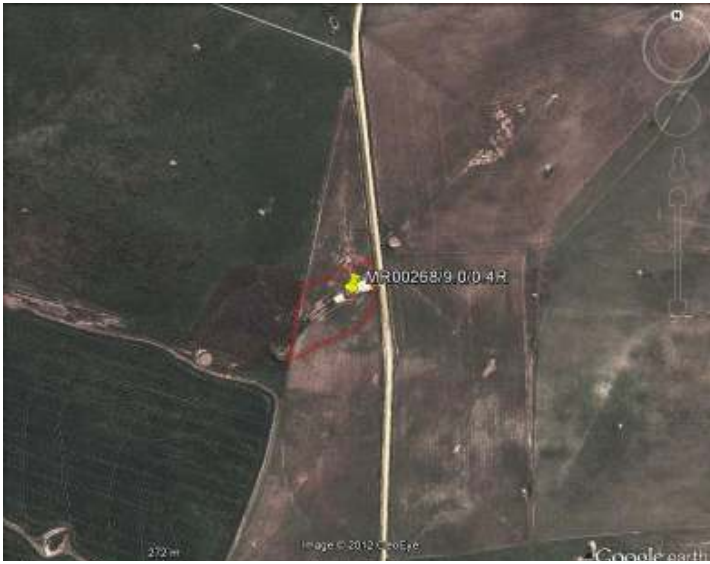
Figure 2: Aerial view of existing borrow pit location and expropriation area (Google earth image, June 2012)

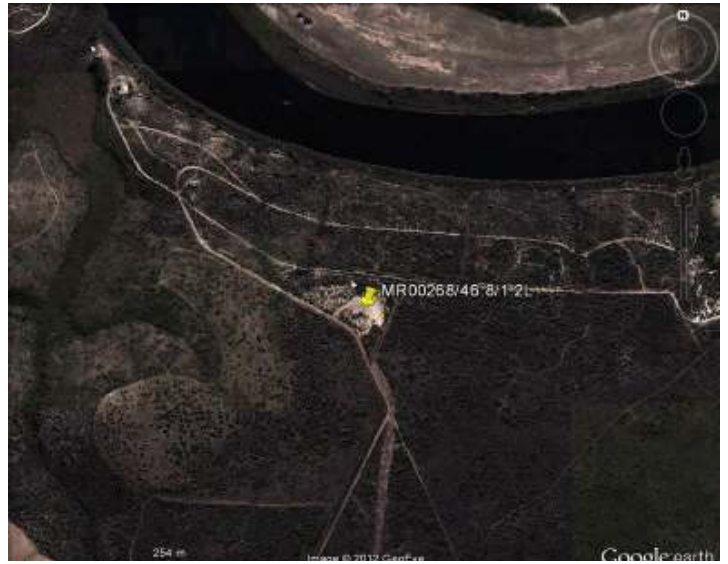
Figure 3: Aerial view of existing borrow pit location (Google earth image, June 2012)

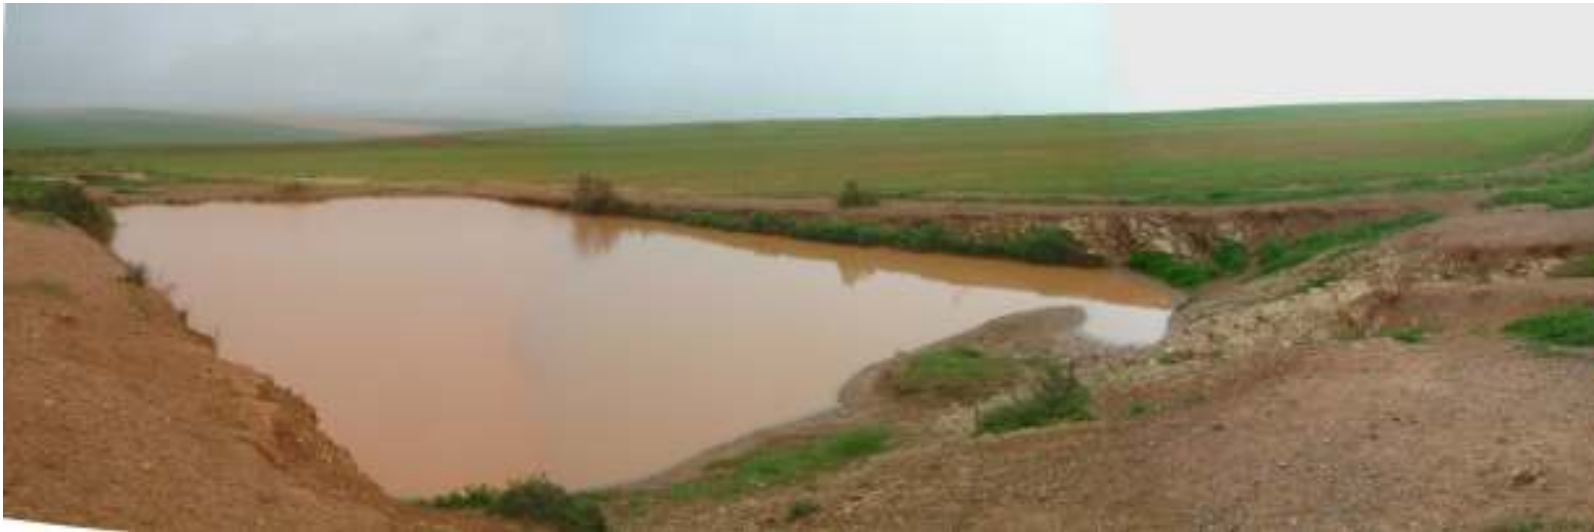
Figure 4: At km 9.0 (8.6) view of easternmost, water-filled, existing pit and surrounds (June 2011)

At **km 9.0** (8.6) the proposed extensions to two small existing borrow pits is located on a low angle, westward-facing hillslope leading to a tributary ephemeral water course that eventually drains into the Breede River. Vegetation is characterised by disturbed coastal fynbos heavily infested with Rooikrans and other aliens and rough grazing occurs in the general context.

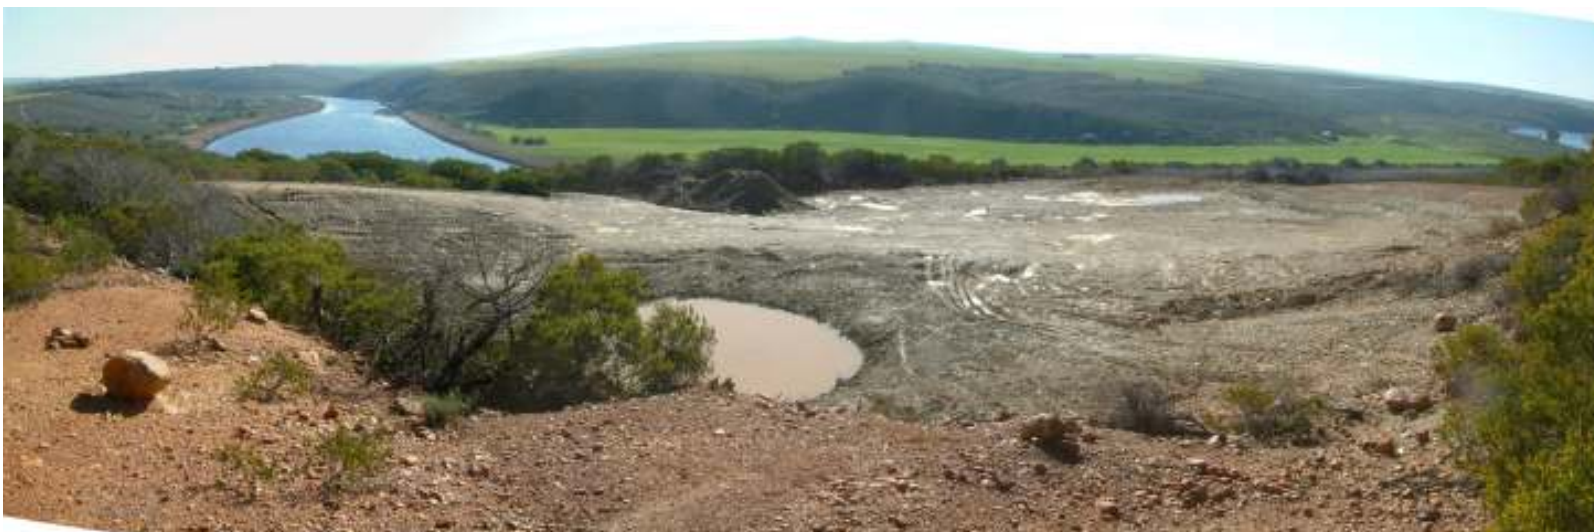
Figure 5: Panoramic view of the existing pit at MR00268/46.8 taken from approach track, with the Breede River in the background sampled stockpile of ripped shale gravel in centre far-foreground (June 2011)

It is proposed to expand two existing borrow pits at km 46.87 and 9.0 along MR 00268. At **km 46.8** the borrow pit extension is located just below the crest of a eastward-sloping valley-side and modern floodplain of the nearby Breede River some 30 m lower in elevation and about 300m distant. The site lies between any defined or even undefined/ephemeral tributary water course.
