HERITAGE IMPACT ASSESSMENT

29 August 2012

MR 00294 Cape Winelands

Montagu – Cape Winelands District Municipality, Western Cape

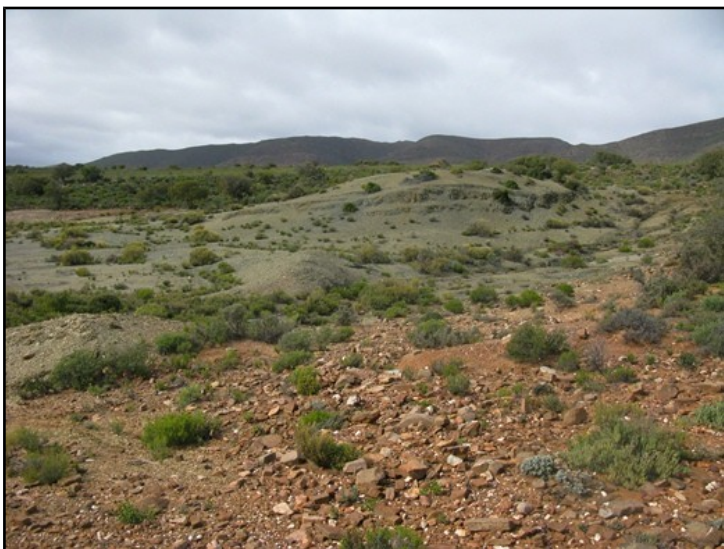
Figure 2: View towards southeast across the existing pit (Almond 2012: 4)

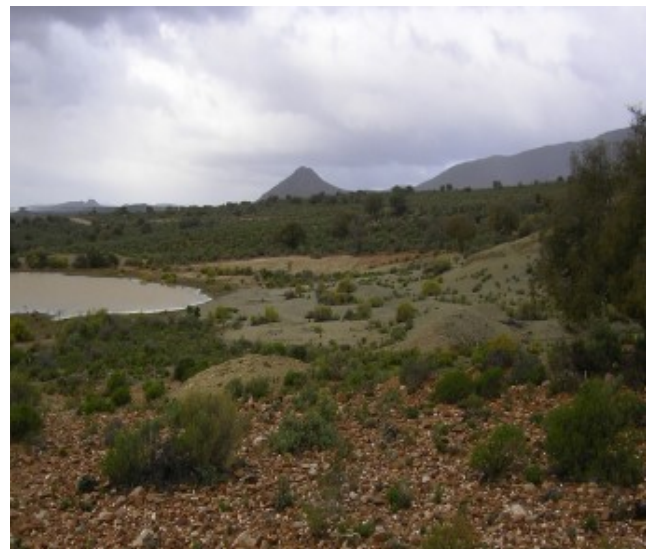
Figure 3: View south across existing borrow pit (July, 2011)

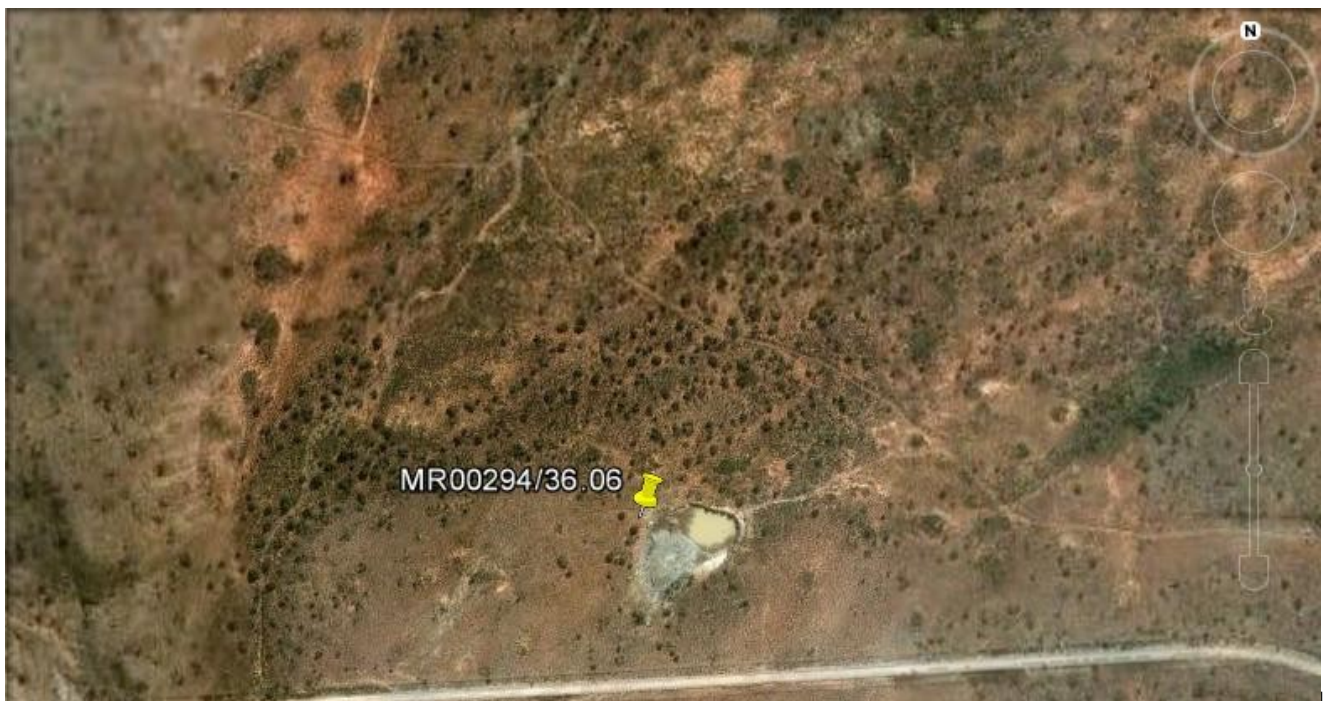
Figure 5: Aerial view of existing borrow pit (Google earth image, August 2012)

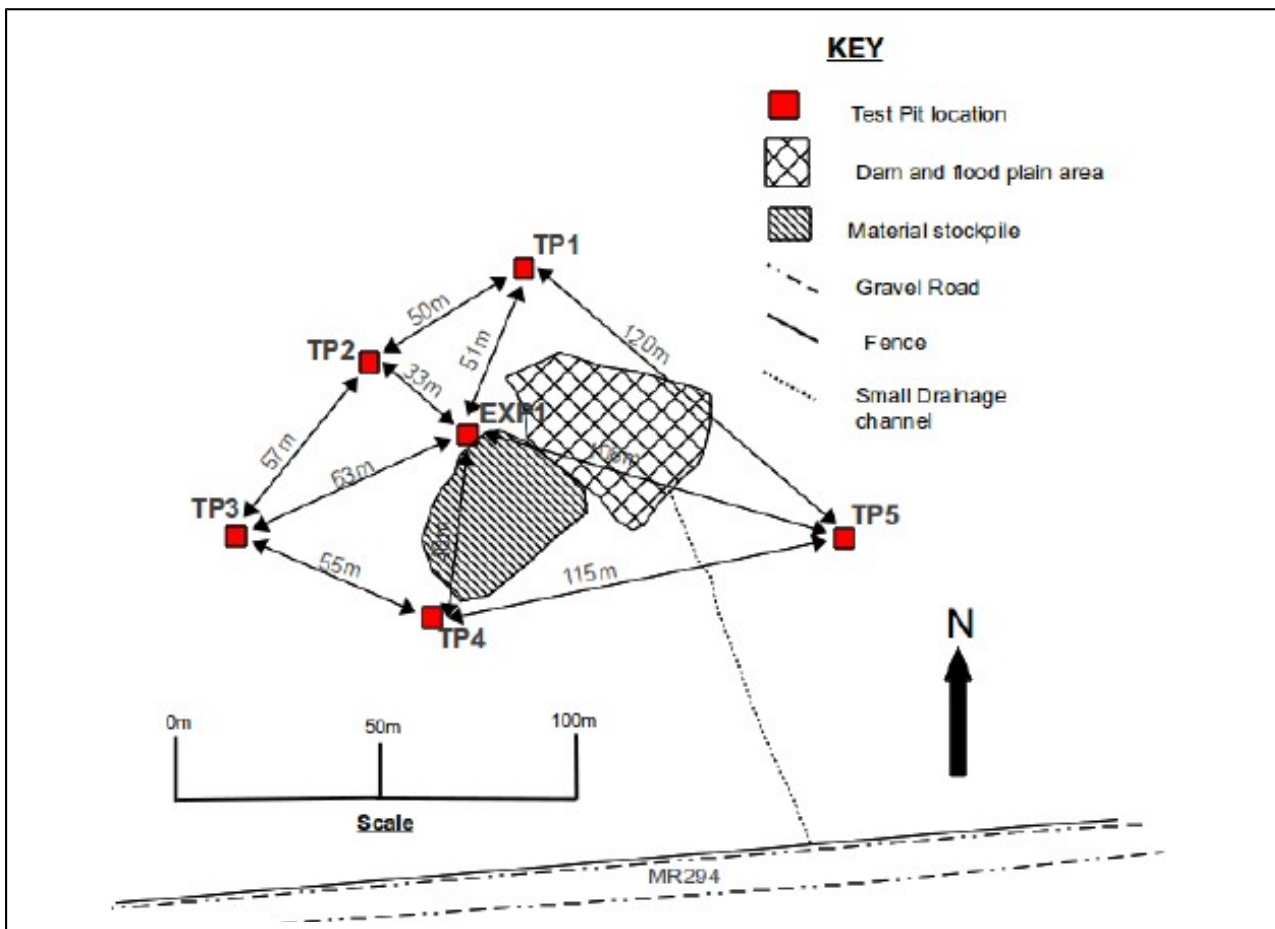
Figure 6: Proposed material to be obtained from the development of a new borrow pit (July 2011)

Summary of borrow pit	
Borrow pit / expropriation area	7 300 m ²
Maximum depth	1 m
Material description	mudrocks of the Waboomberg Formation (Upper Bokkeveld Group)
Proposed usage after rehabilitation	Re-vegetation
Volume of material to be sourced	13 570 m ³

The mine plan outlining extent of borrow pit and mining is outlined in Figure 6. Methodology for the preparation, operation and closure of borrow pit is outlined in Annexure B.
