HERITAGE IMPACT ASSESSMENT

DR01380 Cape Winelands

Worcester – Cape Winelands District Municipality, Western Cape

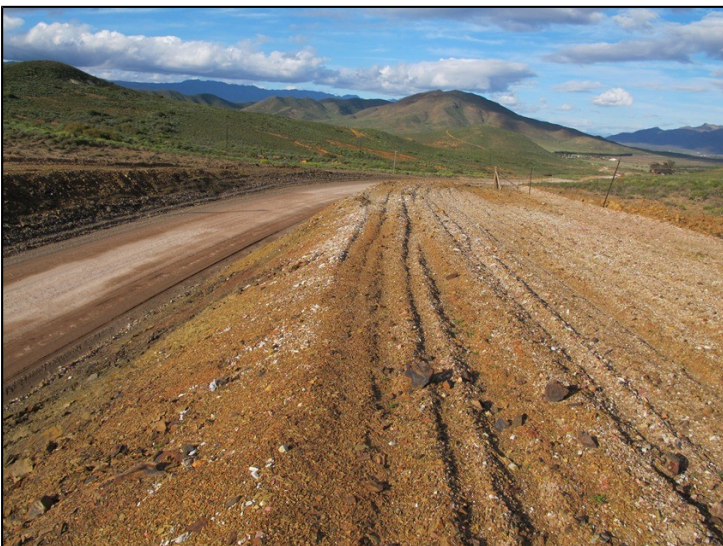
Figure 2: View along the partly-rehabilitated affected area towards the east. The unfenced slope at the eastern end lies beyond the bend in the road. (Tusenius 2012: 8)

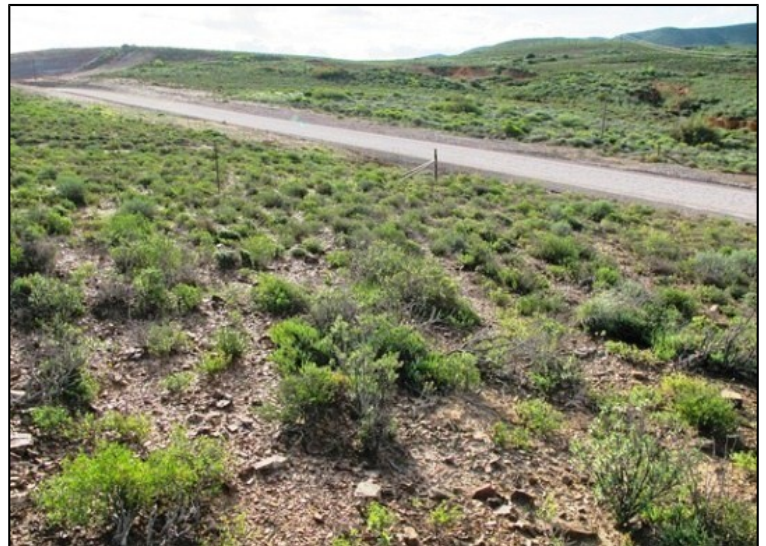
Figure 3: view towards the northwest with the existing quarry (Tusenius 2012: 9)
