HERITAGE IMPACT ASSESSMENT

DR 01381 Overberg

Barrydale – Overberg District Municipality, Western Cape

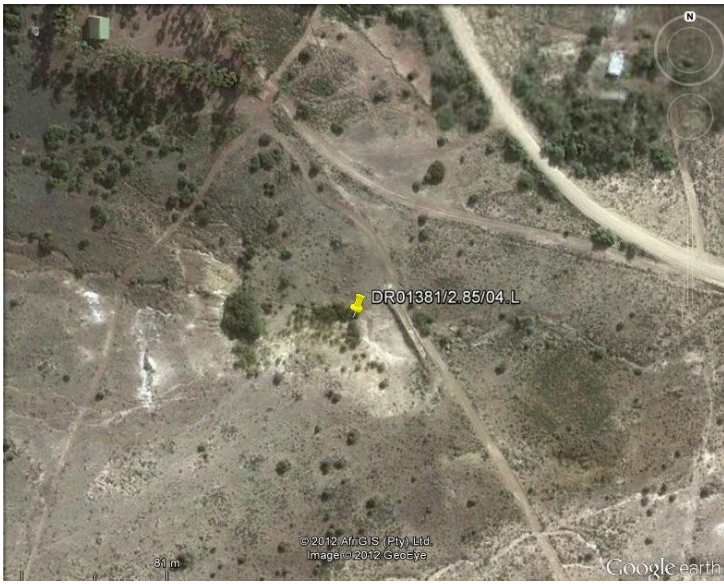
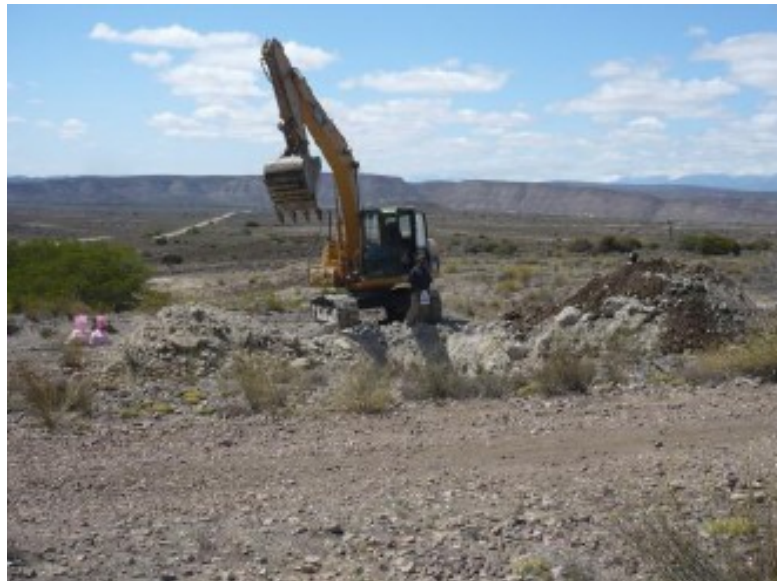
At **DR1381/2,85/0,4L** located on Farm Warmwatersbad Spa

This proposed extension to an existing borrow pit is located on the upper edge of a pediment footing the hillslope of a relatively low Warmwaterberg range of mountains. The pediment extends eastwards for about a kilometre to where it merges into the floodplain of the Doring River. The existing pit has been developed as a floodwater retention pond and stock watering facility. In ownership of Everton Family Trust and borrow pit co-ordinates are 33°46'07,72"S 20°54'09,22"E

Figure 2: Aerial view of borrow pit at km 2.85 and view of the existing pit

Palaeontological sensitivity of sites at km 2.85 and 13.5 is rated as low and therefore, pending the discovery of substantial new fossil material such as shelly fossil, fish or plant remains, no further mitigation of fossil heritage for these two borrow pit sites is recommended.

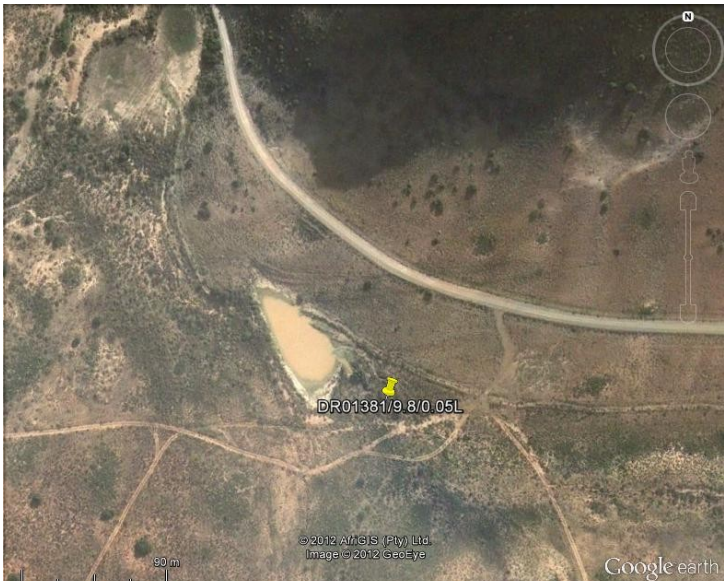
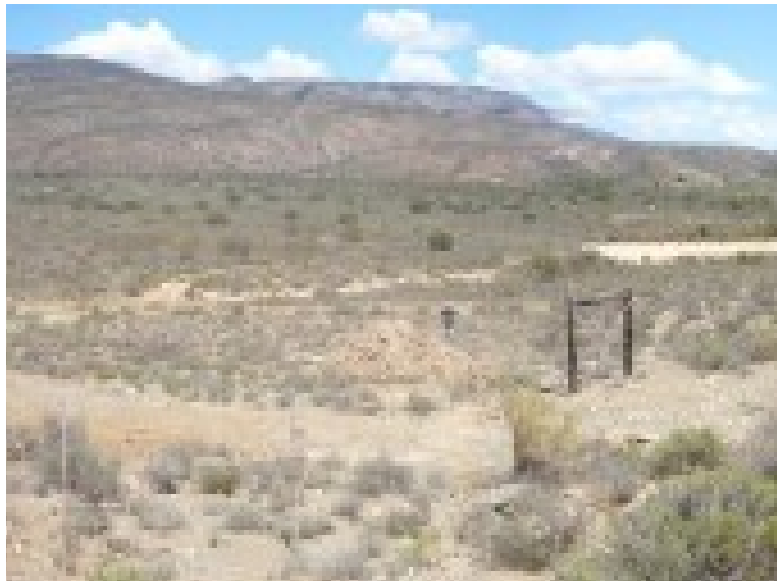
At **DR1381/9,8/0,05L** located on Farm Warmwatersbad Spa

This proposed extension to an existing borrow pit is located mostly in the headwater reach of an existing floodwater attenuation pond that doubles as a stock watering facility. As such, it would be excavated partly into a pediment and partly into the adjoining hillslope of a ridge of moderately high mountains to the north. In ownership of Charite Beleggings (Edms)Bpk and borrow pit co-ordinates are 33°44'57,56"S 20°50'10,18"E

Figure 3: Aerial view of borrow pit at km 9.8 overall panoramic view of the existing pit from the access gate

As very few fossil sites are known from the Voorstehoek Formation of the Little Karoo region, the palaeontological heritage significance of the site located at km 9.8 is considered to be of moderate sensitivity. It is therefore recommended that recording and judicious sampling of fossil remains here be undertaken by a professional palaeontologist once the pit has been opened up to expose fresh bedrock but before the excavated material has been removed for road construction.

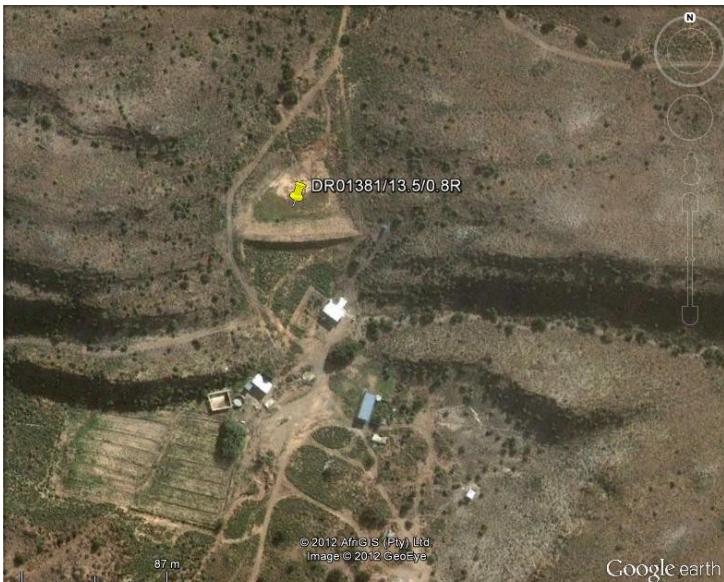
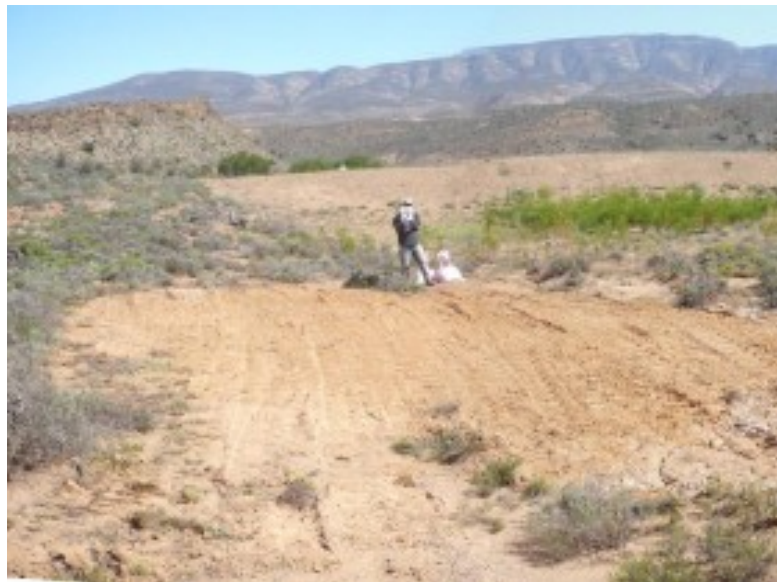
At **DR1381/13,5/0,7R** located on Farm Plattekloof

This proposed new borrow pit is located in the main, in the storage basin of an existing farm floodwater attenuation pond/dam that is located in a relatively narrow southward-flowing water gap. In ownership of Charite Beleggings (Edms)Bpk and borrow pit co-ordinates are 33°43'56,28"S 20°48'22,94"E

Figure 4: Aerial view of borrow pit at km 13.5 and overall panoramic view of the existing dam excavation
