HERITAGE IMPACT ASSESSMENT

27 February 2013

DR 01381 Cape Winelands

Barrydale – Cape Winelands District Municipality, Western Cape

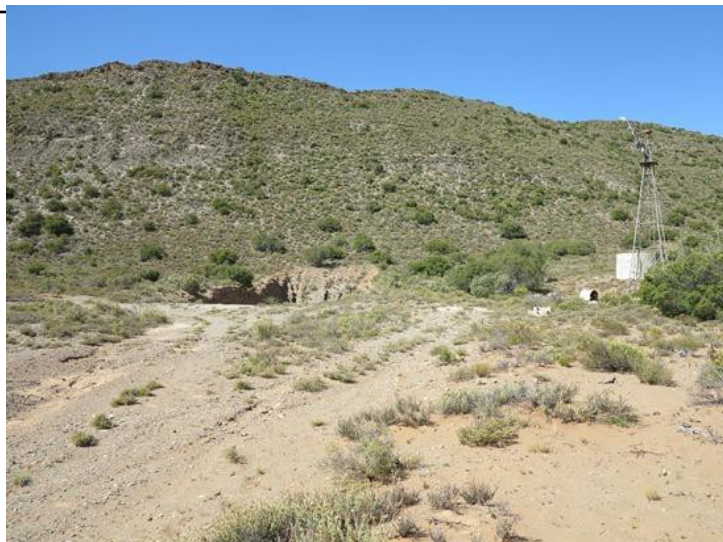
Figure 2 View towards the north of the existing borrow pit with the proposed extension to the left (northwest) and a wind-pump and water tank outside the polygon to the right (Tusenius 2012: 7)

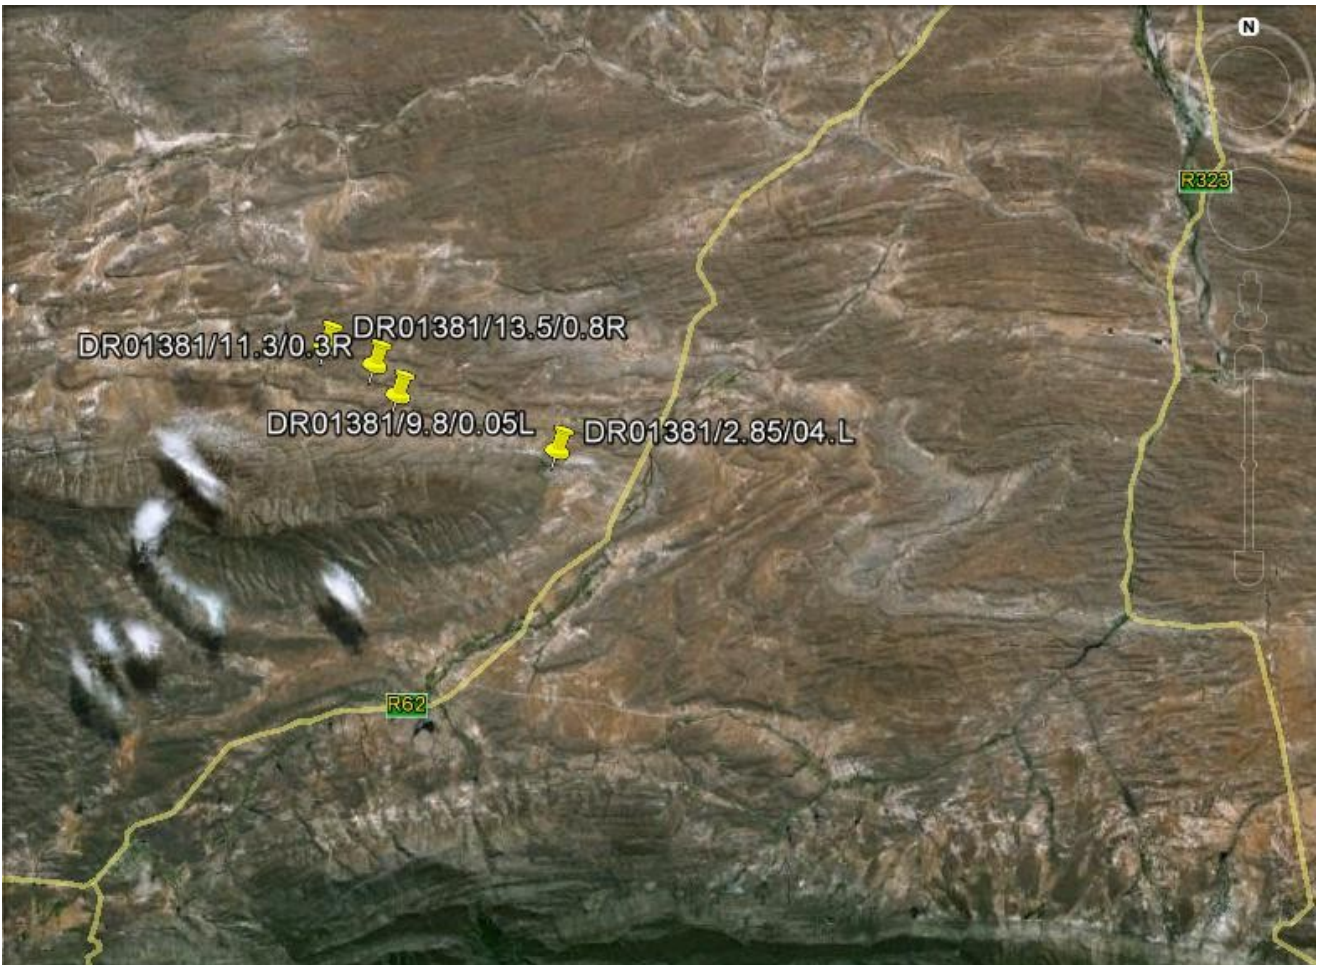
Figure 3: Aerial view of proposed borrow pit location
Image also indicates vidamemoria pit nos. 133, 134 and 135 subject of a separate palaeontological assessment study (refer vida HIA 69)
(Google earth image, February 2013)

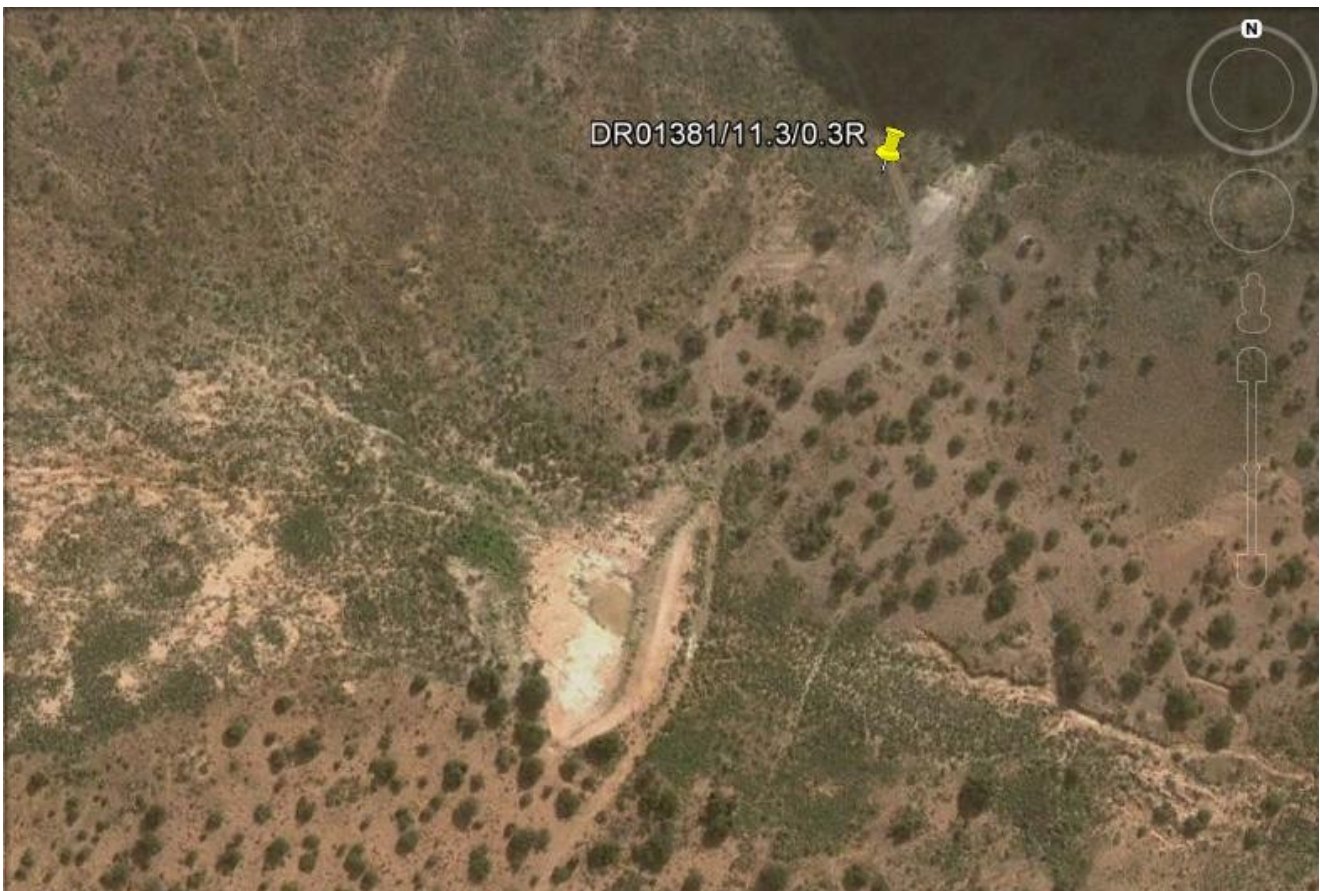
Figure 4: Aerial view of proposed borrow pit area (Google earth image, August 2012)
