**ARCHAEOLOGICAL IMPACT ASSESSMENT
OF THE PROPOSED EXTENSION OF A BORROW PIT ON
PLATTEKLOOF (BELLAIR 13),
BARRYDALE AREA, CAPE WINELANDS DISTRICT,
WESTERN CAPE**

(Assessment conducted under Section 38 (8) of the National Heritage Resources Act as part
of a Heritage Impact Assessment)

JANUARY 2013

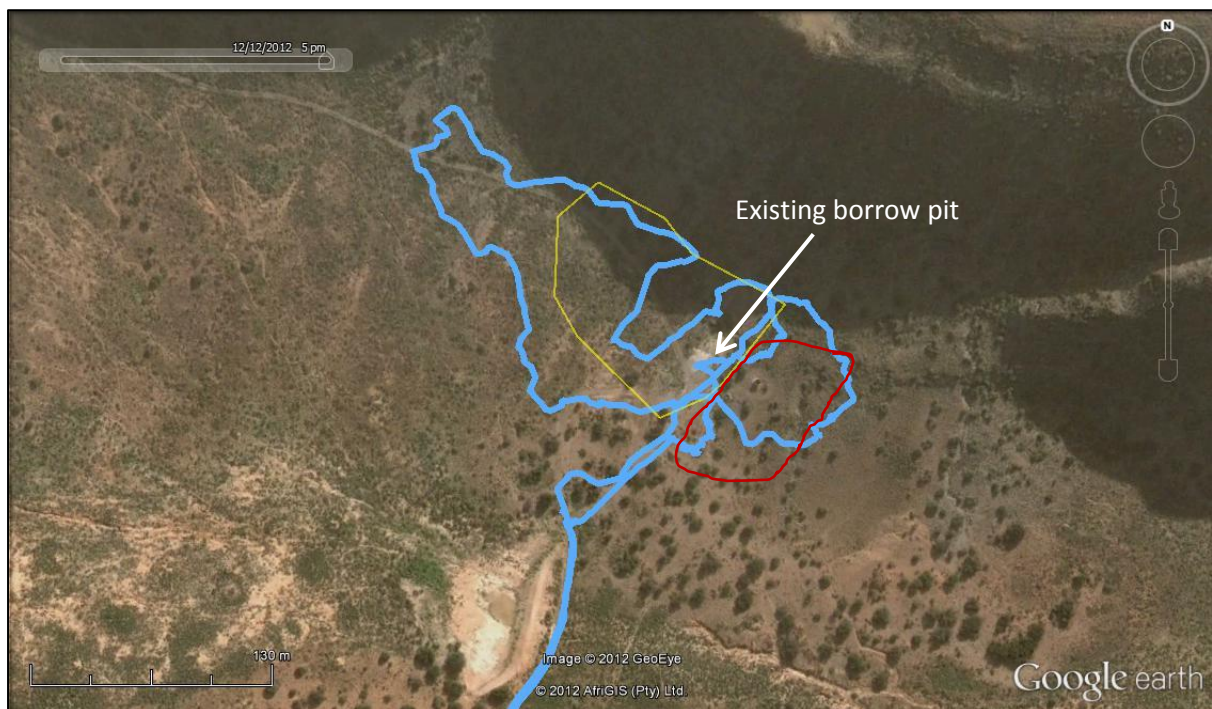
Fieldwork for the proposed extension was undertaken 2 December 2012. A site plan and polygon indicating the affected area were provided by Aurecon for the Phase 1 survey. The area was covered on foot and the tracks were recorded by a Garmin GPSMAP 62s set on the WGS84 datum (Figure 2). The site was extensively photographed.

Environment: The proposed extension to an existing borrow pit is located partly on the lowest slopes of a moderately high, northwest-southeast aligned ridge and partly on the north-eastern edge of an alluvial outwash plain (Figures 2 to 5). The south-eastern boundary of the affected area is indicated by the existing pit (Figure 3). A wind-pump, water tank and drinking trough lie to the southeast of the polygon (Figures 3 and 8). The access track from the gate along the DR1381 cuts across the centre of the affected area, from the southeast to the northwest (Figure 4). The other boundaries delineating the polygon are not clear on the ground. Fine gravelly silty sand of alluvial wash and colluvial origin overlies mudrocks of the Tra Tra Formation of the Bokkeveld Group. The southwest-facing slope is rockier than the flatter-lying alluvial outwash plain. Quartzite cobbles, clasts of sandstone, mudrock and some quartz are evident. Small water courses, currently dry, drain into the stream to the south and southwest of the affected area (Figure 2). Sparse, low karoo bushes, *Salsola* sp. and 'vygies' cover the terrain (Figures 3 to 5), with a few scattered larger shrubs such as *Euclea undulata*, *Schotia brachypetala* and *Gloveria* sp. more common on the rockier slope (Figures 6 and 8). There are clear signs of disturbance – trampling and digging by animals, sheet-wash and erosion on the alluvial outwash plain and the hill-slope.

Figure 2: Google earth image showing the proposed expansion to borrow pit 132, the polygon (in yellow), the existing borrow pit, the tracks of the field survey (in blue) and the area (in red) where stone artefacts were observed. An existing floodwater attenuation dam is visible at the bottom centre of the image.

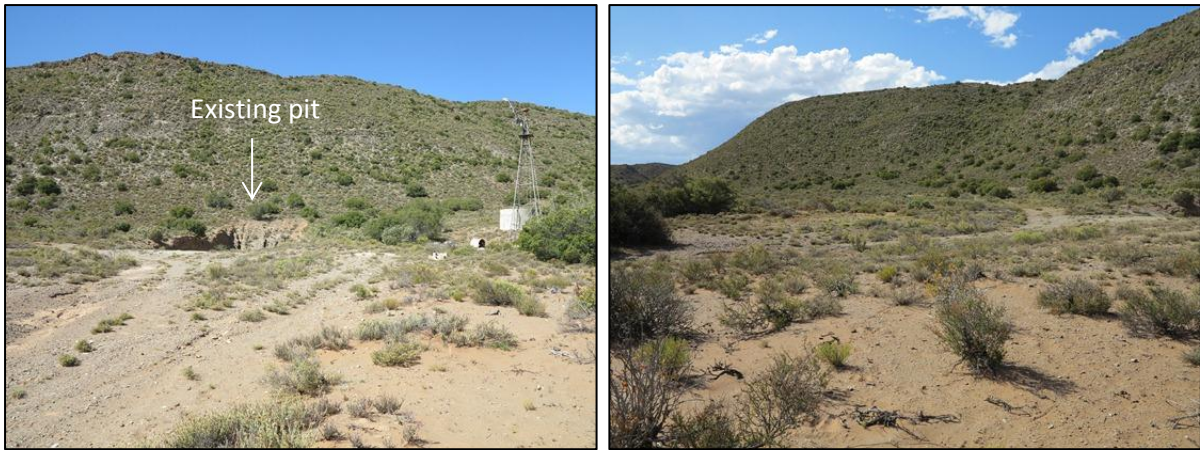
Figures 3 and 4: View towards the north of the existing borrow pit with the proposed extension to the left (northwest) and a wind-pump and water tank outside the polygon to the right (southeast); view towards the northwest of the track cutting through the proposed extension area.

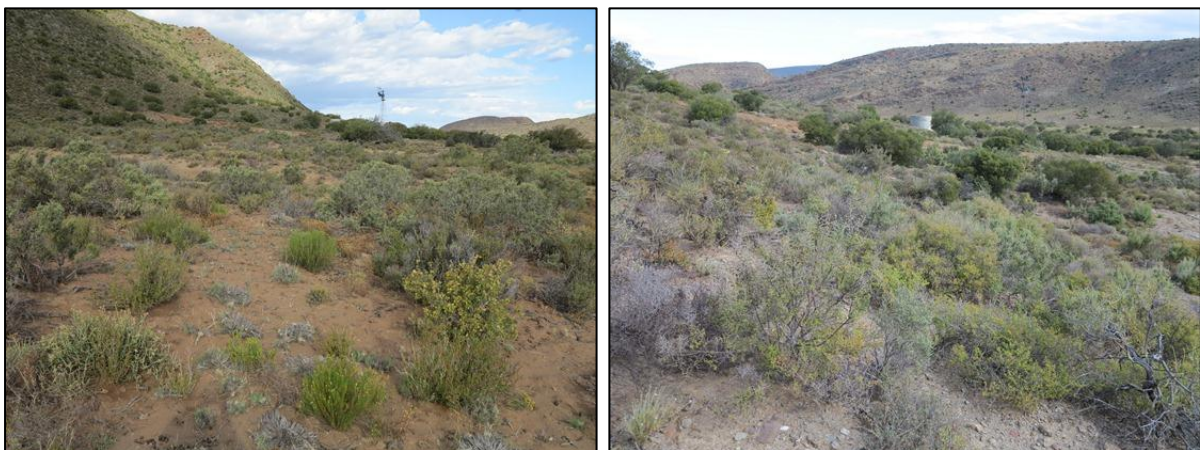
Figures 5 and 6: View towards east with the wind-pump lying outside the area of the proposed extension; view towards the southeast from the north-western slope of the polygon.

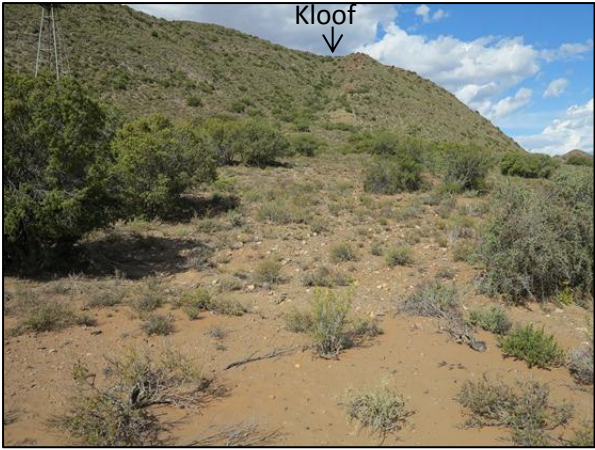
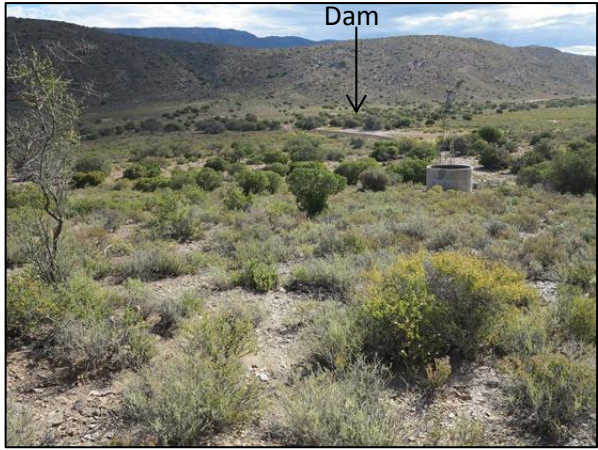
Results of the survey: No archaeological remains, including signs of possible graves in the alluvium, were observed in the affected area itself. However, Stone Age artefacts were noted on the slope and the foot of the slope to the southeast of the polygon, in the area of the wind-pump and water tank (Figures 2, 7 and 8). Most of the 30 or so artefacts observed were manufactured from quartzite, particularly grey quartzite (Figures 9 to 13), but one flake of CCS (cryptocrystalline silica) was seen. Some of the flaked material is of indeterminate age, probably MSA and/or LSA, but some clearly MSA artefacts were recorded (for example, Figures 11 to 13). This material appears to have been washed down the slope from higher up, probably down the kloof visible in Figure 7. The base of a glass bottle was observed close to the attenuation pond and is likely to be of modern origin.

Figures 7 and 8: View towards the northeast showing the area where artefacts were noted to the southwest of the wind-pump, as well as the kloof down the ridge; view towards the southwest showing the same area, as well as the wind-pump, water tank and the nearby floodwater attenuation dam.

The absence of archaeological remains in the polygon itself, as well as the fairly low density of stone artefacts in a secondary context outside the affected area, indicate that the proposed extension of the existing borrow pit is of low archaeological heritage significance. No significant impact on such resources is expected if the proposed extension is developed. No further archaeological studies or mitigation are recommended.

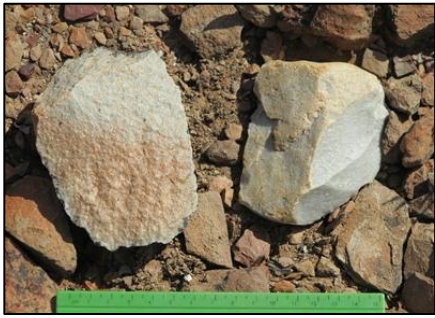
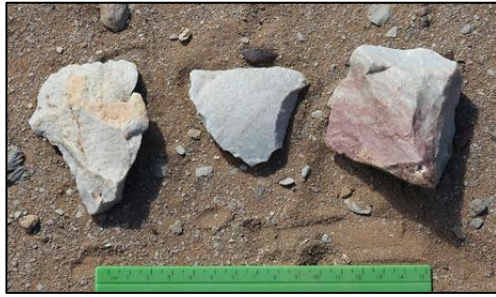
Figures 9 and 10: Selection of quartzite artefacts from the area indicated in red in Figure 2. The scale is in cm.

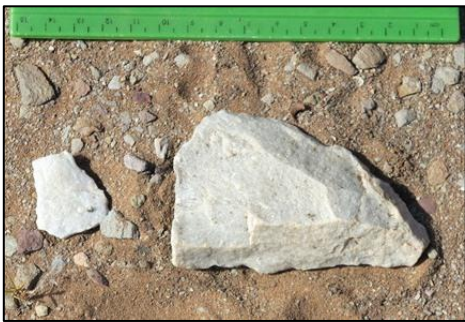
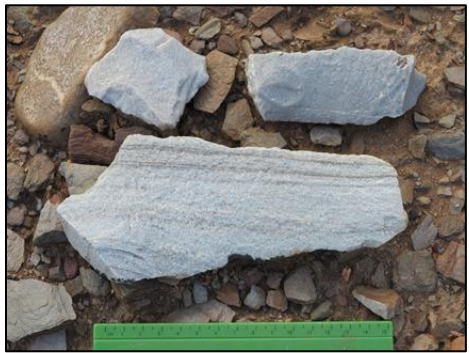
Figures 11 to 13: Selection of quartzite artefacts, most showing MSA characteristics, from the same area as those in Figures 9 and 10. The scale is in cm.
