**ARCHAEOLOGICAL IMPACT ASSESSMENT
OF PROPOSED BORROW PITS ON KLEINDOORNRIVIER
214 AND GROOTDOORNRIVIER 83 NEAR OUDTSHOORN,
EDEN DISTRICT MUNICIPALITY, WESTERN CAPE**

(Assessment conducted under Section 38 (8) of the National Heritage Resources Act as part
of a Heritage Impact Assessment)

MARCH 2013

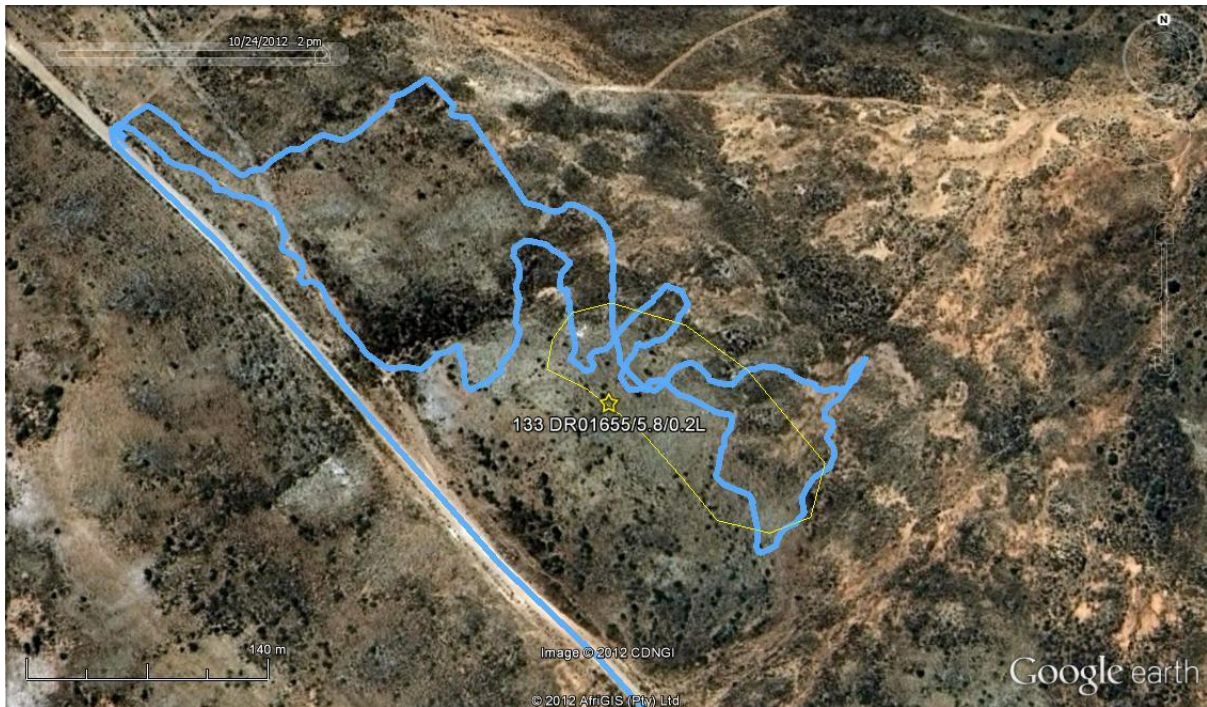
Environment: The proposed borrow pit is situated on the lower, northeast-facing slope of a small hill and the adjoining relatively flat-lying land below it on the floodplain of the Doring

Figure 2: Google earth image showing the proposed borrow pit 133 on the northeast-facing slope of the hill and the tracks of the field survey.

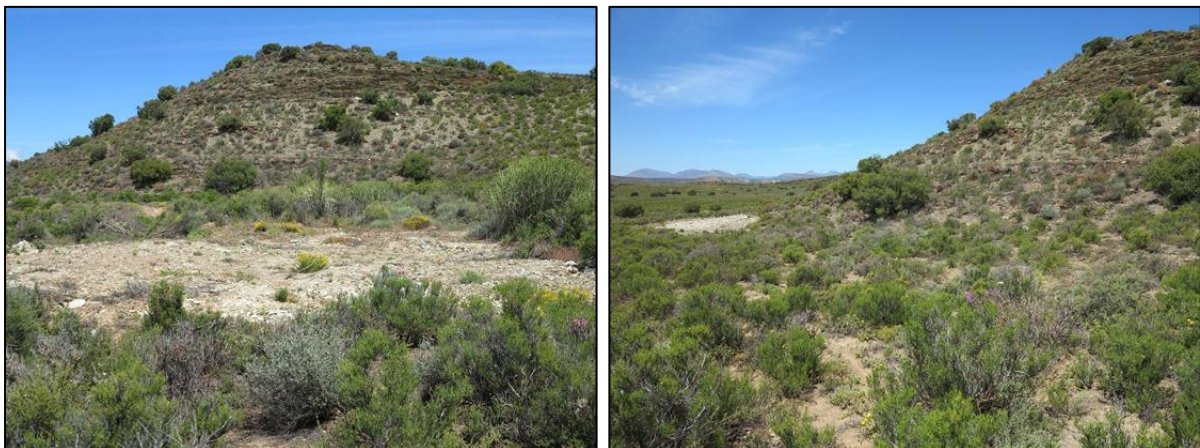
Figures 3 and 4: Pit 133 - view towards the south of the northern end of the hill with the northernmost geotechnical trial pit in the foreground; view towards the southeast.

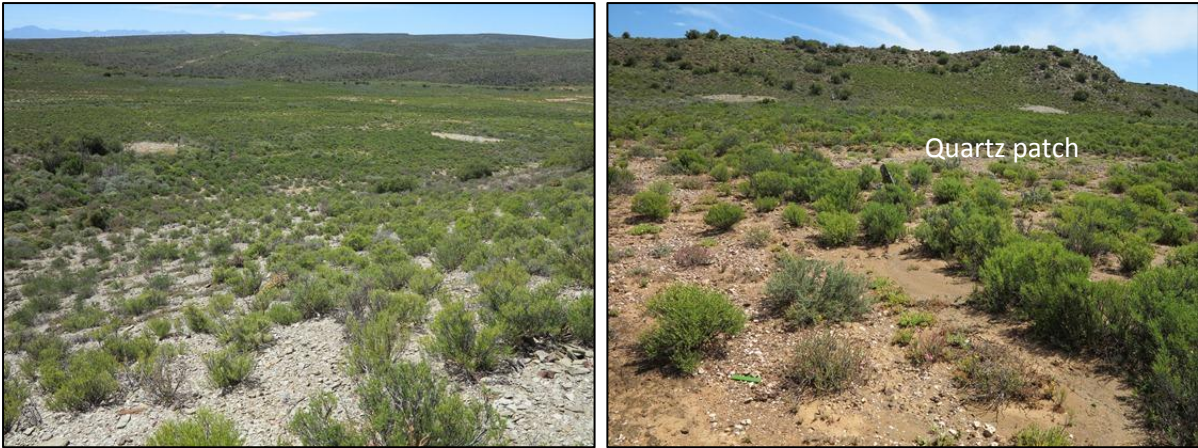
Figures 5 and 6: Pit 133 - view towards the northeast taken from the slope of the hill; view towards the west with the one of the quartz patches where a couple of stone artefacts were observed outside the polygon. An old fence post is visible between the track and the quartz patch.

Results of the survey: No archaeological remains were observed in the polygon of the proposed borrow pit. Four quartzite artefacts of indeterminate age were however noted in quartz patches to the northeast of the polygon (Figure 6). These consist of one flake, two chunks or cores, and one weathered artefact with possible retouch along one edge (Figures 7 to 9 respectively). All appeared to have been affected by sheet wash and are thus in a secondary context.

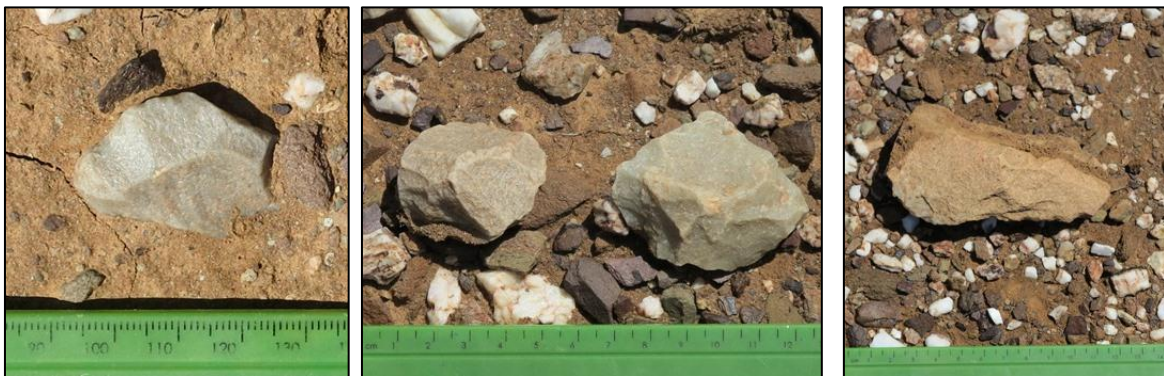
Figures 7, 8 and 9: Pit 133 - stone artefacts observed outside the affected area. The scale is in cm.

Although no archaeological material was found in the actual affected areas of proposed Pits 133 and 134, some heritage remains were observed in the vicinity of the sites. The few stone artefacts found close to Pit 133 are in a secondary context and are therefore of low archaeological heritage significance. The cemetery close to the area of proposed Pit 134 is obviously of high significance and should be protected. It is recommended that the graves be fenced off and declared strictly off-limits to personnel involved with the proposed quarrying activities.

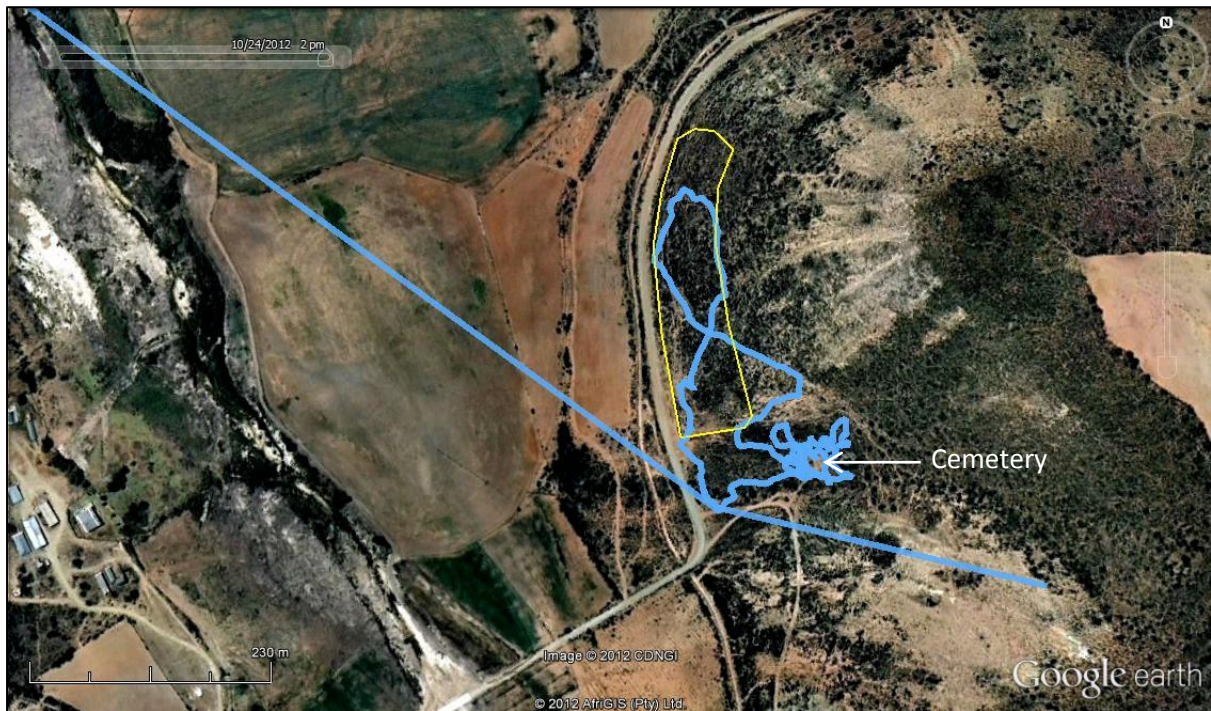
Environment: The proposed borrow pit is located on a west-facing slope of a hill, capped by an old land surface mantled with alluvial gravels, to the east of the DR1655 (Figures 9 and 10). The affected area overlooks agricultural fields situated on the broad floodplain of

Figure 9: Google earth image showing the proposed borrow pit 134, the author's tracks of the field survey and the position of the cemetery. The Grootdoornrivier farm buildings are on the far left of the photo. Please note that the straight blue lines do not indicate survey tracks.

However, the question of the visual impact of the proposed development of Pit 134 on the context of the nearby historical farmstead should be addressed by a relevant specialist. The geotechnical report (Aurecon 2012) does indicate an awareness of the problem of the quarry becoming a “prominent eyesore” (see Figures 9 and 10) and proposes on-going rehabilitation as exploitation progresses.

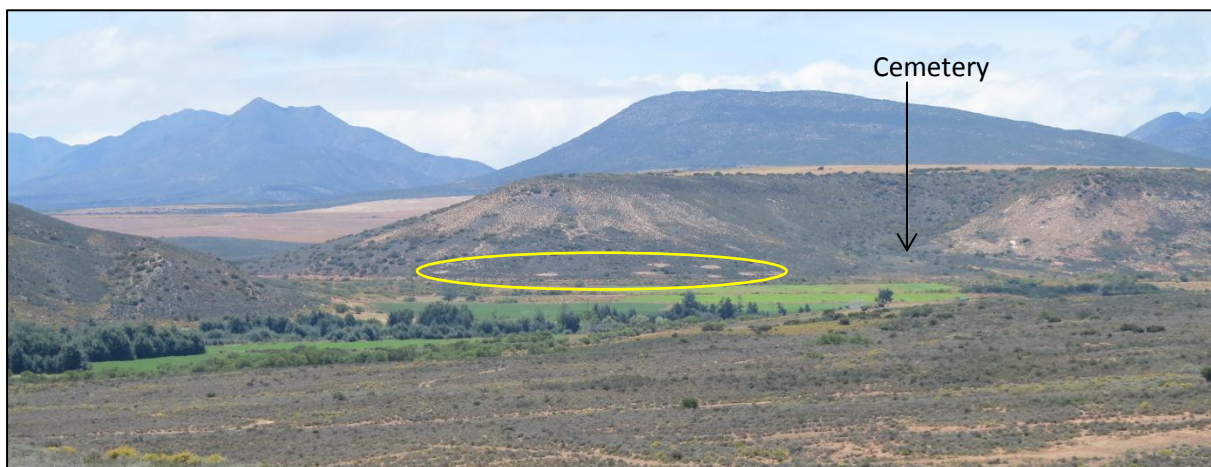
Figure 10: Pit 134 - view towards the east showing the approximate positions of the polygon and the cemetery. The flat pediment surface on the crest of the affected hill is clearly evident. The farmstead is located between the trees in the middle ground and the pit area.

A cemetery was noted some 55m or more to the southeast of the polygon (Figures 9, 10, 14 to 18). The cemetery consists of at least 50 graves, probably more. Most of the graves lie in rows and are orientated ESE/WNW. Most are indicated by heaps of rounded cobbles or angular stones, some are just mounds of earth and a couple have cement boundaries. Many have sandstone headstones, some have cement headstones, a few have crosses (wire or wood) and some have nothing. Broken glass jars and tins are found in association with some of the graves. One small piece of abalone shell was also observed. With the exception of one headstone with writing from 1965 (Figure 18), none of the graves are labelled so it is difficult to date them. Besides the formal part of the cemetery, several scattered mounds and headstones are partly hidden by bushes on the outskirts of the more visible graves. A conversation with the farmer, Mr DM Heyns, revealed that the cemetery is used by farm workers and the oldest graves could possibly be 100 years old. Mr Heyns is the 8th generation of his family to farm the land since 1766 and the present homestead was built in 1803 (DM Heyns, pers. comm.).

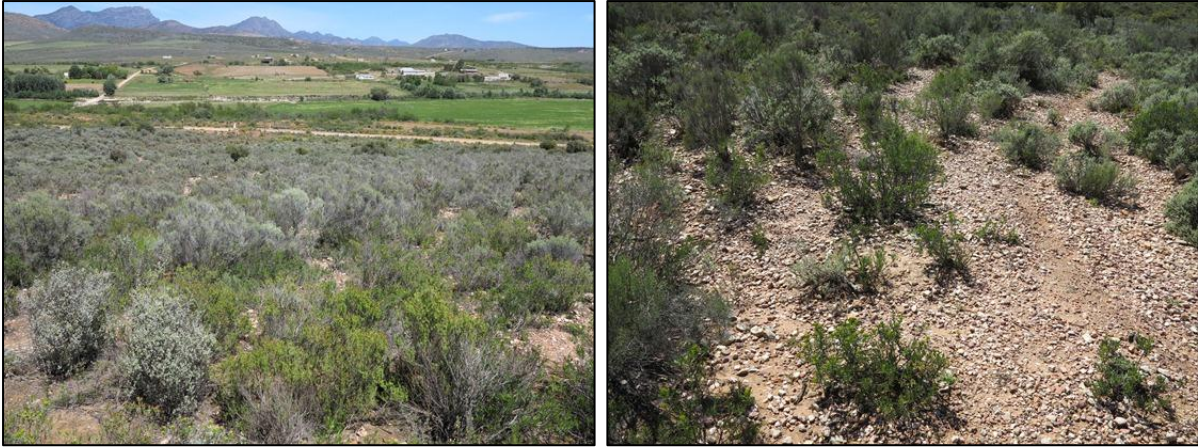
Figures 11 and 12: Pit 134 - view across the affected area towards the floodplain of the Grootdoring River and farm buildings towards the west; detail of the gravelly silty sand.

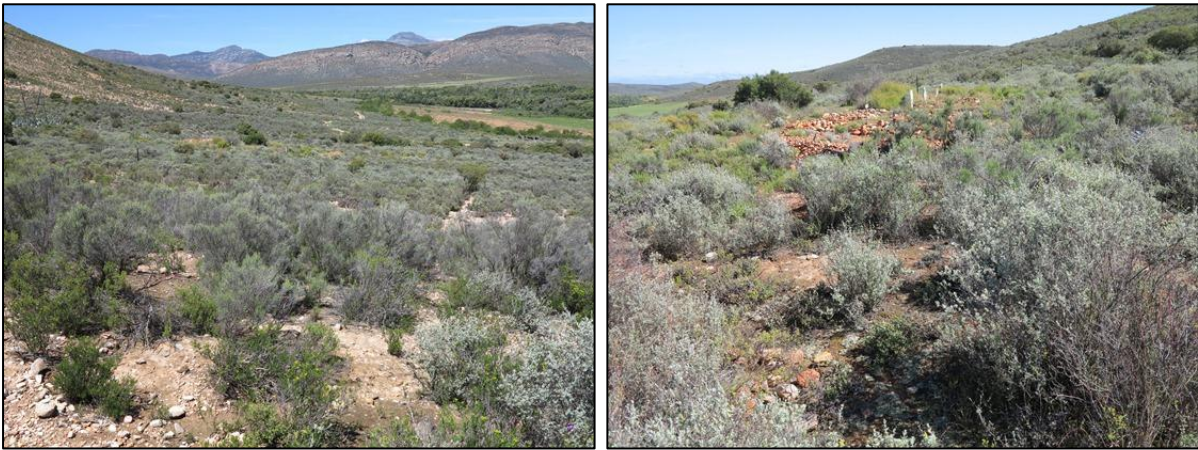
Figures 13 and 14: Pit 134 - view towards the south; view towards the northwest of the cemetery located outside the area of the proposed pit.

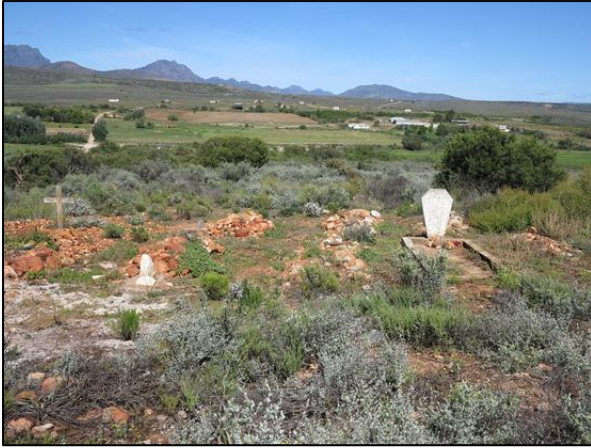
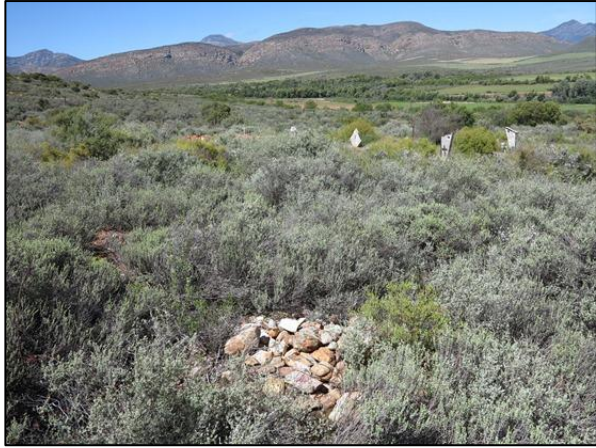
Figures 15 and 16: Pit 134 - view towards the west showing some of the graves in the formal part of the cemetery; view towards the southwest with the cement headstones of some graves visible in the background and one of the stone heaps visible in the overgrown area with scattered graves.

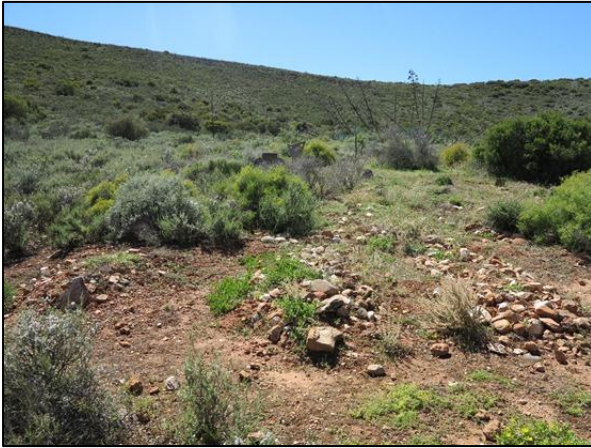
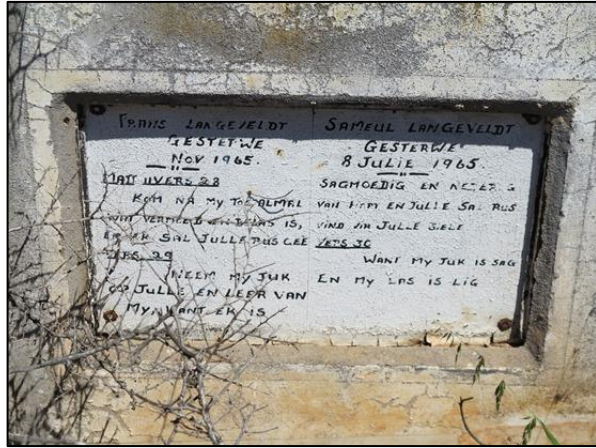
Figures 17 and 18: Pit 134 - view towards the east showing some of the graves in the western portion of the cemetery; detail of the only labelled headstone.
