HERITAGE IMPACT ASSESSMENT

submitted in terms of section 38(8) of the National Heritage Resources Act

DR01649 Eden

Oudtshoorn – Eden District Municipality, Western Cape

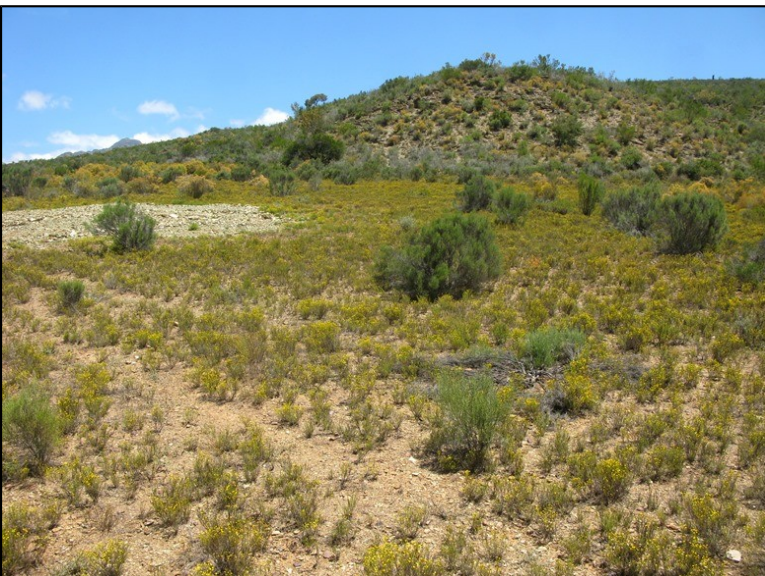
Figure 2: At km 22.35 View southwards across the proposed new pit site (Almond 2013: 5)

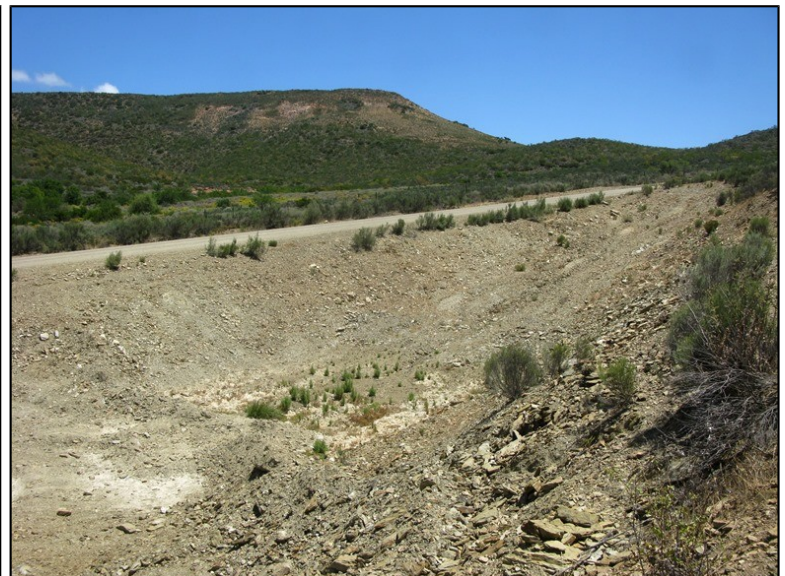
Figure 3: At km 24.0 View south-westwards across existing pit (Almond 2013: 4)
