HERITAGE IMPACT ASSESSMENT

DR 01664 Eden

Vanwyksdorp – Eden District Municipality, Western Cape

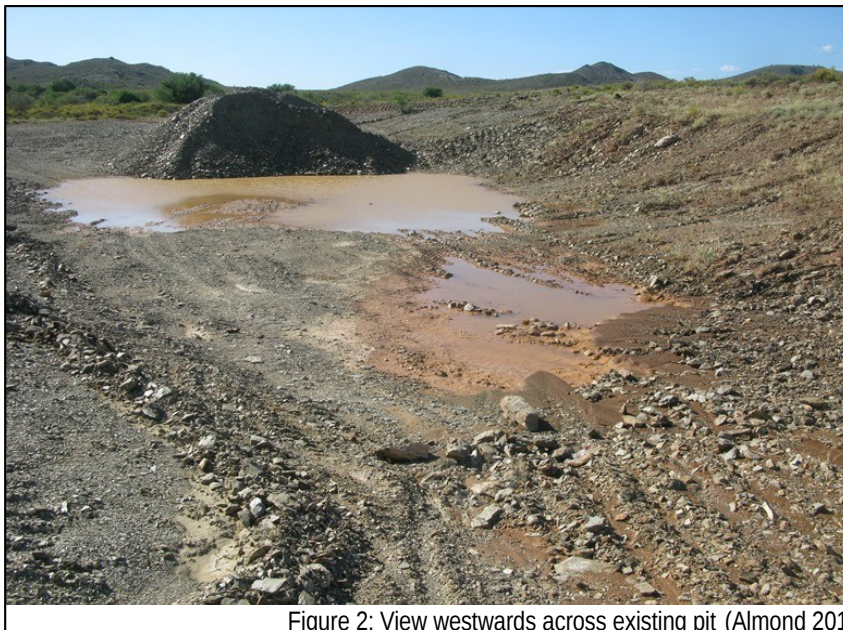
Figure 2: View westwards across existing pit (Almond 2013: 4)
