**ARCHAEOLOGICAL IMPACT ASSESSMENT  
OF A PROPOSED BORROW PIT ON ROODEBERG  
OUTSPAN 194 NEAR LADISMITH,  
EDEN DISTRICT, WESTERN CAPE**

(Assessment conducted under Section 38 (8) of the National Heritage Resources Act as part  
of a Heritage Impact Assessment)

**MARCH 2013**

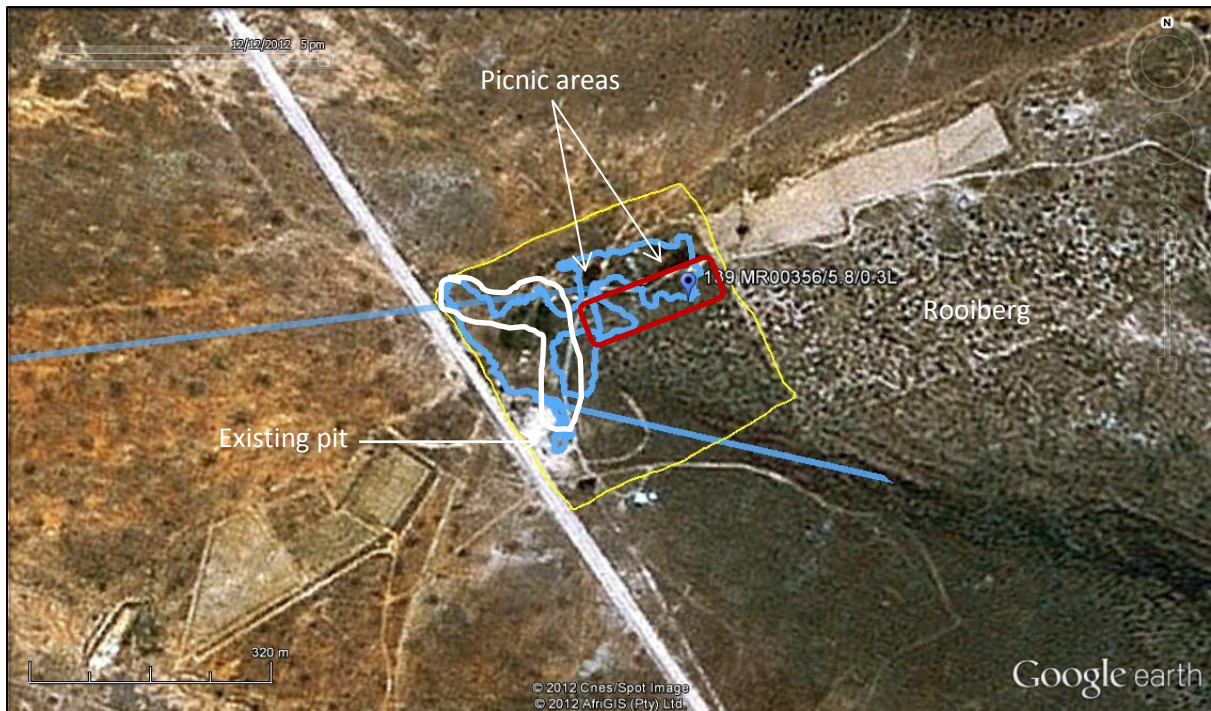
Figure 2: Google earth image showing the area of the proposed borrow pit 139 (red), the polygon of the generally affected area (yellow), the tracks of the field survey (blue) and the area where scattered archaeological remains were found (white). Attention was paid to the actual proposed pit area and the flatter-lying areas. The steeper slopes with denser vegetation in the south-eastern corner were not surveyed. Signs of disturbance in the surrounding area are evident in this image. Please note that the straight blue lines do not indicate survey tracks.

Fieldwork for the proposed pit development was undertaken 11 December 2012. A site plan and polygon indicating the affected area were provided by Aurecon and Vidamemoria respectively for the Phase 1 survey. The area was covered on foot and the tracks were recorded by a Garmin GPSMAP 62s set on the WGS84 datum (Figure 2). The site was extensively photographed.

Gravelly silty sand overlies angular colluvial gravel, which in turn overlies sandstones of the Rietvlei Formation of the Cape Supergroup. Many angular sandstone blocks occur on the slope in the south-eastern corner of the affected area. With the exception of the picnic areas, fairly dense karoo vegetation covers most of the polygon but there are some patches where gaps between the bushes provide better visibility of the ground. Throughout the affected area there is evidence of sheet-wash and erosion, as well as digging by people and animals. The many tracks and disturbed vegetation evident within and around this area in Figure 2 indicate the broader, disturbed context of the polygon.

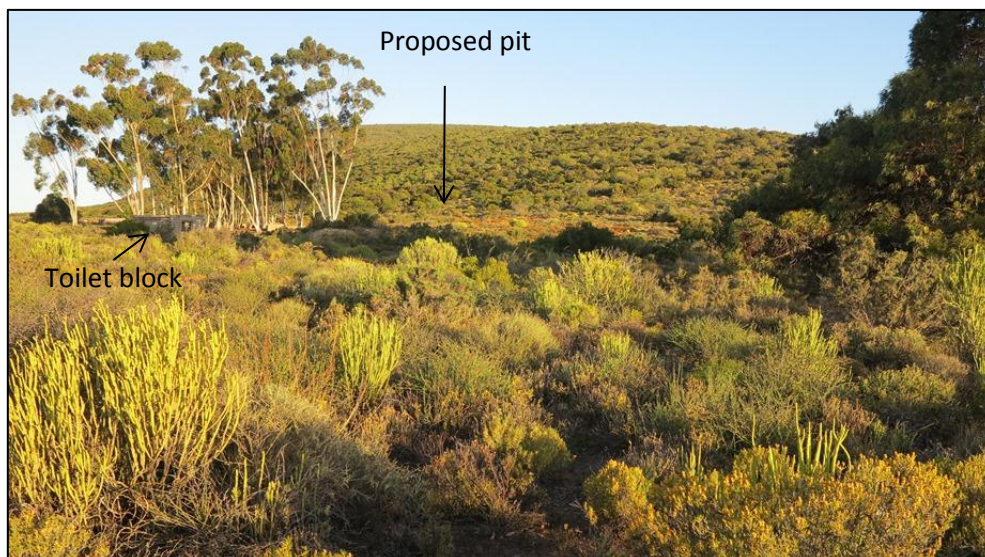
Figure 3: View towards the east showing the proposed new pit, the larger picnic area under the blue gum trees and the toilet block.

**Environment:** The proposed borrow pit is situated at the foot of a northwest-facing, moderately steep slope at the western extremity of the prominent Rooiberg (Figures 2 and 5). It is located within public land which is an historic overnight resting place for herded livestock and the attendant drovers (Aurecon 2012). It has subsequently been provided with two picnic areas with concrete braai places, tables and stools which are situated in two clusters of blue gum trees. Toilet facilities built of concrete blocks lie between the picnic areas (Figures 3 and 4).

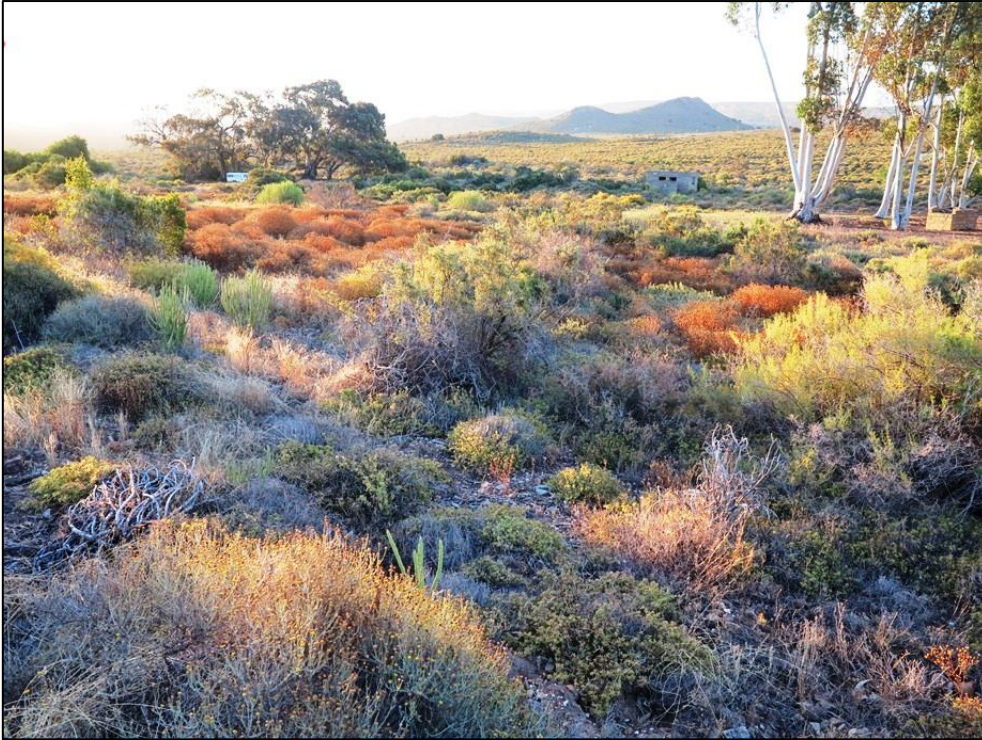
Figure 4: View towards the northwest with the proposed borrow pit area in the foreground, the small picnic area near the trees on the left, the large picnic area under the blue gum trees on the right and the toilet block between them.

The actual area of the proposed new pit (Figures 2 and 4) lies to the south of the picnic sites and some 300m to the northeast of an existing pit adjacent to the MR00356 (Figure 5). Besides the existing borrow pit in the south-western corner, another large excavated pit situated between the picnic areas is now overgrown. Fences indicate the boundaries of the polygon (Figure 2). A couple of modern buildings are situated to the south of the polygon and a wind-pump and water tank lie in cultivated land to the northeast of the proposed pit.

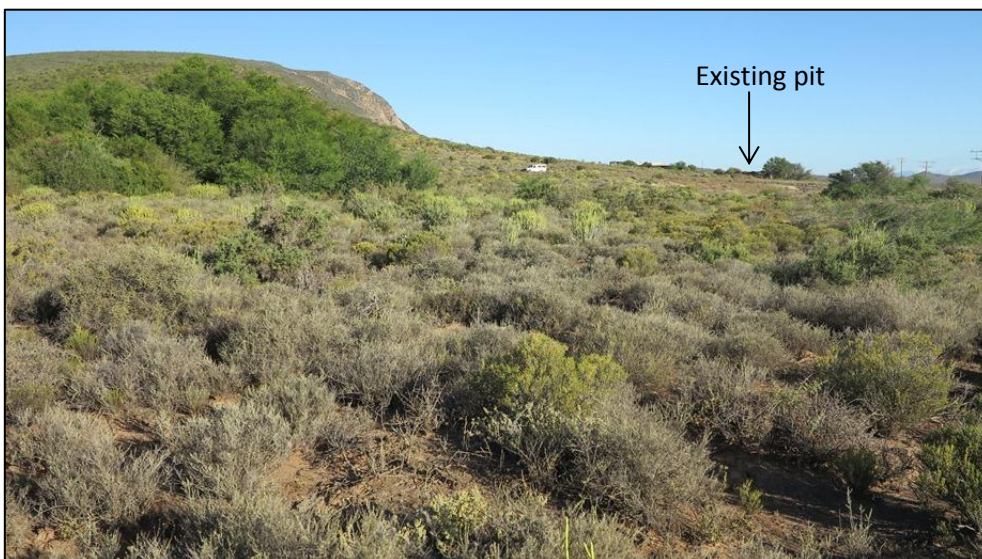
Figure 5: View towards the southeast of the affected area showing the position of the existing pit. The area of the proposed new pit and the picnic areas lie beyond the clump of *Acacia karroo* trees lies on the left. The vehicle indicates the position of the access track. The Rooiberg is visible in the background.

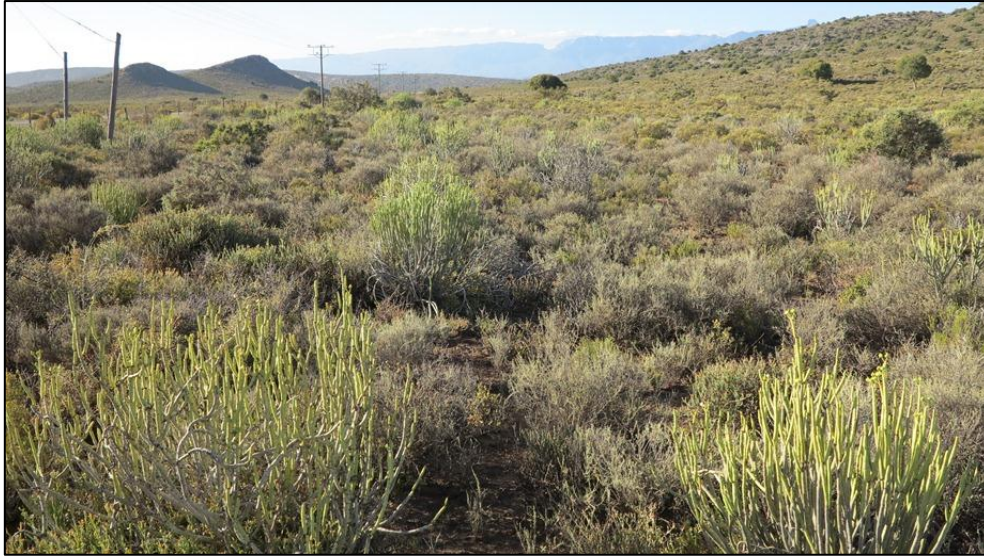
Figure 6: View towards the north of the north-western part of the study area where scattered artefacts were noted.

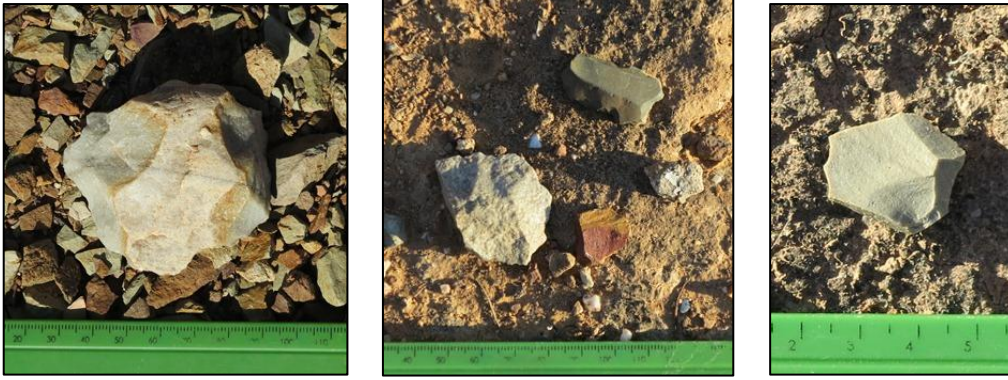
Some 20 scattered stone artefacts, a few small pieces of ostrich eggshell, two fragments of pre-colonial pottery (one with red slip), a few pieces of glass and a metal horseshoe were noted outside the borrow pit area (Figures 7 to 15). The stone artefacts are made of a variety of raw materials - quartzite, chert, silcrete and hornfels. Some of the flakes, cores and chunks are indeterminate in age but are likely to be either MSA or LSA, while others are clearly diagnostic. For example, the quartzite artefacts in Figures 11 and 12 are MSA whereas the small silcrete and hornfels flakes in Figure 9 are LSA. One piece could perhaps be the end of a crude ESA biface (Figure 10). The pottery (Figure 13) dates to the last 2000 years and could possibly be linked to Khoekhoen herders. It is not clear whether the horseshoe and thick glass fragment (Figures 14 and 15) are historical or modern. Fragments of tortoise shell were noted in a few spots, but as a complete shell of a recently deceased tortoise was also observed, these are likely to be of modern origin. Similarly, bone fragments, including several isolated vertebrae, are also probably of recent origin. All the above-mentioned material has clearly been washed into position from elsewhere and is thus in a disturbed, secondary context. No graves or potential graves marked by heaps of stone were observed.

Figures 7 to 9: Quartzite core; artefacts made of quartzite, silcrete and hornfels: chert flake. The scale is in cm.

The mix of sparse, scattered archaeological and historical material of various ages in a secondary context indicate that the affected area is of low archaeological heritage significance. No significant impact on such resources is expected if the proposed borrow pit is developed. No further archaeological studies or mitigation are recommended.

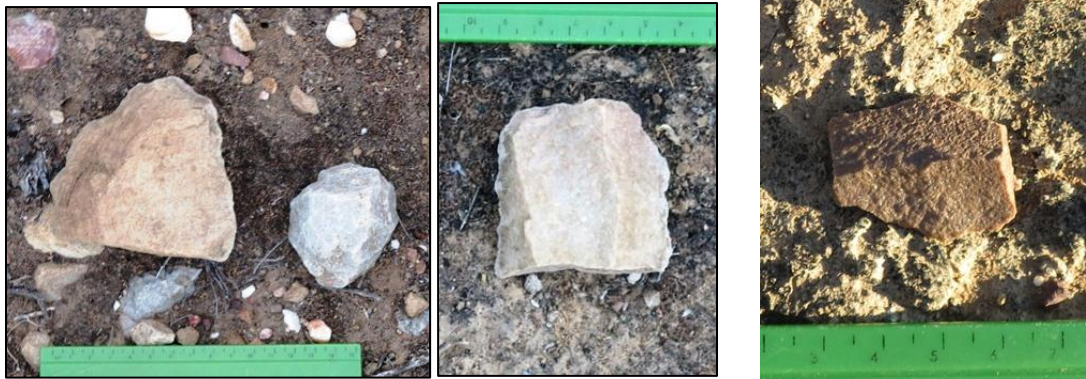
Figures 10 to 12: Possible biface tip to the left of the core; snapped MSA blade; broken MSA flake. The scale is in cm.

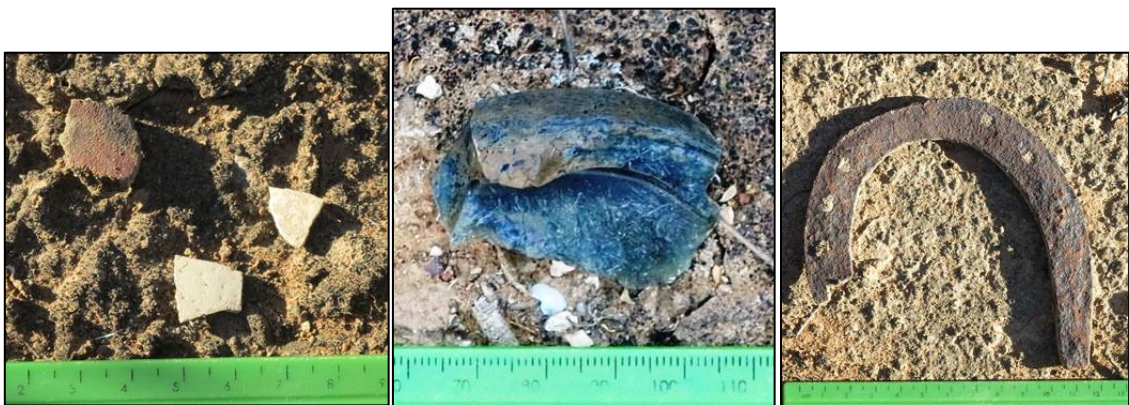
Figures 13 to 15: Pre-colonial pottery with red slip and two pieces of ostrich eggshell; fragment of glass bottle; horseshoe. The scale is in cm.
