# HERITAGE ASSESSMENT OF THE PROPOSED UPGRADE TO THE STORMWATER AND RETENTION FACILITIES AT BEAUFORT WEST, WESTERN CAPE

(Assessment conducted under Section 38 (8) of the  
National Heritage Resources Act (No. 25 of 1999) as part of an BAR)

28 February 2011  
Revised: 4 August 2011

PALAEONTOLOGICAL IMPACT ASSESSMENT OF THE PROPOSED  
UPGRADE TO THE STORMWATER AND DETENTION FACILITIES IN  
HILLSIDE, BEAUFORT WEST, WESTERN CAPE

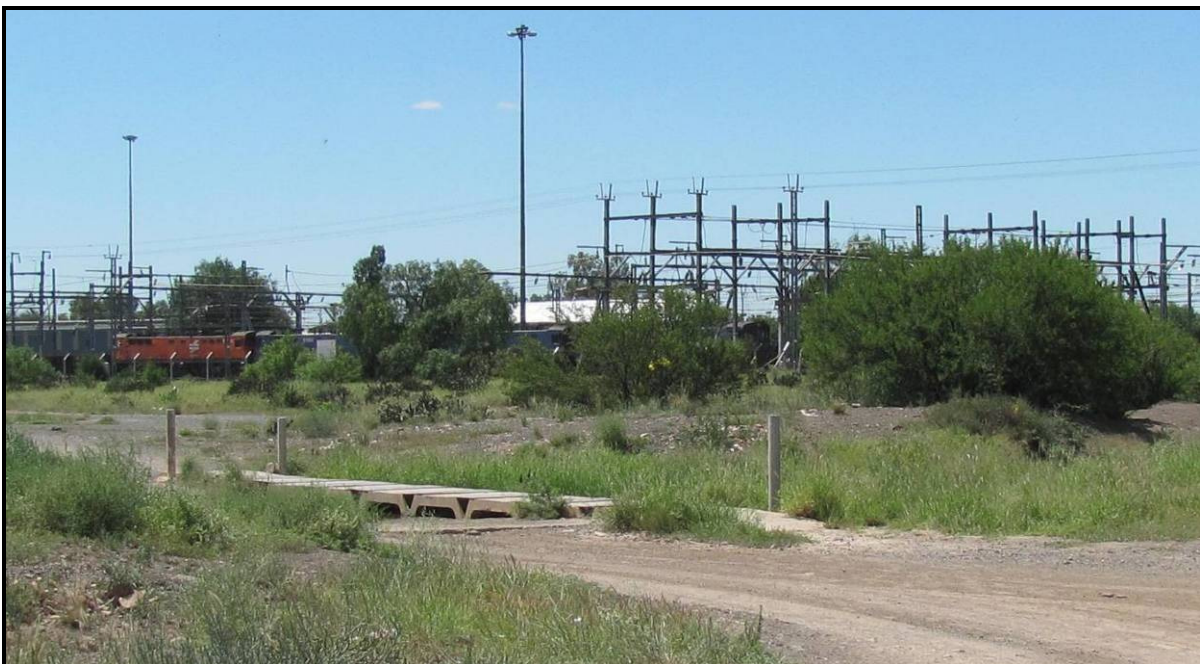
**Plate 1:** Proposed location for retention dam 1 - view eastward toward the railway lines.

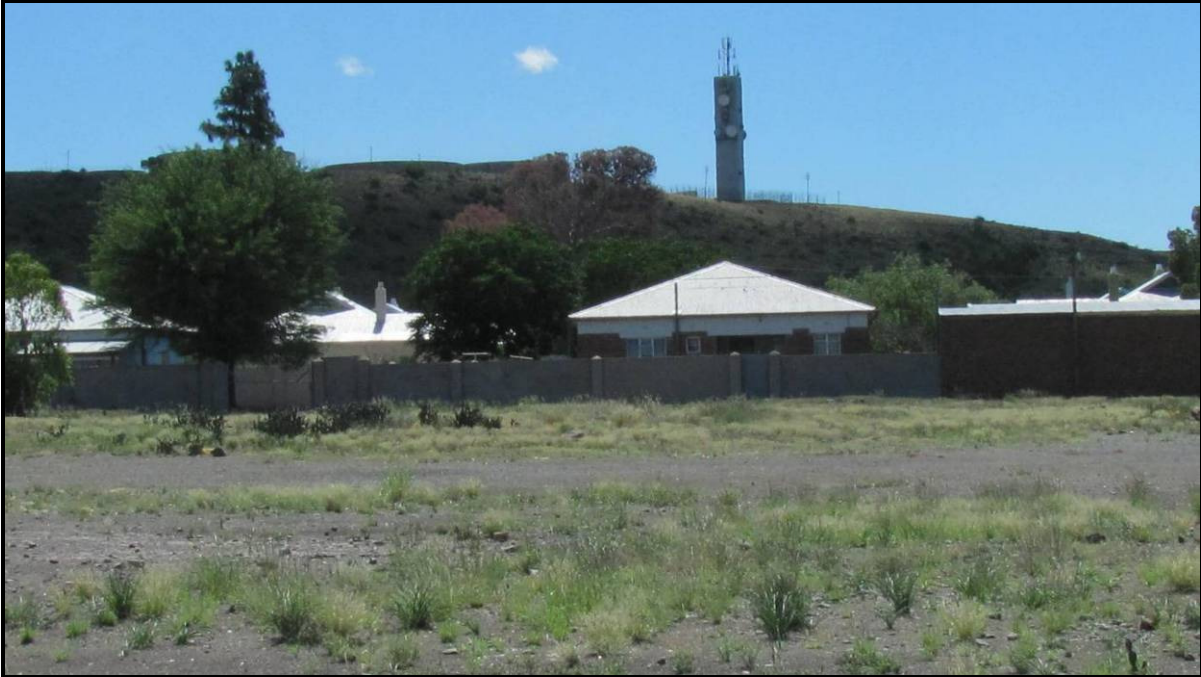
**Plate 2:** Retention dam 1 - view to the north. Note the hill to the north of the suburb with radio mast and water reservoirs.

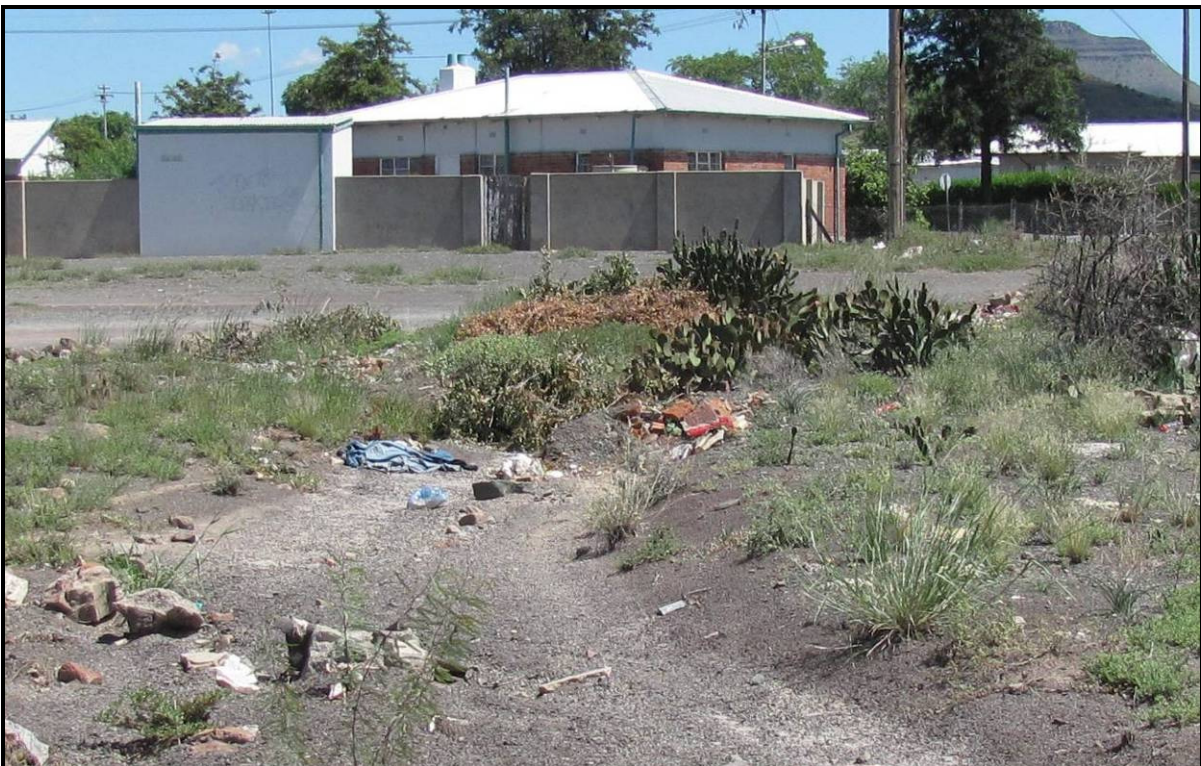
**Plate 3:** Retention dam 1 – view of the shale substrate, the alien vegetation and the dumping of rubble.

The suburb of Hillside lies to the west of the railway line which bisects the town. A small hill, reaching a height of 800 m, is positioned to the north of the suburb. It has a water tower and reservoirs on top. The suburb of Hillside is a mix of older houses (probably dating to the early part of the 20<sup>th</sup> century) along the base of the hill. However, there are more recent houses (from the 1970s) to the south, abutting the area identified for retention dam 1 (Figure 2). Retention dam 2 is located next to a recently constructed township (post 1999). Both vacant areas comprise a mix of shale bedrock and alien vegetation. These areas have been used as a general dumping ground by residents and they contain builder's rubble and rubbish. After recent heavy rains in the area, there were also pools of water.

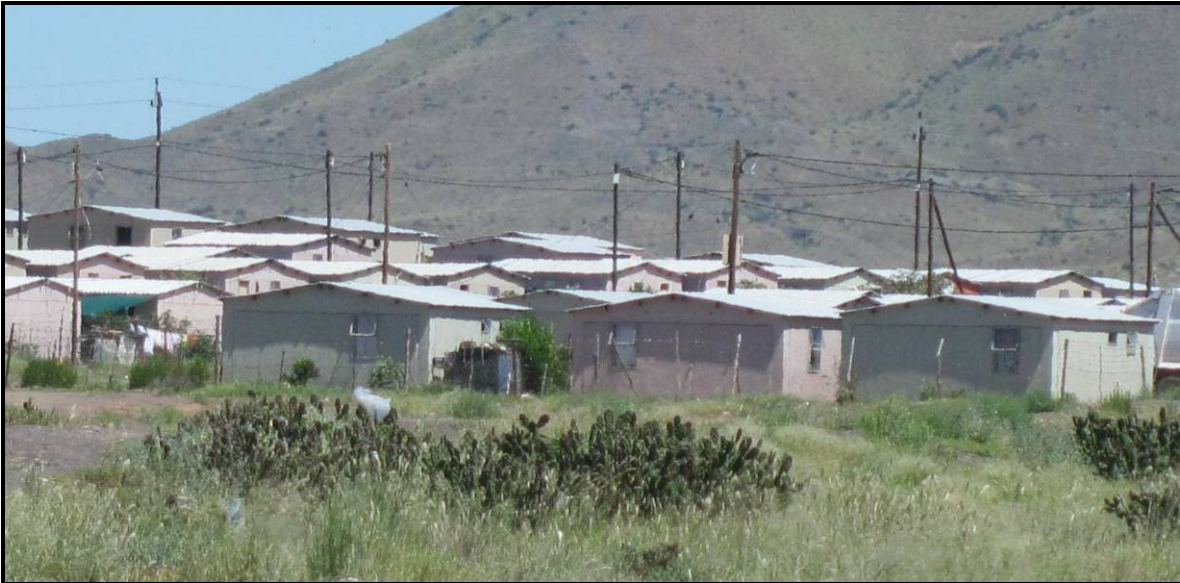
**Plate 4:** Retention dam 2 – view of the houses which surround the property and the dense vegetation which covers the area.

The vacant land identified for retention dam 2 (Figure 2) is now completely enclosed by sub-economic housing. It has more evidence for dumping of builders rubble and the vegetation is also higher, suggesting a greater water flow in the area.

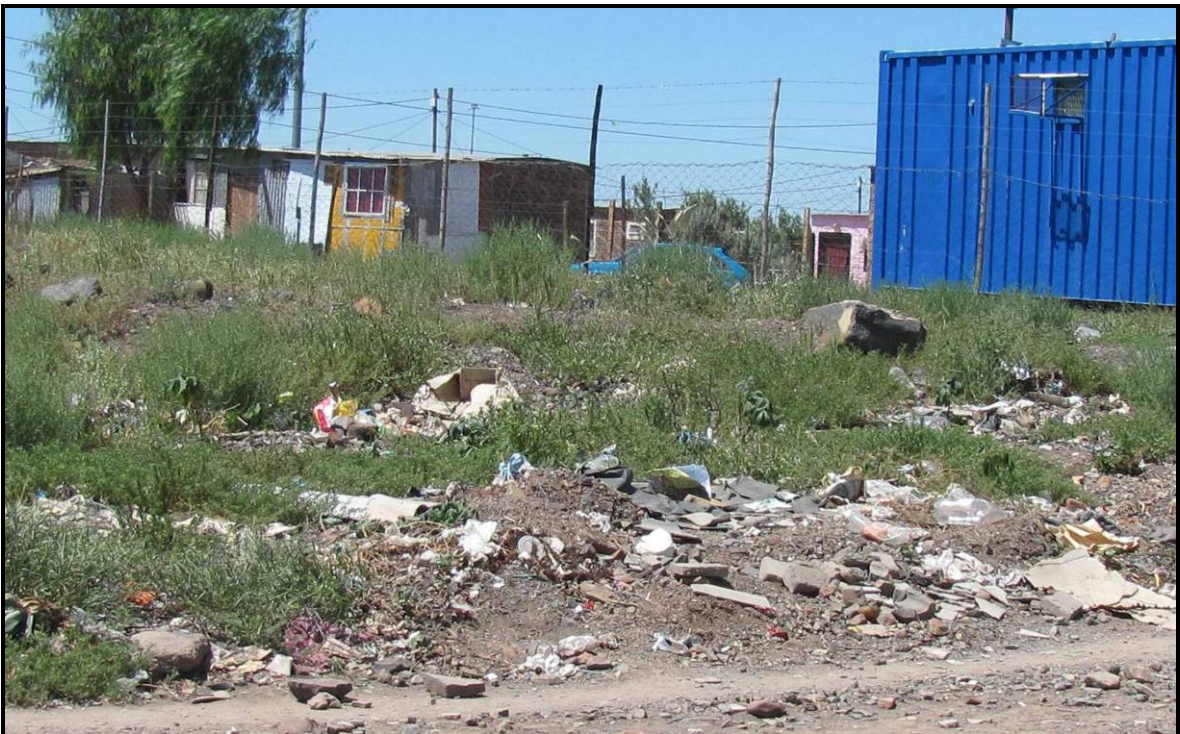
**Plate 5:** View of the rubbish which has been deposited on the site.

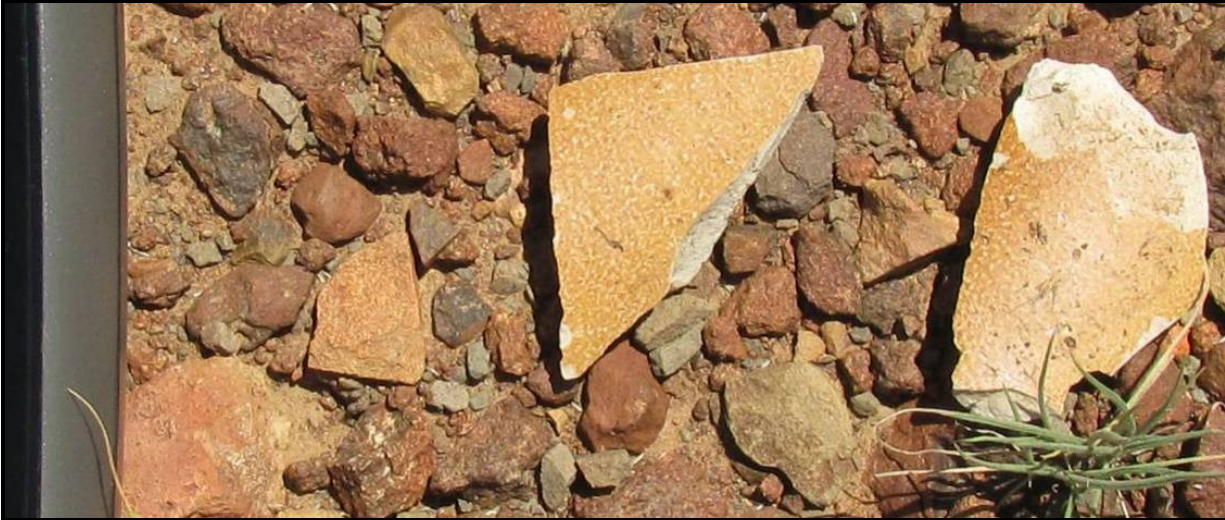
**Plate 6:** A few fragments of European stoneware found at the base of the hill, above the houses on Park Avenue.

A number of fragments of European stoneware, possibly representing a single vessel, were found at the base of the water tower hill (Plate 6). They were mixed with more common 20<sup>th</sup> century bottle glass and debris, including scrap metal and builders rubble.

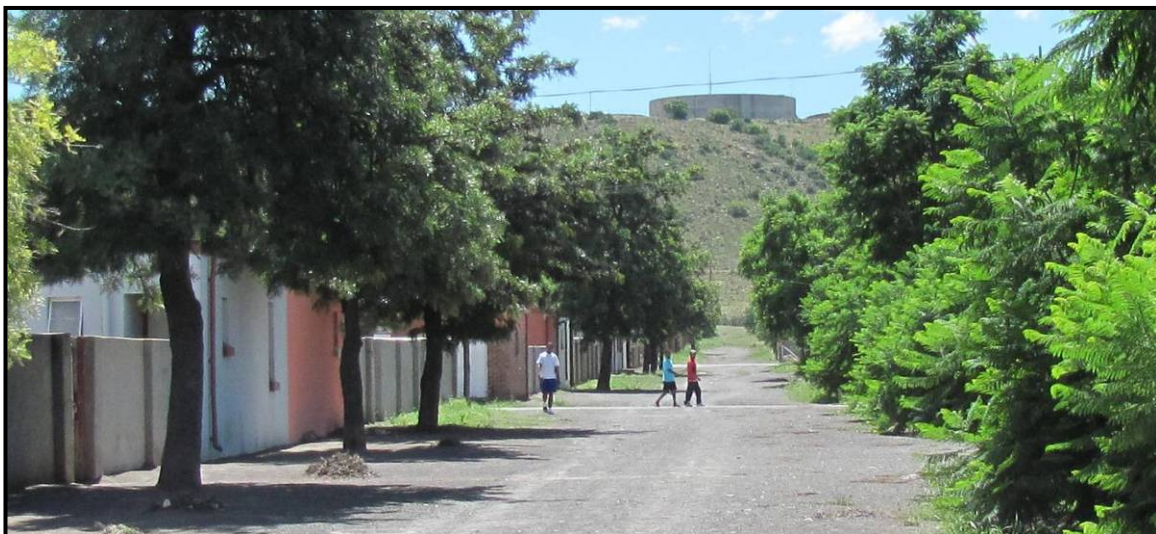
**Plate 7:** Basson Street is wide and lined with trees. It has a gravel surface, making it the most appropriate road for a channel to connect the retention dam 1 to the existing channel (Figure 2). Note the hill at the end of the road and the water reservoir.

No issues of built environment will be impacted. A channel will run down Basson Street, connecting to retention dam 1. This street was examined for heritage indicators. The channel will be below ground and no heritage issues were identified.
