# HERITAGE IMPACT ASSESSMENT

MR00280 Cape Winelands

Bonnievale – Cape Winelands District Municipality, Western Cape

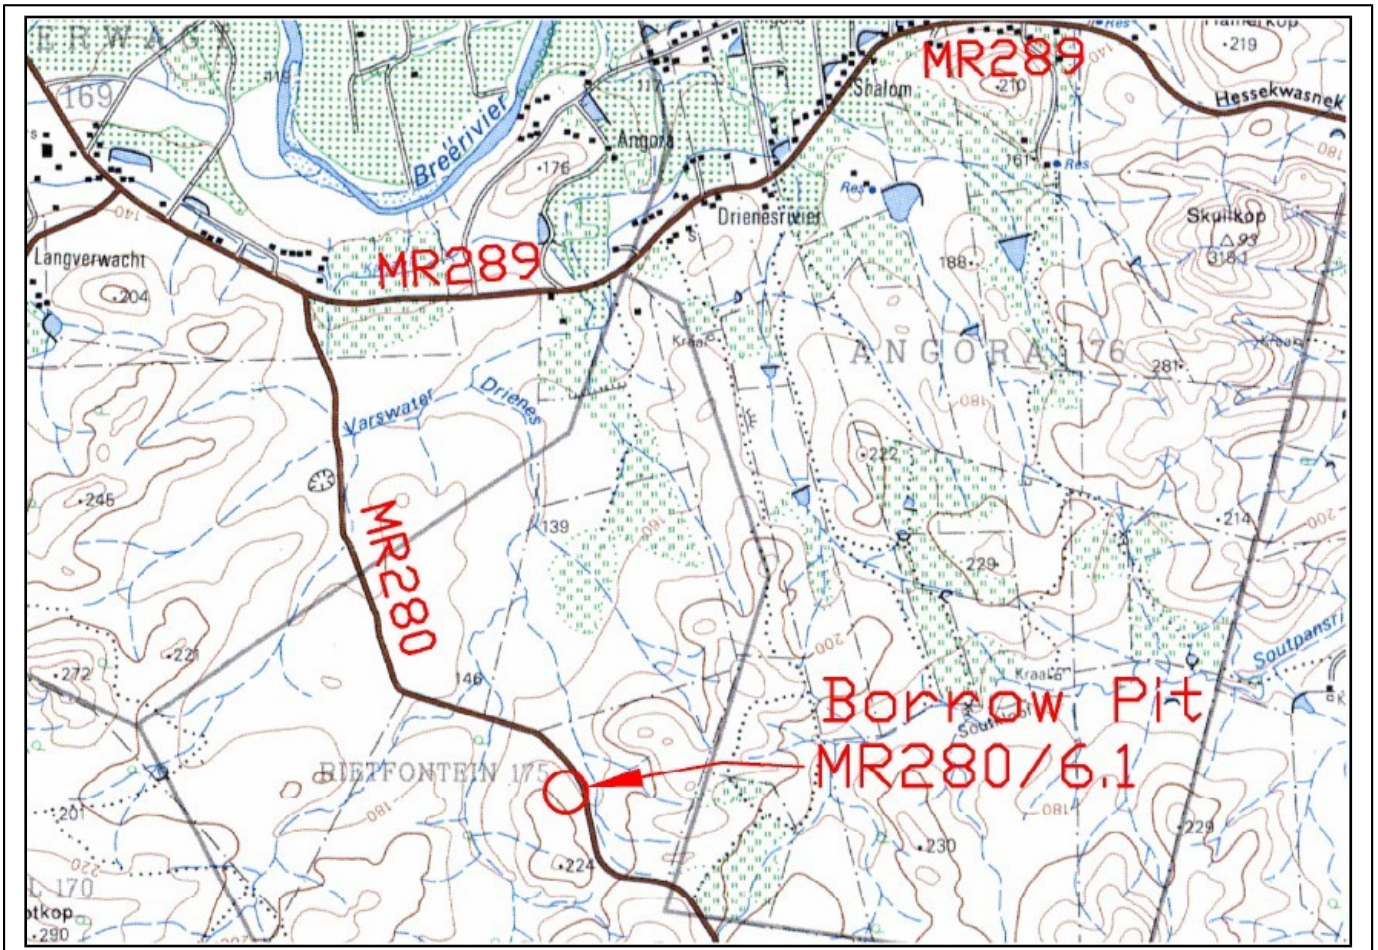
Figure 1: Extract from topographical sheet 3320 CC (extracted Almond 2013: 2)

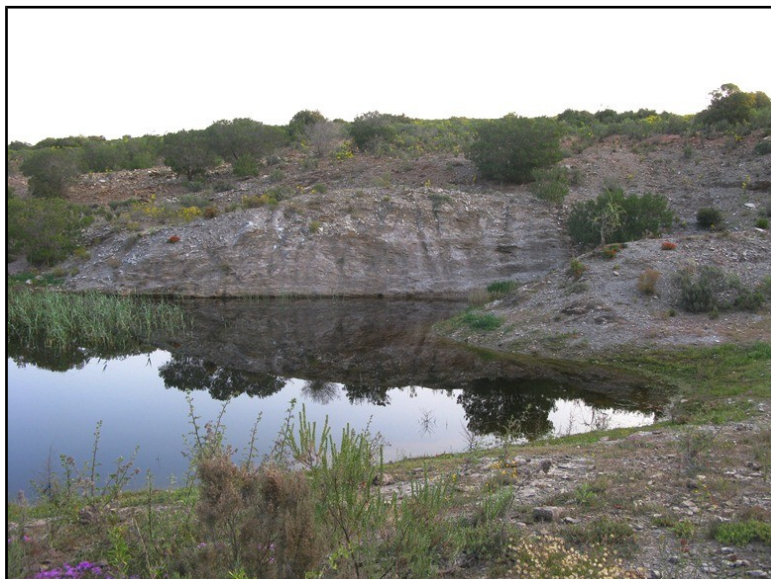
Figure 2: View westwards across the existing, partially water-filled pit (Almond 2013: 5)

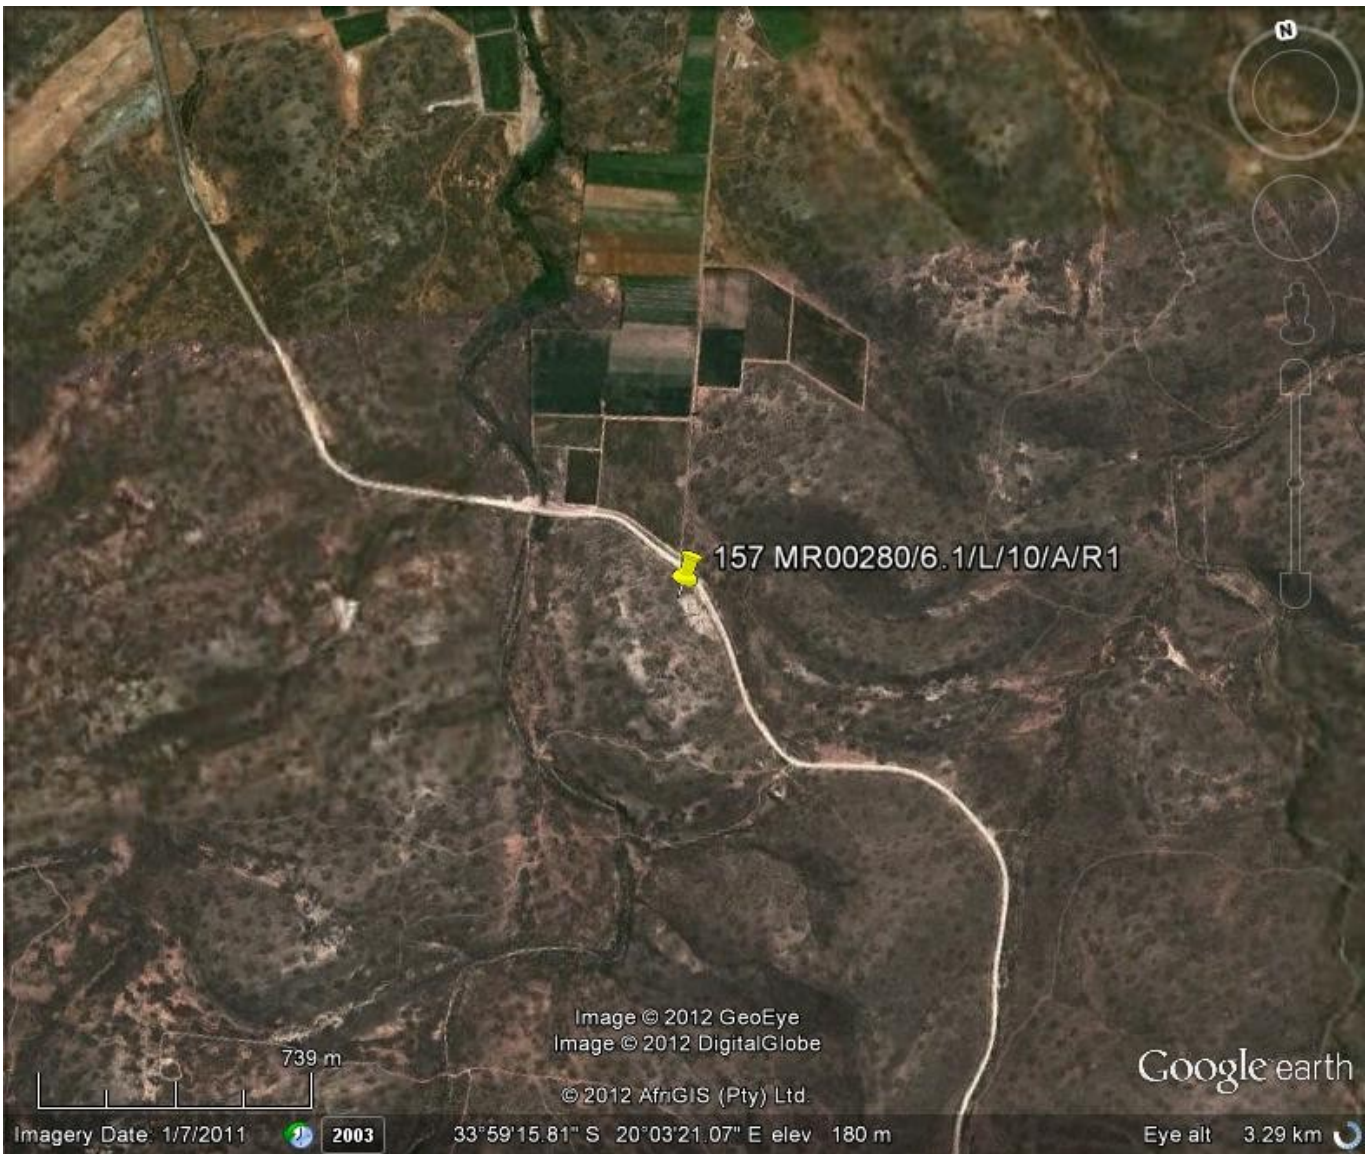
Figure 3: Aerial view of existing borrow pit location (Google earth image, February 2013)
