HERITAGE IMPACT ASSESSMENT: PROPOSED LOXTON WIND ENERGY FACILITY 2, CARNARVON AND VICTORIA WEST MAGISTERIAL DISTRICTS, NORTHERN CAPE

Required under Section 38(8) of the National Heritage Resources Act (No. 25 of 1999)

1st draft: 19 October 2022

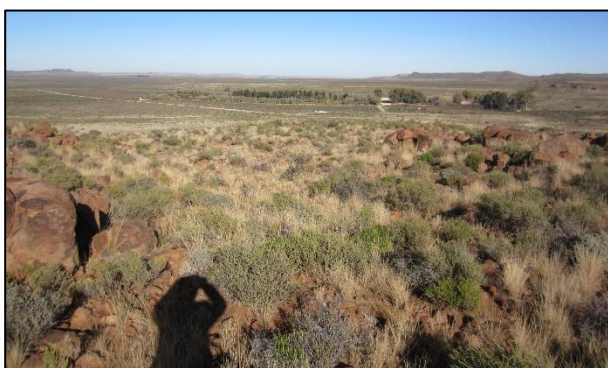
Figure 15: The location of the LSA site at waypoint 1988. The river is visible in the background.

Stone Age materials were rarely found. No ESA artefacts were seen and MSA artefacts were restricted to rare background scatter items. One LSA site was found at waypoint 1988. The site lies on an open sandy patch atop a dolerite dyke and is some distance from the nearest river (Figure 15). The artefacts were on hornfels and chert (Figure 16). Many pieces of ostrich eggshell were also seen.

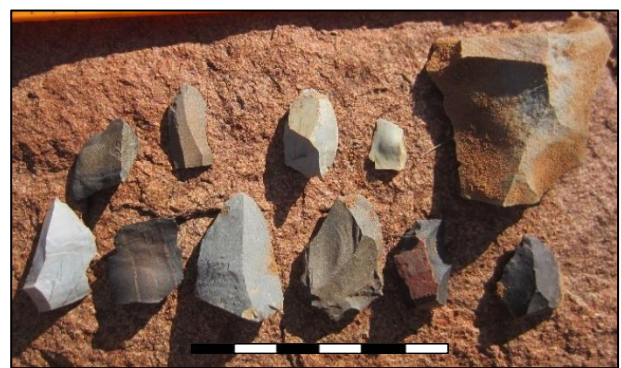
Figure 16: Stone artefacts on hornfels and chert from waypoint 1988. Scale in cm.

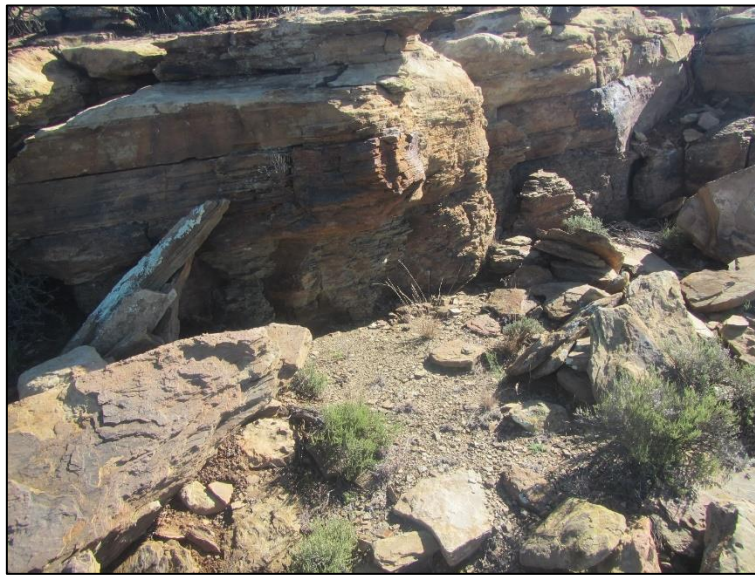
Figure 17: *The ephemeral, semi-circular stone feature at waypoint 1237. The alignment is not clearly visible in the photograph but on site it was clear that stones had been moved into position.*

A few historical archaeological sites were also found. These ranged from very ephemeral alignments of stones to ruined formal structures. The tiny, semi-circular feature at waypoint 1237 (Figure 17) is

an example of the former and several other small stone features of indeterminate function were noted in other places.

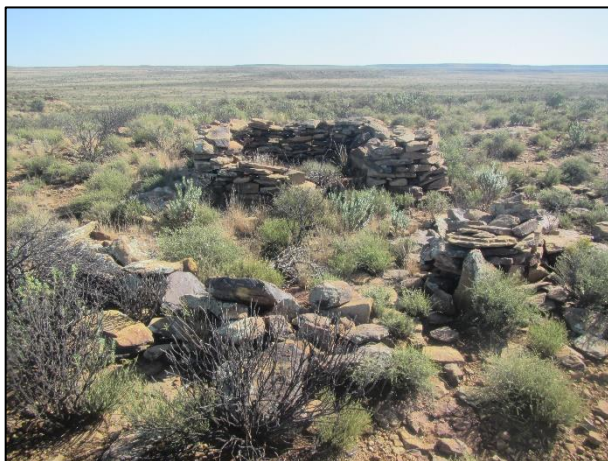
Figure 18: *Stone-walled hut in the background with a vestibule in the foreground at waypoint 1272.*

Slightly more formal was a stone walled structure that must have been a shepherd's hut at waypoint 1272 (Figure 18). The main room of the structure was about 2 m by 2 m but a 3 m diameter and opens into a slightly less formally built vestibule that lies to the south. A few historical items were noted in the area (Figure 19).

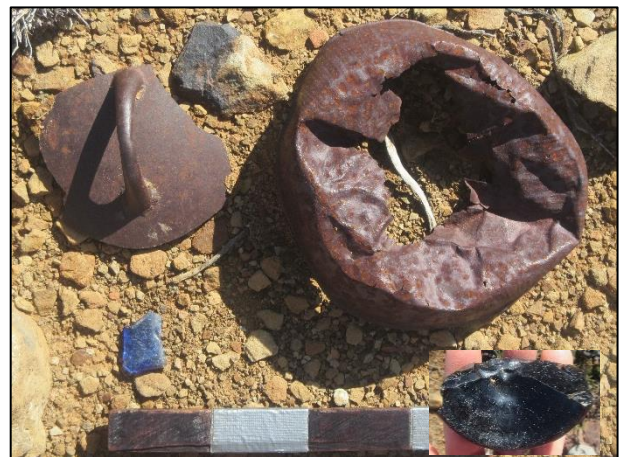
Figure 19: *A fragment of potjie, an enamel bowl, and pieces of cobalt blue and black bottle glass from waypoint 1272.*

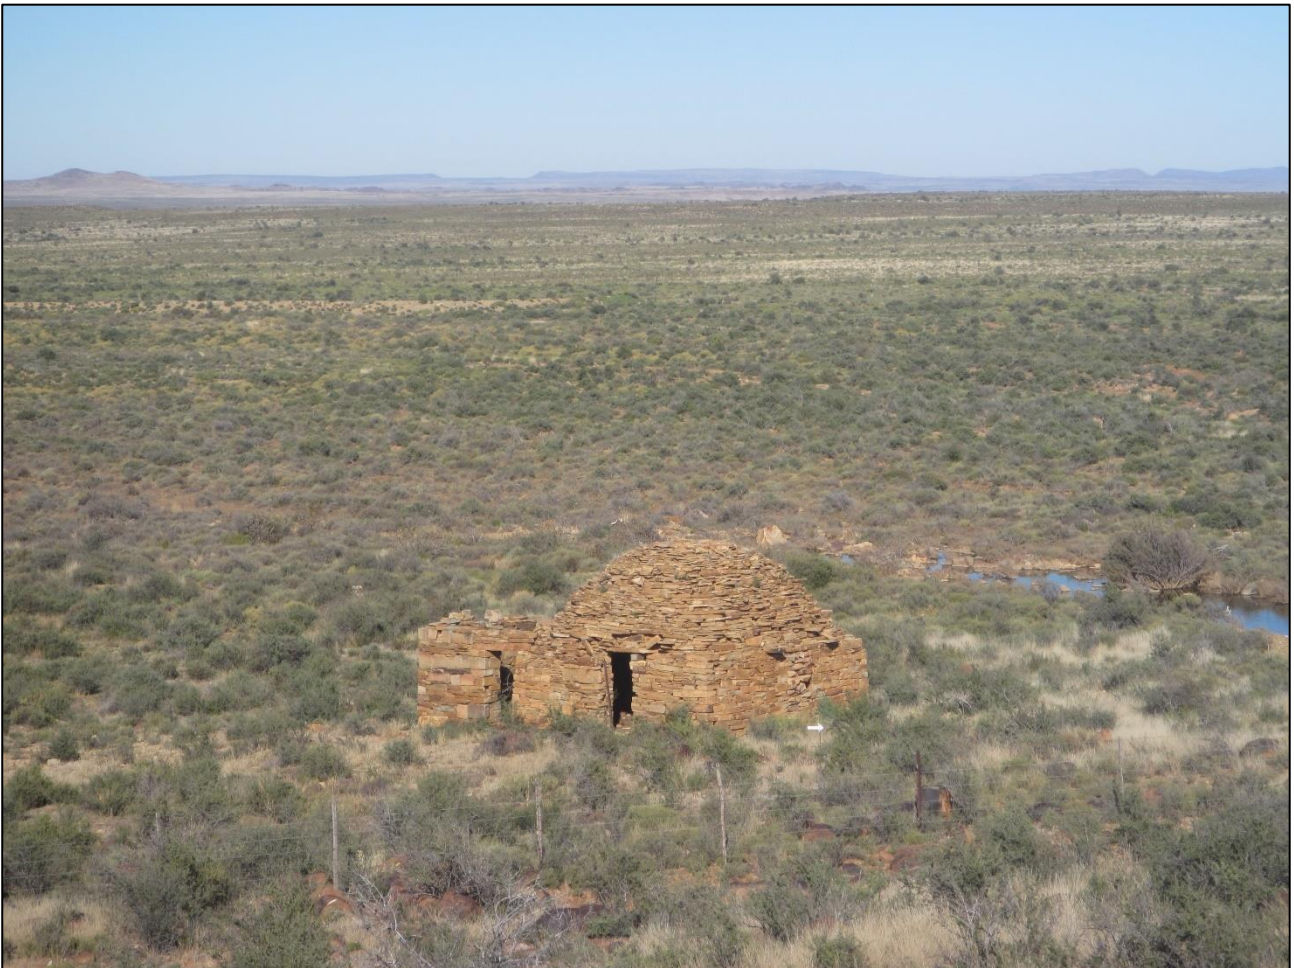
Figure 20: East and north sides of the corbelled building at waypoint 1270 and recorded as Ystervarkspoort 2 by Kramer (2012).

The most important site located during the survey was a corbelled building at waypoint 1270 (Figure 20). Although it lies just outside the study area, it has been illustrated here because of its significance. It is also on the borderline between the legal definitions of archaeology and built environment, but because of clearly archaeological features associated with it, it has been included under archaeology. The structure is a square-based structure with a round dome. It originally had

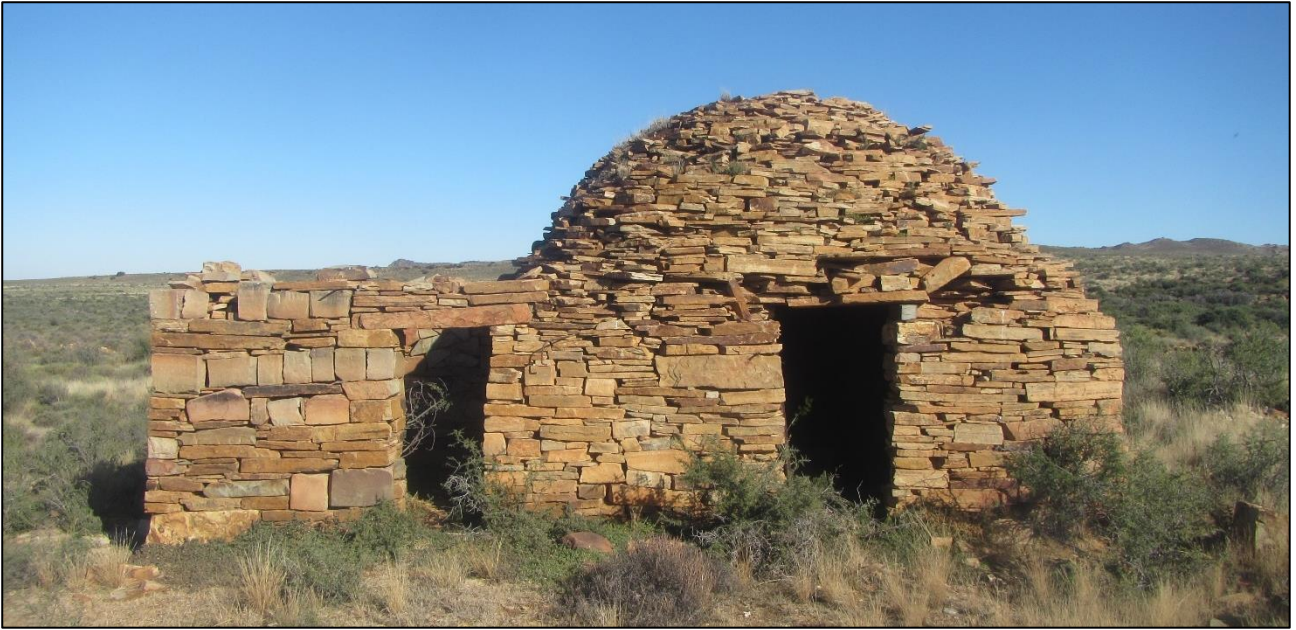
Figure 21: East and north sides of the corbelled building at waypoint 1270.

doors to the east (Figure 21) and north, but the northern one has been closed up (Figure 22). A window to the west has also been closed up (Figure 23), while a rectangular, flat-roofed addition (also opening to the east and with a window facing west) has been made to the southern side (Figure 21). Internal features of the main building include some pierced wooden blocks with pegs through them set into northern wall above the closed-up door (Figure 24) and a corner shelf in the south-eastern corner (Figure 25). The top of the dome has been closed by two thin rock slabs (Figure 26). This site was recorded by Kramer (2012) but the floor plan she provides is incorrect in that the southern addition stops short of the western wall of the main structure (Figure 27). To the east are several stone-walled features. One is clearly the remains of a kraal, while others are of indeterminate function. Kramer (2012) noted a feature she thought might be a threshing floor to the southeast of the house. On aerial photography it looks to be about 12 m in diameter which is consistent with a threshing floor. This feature was not seen during the survey. Artefactual materials were also seen in the area and seem to be typical late 19th century materials (Figure 30). Kramer (2012) noted the dump to have been to the west of the house, but it is not known whether this was a proper dump or just an area of dense artefact scatter since no proper dump was seen there during the survey. The site lies adjacent to a river which flows through a small poort in dolerite dyke, but the poort has been dammed.

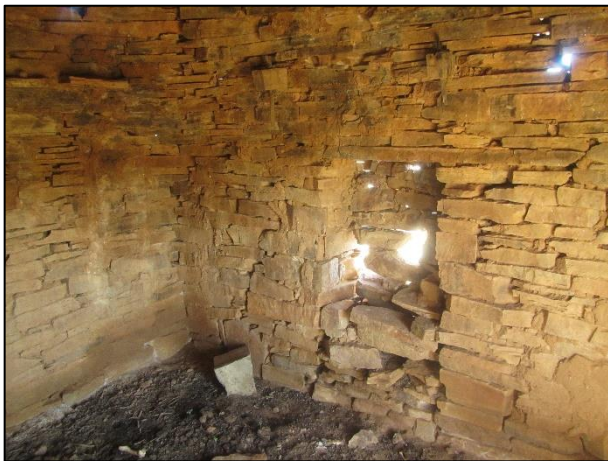
Figure 22: Closed up door in the north wall of the corbelled building at waypoint 1270.

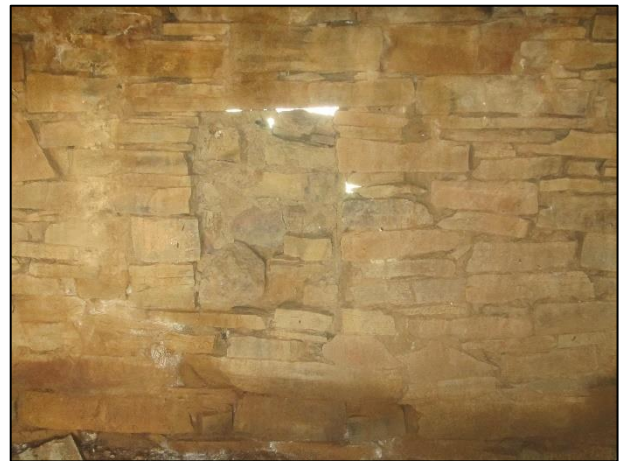
Figure 23: Closed up window in the west wall of the corbelled building at waypoint 1270.

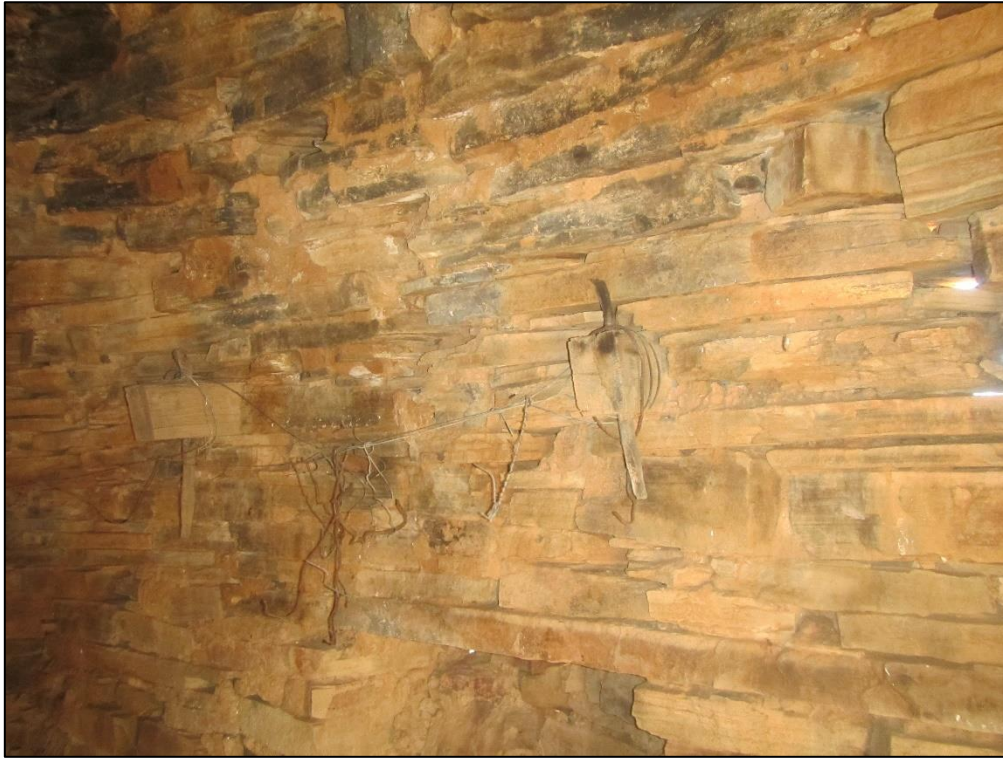
Figure 24: Internal features of the corbelled building at waypoint 1270. Two pierced wooden blocks with pegs through them are visible in the wall above the lintel of the now closed up northern door. Some wire has been fastened to the wooden blocks.

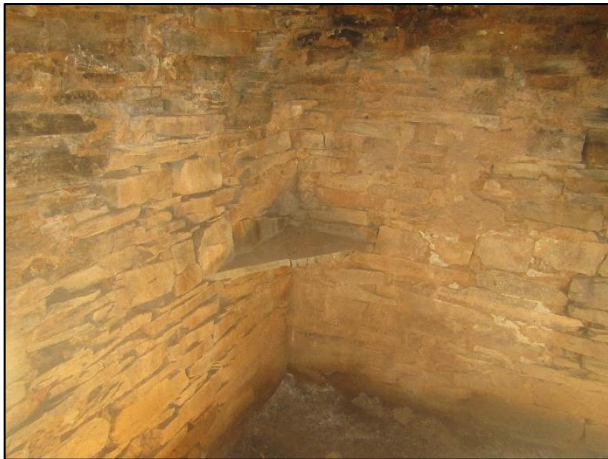
Figure 25: Internal corner shelf in the corbelled building at waypoint 1270.

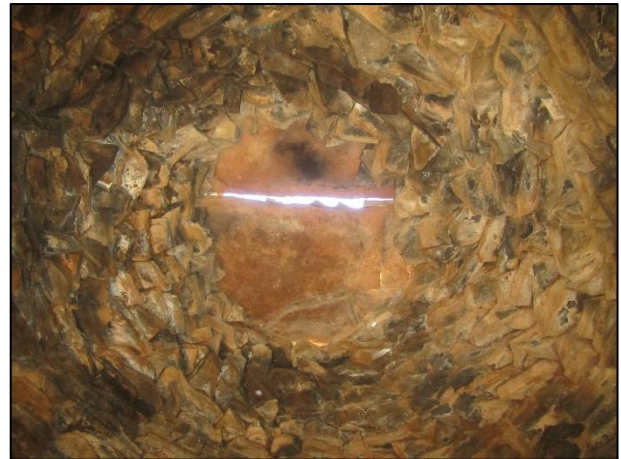
Figure 26: The inside of the dome in the corbelled building at waypoint 1270 showing two large slabs closing the top.

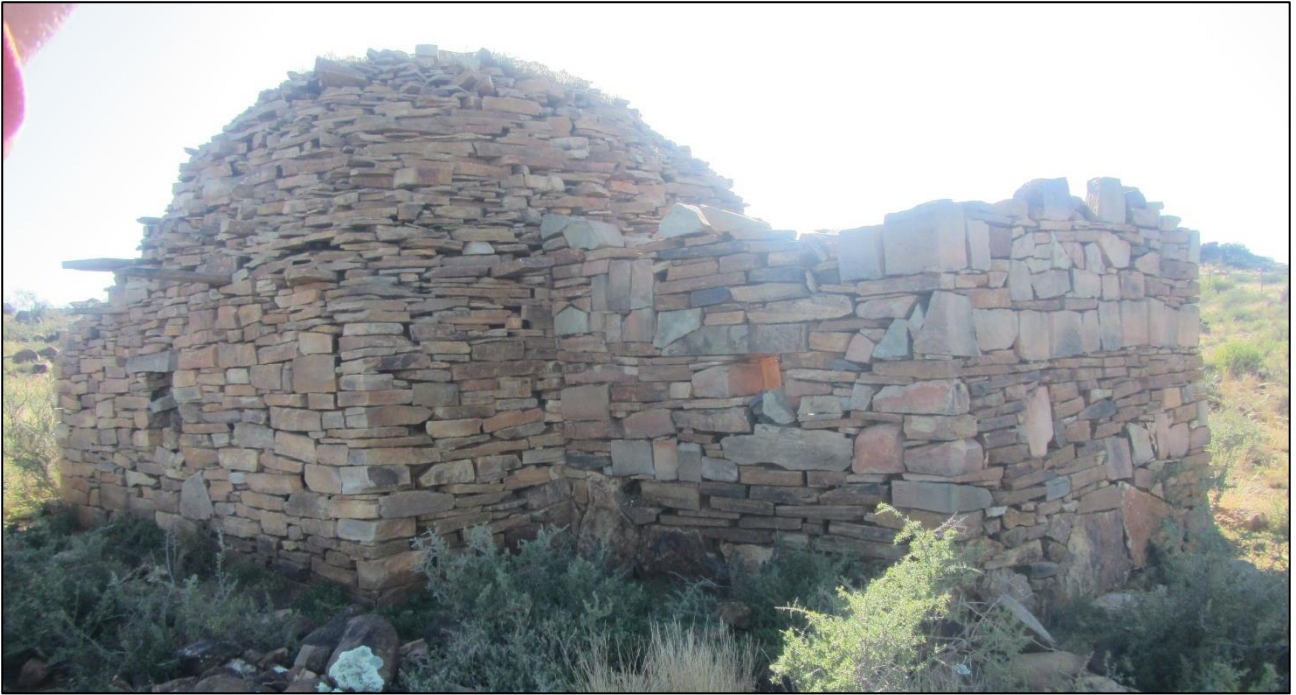
Figure 27: West and south (with added flat-roofed room) faces of the corbelled building at waypoint 1270.

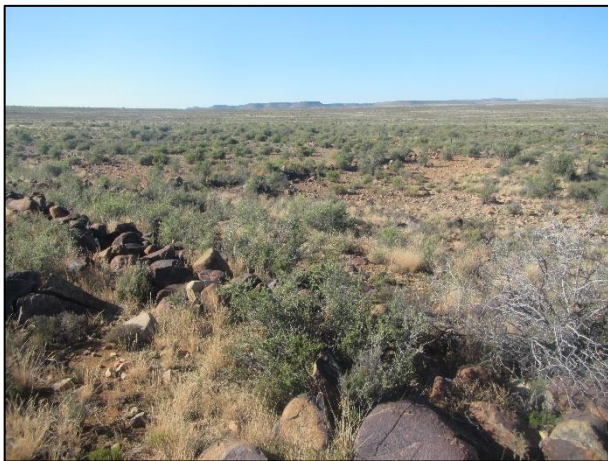
Figure 28: Stone-walled kraal at waypoints 1268-9.

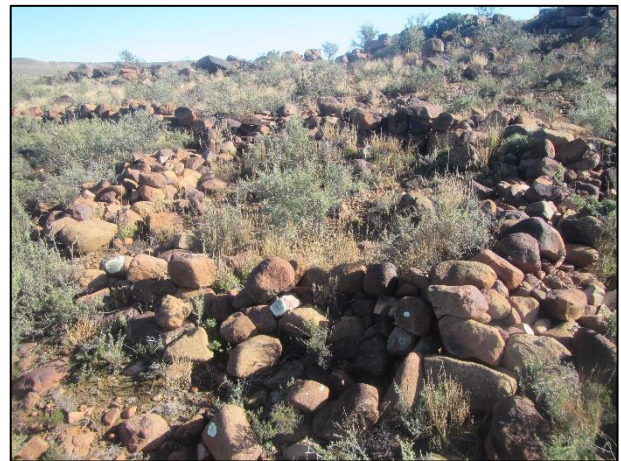
Figure 29: Stone-walled feature at waypoint 1269.

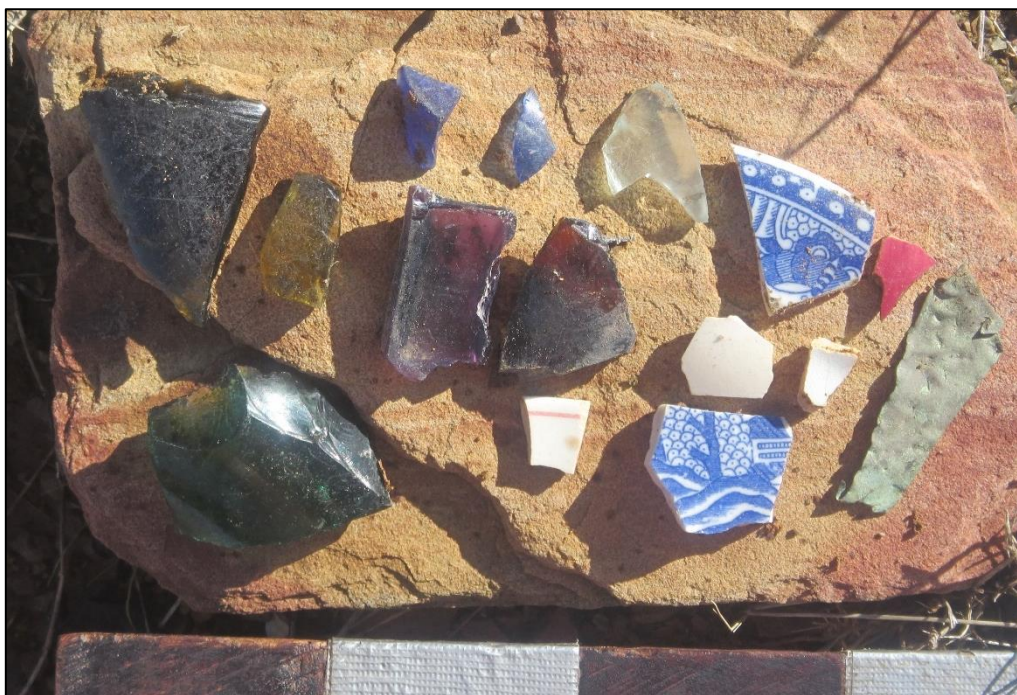
Figure 30: Historical materials from outside the corbelled building at waypoint 1270.

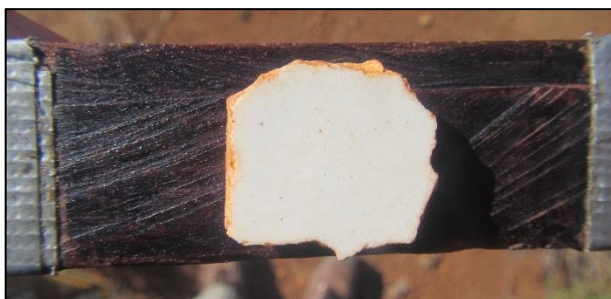
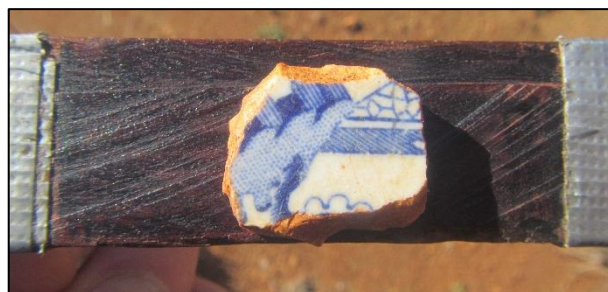
Figure 31: waypoint 1233.

Although only an isolated artefact, one other historical observation of interest was a ceramic game counter seen at waypoint 1233 in the absence of any other associated materials. It was clearly dropped there on purpose or by mistake. It was made on a piece of willow pattern refined white earthenware (Figures 31 & 32).

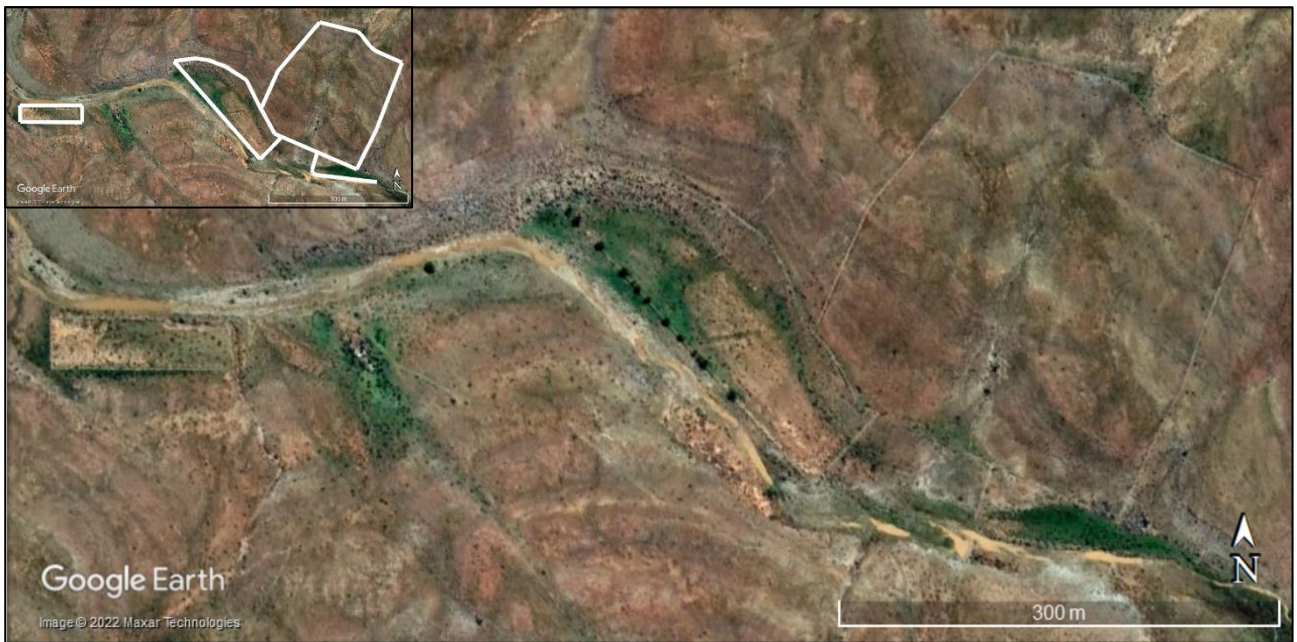
Figure 33: Aerial view of the stone-walled features at waypoints 013 (left) and 014 (right). The inset shows the exact same view but with the walling highlighted.

Further archaeological features were seen on aerial photography. Most impressive was a series of large walled features to the west of the Aarfontein farm complex. While two are clearly garden areas because they lie on the river floodplain, one of far larger and extends up the hill to the north of the river (Figure 33).

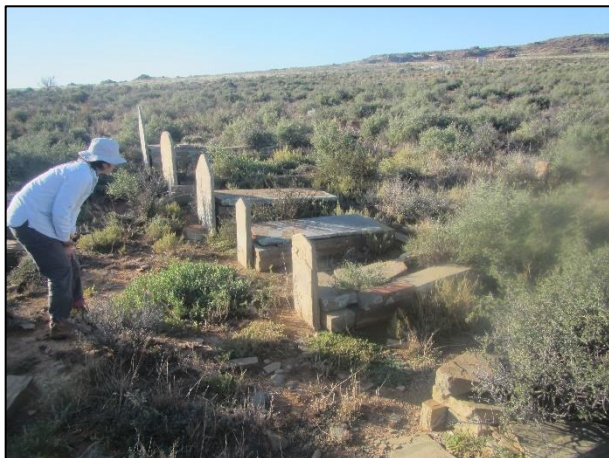
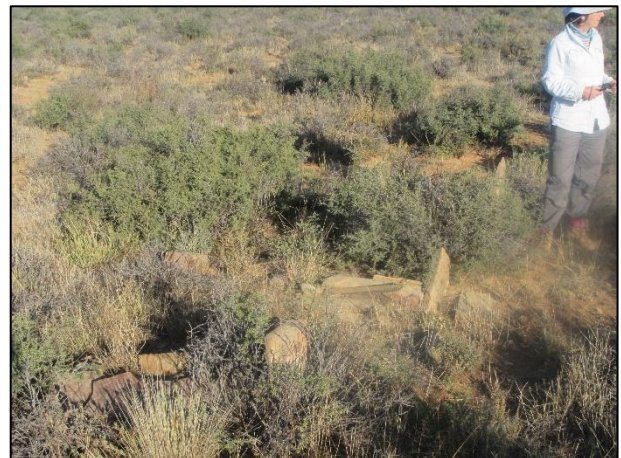
Figure 34: Graveyard at waypoint 1281 in the Ystervarkspoort farm complex.

Figure 35: Graveyard at waypoint 1281 in the Ystervarkspoort farm complex.

No isolated graves were seen during the survey but a graveyard was found in the Ystervarkspoort farm complex.

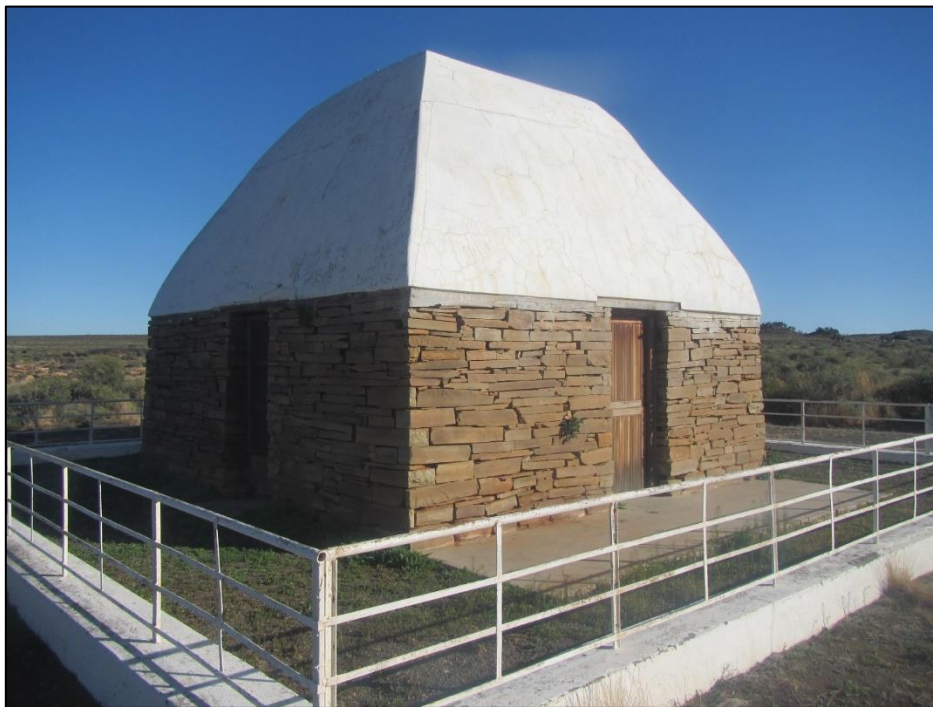
Figure 38: The corbelled building at waypoint 1265 and recorded as Ystervarkspoort 1 by Kramer (2012).

Historical and built heritage resources all occur along river valleys and they are generally few and far between. Only one farmstead was visited during the survey and this was that at Ystervarkspoort in the east. There are two generations of farmhouses with the oldest being a corbelled building that has been renovated and maintained. Although it has lost its charm by having its corbelled dome plastered and painted, the overall structure will certainly last longer (Figure 38). The current farmhouse appears to date to the mid-20th century (Figure 39), and seemingly after 1960 (Figure 40). Another structure on the farm may have served as a house in between. Other features include a stone-walled kraal complex which, according to the evidence of Figure 40, has been partly dismantled sometime during the last 60 years. The remaining section, however, is well-preserved and well-maintained (Figure 41).

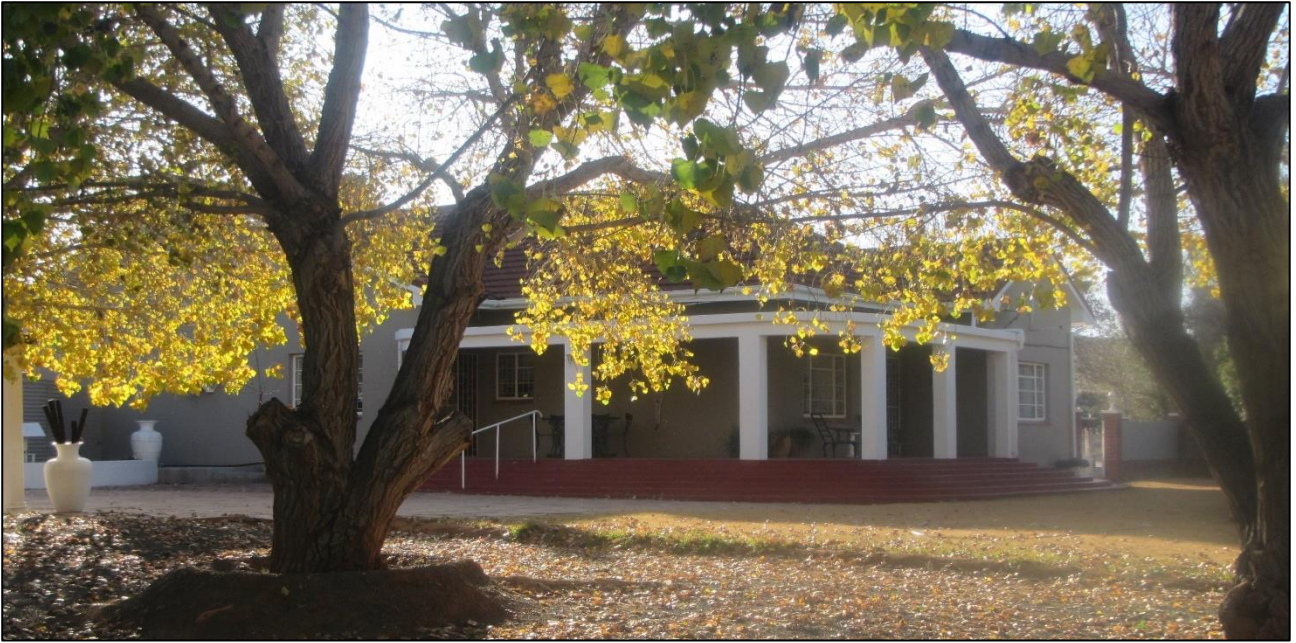
Figure 39: The current main farmhouse at the Ystervarkspoort farm complex at waypoint 1264.

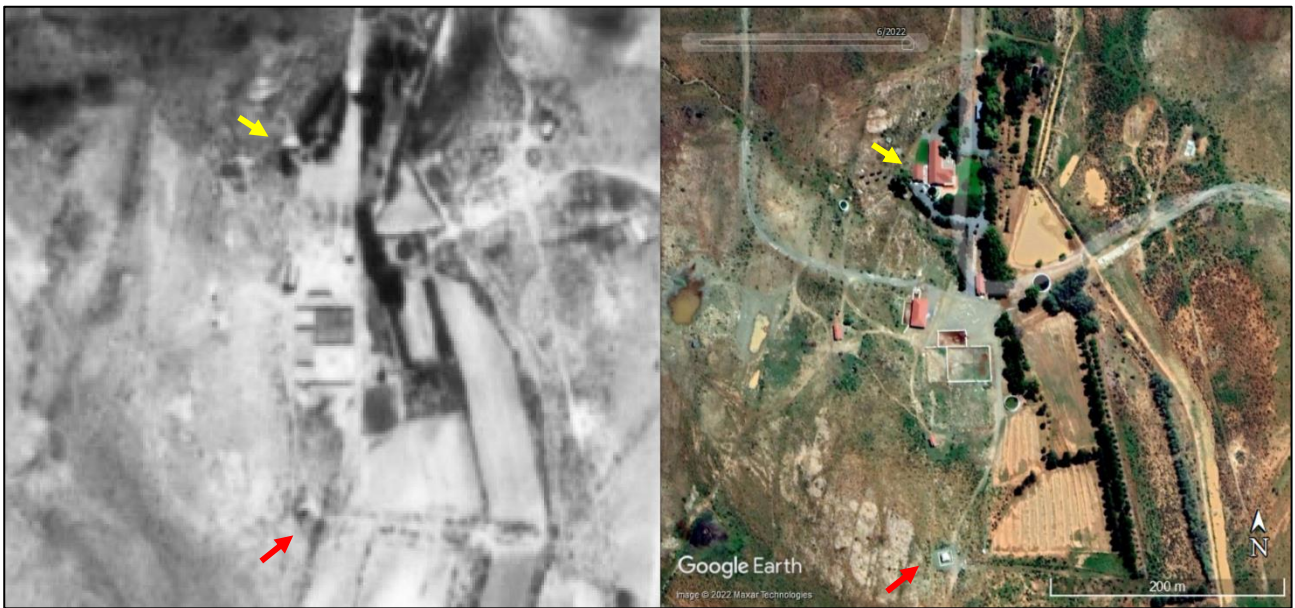
Figure 40: Historical aerial views from 1960 (434_005_02986) and today (Google Earth) of the Ystervarkspoort farmstead. Arrows show the corbeled building (red) and small outbuilding (yellow) behind the current farmhouse which does not seem to have been present in 1960.

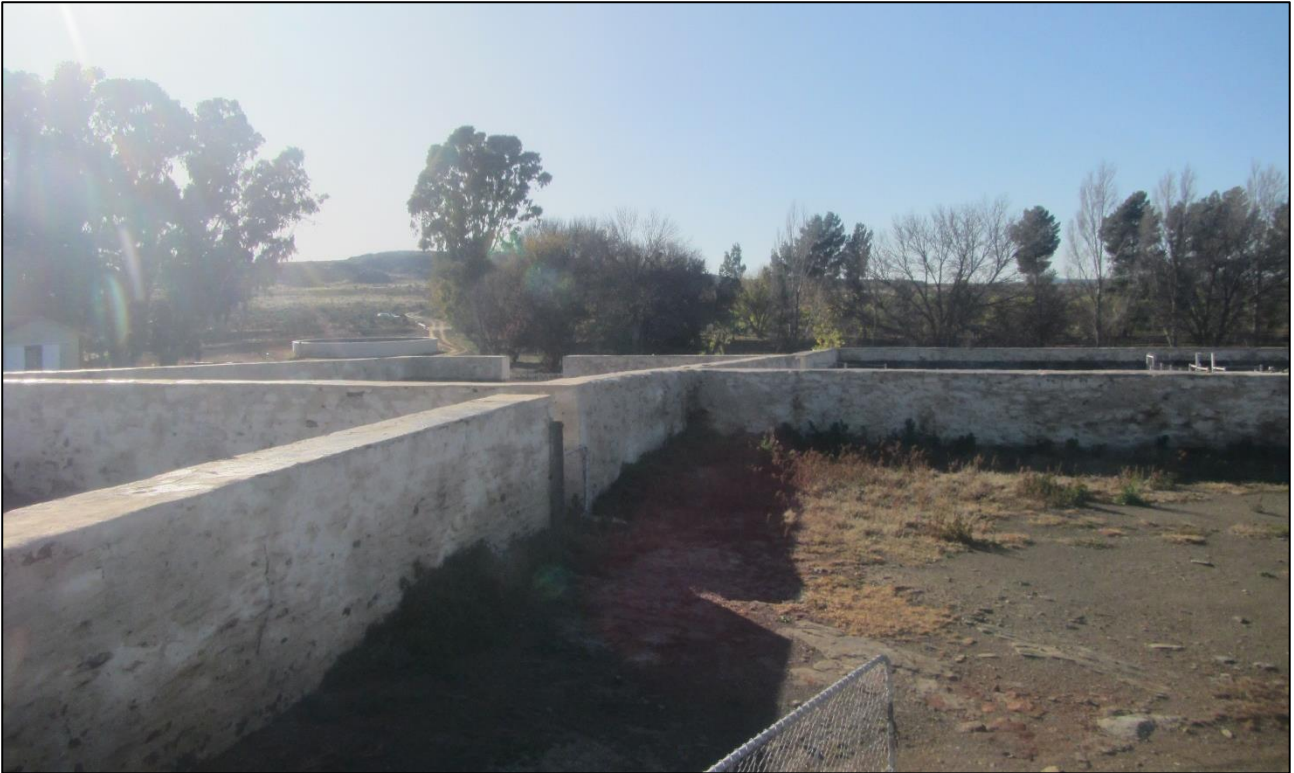
Figure 41: *The well-preserved remaining section of the stone-walled kraal complex at waypoint 1264.*

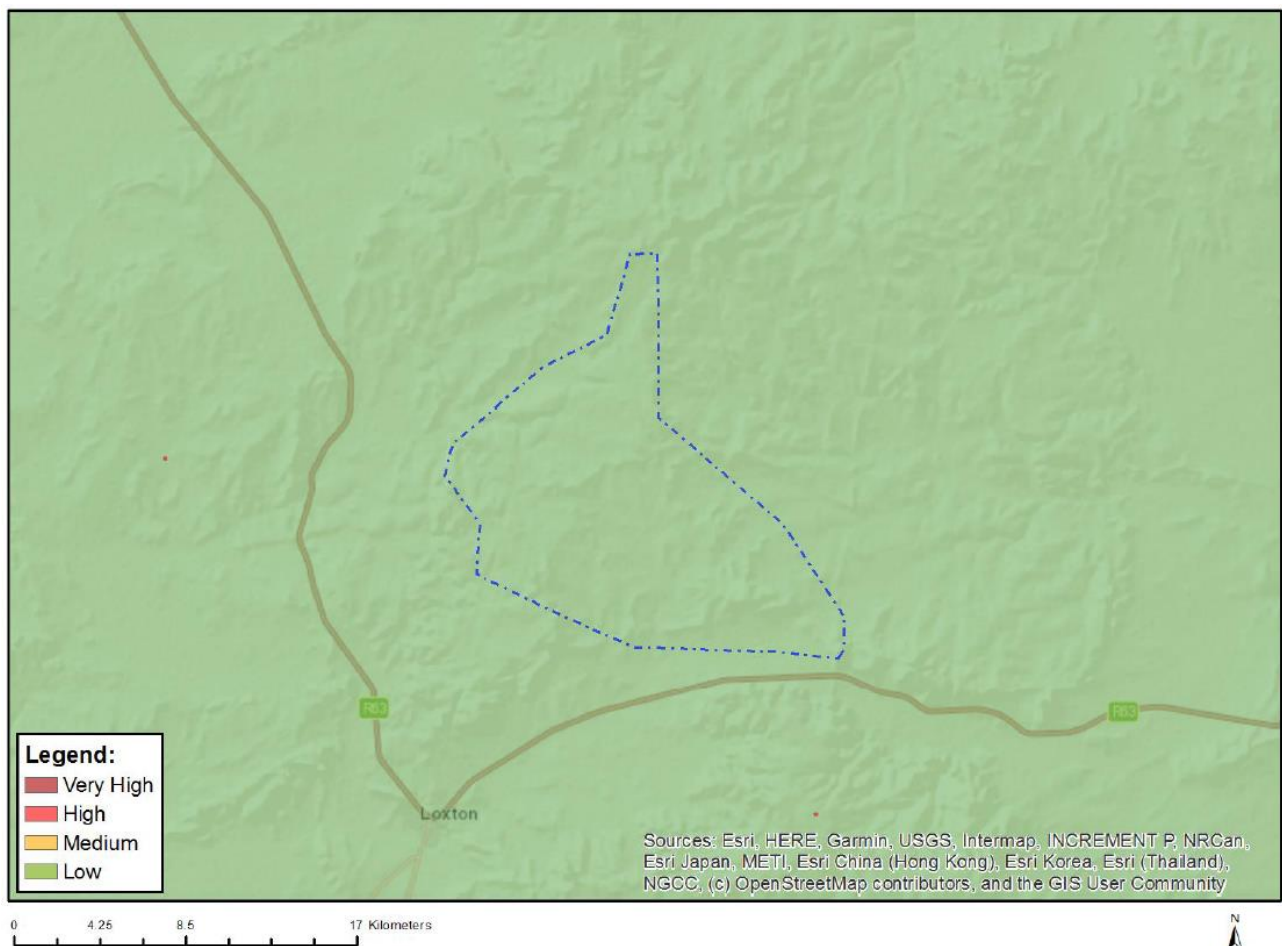
The map below is extracted from the screening tool report and shows the archaeological and heritage sensitivity to be low throughout the study area. The site visit showed that in fact the majority of the site is of low sensitivity with only small pockets (where heritage resources occur) considered to be of higher sensitivity. Figure 42 (in the HIA above) shows the areas considered to be sensitive from a heritage point of view. The main concerns are the farm complexes (inhabited and abandoned/archaeological) since these have high densities of heritage resources and are considered locally significant cultural landscapes. These tend to be in river valleys, while the ridges targeted for development have almost no traces of heritage. A photographic record and description of the relevant heritage resource is contained within the impact assessment report. The heritage specialist thus disputes the uniform low sensitivity, noting that several pockets of medium to high sensitivity are also present in the area.
