# PHASE 1 ARCHAEOLOGICAL ASSESSMENT OF NOVA CONSTANTIA

**Margie Walsh & Associates**

November 1993

**Archaeology Contracts Office**

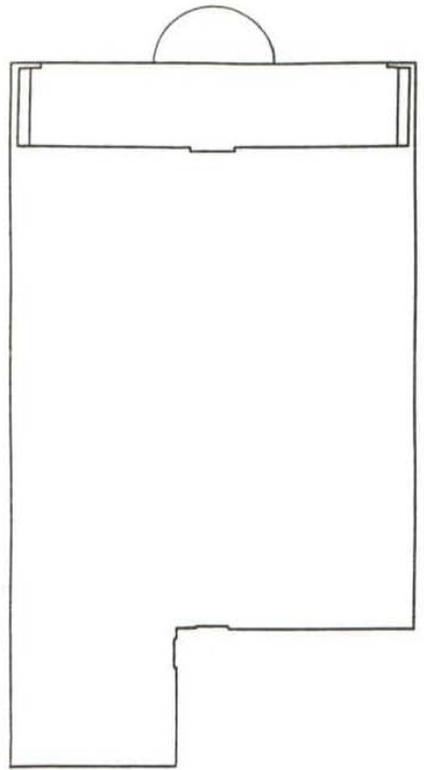
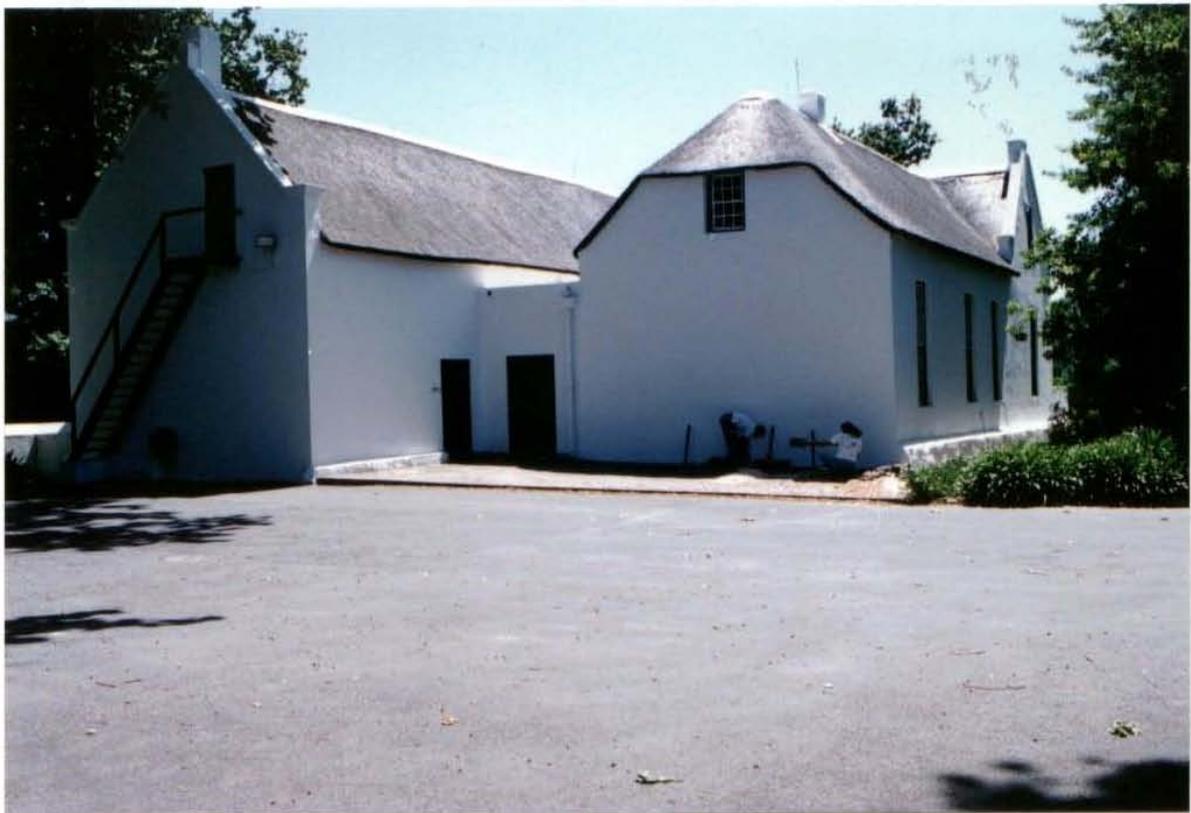
2

Nova Constantia was originally part of the farm "Berg Vliet" until it was deducted in 1793. The house was thought to have been built at this time, but according to Fransen and Cook, the joinery displays a number of early Georgian features, possibly indicating a period of early alteration. The front gable is neoclassical and bears affinities to the work of Thibault (Plate 1). The present layout of the house is a narrow "U" but the back wings are of unequal length - the short south east wing having a half-hipped end (Plate 2).<sup>1</sup>

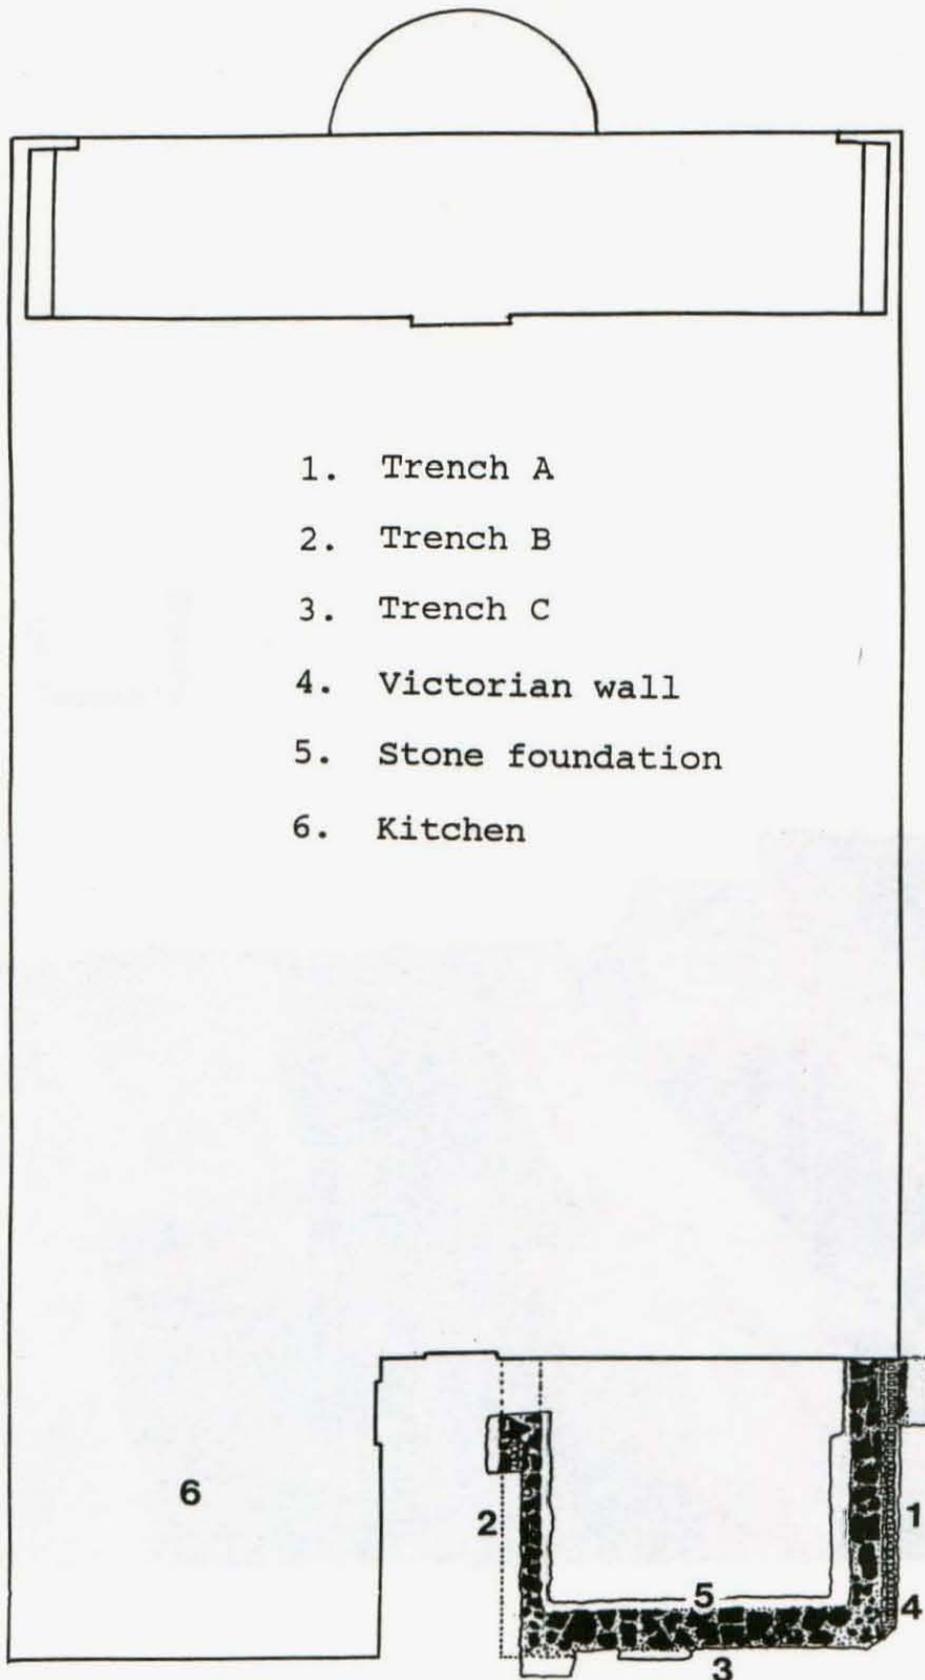
**2**

Three trenches (A, B and C) were excavated behind the south east wing. The first of these (A) was initially positioned to check for an extension to the south east wall of the main house (Figure 2).

- 1. Trench A
- 2. Trench B
- 3. Trench C
- 4. Victorian wall
- 5. Stone foundation
- 6. Kitchen

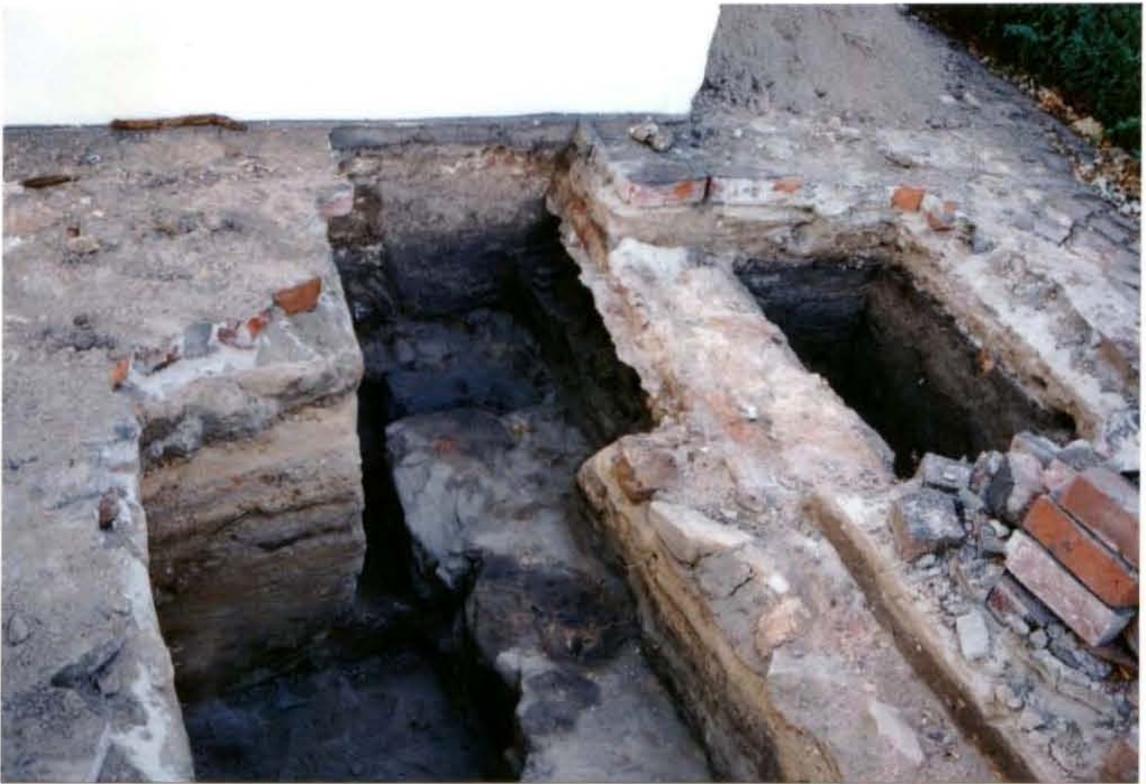
3

A deep trench was sunk to link the corners of the foundations exposed in both trenches A and B. The foundation, which lay some 120cm below the surface, (Plate 4) was made up of an alignment of large boulders with fragments of ferricrete and small stones used as gap fillers. The base of the foundation is set into a hard compacted 'B horizon' which lies 165 cm

below the present surface. Again, there is evidence to show that considerable effort had been taken to remove boulders from the foundation at some stage in the past.
