PHASE 2 ARCHAEOLOGICAL INVESTIGATION OF COLONIAL PERIOD BURIAL PATTERNS ON THE GROOT CONSTANTIA ESTATE, CONSTANTIA.

Groot Constantia Trust

March 1996

Archaeology Contracts Office

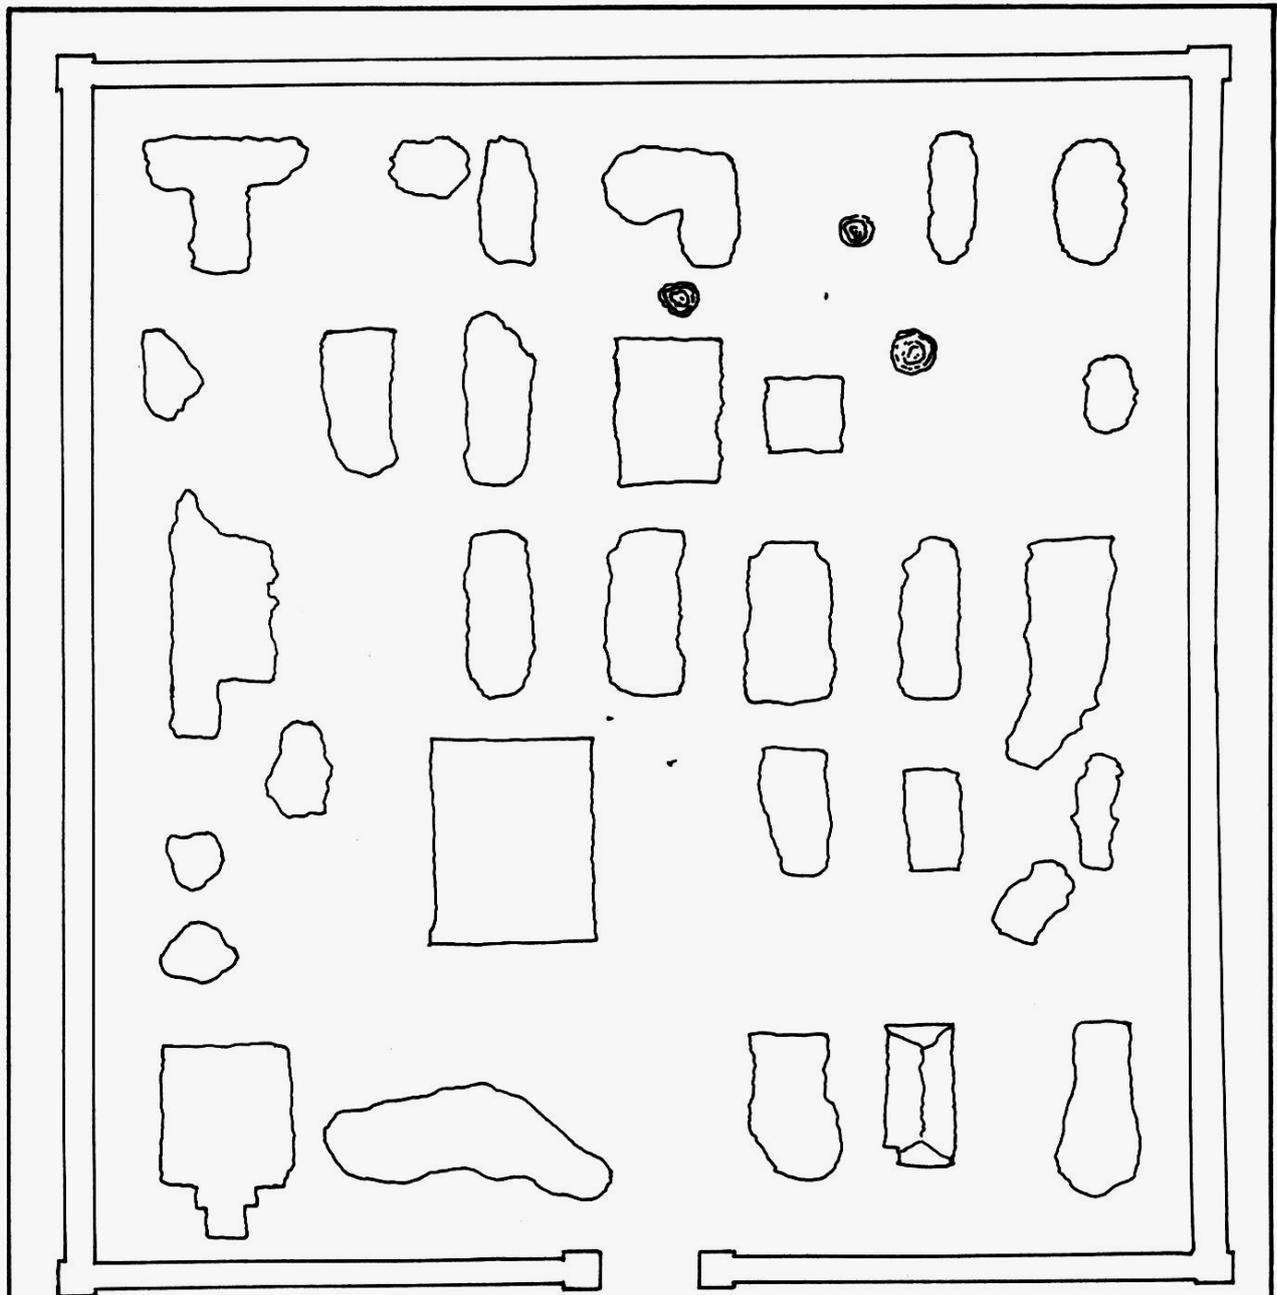
Cloete Cemetery - distribution of graves and other brick features prior to archaeological investigation.

(not to scale)

Five graves (see Figure 2: 5, 9, 7, 16) did not take the low vault form characteristic of this cemetery. Three of these were conventional graves with memorial stones. The fourth (grave 16) took the form of rectangular brick structure with a hollow interior (this had been badly damaged and collapsed) while the other (grave 7) consisted of a large low rectangular structure that had been filled and capped. This may have been a large tomb that had been made good at some stage in the past after its interior had caved in.

Besides features that were clearly graves, 12 piles of broken brick were investigated. Of these, 4 were shown to be collapsed vaults while 8 were piles of miscellaneous builder's rubble. Further remains of 2 vaults were found under soil that had accumulated over the walls after the interiors had collapsed inwards. This brought the total number of graves in the cemetery to 23. A diagram showing plans of the cemetery before and after archaeological excavation is presented in Figure 1 and Figure 2.

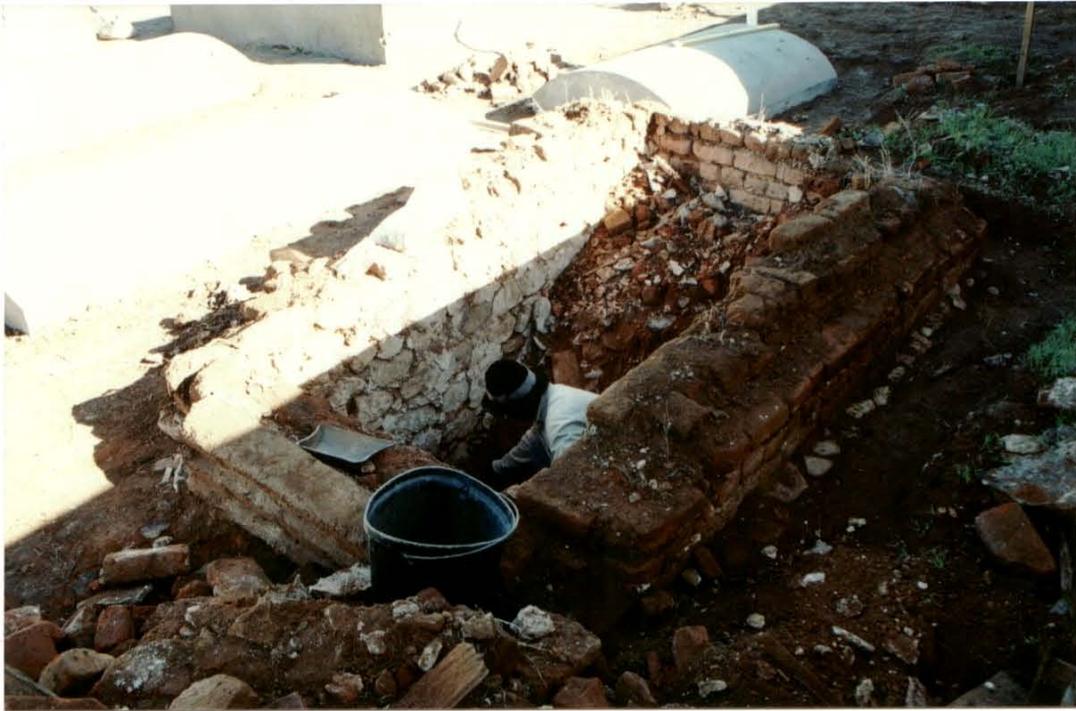
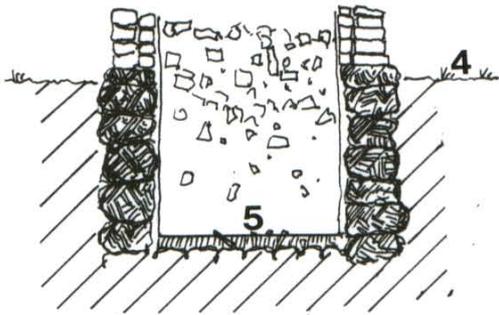
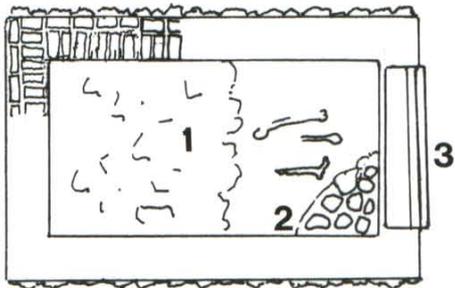
4

1. Rubble fill
2. Cobble base
3. Entrance feature
4. Existing surface
5. Human remains, coffin frags

Summary of observations: Grave 16 appears to have been a vault. The subterranean portion was built of stone to a depth of 1.20 m below surface level and plastered on the interior (Figure 4). The upper structure was built of frog bricks typical of the 19th century. A lintel-like feature lay where it had collapsed on the south side of the grave indicating the probable location of the vault door. A large portion of the structure must have projected above ground as it would have to have been high enough to accommodate a standing person (i.e. the Undertaker). As yet there is very little to indicate how the upper portions of the structure may have appeared. There is some evidence in the brickwork to suggest that the tops of the side walls may have been curved upwards along their length. It is known that this particular structure had a door and possibly a gable.

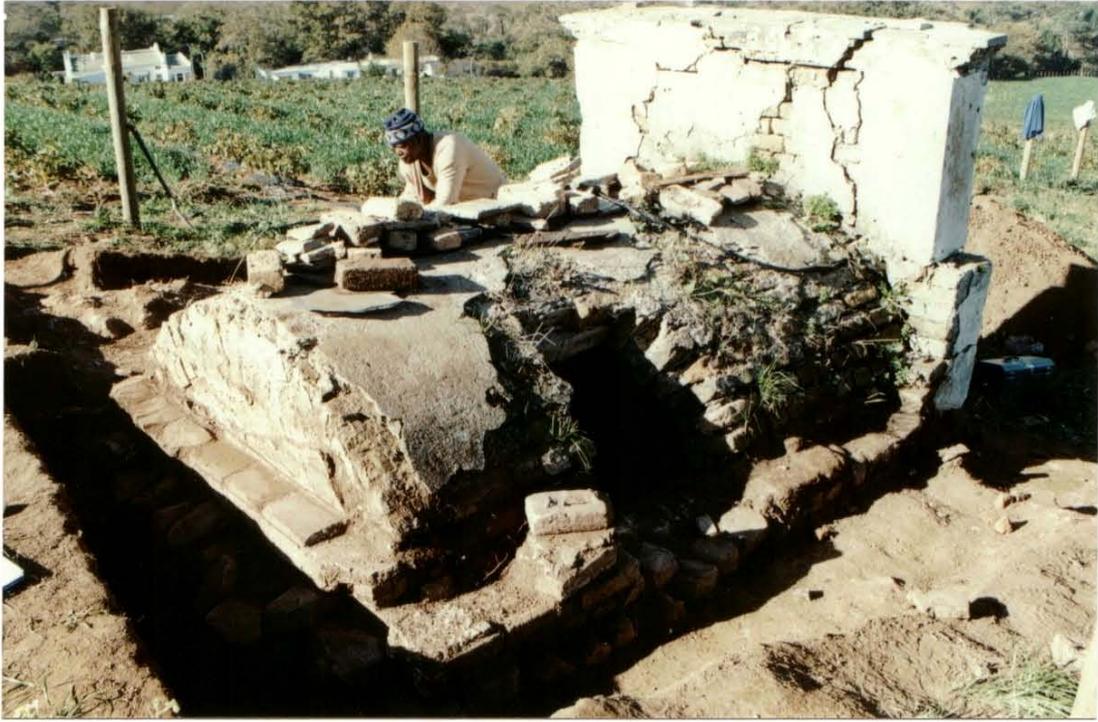
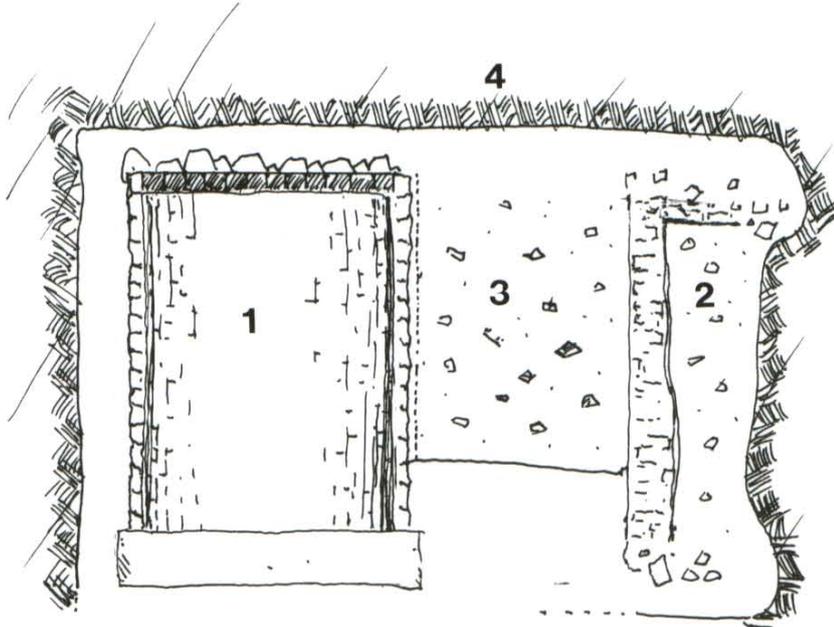
5

- 1. Vault A
- 2. Vault B
- 3. Rubble
- 4. Soils

It was of interest to note that the soil on the exterior of the vault A contained fragments of lime plaster and brick rubble that did not have its origin in the standing structure. The foundation trench for vault A had clearly penetrated this soil rubble layer indicating that the vault post-dated this. Broadening of the excavation clarified the situation by revealing the remains of a second structure (termed vault B) 1500 mm off to the right hand side of vault A (Figure 5). The second structure was evidently older judging by its soft red brick and lime plaster construction. Vault A, in contrast is built of hard yellow frog bricks.

Only a side wall and a portion of the rear wall of vault B has survived. The rest appears to have been destroyed. The dimensions of the structure are similar to that of vault A and the interior has been plastered. For this reason it is suggested that vault B is an older burial structure that has collapsed and subsided. It is possible that it may have been similar to other graves present in the Cloete cemetery. Thorold (pers. comm) has obtained reliable oral evidence that in the past other graves were visible in the area but these were destroyed when the land was cleared for vineyards. There are quantities of brick rubble in the vineyard surrounding the vault indicating that it is quite likely that there are other graves beneath the top soil.

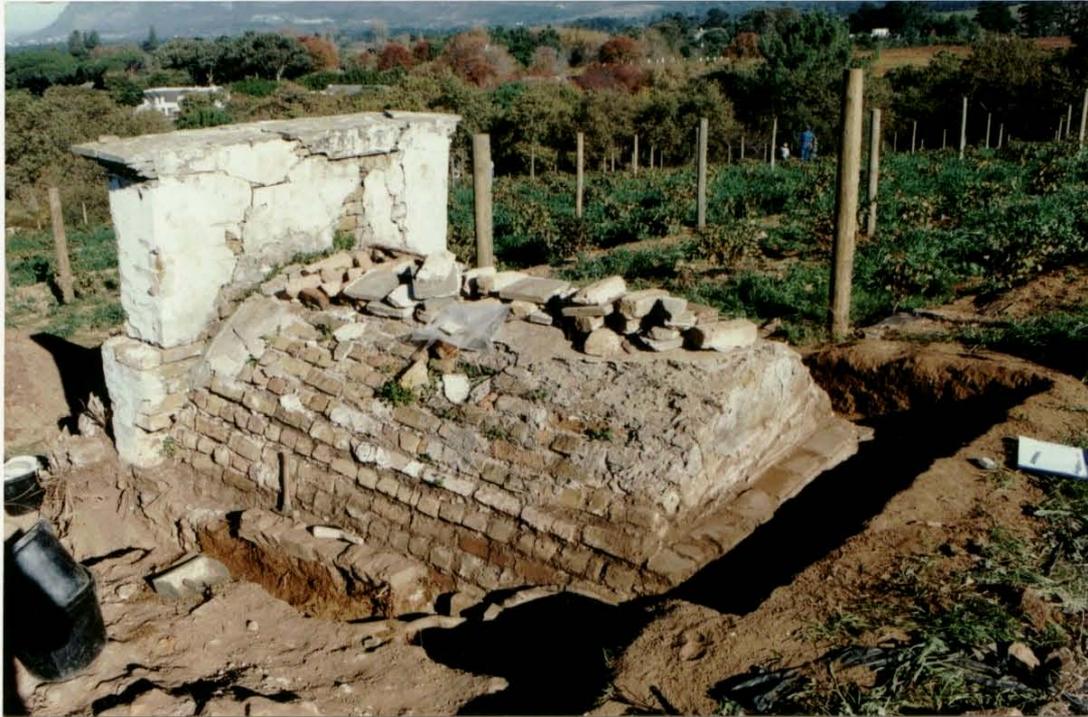
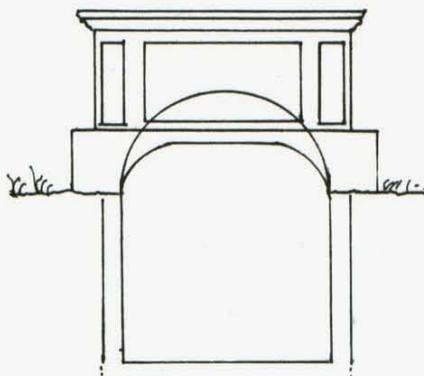
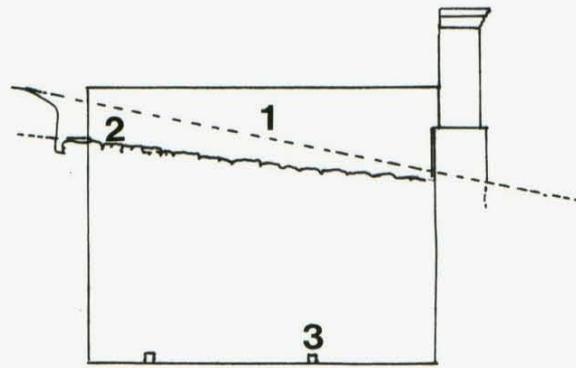
6

Front aspect

Side aspect

- 1. Present surface
- 2. Original surface

- 2. Original surface
- 3. Brick coffin res

ts

Some 60 mm thickness of humic material was excavated to reveal the floor of the vault which consisted of well fired grey tiles which had been plastered into position. Several of these were missing but the floor was largely intact. Two brick coffin rests spanned the width of the vault. The interior of the structure was high enough for a person to stand comfortably although the floor was only 1200 mm below the entrance (Figure 6). The condition of the contents of the vault indicated that the interior was subject to damp and almost certainly periodic flooding. It is likely that vandals had helped themselves to many of the larger of the human bones.
