AN ARCHAEOLOGICAL INVESTIGATION OF PORTIONS OF THE CALEDON HOT SPRINGS SITE

Prepared for

TCI Projects

May 2000

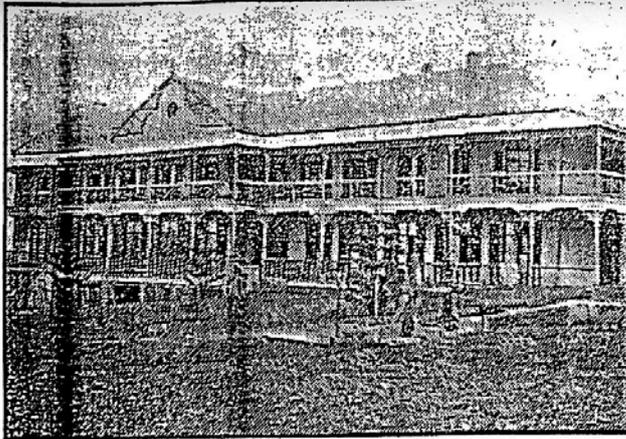
FIG.30 An early photograph of the East Wing Sanatorium built in 1897. The Norfolk pines were only about 2 m high. Note some kind of construction in the right foreground, approximately where the pit is now situated (Edwards 1979:5).

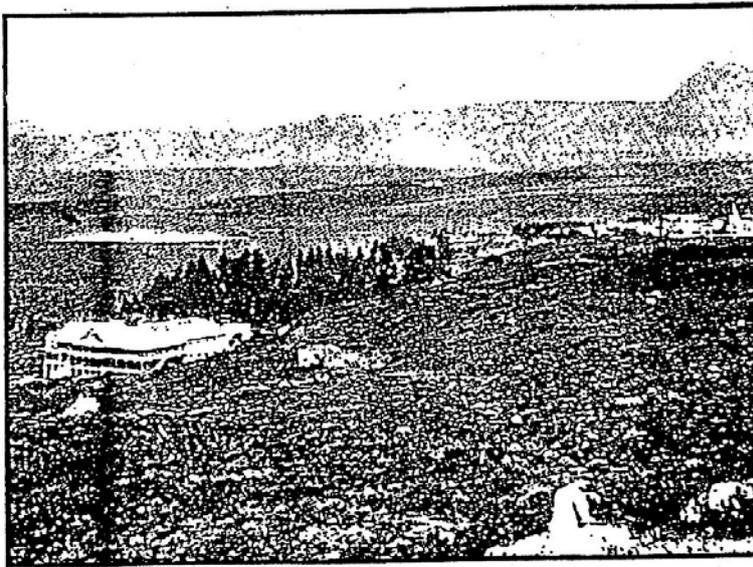
FIG.31 A photo of about 1900 shows the treeless *bronbult*, ruins, or a cottage above the East Wing, and a grove of bluegums at the entrance of the Baths (J.B.G. 1904:ii).

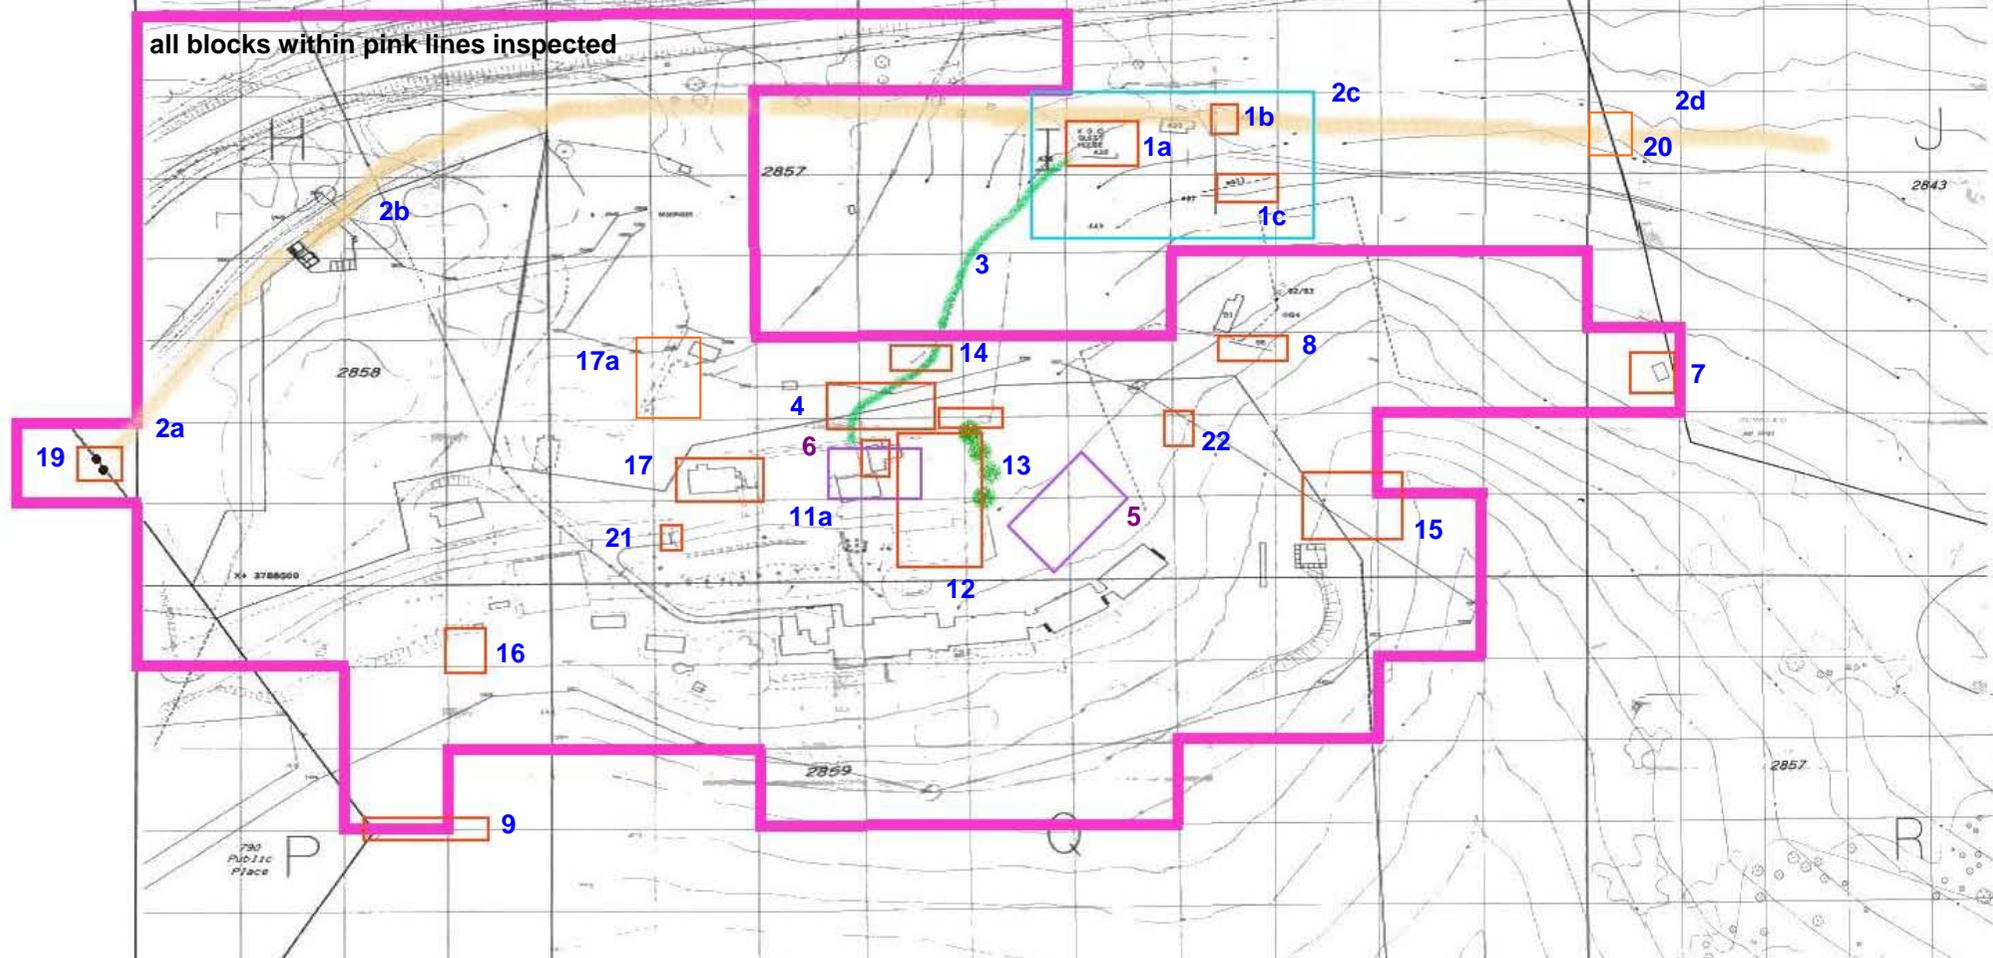
No vehicles should be permitted beyond the turnoff to the proposed haul road, as heavy vehicular traffic will damage the surface. Care should be taken that where the haul road comes close to the wagon road, that vehicles do not inadvertently stray onto it (the haul road may not be part of the latest planning).

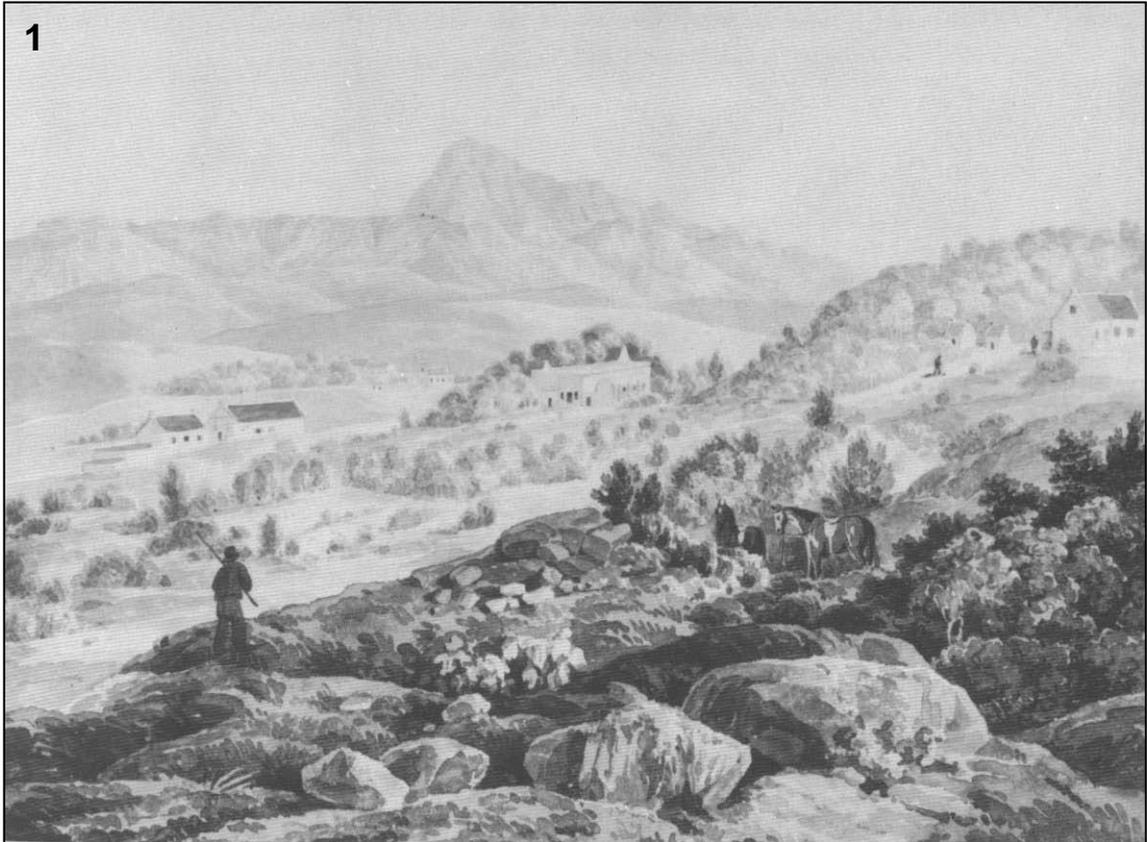
A painting showing several buildings. From left to right, Hässner's farm buildings, Hässner's guesthouse and on the upper slopes, the VOC guesthouse. *From: The Cape Sketchbooks of Sir Charles D'Oyly 1832-1833. Depicting Cape Town, the countryside and neighboring villages. 1968. A.A. Balkema, Cape Town. Page 83*

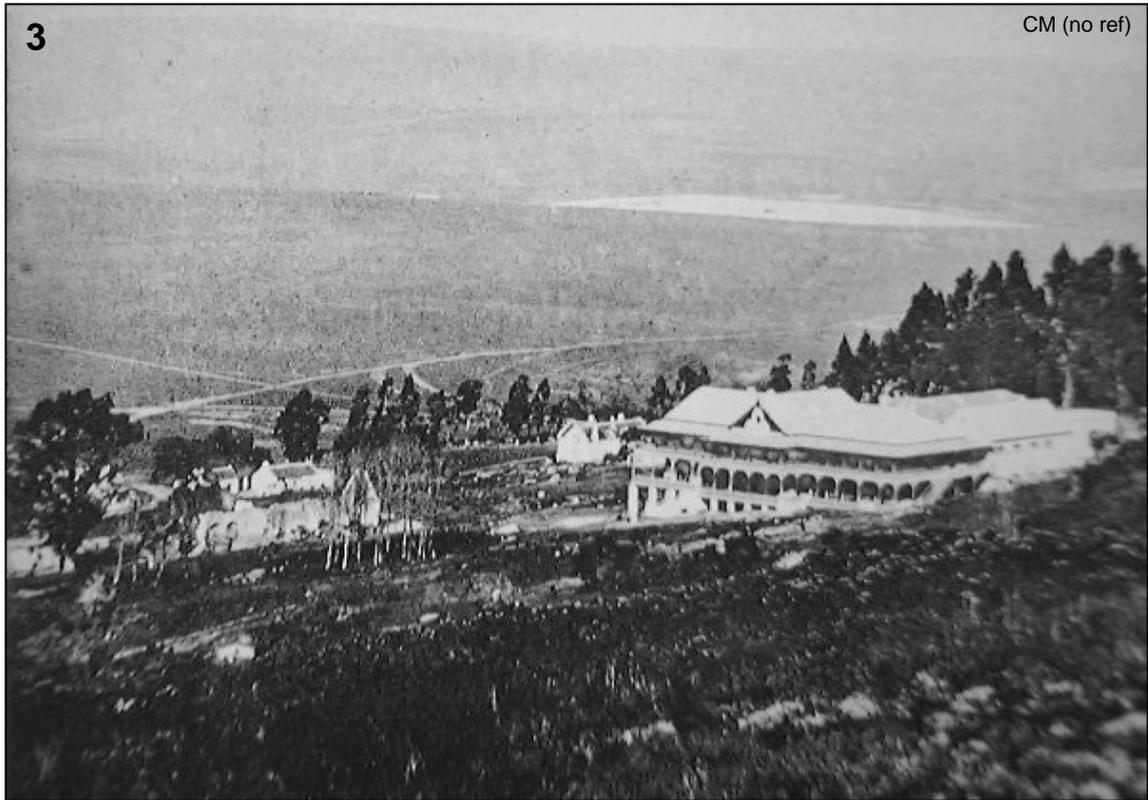
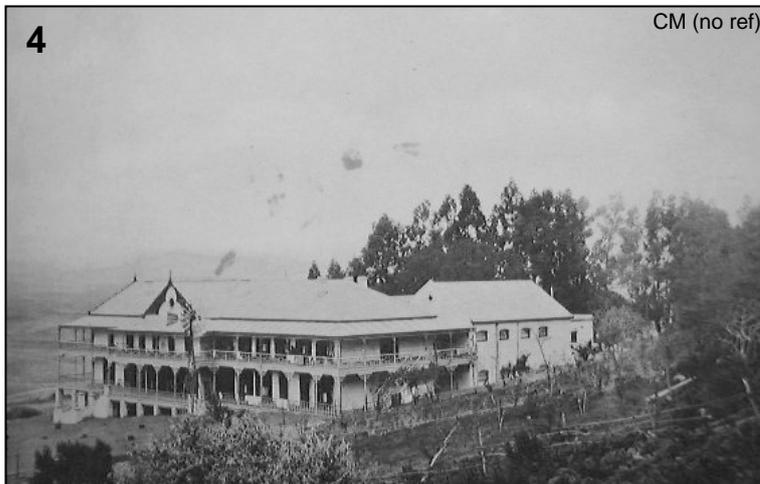
One of the 52 Bathrooms. Caledon Baths.

Two photographs of the Victorian sanatorium east wing which was completed in 1897. The upper photograph is taken from a similar perspective as the painting shown in plate 1. Farm buildings are still present at this time. Visible in both of the photos is the double storeyed bathhouse at the rear of the east wing. Many of the features and pipes on the upper terrace were probably part of the system to supply hot spring water to this bathhouse. At left is a post card showing one of the bathrooms in this building. Note the tiling pattern on the wall above the bath. Similar tiling is still visible in the Duminy Building.

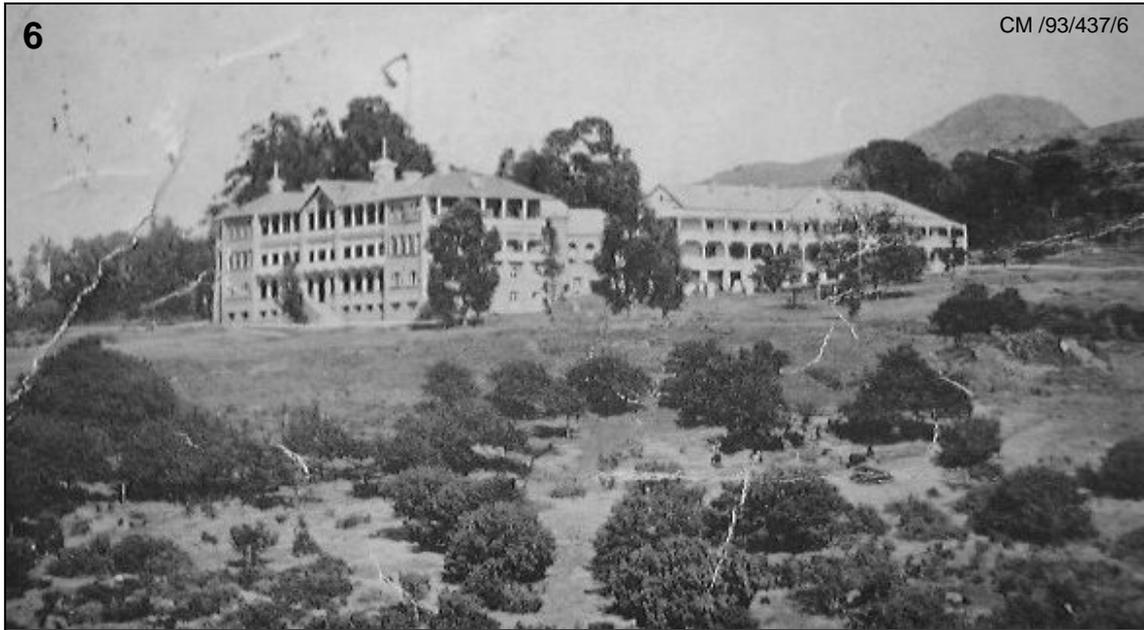
Photographs showing both wings of the Victorian sanatorium. The east wing of 1897 at right, and the newer south wing, which was added in 1904, to the left.

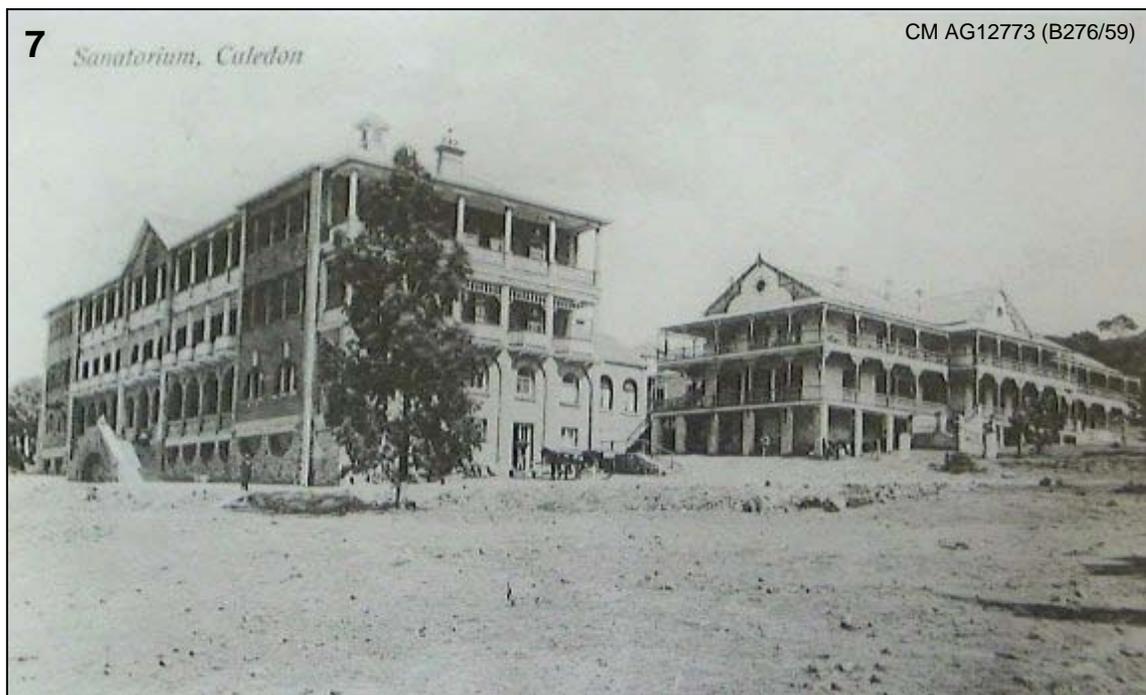
The sanatorium east wing. Visible on the slope behind is a structure that could be where the stone platform (feature 14 on the site map) stands today.

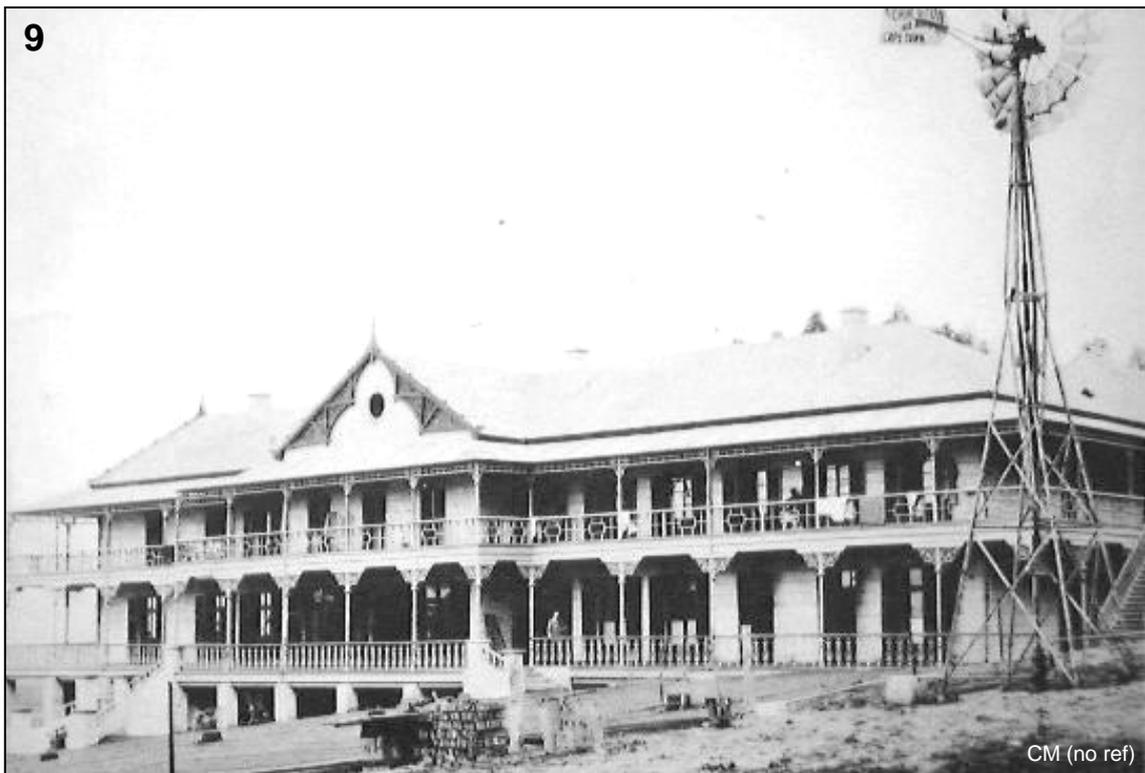
The front of the east wing. In the foreground at right is a windpump with a discharge pipe leading into what may be the reservoir (feature 10 on the site map). The presence of piles of building materials may indicate that the reservoir was being constructed at this time.

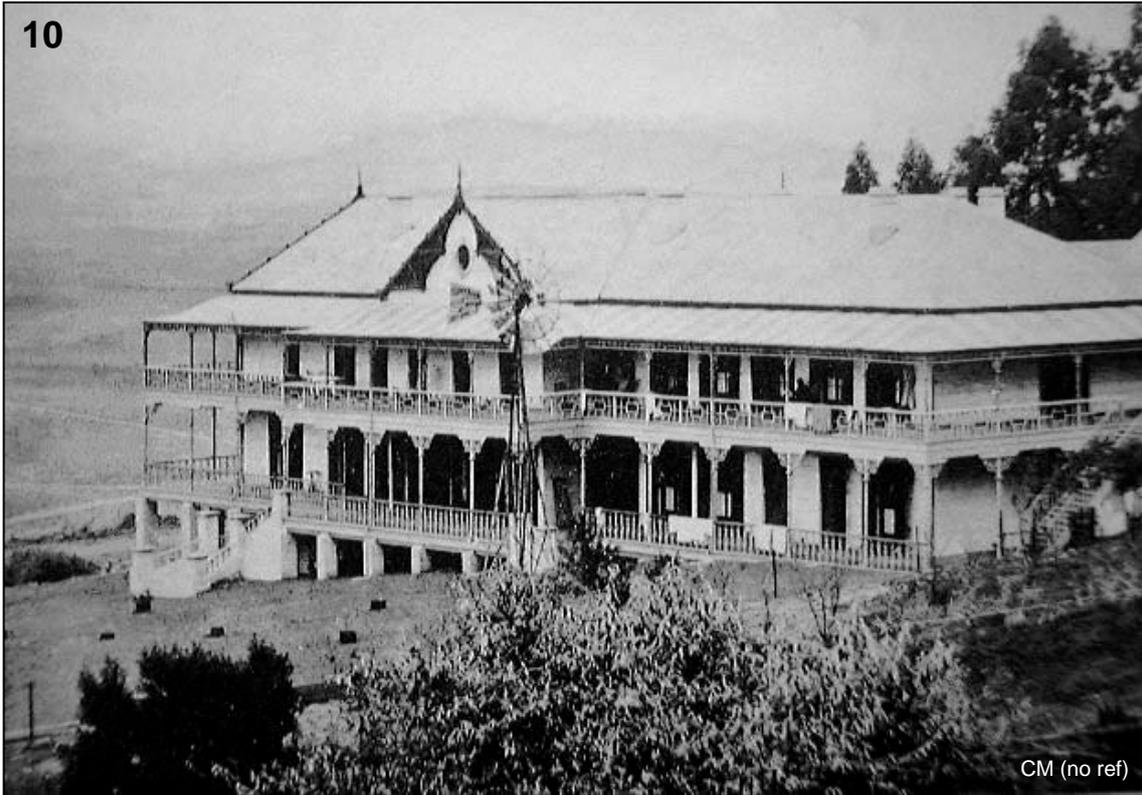
Another view showing the windpump in front of the east wing.

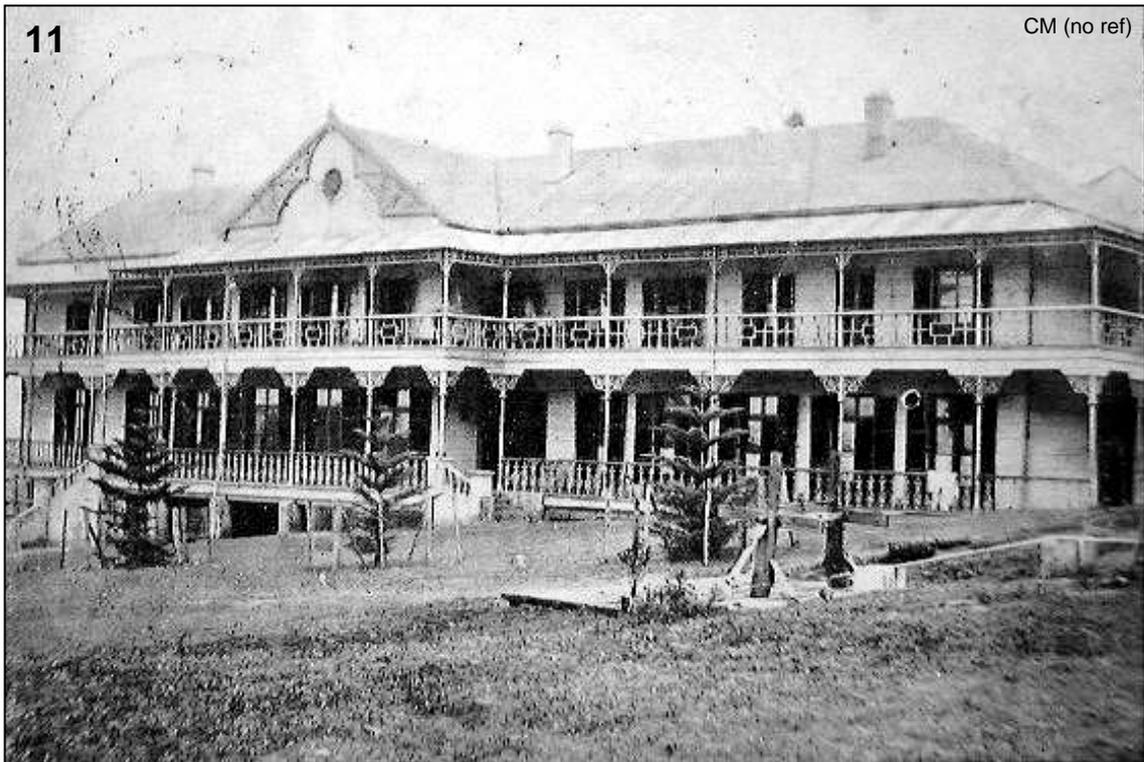
The three Norfolk pines in circa 1900. In the foreground is a feature that is probably the reservoir. In this photograph it would appear that there is a cover on which is mounted some form of device, possibly a hand operated hoist for lifting buckets of water.

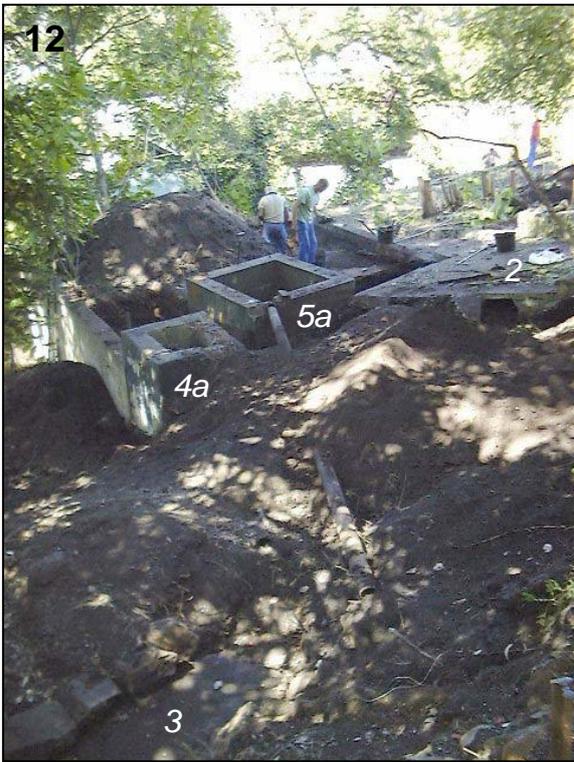
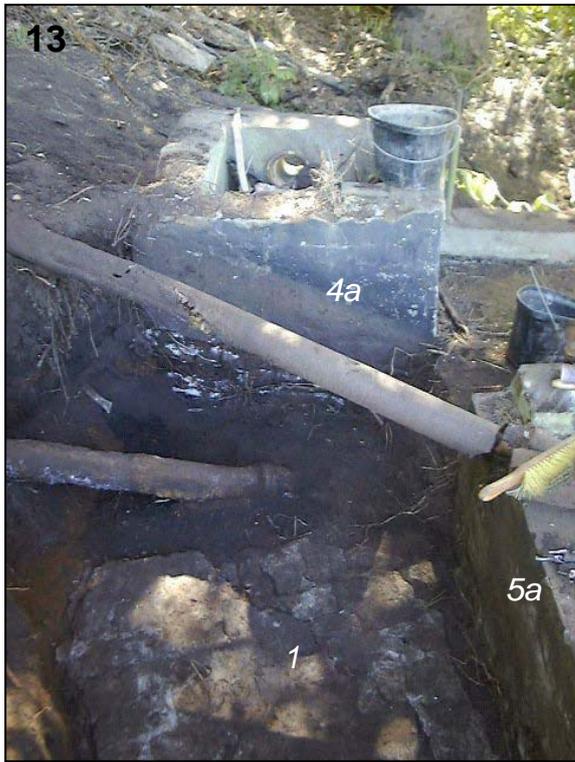
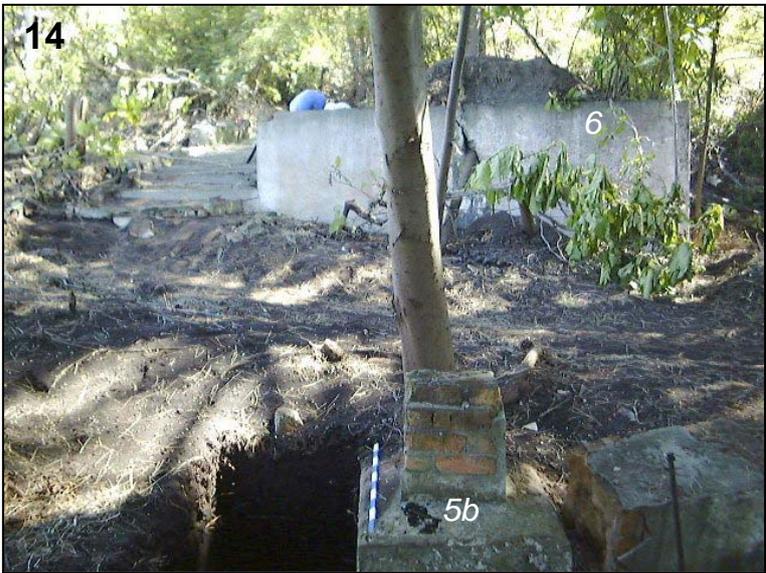
Features on the upper terrace.
 Numbers in italics refer to

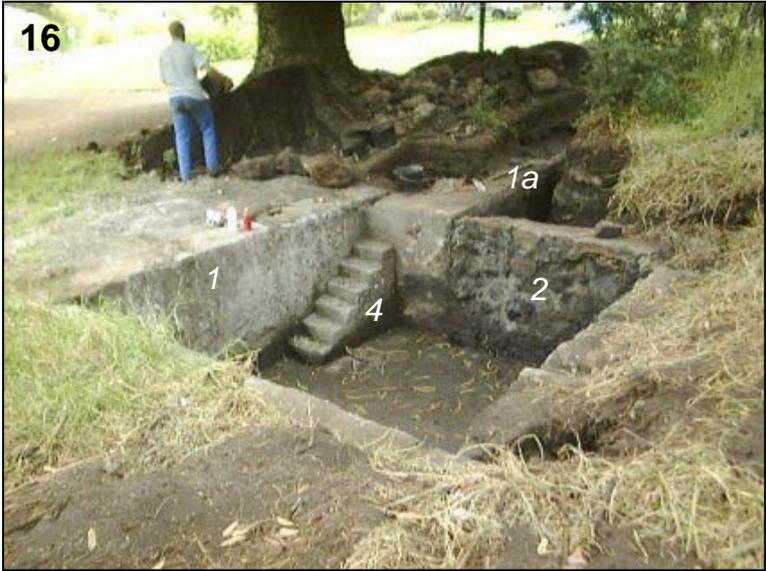
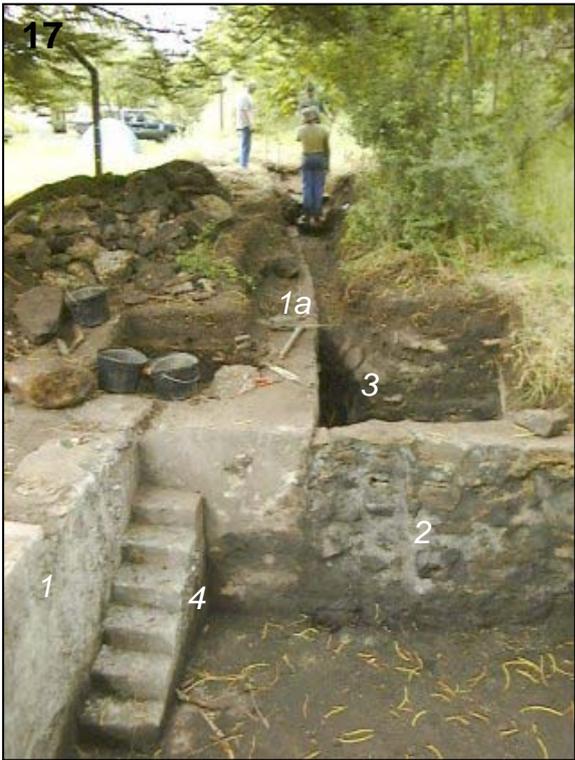
The 19th century reservoir and channel. Numbers in italics refer to

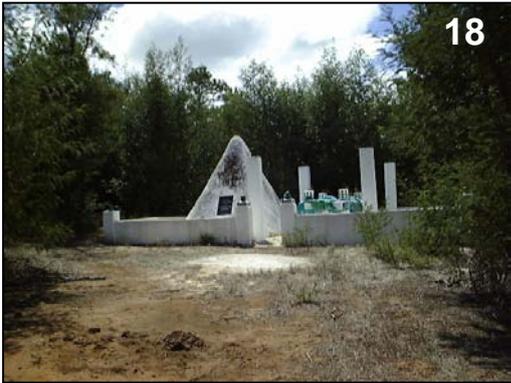
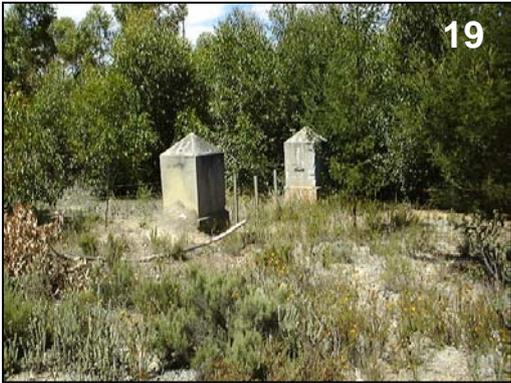
The graveyard, Feature 7 on Figure 2 and a set of gates. Feature 19

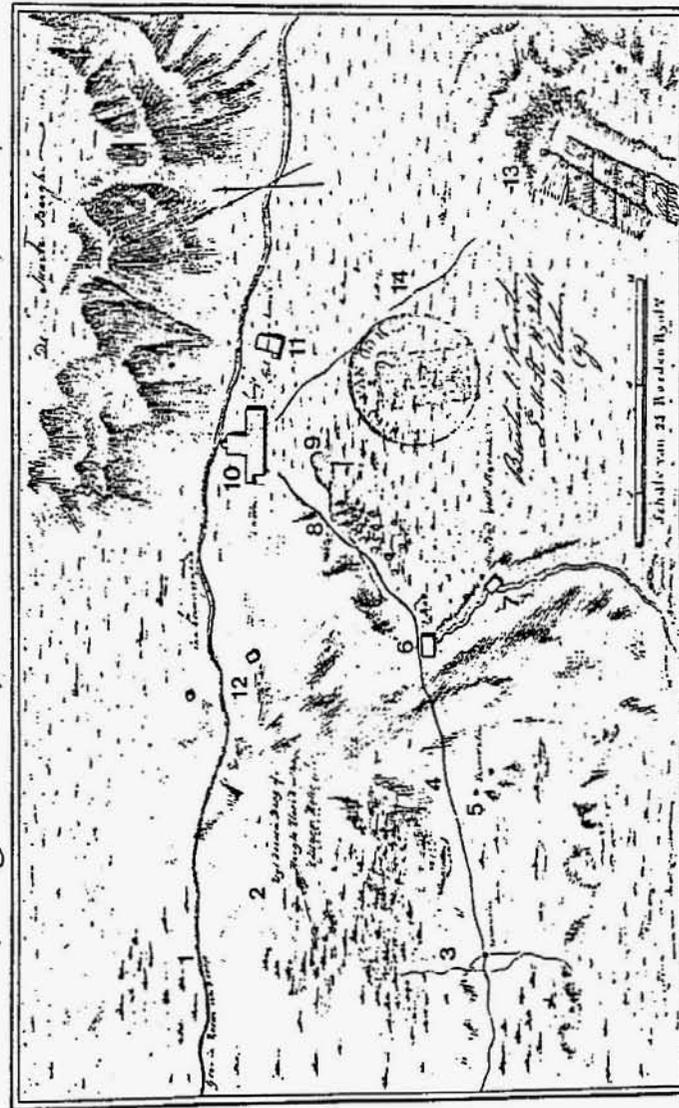
Kaartje van De Situatie van het Waarme-Bad, gelegen Over Berg aan De Caap De Goede Hoop, ~ 1788

FIG.10 The government's outpost at Waarme-Bad, was properly surveyed by J.W. Wernich in 1788. See text on next page for interpretation.

Towards the end of the 18th century we have at least two accurate drawings of the old government baths, the first done by surveyer Wernich in 1788 (FIG.10). Just below the old Cape road lay the old VOC Guesthouse, with slight protrusions (lean-to's?) on the west and north of the T-shaped building. This generally agrees with the old ruins. Rectangular kraals and stables are shown towards the east, of which portions of enclosing walls were found on site. Two roads diverge from the guesthouse. One leads to the gardens, watered by a spring, where vegetables and fruit would have been cultivated for the visitors. The other road leads to the main bathhouse. This road, though much overgrown, was identified through some old pines flanking its upper part. A bathhouse lower down served the slaves and free-blacks. A few other hot springs are identified.

Is Klein correct in his identification of the bathhouses B, D & E? The old rectangular bathhouse (B) is practically windowless. Could it be feature A.51? Keeping in mind Wernich's plan (FIG.10), can it be the old Christian slave bathhouse? It directly faces a cemetery (C), where coffins are partially exposed. Building D is indicated as the New Bath (the one for Europeans), with another crude bath for slaves and Hottentots (E). A more detailed survey of the area would certainly cast more light on these problems.

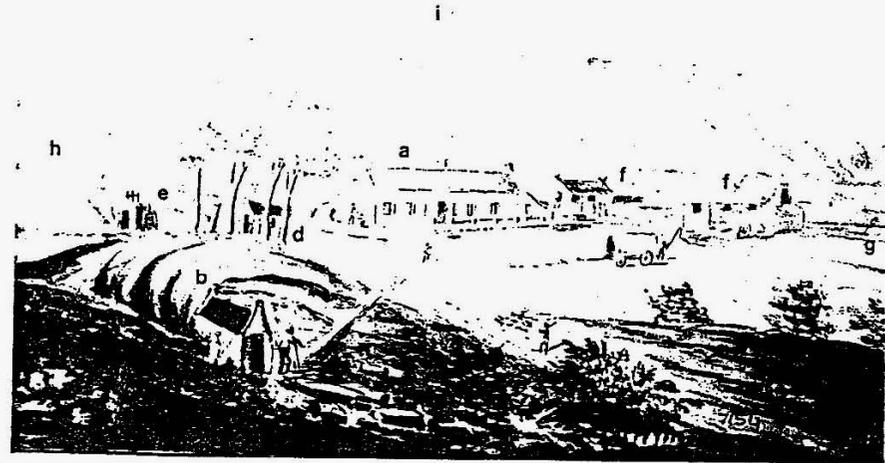
FIG.11 Probably the most remarkable drawing of the Old Baths was made by H.J. Klein in 1799 (Fehr Collection, Rust & Vreugd, Cape Town). The letters represent:

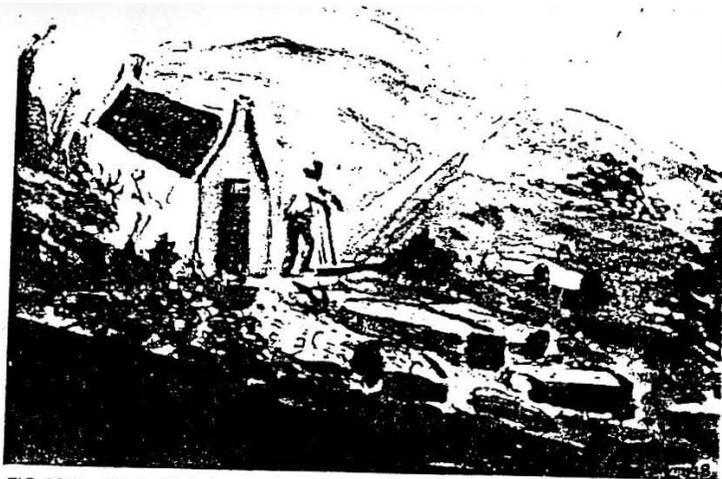
FIG.18.1 M.J. Klein's drawing of 1799 depicts at least six coffins, all exposed to the elements. It was probably a discouraging sight for the crippled and sick! (William Fehr Collection, Rust & Vreugd).

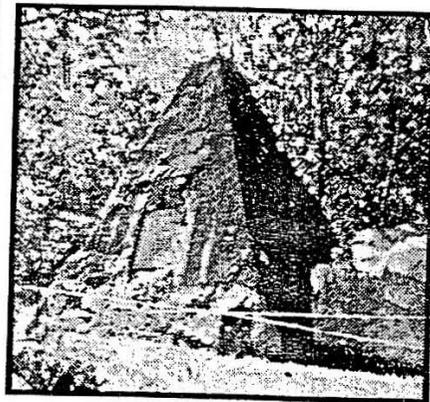
FIG.18.3 In 1979 the tomb was already in bad condition (Edwards 1979:25).

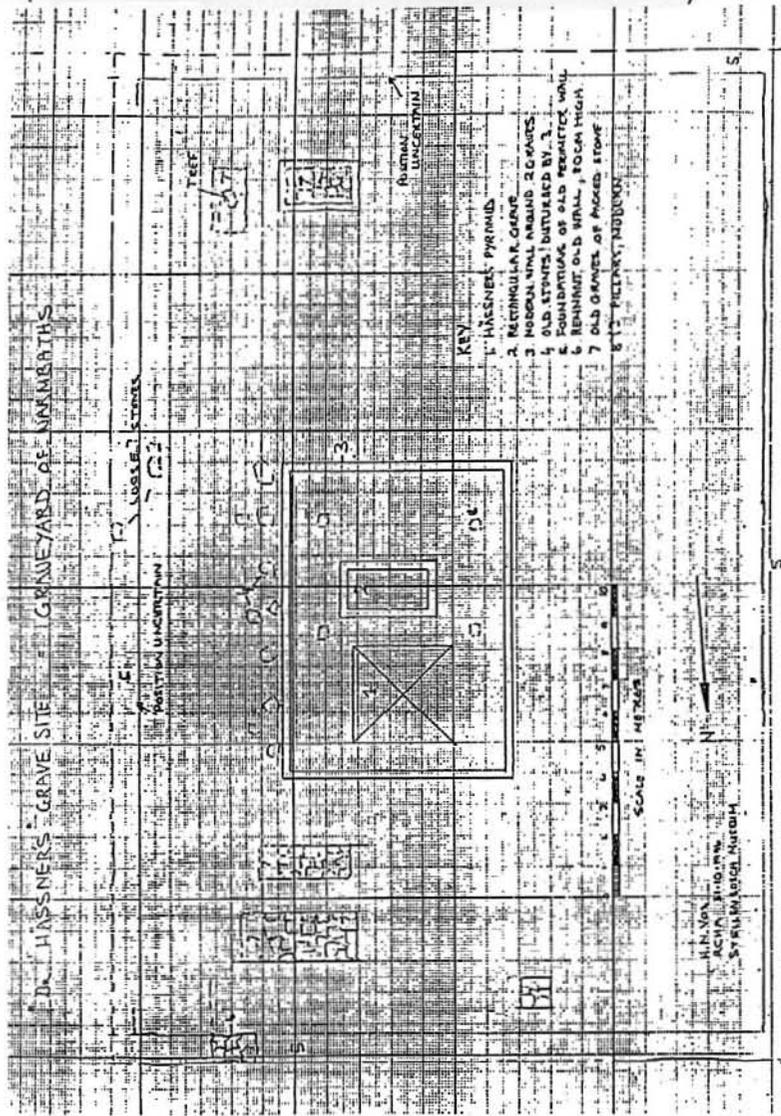
FIG.19 In October 1996 the following approximate drawing was made of the Warmbath's graveyard, measuring about 30 x 15 m. Apart from the two central graves a further 4-5 others were also discernable.

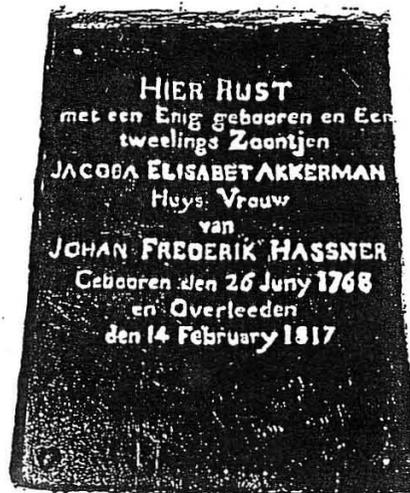
9. A close-up photo of the slate inscription on the tomb. It has been painted black and the carved lettering painted white.

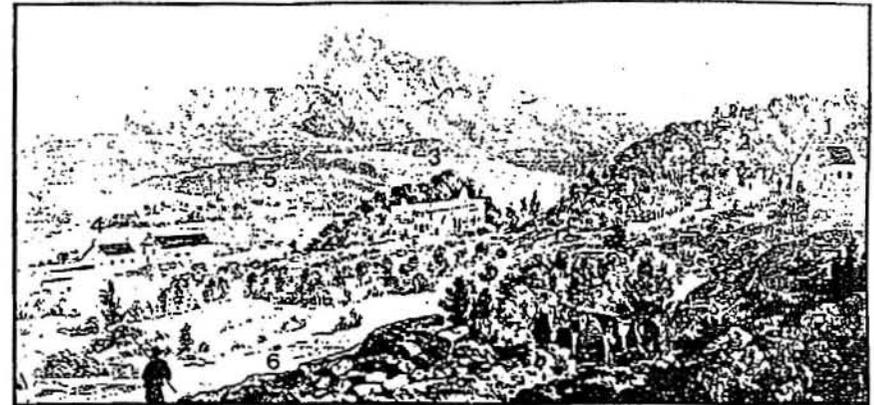
FIG.23 Another important sketch by D'Oyly dated 18-11-1832 shows the old VOC Guesthouse (1), two bathhouses (2), the New Guesthouse with its vaulted bathhouse against the back (3), the buildings of Hässner's old farm (4), Caledon in the distance (5) and the old Cape road (6) (Gordon-Brown 1968:85).

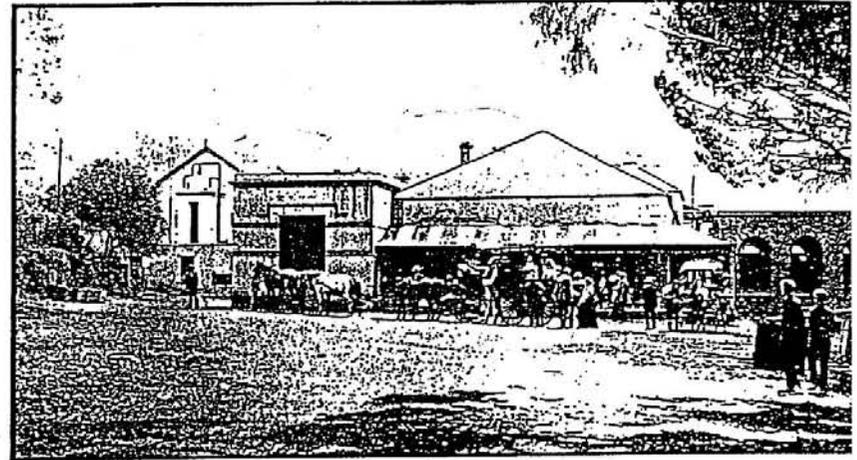
FIG.28 A flat-roofed building was erected at the back of the Old Sanatorium by the late-19th century. Note the "reservoir" atop the Duminy Conference Centre (J.B.G. 1904:against 18).
