SCOPING HERITAGE IMPACT ASSESSMENT OF FARM HOOGKRAAL 182 WILDERNESS LAKES AREA, SOUTH WESTERN CAPE

January 2003

Archaeology Contracts Office

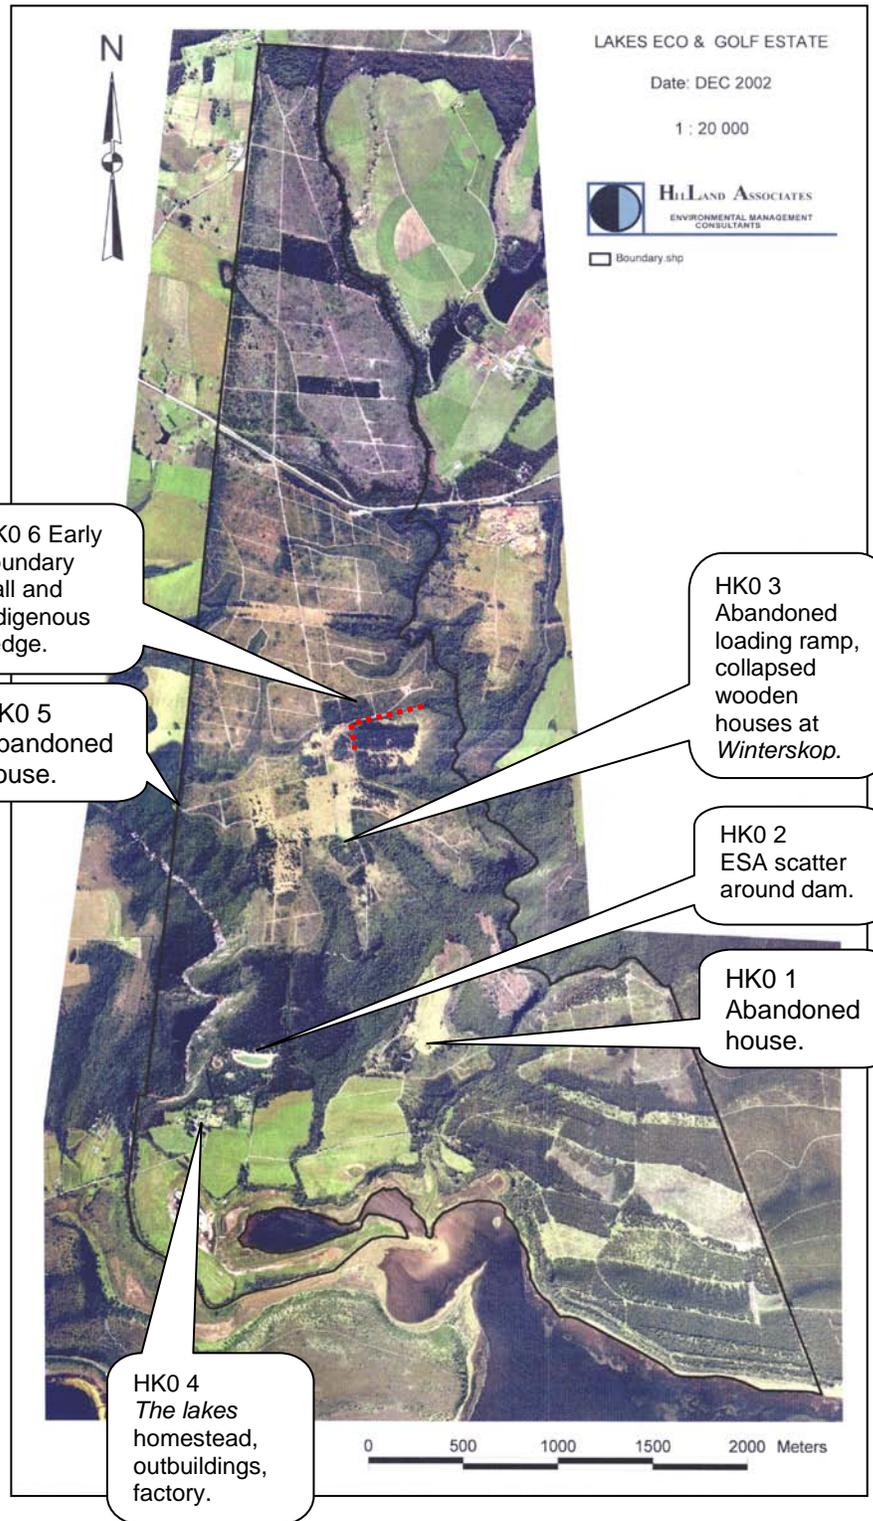
The locations of these sites are indicated on Figure 2 (right). Detailed descriptions are contained in following pages.

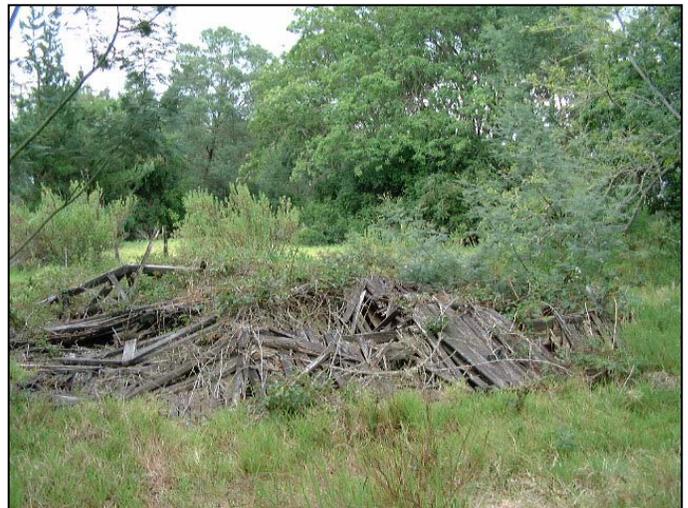
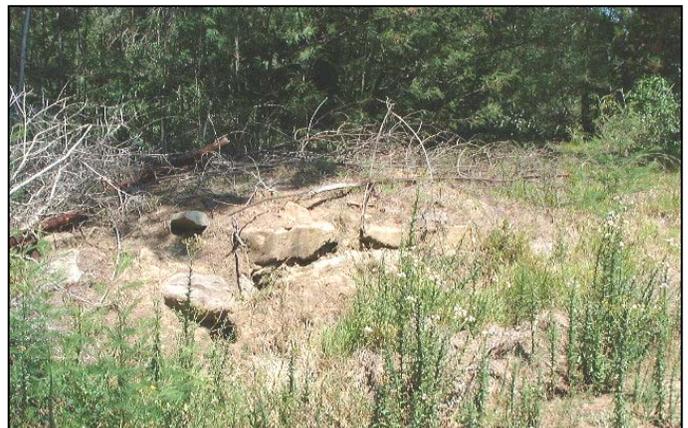
Site name: HKO3 (Winterskop)

Description: The remains of three small collapsed wooden cottages in a forest clearing. The structures were elevated on concrete supports. One of the cottages had a brick fireplace and chimney. Close to the road is a stone loading ramp.

Sensitivity: Low due to very poor preservation.

Mitigation: None required.

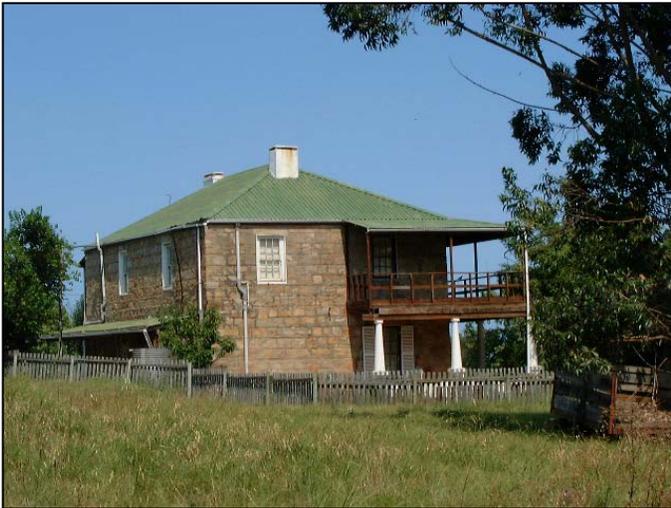
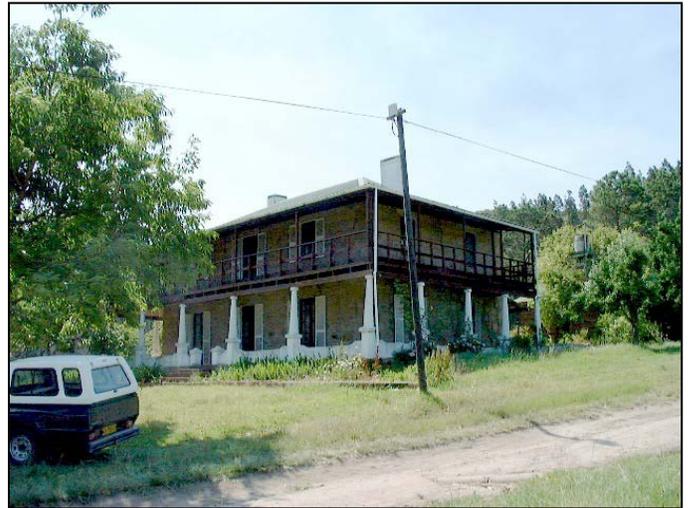
Homestead: A large double storied Victorian homestead built of dressed stone dating to 1883. The building has a simple rectangular layout with a pitched corrugated iron roof. The upper story has a wooden roofed balcony extending across both side and front elevations. It is possible that the balcony was added to the building in the early 20th century. The building is in good condition and preservation of the both joinery and interior is excellent. Indigenous woods that grew on Hoogekraal farm were extensively used in its construction (Urban pers. comm.) The building represents a good conservation opportunity, however its original state and quality mean that it is unlikely the SAHRA will grant permits for *extensive* alteration in the interests of conserving its character and historical qualities.

Mitigation: The “Lakes” farm needs to be subject to a focused Heritage Impact Assessment and Built Environment conservation study (in terms of section 38 of the National Heritage Resources Act) before any solid plans are drawn up for its redevelopment.

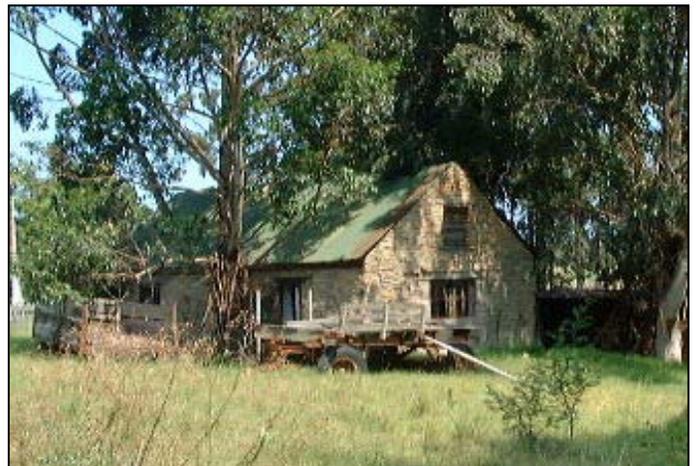
Barn 1. The closest barn to the residence is a vernacular stone structure which appears to have been adapted for habitation in the late 20th century. It has since fallen into disuse and has been damaged by weather. Notwithstanding this, it is conservable and could be sensitively adapted for reuse. It is quite possible that the barn may predate the main homestead. The structure is protected by legislation.

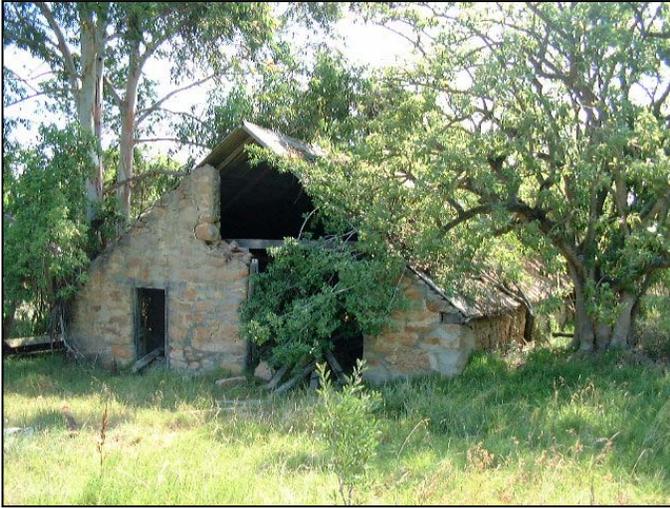
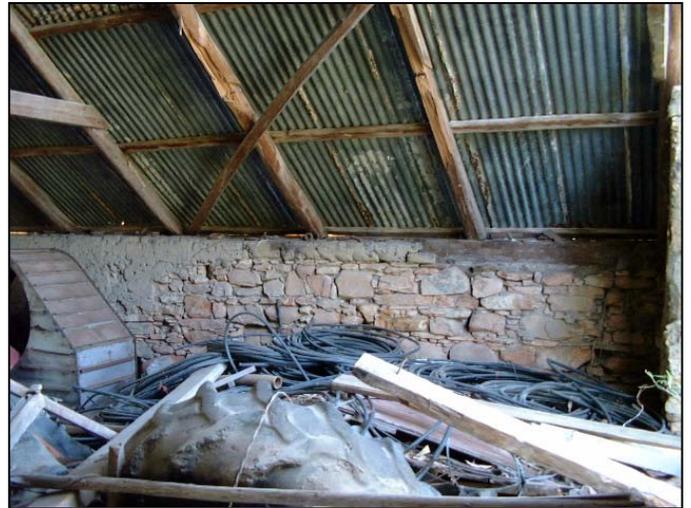
Barn 2. A vernacular stone structure with a high pitched roof and very low stone walls. This building is also in a poor state of repair and a mud brick divide down the interior of it has collapsed. Elements of original joinery have survived. Adaptive reuse of the structure is possible and is encouraged. The building is also protected by legislation.

Factory. This factory for drying hops was built by the Urban family in the 1960's. Now stripped of most of its fittings the factory consists of a large concrete block and steel frame structure that has grown organically in response to the machinery that has been housed in it over time. A large smoke stack still remains however the boilers have been removed (boiler tubes and other items are to be seen lying about the yard). Remaining equipment within the factory includes various steam pipes, a condenser, some electrical equipment and a conveyor belt system. While certain industrial structures do have conservation merit, this particular building does not include any unique physical elements and is less than 60 years old. It is situated very close to the homestead and tends to dominate the landscape. While we do not advocate conservation of the physical remains of the factory, the story of its reason for being, the technology involved, and the regional economic role it played needs to be documented.

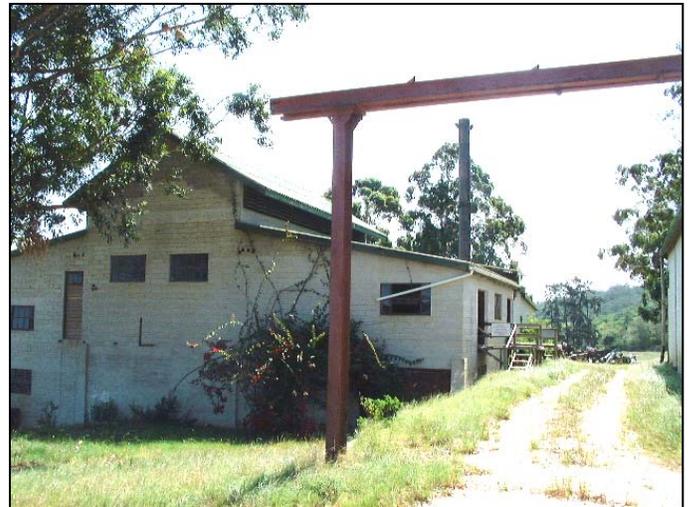
Barn near factory. Associated with the factory is a large contemporary barn containing pipes, valves and agricultural equipment. It is of little conservation value (other than being an element of the local agricultural industrial landscape).

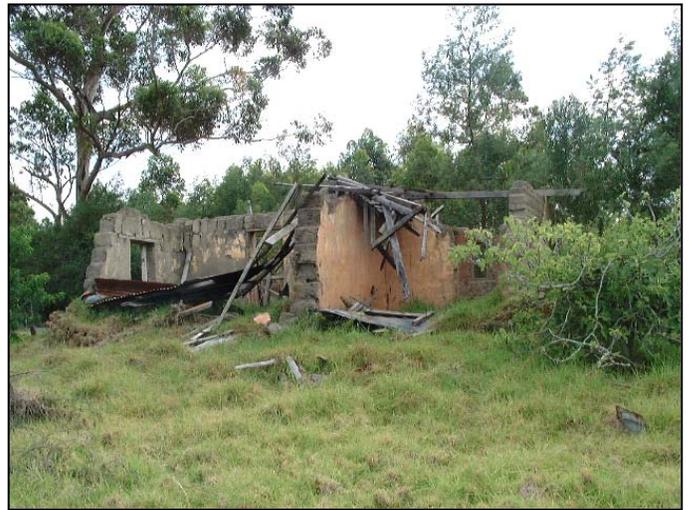
Site name: HKO 5

Description: Cottage consisted of 4 inter-leading rooms with no corridor. These are arranged around a square, but may have initially started as an “L” shaped arrangement. Large unfired mud bricks have been used in its construction however modern plaster is evident in places. The corrugated iron roof has collapsed. Artefacts laying around suggest that the building was used a labourer’s cottage but vacated and allowed to fall into disrepair during the last 20 years. There are also early 20th century artifacts (bottle glass) in evidence.

Sensitivity: Too damaged to be readapted or considered conservation-worthy.

Mitigation: Measured drawings and photography before demolition.

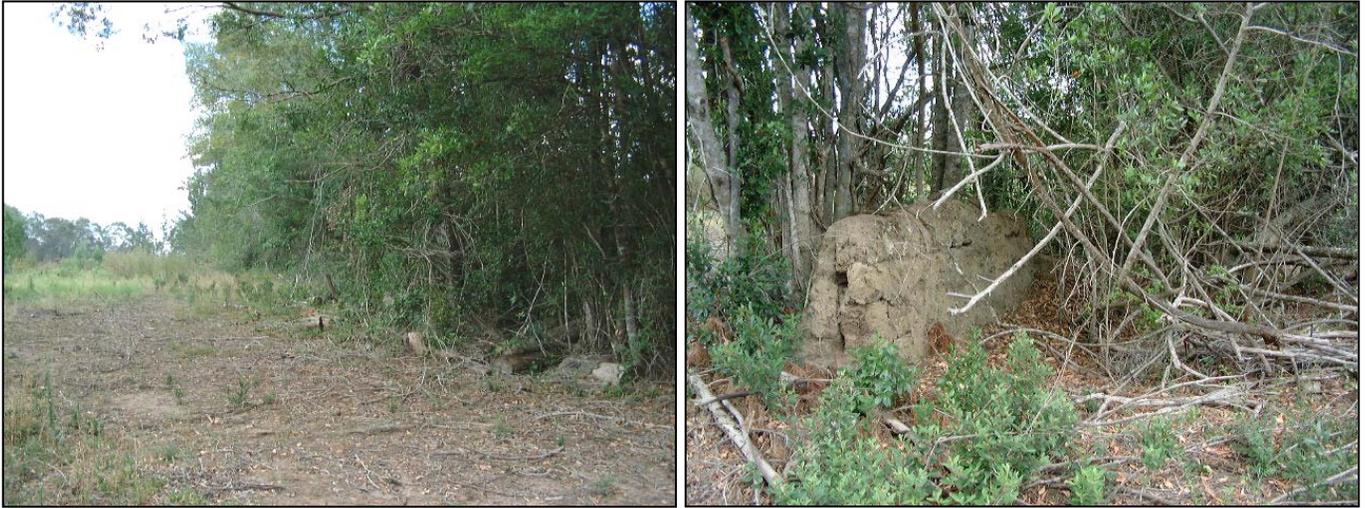
Site name: HKO 6

Description: An extensive length of boundary wall associated with and enclosed by a well-established hedge of indigenous trees and shrubs. The wall, built with large mud bricks is eroded in places but well preserved under areas of dense vegetation. The size of the trees contained within the hedge are good evidence that this is a very old feature, which in style and form are characteristic of boundary walls typical of the Dutch East India Company period at the Cape.

Sensitivity: A highly sensitive feature vulnerable to erosion if hedge is damaged, illegal demolition.

Mitigation: The wall, together with the hedge should be conserved. Archival research will be need to determine its history. Focused fieldwork (informed by archival research) will be needed to determine if there are any related structures/features in the area.

- The hedge and boundary wall (site HKO 6) needs to be researched and conserved. This site should not be impacted in any way unless the outcome of focused research finds it to be insignificant.
