STAGE 1 HERITAGE IMPACT ASSESSMENT OF THE NORTHERN BREAKWATER AND HARBOUR WALL, MURRAY'S BAY HARBOUR, ROBBEN ISLAND

Planning Partners

September 2002

Archaeology Contracts Office

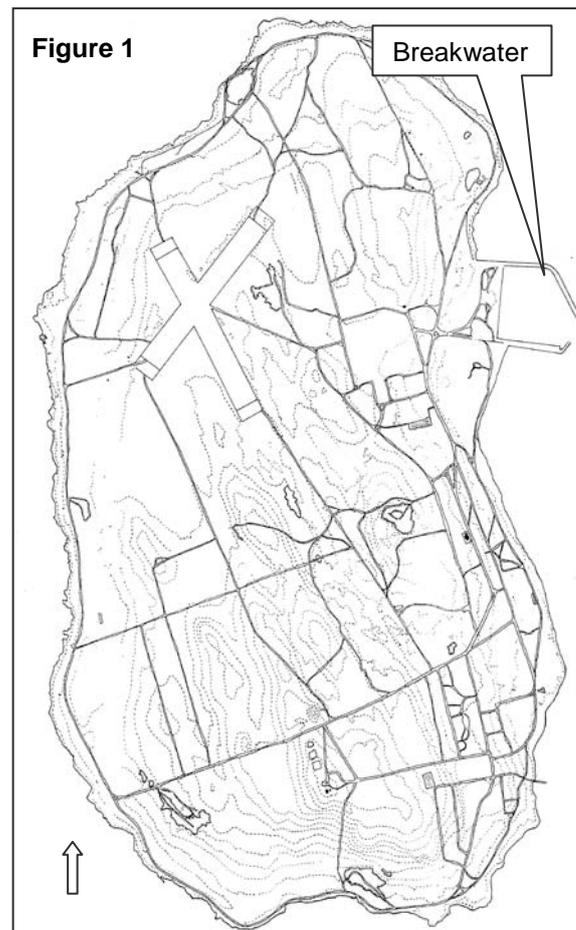
According to the Robben Island Conservation and Use Plan (discussion document)¹ the harbour precinct (Figure 1) has particular significance, as this was the portal to the island and the prison since after WW2 through the apartheid period. Today, Murray's Bay Harbour has a greatly changed role providing berthing for the tourist and supply ferries that service the island. The symbolic and historical significance of the harbour area is inextricably linked with the built fabric of the place. Impacts to fabric can impact the intangible qualities – ambience and sense of place that are critical to maintaining authenticity and significance. Previous studies have commented how slow but cumulative impacts from unplanned and poorly conceived *ad hoc* changes can change the character of a place such as Murray's Bay Harbour over time. Yet a harbour by virtue of being a facility that has to hold up against the harshest conditions of sea and weather will require maintenance and is not an asset that can be "mothballed" like other structures on the island. The challenge is to carry out the necessary maintenance in a way that minimises impacts to the complex heritage that Robben Island represents.

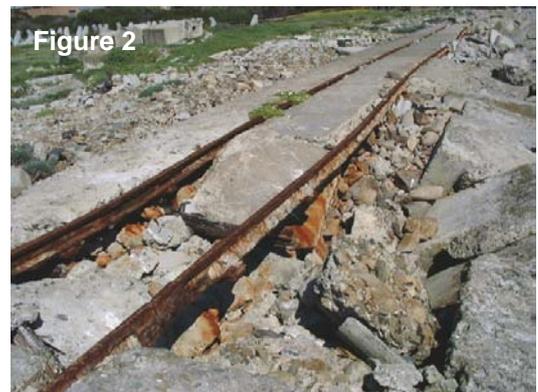
Severe degeneration of the fabric of the northern breakwater has necessitated virtual rebuilding. The existing armour blocks (made on the island) are of inferior quality and not reinforced. Many have cracked and others have been shifted from their original positions by wave action. In addition to extensive reconstruction, new armour blocks will be placed along the exterior of the breakwater, while older ones which are still useable will be repositioned along the inside of the breakwater.

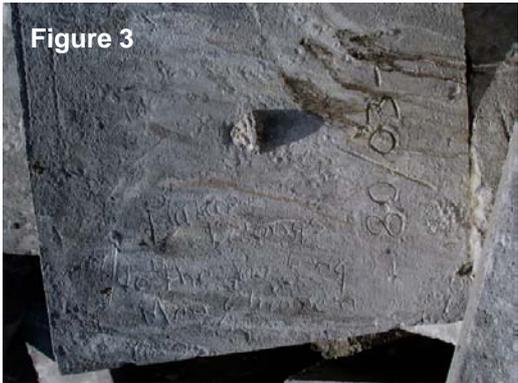
The northern breakwater is constructed from rubble fill, square concrete wave breakers and capped with concrete. The landward section of the breakwater still contains the remains of a "cape gauge" railway, fishplates and hard wood sleepers (Figure 3). This has been badly eroded on the breakwater and is unlikely to survive for many more years unless intervention takes place. The railway continues inland in an easterly direction into thick bush close to the penguin colony walkway. The railway line was

An initial inspection of the existing concrete armour blocks has revealed several construction phases. The earliest identified phase is signified by the date of 1941 engraved on many of the older blocks (Figure 3). Newer blocks of similar size cast on the island signify a more recent phase. Many of these bear the date 1981. Graffiti scratched into the blocks before they cured bears peoples' names, and various comments, some of which are political in character (Figure 4).

Removal of the railway on the landward end of the breakwater will result in the destruction fabric dating to the WW2 period at the harbour and the disturbance of the only visible remaining section of railway on the island.

- Casting a section of track into the concrete surface of the breakwater will help acknowledge past events, and to some extent also alleviate the condition of the existing track, which is eroding and badly corroded.

The required repairs will necessitate the removal and repositioning of existing armour blocks (many with engraving). Broken armour blocks will be used as fill material. This will result in the loss of original fabric (1941) and will potentially result in the loss of engraved armour blocks made by Robben Island prisoners during the apartheid era.

- Before construction work begins the inscriptions on the armour blocks must be photographically recorded (digital and analogue), and the words transcribed in a documentary record.
- Engraved armour blocks to be set aside for conservation and possible display must be identified and marked for careful removal (to be stockpiled within the harbour precinct at the convenience of RIM).
- A programme should be established in collaboration with the museum to identify and collect the oral testimonies of ex-prisoners who worked on the “blok span”.

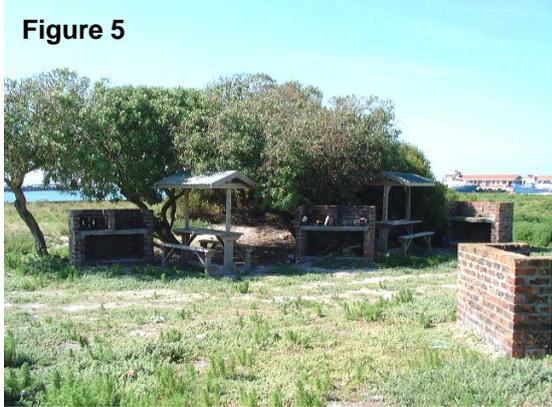
Other aspects of the harbour precinct, which are physically close to proposed construction area, are the old Royal Cape Yacht camping facilities. This consists of an ablution block, barbecue facilities, a vibracrete wall enclosure and alien trees (Figure 5).

- Activities associated with the yard must not impact on any of the structures associated with the yacht club.
- The steel gate, which has been abandoned in the area must be retrieved and handed over to the Museum Heritage Department.

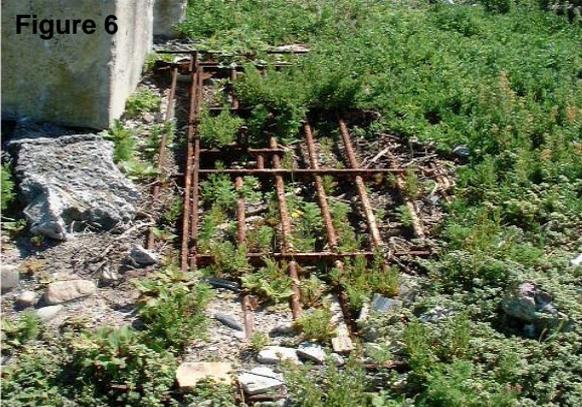
Little by way of artefactual material was noted; however a steel gate (possibly originating from the high security prison) lies in the open close to a pile of disused armour blocks (Figure 6)

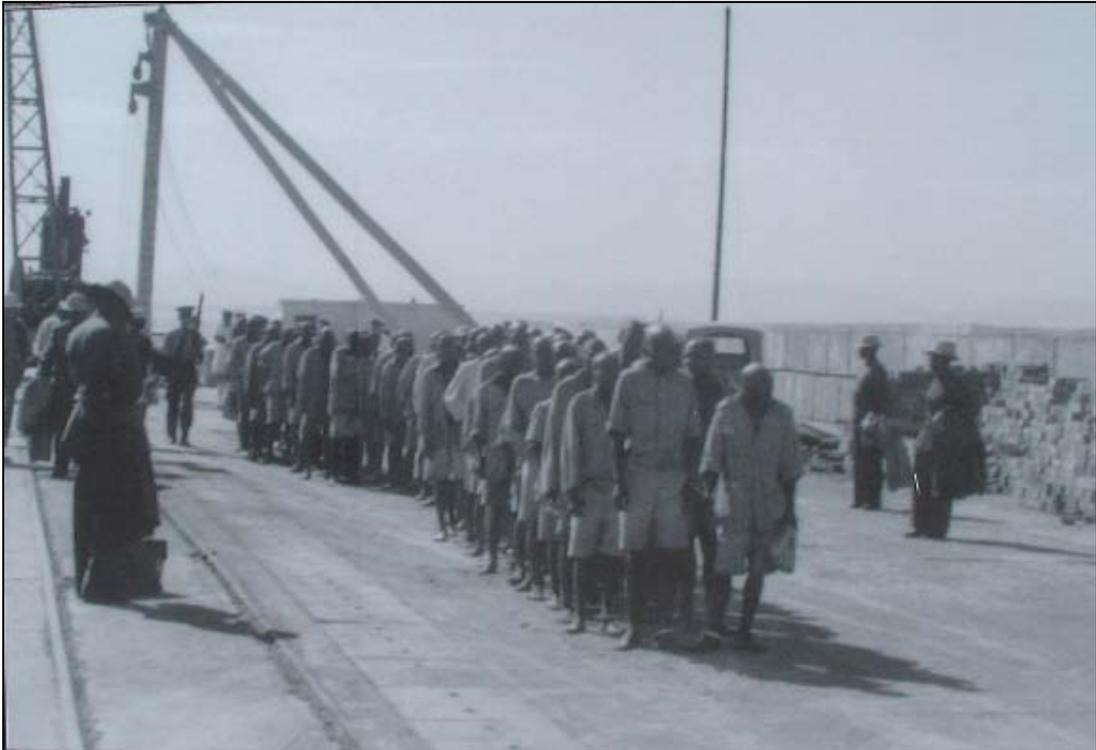
This image displayed on the wall of the quay at Murray's Bay harbour shows, besides the prisoners, a railway set into the surface (no longer existing) as well as a railway mounted steam crane in the left background.
