ARCHAEOLOGICAL INVESTIGATIONS AT THE CLOCK TOWER PRECINCT VICTORIA AND ALFRED WATERFRONT

Prepared for

V&A Waterfront (PTY) Ltd

May 1999

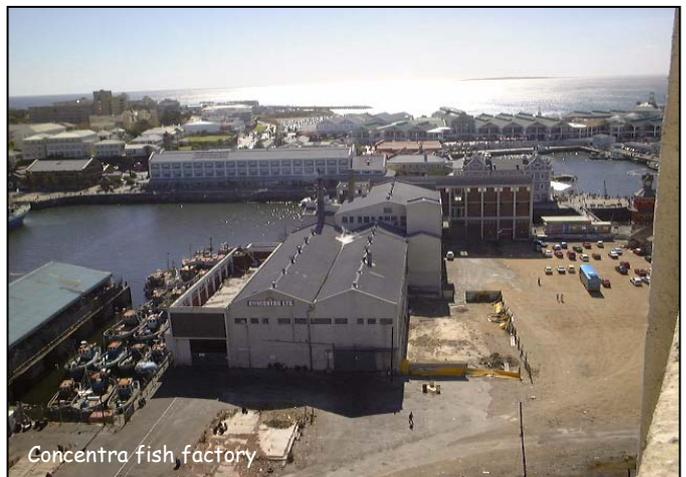
The projected location of the historical site lay in a portion of land to the south east of the Alfred Basin Cut. The Concentra Fish Meal Factory presently occupies the site. The Chavonnes Battery became redundant in the mid-19th century and was lost under landfill when the Alfred Basin was excavated after 1860. After 1870, several warehouses were built on the landfill. Oral history indicates that the fish meal plant was established in the 1930's incorporating one of the early warehouses. Plans exist indicating that the plant was significantly expanded in 1949 with the result that the bulk of the existing factory dates from this period. In summary, four separate phases of development have taken place in the area. These are:

- a) The Chavonnes Battery was built on a promontory of land (the most seaward extent of the Signal Hill ridge) in the early 18th century.
- b) The construction of the Alfred Basin and Cut from 1860 onwards. This involved excavating a deep basin and channel into the Malmsbury shale and using the resulting rubble to reclaim land from the sea. During this time the battery was filled in with rubble and partially demolished. The Clock Tower jetty was built and the coastline was advanced by pouring rubble fill into the sea.
- c) Railways and cargo sheds were built on the reclaimed land, which formed the north east wharf of the Alfred Basin.

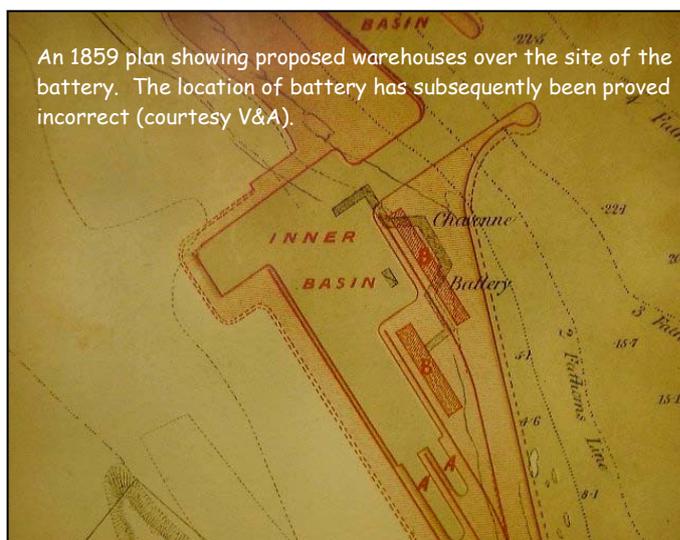
A report on the state of forts and batteries⁵ prepared by the British authorities in 1809 describe the Chavonnes Battery as a "formidable sea battery in good order, in which are stationed one Captain of Artillery and 40 Rank and File. In this work is a magazine containing 1592 rounds of ammunition for service of the battery, besides a quantity of powder in the charge of the ordinance stock keeper. There are two furnaces for heating shot. The mounted guns are on wooden platforms out of repair, and it is the opinion of the commanding engineer that it would be useful to go to the expense of laying new platforms." The armaments installed at the battery consisted of 12, 36-pounder cannons, 16, 18-pounder cannons, 2, 18 inch and 1, 10 inch English mortars. By 1812 some of the gun platforms had been repaired and new wood was ordered from Plettenberg Bay for the repair of others.

By mid-19th century the Chavonnes Battery had been put to a number of uses. Besides serving a military role, it was used as an isolation and convalescent wing of the old Somerset Hospital. Crews and passengers of ships stricken with contagious illness (such as small pox) were confined to the battery until they were considered fit.⁶ Initially prisoners who were put to work on the breakwater and harbour were incarcerated at the battery until the breakwater prison was complete.⁷ When the Chavonnes Battery was handed over to the Government for harbour building activities in 1861 it

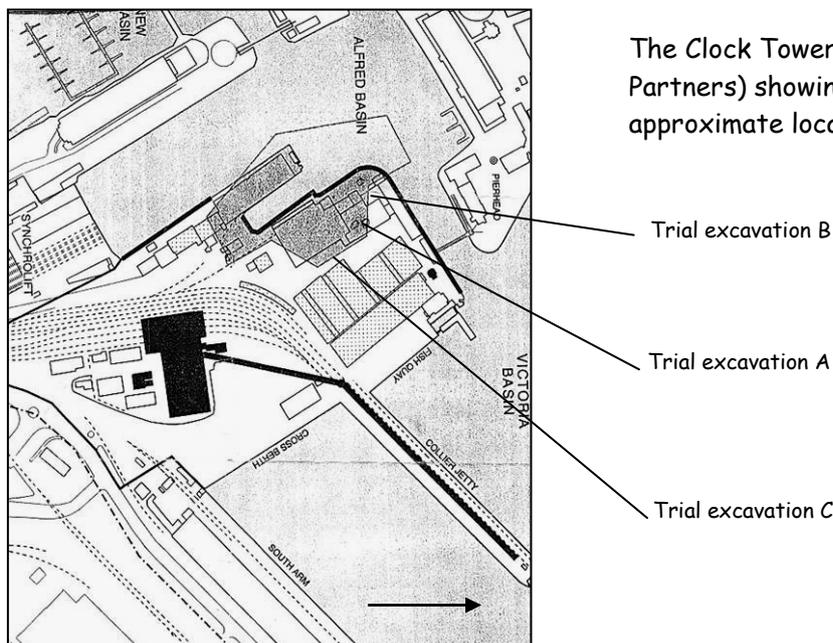
The Clock Tower Precinct (source Revel Fox and Partners) showing what was believed to be the approximate location of the Chavonnes Battery.

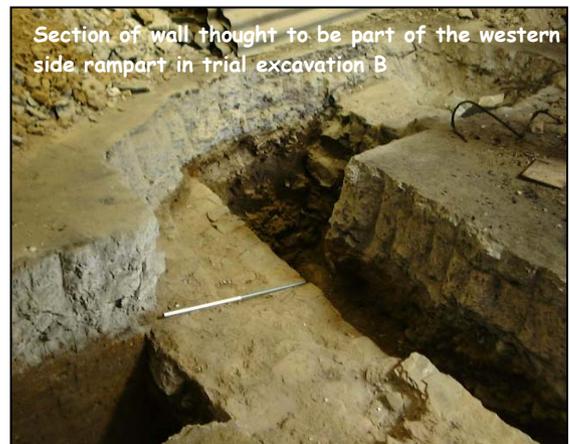
Removal of between 400-600 mm of concrete in the disused annex to the boiler house revealed two stone walls covered with fill material immediately under the concrete. One of these walls (the southern) is considered to be a footing of one of the 19th century cargo sheds. The other is carefully constructed and plastered with lime mortar. The remains of iron eye bolts are still set into the fabric. At the base of the wall is a shale floor (1200 mm below top of wall) which has suffered some disturbance as a result of the positioning of the later cargo store footing. It too, has iron fixtures set into its base.

We interpreted the find as the top of one of the ramparts of the battery. The wall, which we have located, is probably the inside skin of one of the ramparts. This was separated from the outside wall by a sand-clay fill. It is expected that further investigations will show that the outer rampart wall continues downwards to a depth of 3000 mm or more.

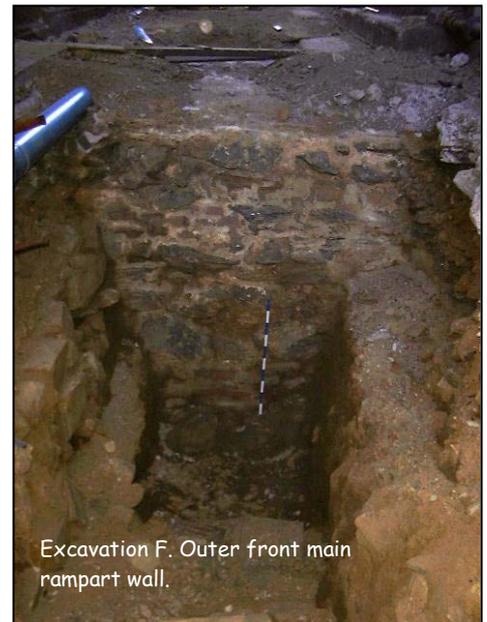
The outer skin is no less than 4m thick and appears to be solid. It was built directly onto bedrock. The front face is somewhat angled and massively constructed. Numerous repairs have been made to its face with Dutch and British brickwork. Although it would appear that some of the top portions of the wall have been demolished in the past, the remaining structure is in excellent condition and represents the most visibly spectacular aspect of the site to date. In total the rampart together with the earth fill is 12.5m thick at this point.

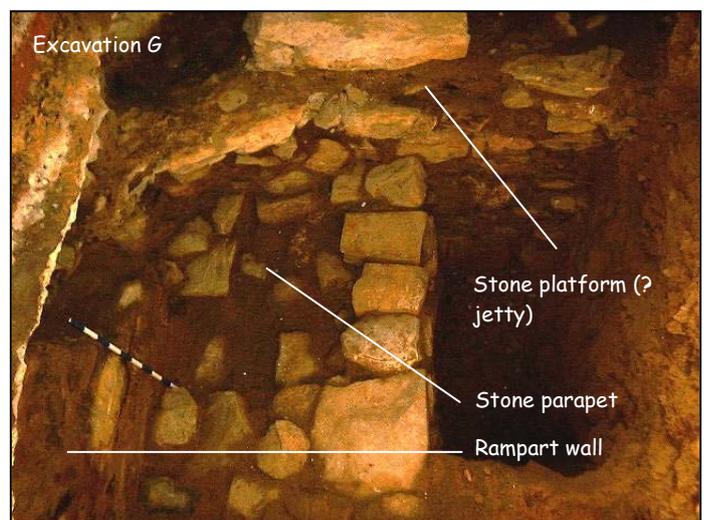
A large slab of concrete was removed in the redbrick building to allow for an investigation of the presence/absence of the front wall. The fill area contained a number of very large stones (up to 500 kg) which had to be broken into manageable fragments to be removed. The top of the main front wall was found immediately under the two layers of concrete under the factory floor. It soon became apparent that it had undergone some partial demolition and modification to accommodate some very heavy stone structures, which we believe relate to the building of the Clock Tower jetty (South pier) circa 1862. A crudely constructed stone parapet had been built against the outer wall of the battery. A further massive built wall had been carefully bonded

into the fabric of the battery wall projecting towards the Clock Tower. This has its foundations on bedrock, which is about 4000mm below the surface at this point.

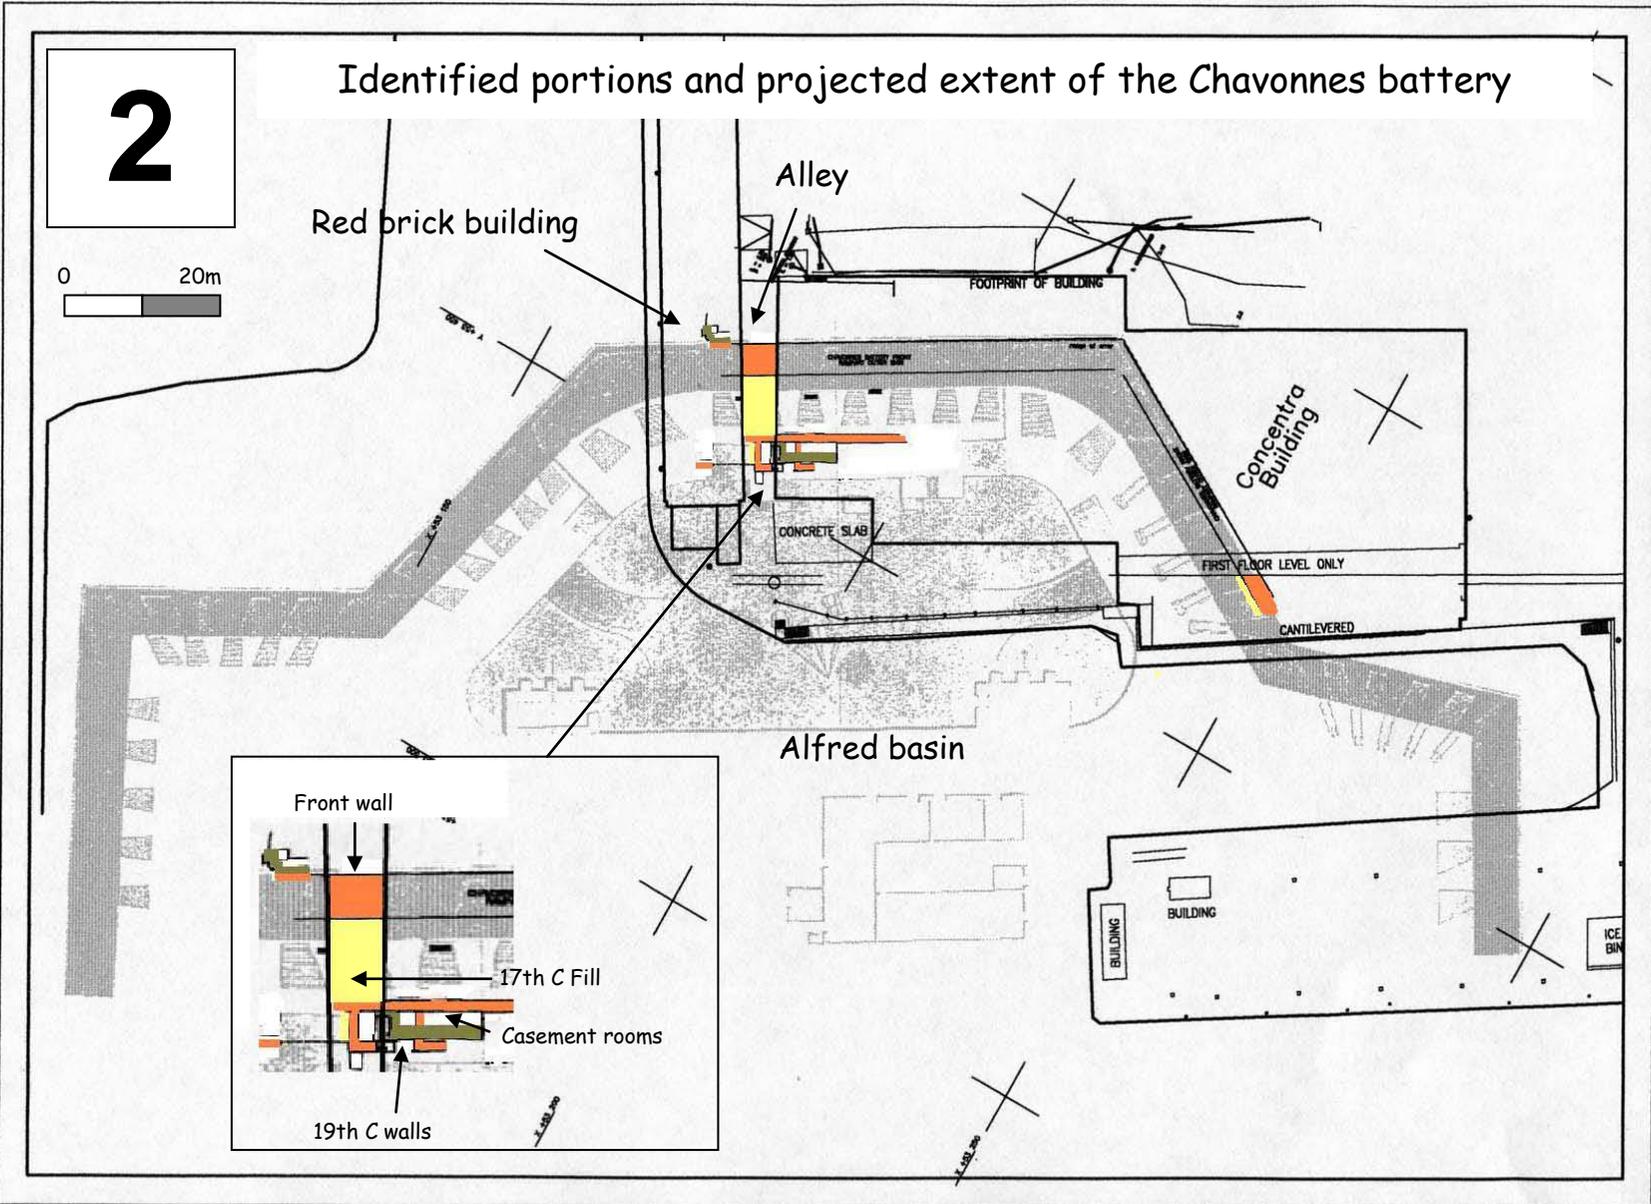
2

Identified portions and projected extent of the Chavonnes battery

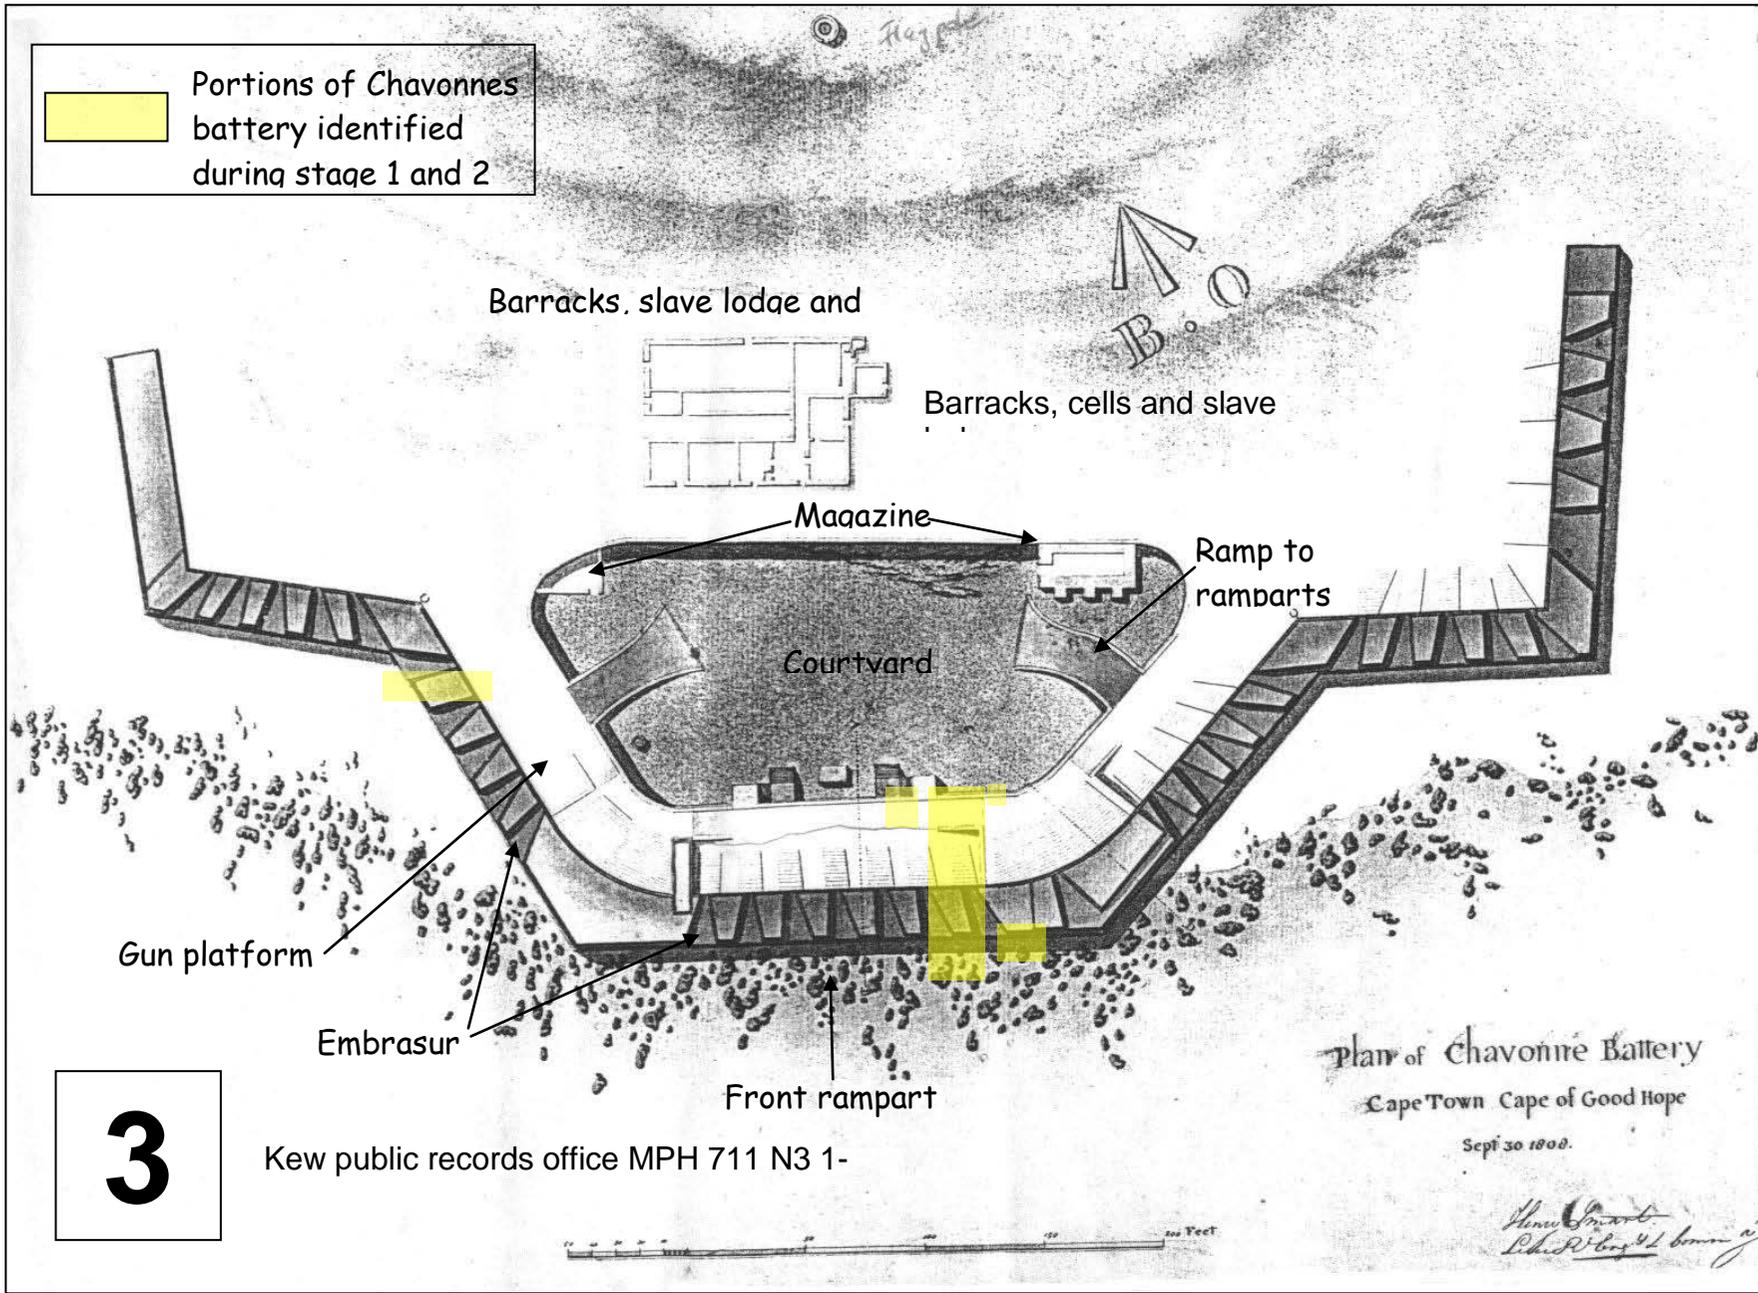
Portions of Chavonnes battery identified during stage 1 and 2
