# CHAVONNES BATTERY

*A Conservation Plan  
Prepared for Syfrets  
August 2001*

**Tim Hart**  
Archaeology Contracts Office  
Department of Archaeology  
University of Cape Town  
Ronsebosch  
7700

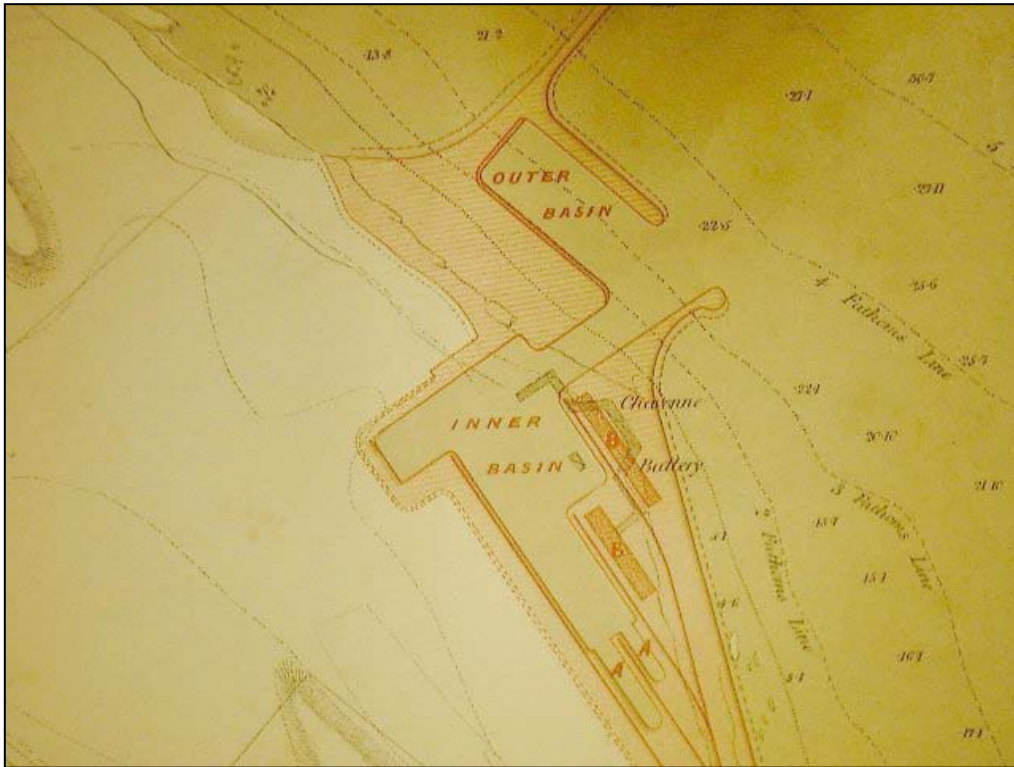
Figure 1 The Chavonnes Battery depicted on an 1859 diagram of the proposed Alfred Basin (after Coode courtesy V&AW)

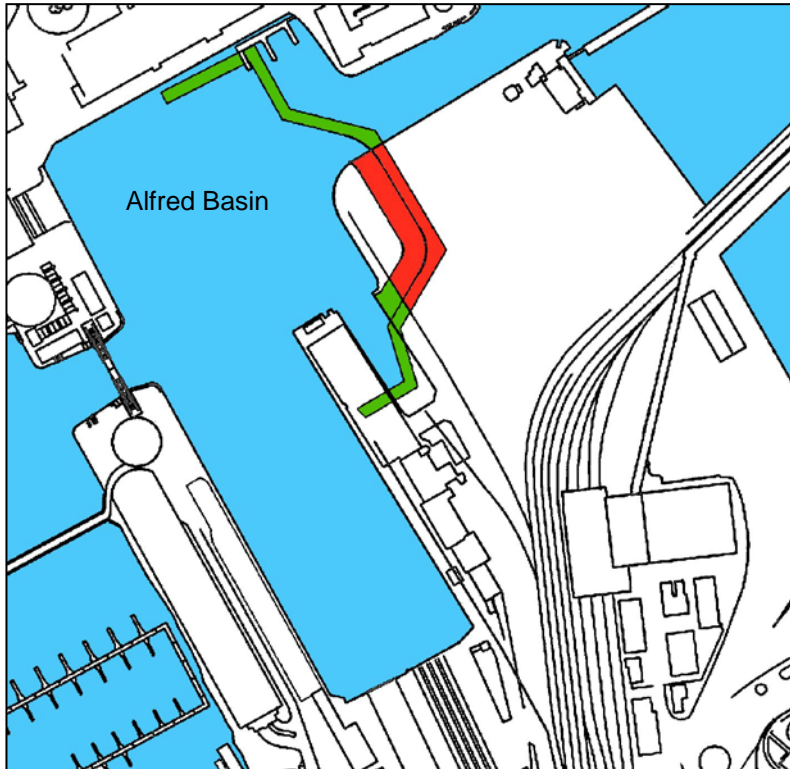
Figure 2

The location of the surviving remains of the Chavonnes Battery on the edge of the Alfred Basin as revealed by archaeological excavations in 1999 (after precinct plan MLH Architects and Planners)

After 1870, several large stone warehouses (Figure 2) were built on the landfill. Two of these lay directly over the Chavonnes Battery. Their stone foundations cut across the length of the casemate rooms and the return of the eastern side of the front wall. Despite the direct placing of these heavy footings on the site of the Battery, the damaged they caused was relatively insignificant.

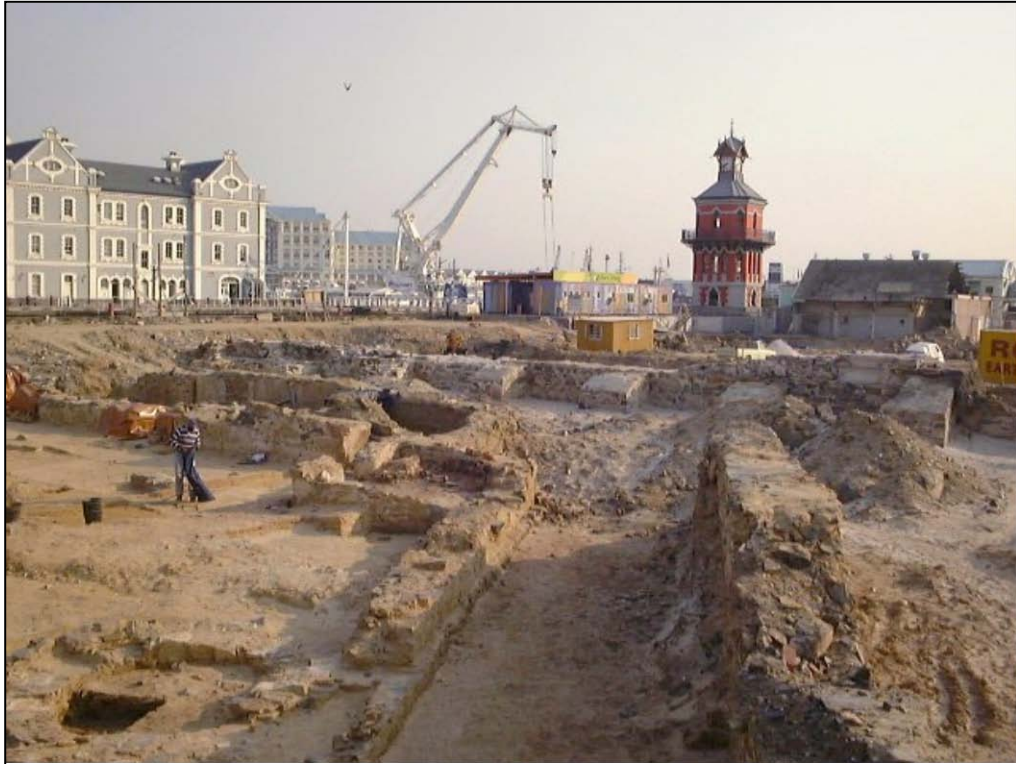
*Figure 6 View of the remains of the Chavonnes Battery. In the background is the front wall, in the foreground is the courtyard and well (left) and remains of the ramp (center).*

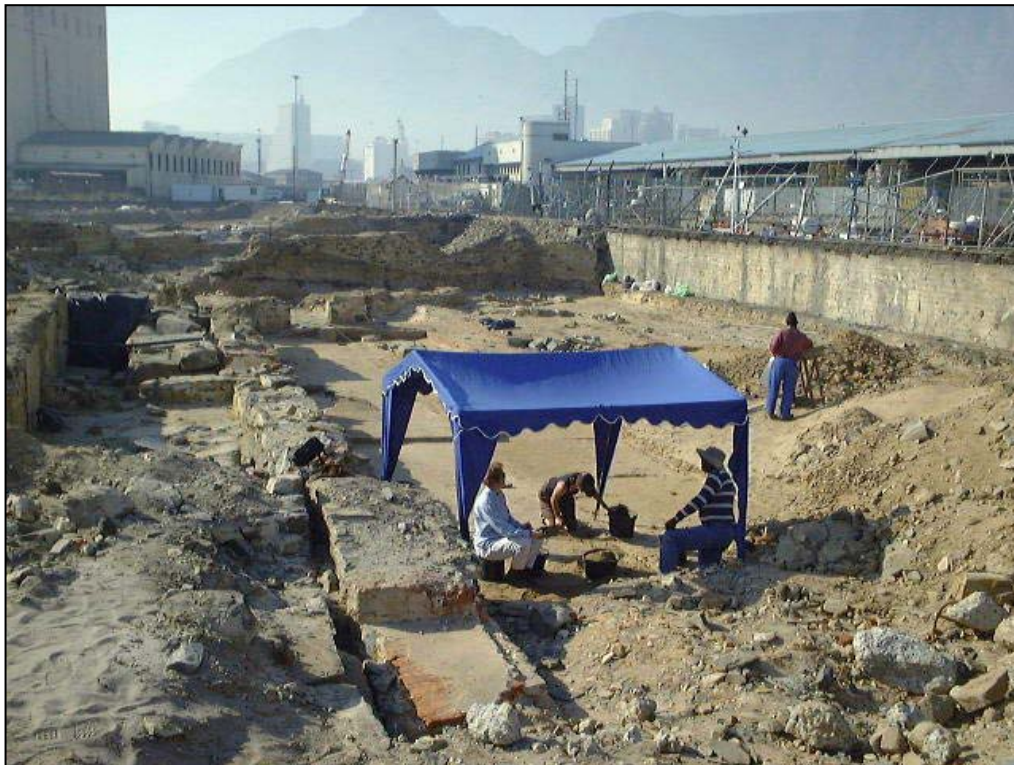
*Figure 7 View of the Battery courtyard with archaeologists working on the courtyard deposit. Partially excavated casemate rooms are to the left.*

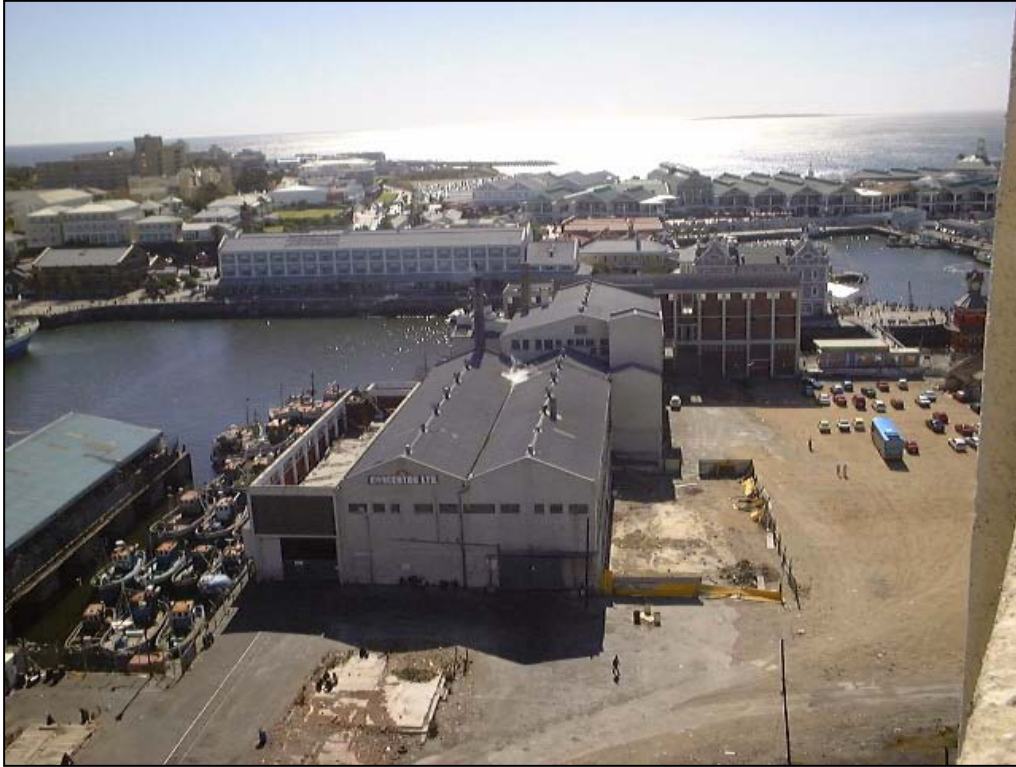
*Figure 8 The Concentra Factory over the site of the Chavonnes Battery in January 1999 prior to demolition.*

Oral history indicates that the Concentra Fish Meal plant was established in the 1930's incorporating one of the early warehouses. Plans exist indicating that the plant was significantly expanded in 1949 with the result that the bulk of the existing factory dates from this period. The engineers who erected the Concentra Fish Factory caused further damage by positioning heavy concrete bases to support the five-story structure. A number of bases were positioned directly on top of the surviving portion of the Battery causing further impacts in the form of depressions in the front wall. Believing that they were building on unstable reclaimed land, engineers cast a 2m thick concrete raft to support a pair of large boilers. This, which lay directly over the courtyard and eastern casemate rooms, may have impacted structures such as hot shot ovens that stood in the courtyard. The Concentra Fish Factory was demolished in 1999 when development of the Clock Tower precinct commenced.

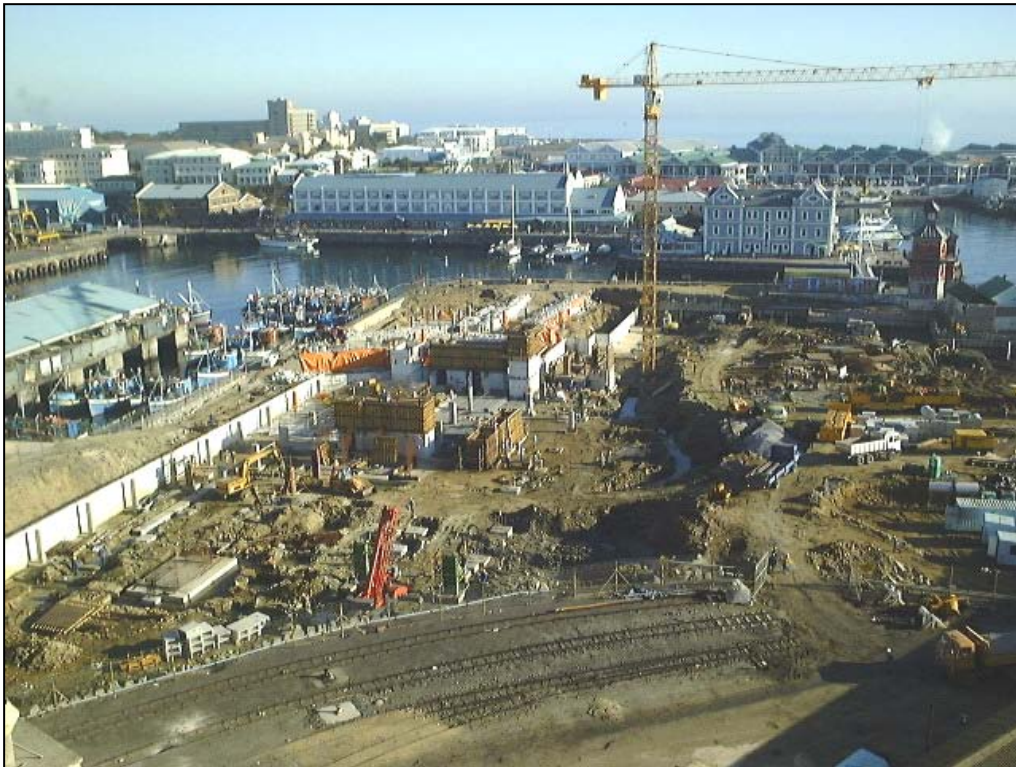
*Figure 9 The site of the Chavonnes Battery (left of crane) is encased by a retaining wall and protected by orange plastic covers and sand bags. Excavation of the underground parking level is in progress.*

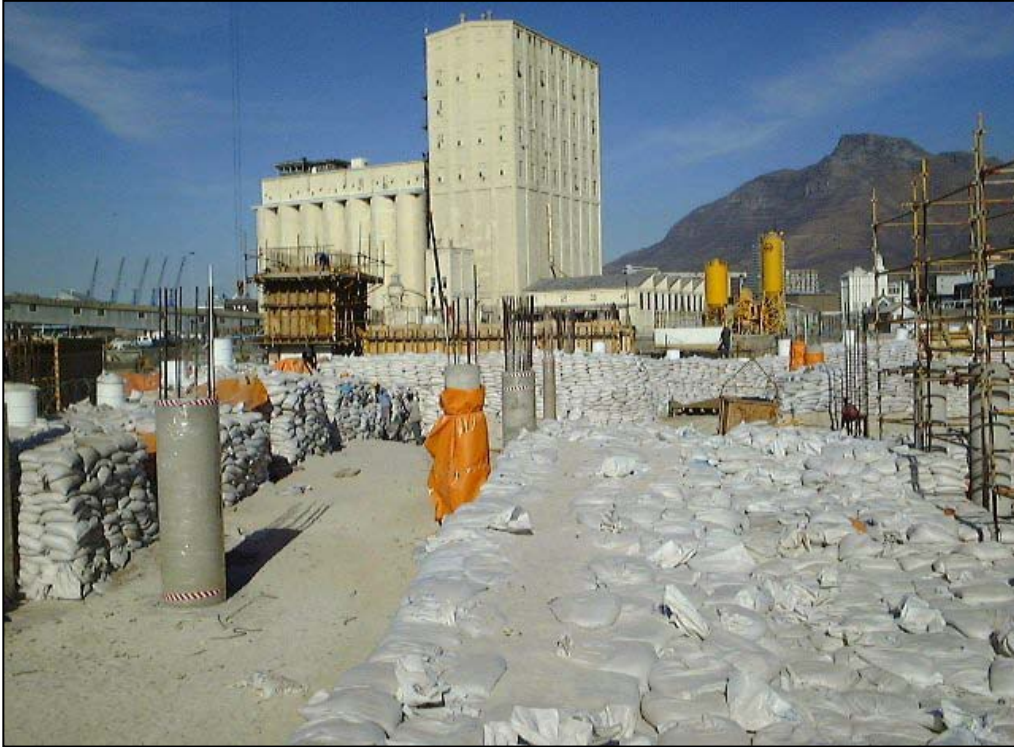
*Figure 10 Original fabric has been protected with sand bags prior to construction of the BOE building. Columns are being cast well clear of the Battery walls.*

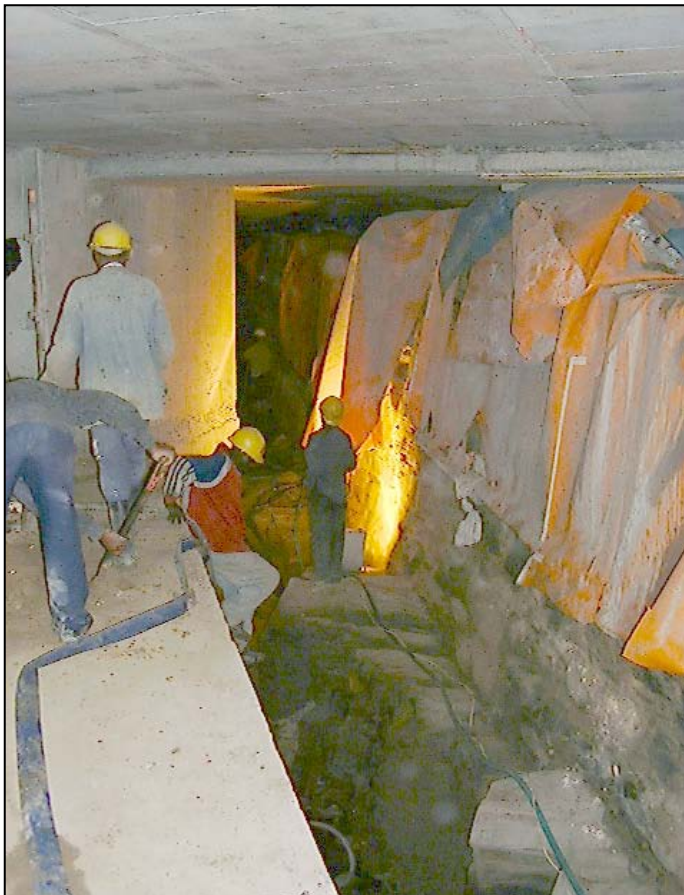
*Figure 11  
Workers  
prepare to  
remove the  
protective  
plastic  
covering  
before  
cleaning the  
south wall  
and rocky  
seabed.*

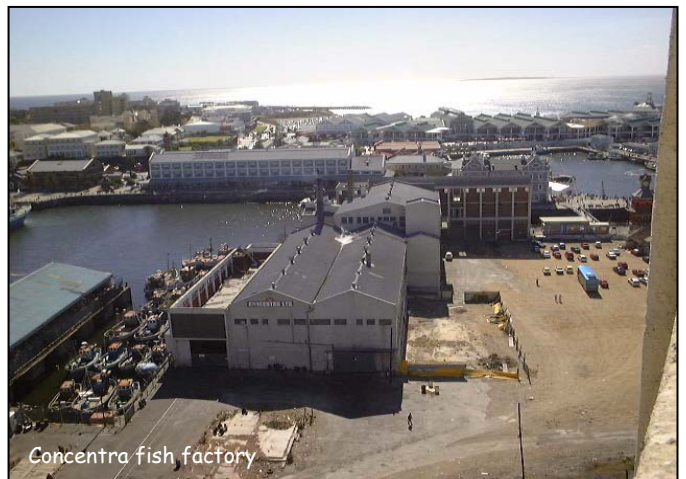
The projected location of the historical site lay in a portion of land to the south east of the Alfred Basin Cut. The Concentra Fish Meal Factory presently occupies the site. The Chavonnes Battery became redundant in the mid-19th century and was lost under landfill when the Alfred Basin was excavated after 1860. After 1870, several warehouses were built on the landfill. Oral history indicates that the fish meal plant was established in the 1930's incorporating one of the early warehouses. Plans exist indicating that the plant was significantly expanded in 1949 with the result that the bulk of the existing factory dates from this period. In summary, four separate phases of development have taken place in the area. These are:

- a) The Chavonnes Battery was built on a promontory of land (the most seaward extent of the Signal Hill ridge) in the early 18th century.
- b) The construction of the Alfred Basin and Cut from 1860 onwards. This involved excavating a deep basin and channel into the Malmsbury shale and using the resulting rubble to reclaim land from the sea. During this time the battery was filled in with rubble and partially demolished. The Clock Tower jetty was built and the coastline was advanced by pouring rubble fill into the sea.
- c) Railways and cargo sheds were built on the reclaimed land, which formed the north east wharf of the Alfred Basin.

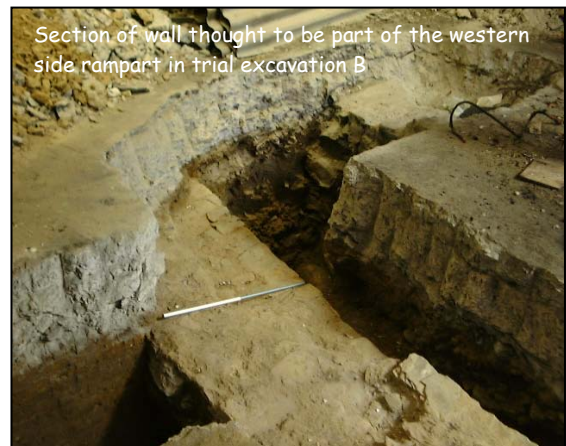
We interpreted the find as the top of one of the ramparts of the battery. The wall, which we have located, is probably the inside skin of one of the ramparts. This was separated from the outside wall by a sand-clay fill. It is expected that further investigations will show that the outer rampart wall continues downwards to a depth of 3000 mm or more.

The location of the walling has shown that the overlay map is correct in broad terms but not precise enough to act as a guide for accurate positioning of trial excavations.

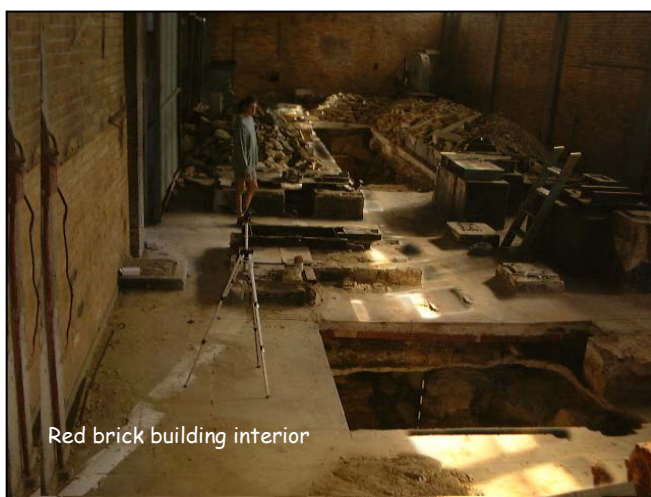
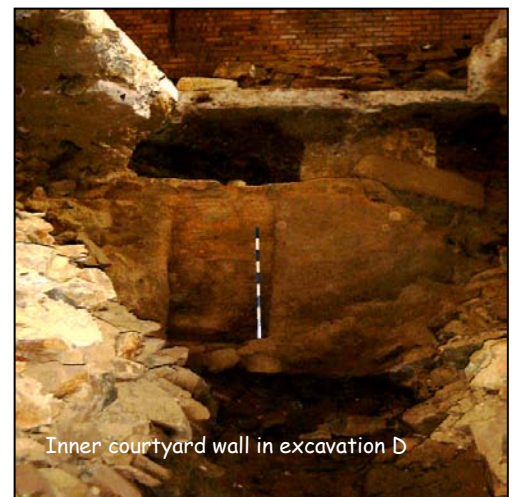
An extensive area of concrete floor within the disused red brick fishmeal factory was lifted so that we could check whether the inner skin wall (previously located in excavation B), extended across the alley into this area. The deposit here consisted of a coarse shale rubble fill characterised by numerous voids and very little soil matrix. The stones were

“unpacked” by hand until a beach deposit and bedrock was reached at a depth of 3m. A short length of carefully constructed stone wall was found at the south end of the trench while several slabs of dressed shale were found on wave worn bedrock on roughly the same alignment of the inner wall located in excavation B.

The standing section of wall was later identified as part of the inner courtyard wall of the battery (Diagram 2). Initial indications are that considerable damage was done to aspects of the battery during the excavation of the nearby Alfred Basin shortly after 1860. The sandy fill of the front wall was removed along the edge of the cut and replaced with a coarse rubble fill.

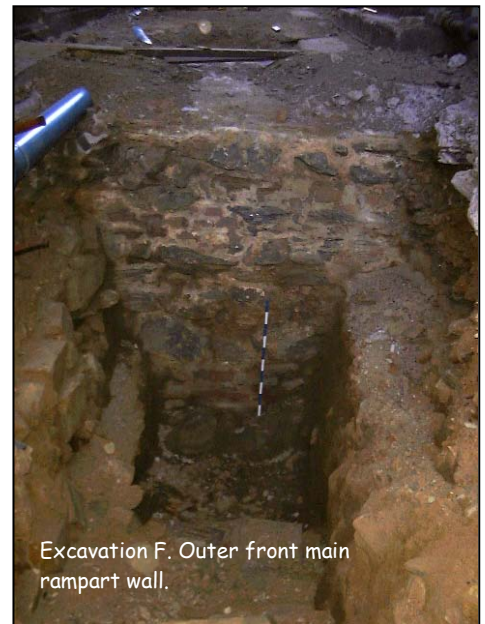
The next plan of attack to locate the elusive front skin of the wall involved concentrating our efforts in the alley - the only area of the site where we could open a full southwest-northeast section. Continuation of excavation B in the boiler room annex had already demonstrated that the inner skin of the wall continued across into the alley so we were hopeful that the outer wall would continue across as well. The tarmac in the alley was removed. Underlying this was 150mm of concrete reinforced with wire and lengths of railway line. Underneath this lay a thin rubble layer followed by the clay and sea sand fill with which we had become familiar with in excavations B and F. We located the top of the front skin immediately as it consisted of a solid mass of shale and lime plaster just below the rubble layer. Once the outer edge was located, we used the mechanical excavator to dig a ramped trench down to bedrock and revealed the full remaining extent of the outer wall of the front rampart.

The outer skin is no less than 4m thick and appears to be solid. It was built directly onto bedrock. The front face is somewhat angled and massively constructed. Numerous repairs have been made to its face with Dutch and British brickwork. Although it would appear that some of the top portions of the wall have been demolished in the past, the remaining structure is in excellent condition and represents the most visibly spectacular aspect of the site to date. In total the rampart together with the earth fill is 12.5m thick at this point.
