AN ARCHAEOLOGICAL INVESTIGATION OF THE CAFE ROYAL BUILDING, CHURCH STREET CAPE TOWN

Prepared for

Syfrets Ltd

May 1995

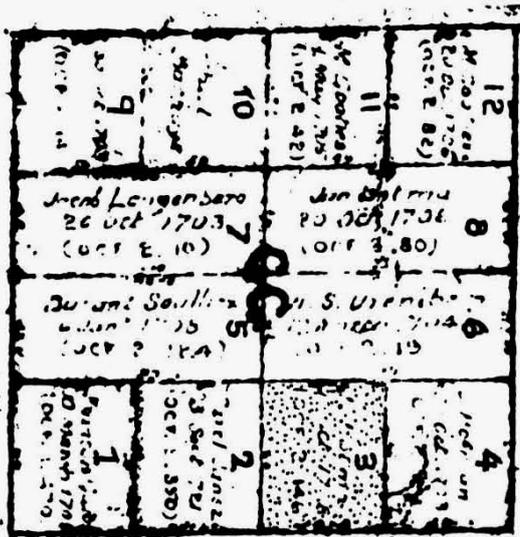
Lots granted in block GG in the early 18th century

- 1708 *Lot 3 in the Block GG (Figure 1) in Cape Town was granted to the Free Burgher Jan Botma. This plot of land was situated close to the Company gardens. Another significant building in the area was the large Company hospital on the top portion of what is now St Georges street. The extent of Jan Botma's property was 20 sq rds and 70 sq ft³. It is not known whether a house existed on the site at this time but Jan Botma owned the property for a number of years and passed it on to his widow after his death. The Botma's were a Free Burgher family of some stature. At the time of Jan Botma's death he owned land and house and slaves in Schotsekloof, a further property in Cape Town, as well as a cattle posts at Riebeeckskasteel and at Sonquasdeurdrif at Drakenstein⁴.*

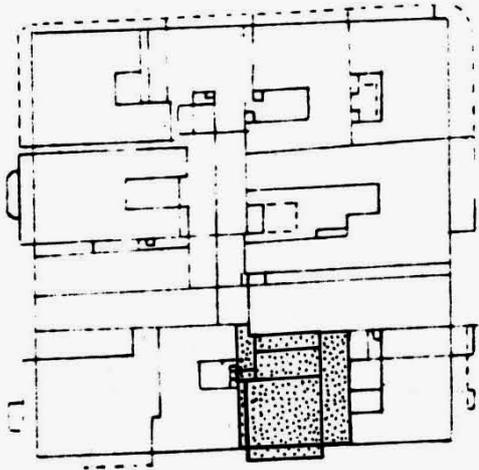
Block GG as it appears in the Snow municipal survey of 1862

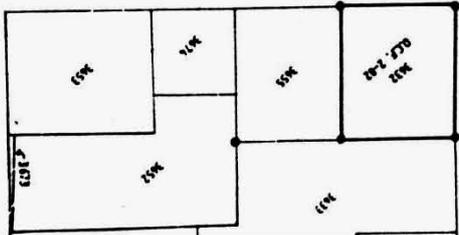
Erven in Block GG according to today's noting sheets

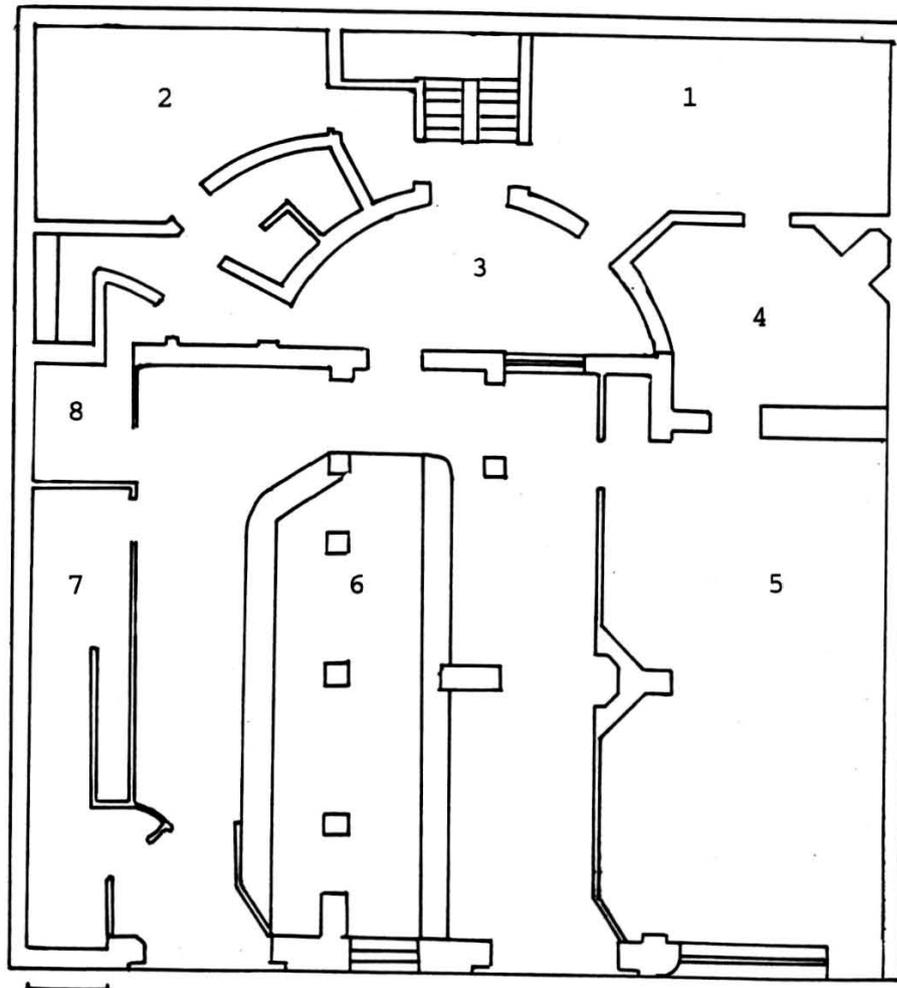
- 1 Kitchen and scullery
- 2 Stores
- 3 Courtyard
- 4 Grill room
- 5 Restaurant
- 6 Bar and bar counters
- 7 Store
- 8 Office

The ground floor of the Cafe Royal as it appears on a plan of 1937. This layout is very similar to that

This particular part of the Cafe Royal (Figure 2) had been ravaged by fire resulting in extensive damage to furnishings and joinery (Plate 3). The north west wall had been paneled while the south east wall consisted of a paneled partition. The ceiling was Victorian matchwood with elaborate wooden cornice mouldings. Removal of the damaged paneling on the north west wall revealed a soft white cement plaster. This was removed along the entire length of the wall to expose the underlying fabric. The lower portion of the wall along the entire length of room 1 was built of carefully packed chunks of mostly undressed Malmesbury shale bonded with clay mortar (Plate 4). At a height of 1900 mm the wall was continued upwards with brickwork. These were fired but crudely moulded. The average size of the bricks was quite small (200x50x100mm) but with substantial variation within the sample (Plate 5). There was no evidence that any of the original shell lime plaster had survived, indicating that if any wall paintings existed these would have been destroyed during the Victorian era.

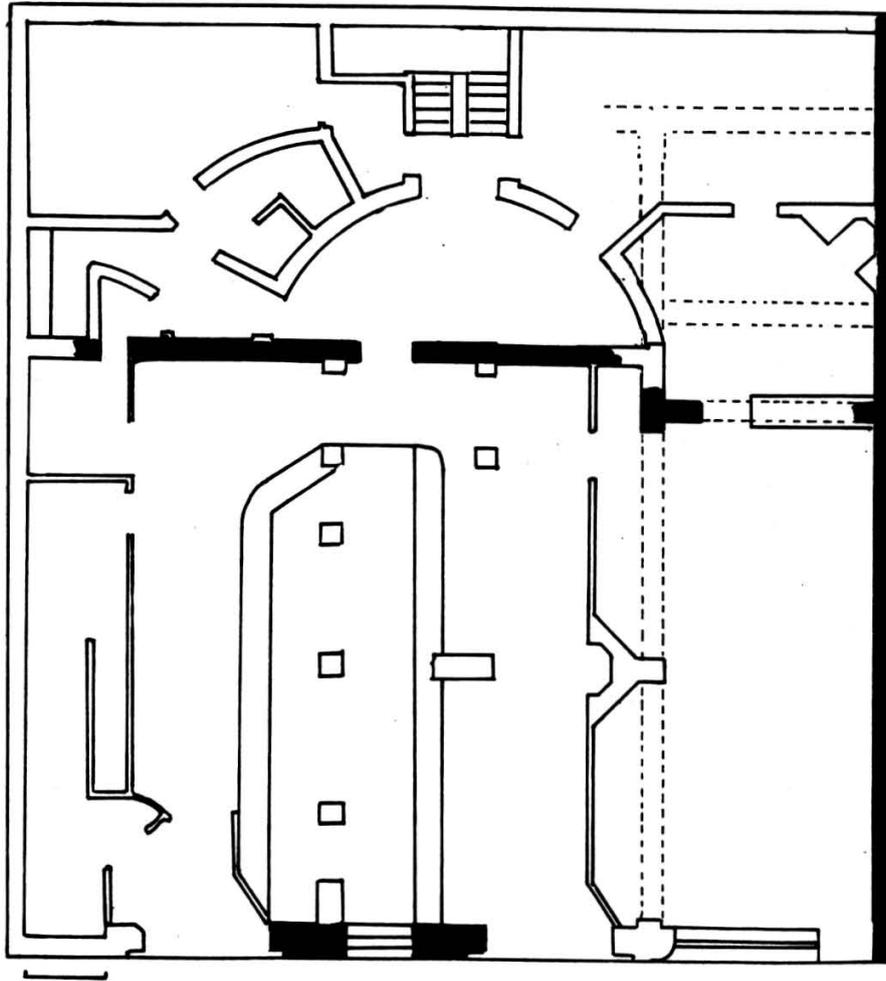
3

- 18th century fabric (ground Floor)
- ⋯ Buried foundations under the Pakhuis

The north east wall of the *Pakhuis* (ground floor) had been demolished by 1906⁵¹. The fact that it existed was verified by examination of the fabric hidden by the matchwood ceiling and excavations under the floor of the *Pakhuis* which located the foundations. It is likely that this alteration was made in the 1880s to increase the ground floor bar area of the Cafe Royal. The wall was cut away and steel beams supported on piers were inserted to support the weight of the wall above on the first floor. Removal of the matchwood ceiling revealed that a strip of original walling existed between the top of the steel supports and first floor. The brickwork and bonding was very similar to the north west wall.

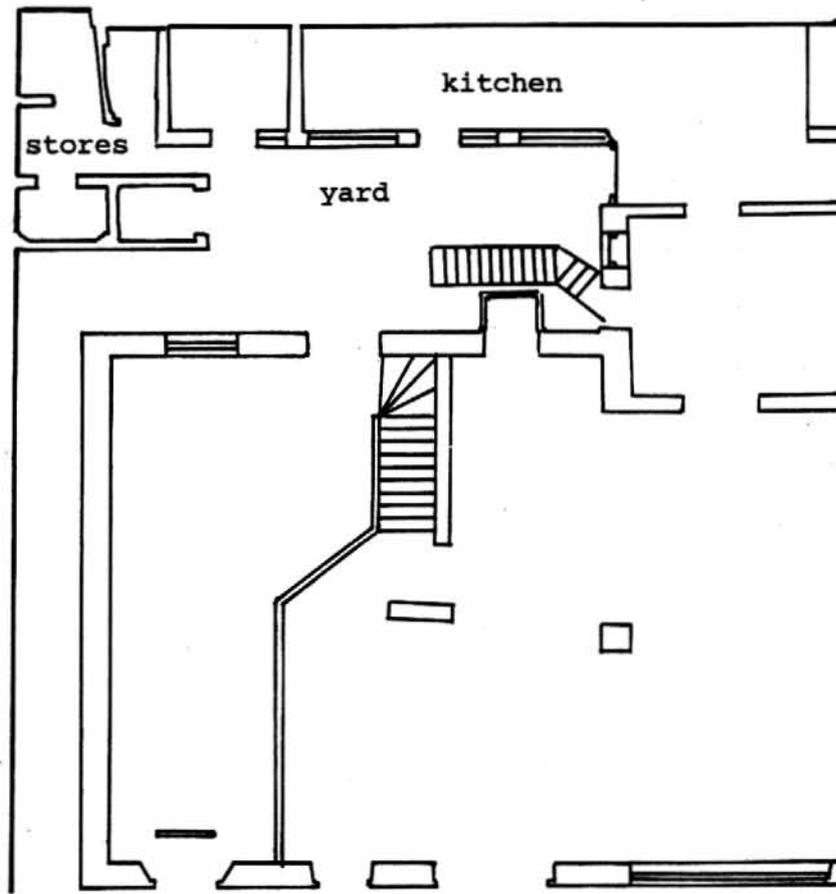
6

Ground floor plan of the cafe Royal
(after C. Freeman 1906)

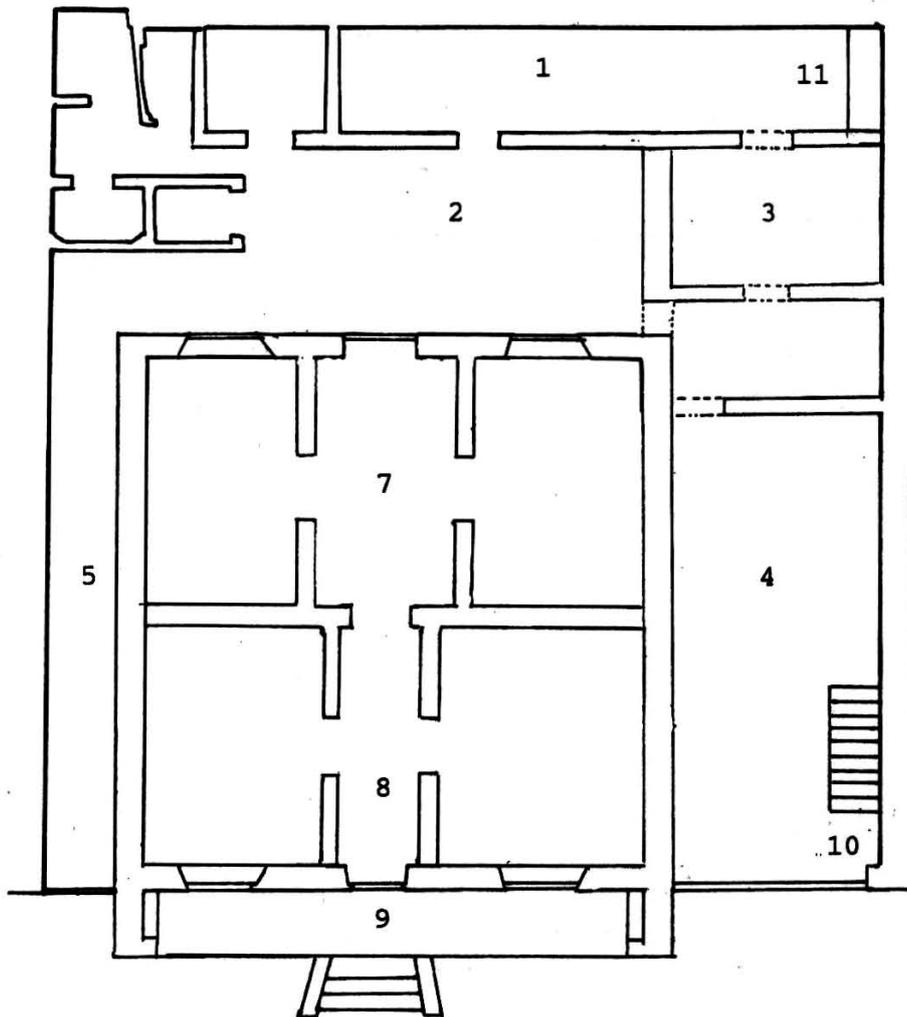
- 1 Backyard structure
- 2 Yard
- 3 Pakhuis rear extension
- 4 Pakhuis
- 5 Outside alley
- 6 Town house rear door (existing)
- 7 Galdery
- 8 Voorhuis
- 9 Stoep
- 10 Pakhuis stairs

- 10 Pakhuis stairs
- 11 Hearth

The archaeological investigations have shown that a *Pakhuis*, a *Town House* and an alley leading to a rear courtyard and backyard rooms existed on the site prior to its becoming a hotel. The complex was altered for accommodation purposes but was modified to its present layout in the 1930s. This involved fusing the complex, adding a storey and demolishing the courtyard structures. These were replaced with a semi-circular structure designed to bolster the rear of the building.

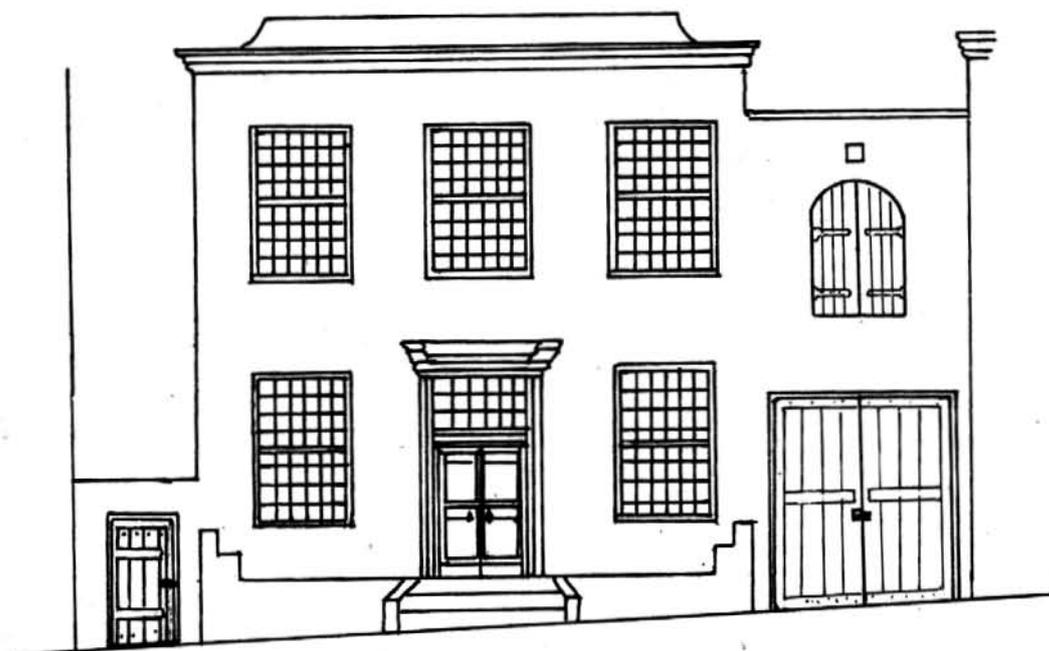
9

The facade of the Cafe Royal as it may have appeared at the beginning of the 19th century.

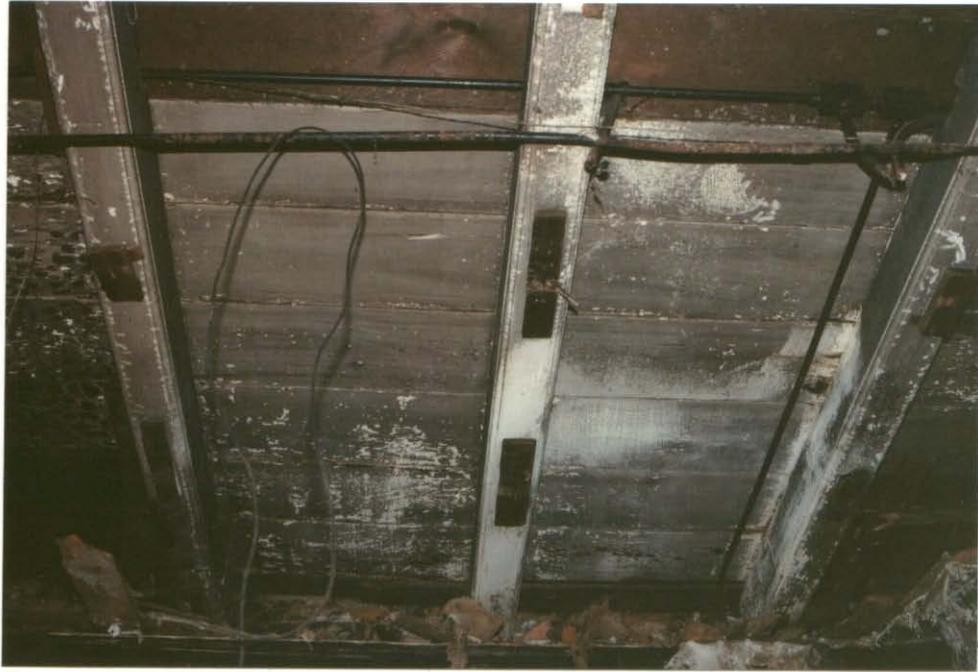
6

A portion of the matchwood ceiling was removed and revealed the largely intact 18th century joists and floor boards of the first floor of the *Pakhuis* (Plate 6) There is evidence that a staircase had once led to the first floor but this had been boarded up with planks of imported pine (Plate 7) Although samples of wood were not submitted for laboratory examination, the boards had the appearance of yellow wood and the joists of teak. Several boards had been replaced by similar sized ones of pine.

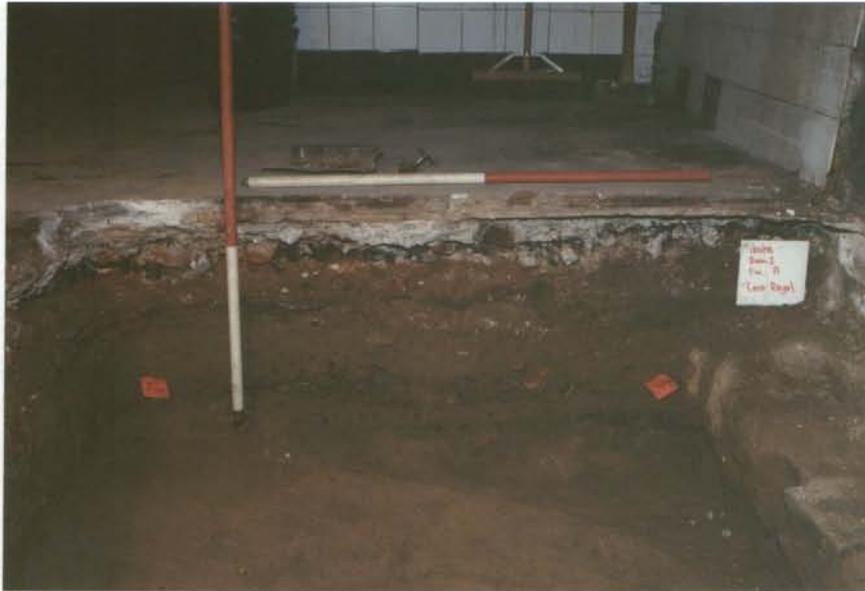
10

Excavation Room 1a (R1a) This excavation was positioned in the rear extension of the *Pakhuis* to check for archaeological deposits that may have predated the building of the additions. Four distinct stratigraphic units (Plate 10) and a cross wall foundation partitioning the rear of the *Pakhuis* (Plate 11) were noted. Figure 5 shows the location of the excavation within the *Pakhuis* and a section drawing showing the following stratigraphic sequence.

Below cement (BC). Under the cement floor lay a coarse rubble soil. It contained numerous bones of rats and some food bones (chicken, sheep, cow) as well as a number of artefacts relating to the late 19th/early 20th centuries. It is likely that this area once had a wooden floor and rodents had been dragging food scraps from the hotel kitchen underneath it.

Smooth Brown Fill (SBF). This unit, which consists of a smooth clay-sand mix, contained small fragments of bricks, quantities of Dutch smoking pipe stems, some fragments of

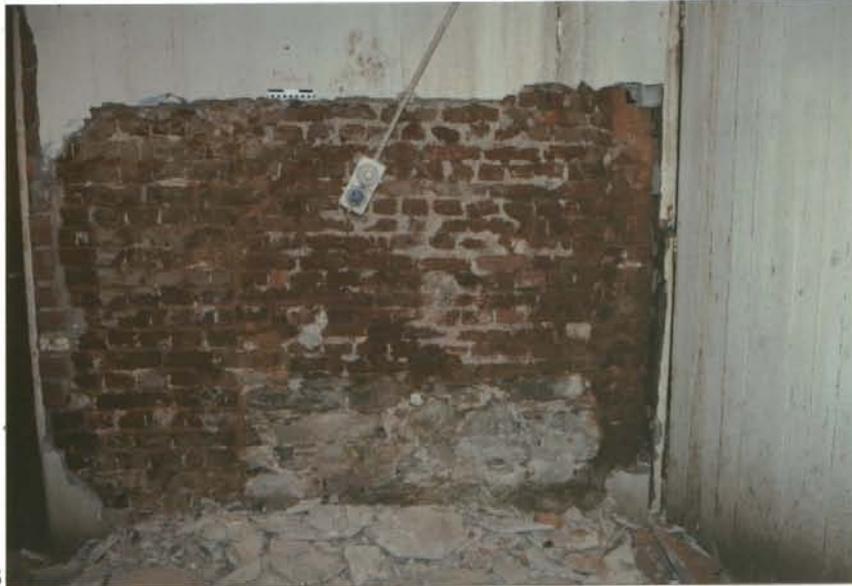
13

Examination of fabric showed that the rear wall (South West) had survived in part (Plate 13). There was evidence of at least two phases of early alteration in addition to the insertion of a modern door. A section of original fabric has remained. This consisted of shale stone foundation to height of 600mm above ground level. The bricks above this were

small by modern standards measuring 200x110x50mm. They were bonded with clay mortar and the wall was plastered on both the exterior and interior with shell lime plaster.

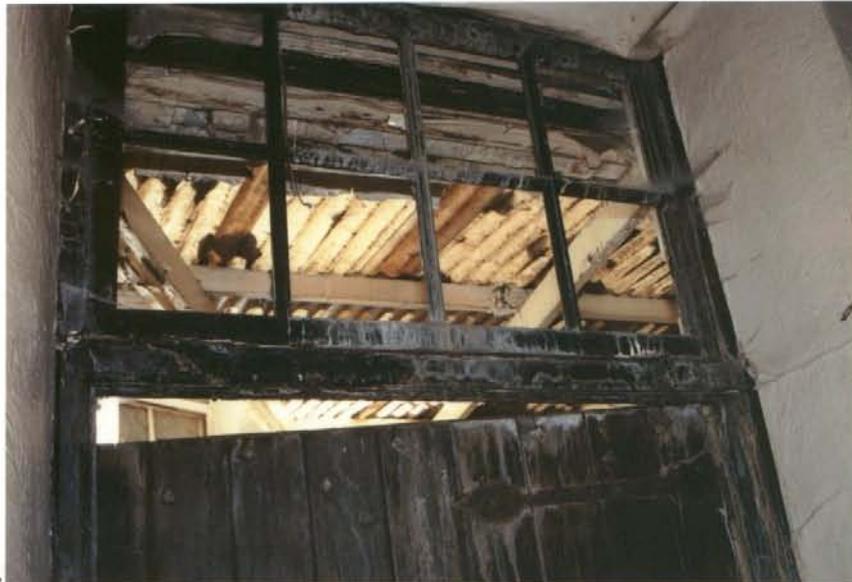
14

The next phase of modification involved putting a central door with fanlight (Plate 14) in the center of the rear wall. Plaster sampling on the interior revealed that the door had been inserted into a modified Dutch period window architrave. The door itself is late 18th century suggesting that these were all early modifications.

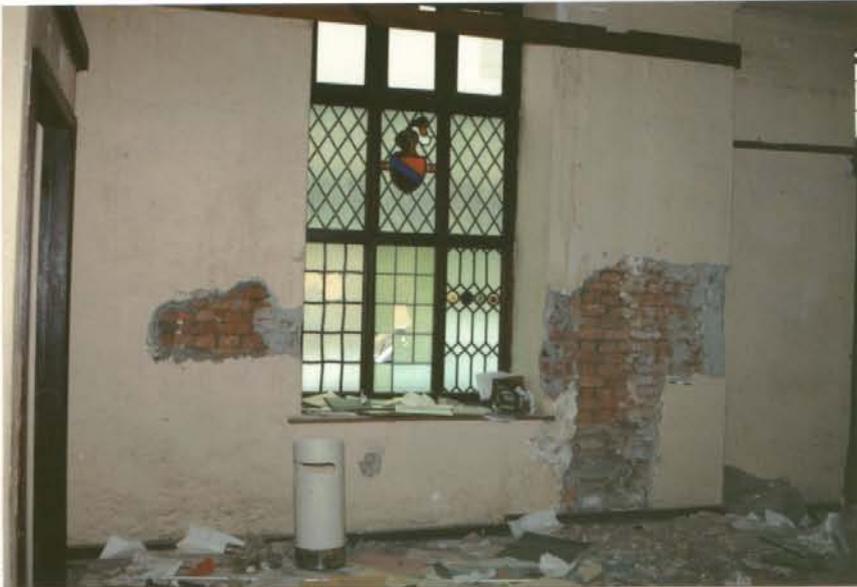
17

This area has been heavily altered with the addition of walls and windows. Plaster removal revealed the architrave of what would have been a central front door of the *Town House* (Plate 17). This had been walled up in the 20th century and converted to a window. As with the rear wall, the foundation was shale extending to a height of 600mm above the floor surface. Two sizes of brick (Plate 18) were used in the wall above (220x140x60mm, 200x110x50mm) which means that the brickmakers had two mould sizes, or the builders were simultaneously using batches of bricks from different suppliers.
