PHASE 1 ARCHAEOLOGICAL INVESTIGATION OF SELECTED ERVEN, BLOCK A, CAPE TOWN

UCKG Properties Pty Ltd

March 2002

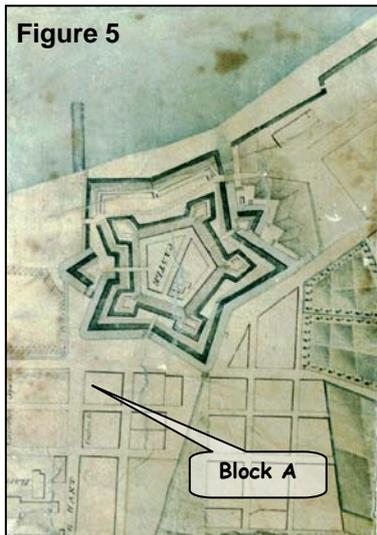
Figure 5

The river, which flowed through a deep donga from Devils peak to the Castle moat, was filled in and replaced by a barrel drain. A plan of the Buitenkant Street area thought to have been drawn by Thibault in the early 19th century indicates an intention to fill the donga and divert the river into an underground drain. Ellerman's plan of the area (circa 1818) shows the layout of the Blocks as they are today (Figure 5). By 1860, the river had been diverted into a drain down Canterbury Street. Certainly, by the early 19th century, Block A appears to have been prepared for development purposes with mixed activities ranging from industrial to retail and residential taking place on the site.

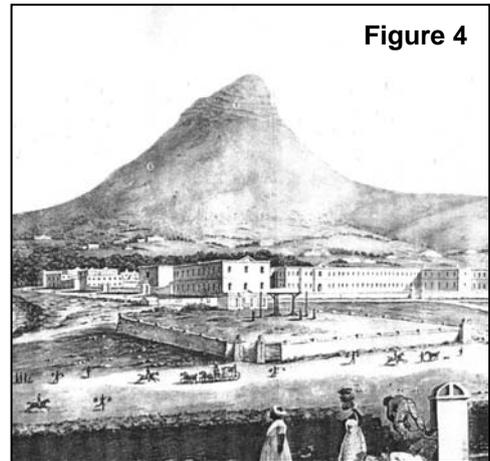
Figure 4

The earliest colonial period structure in the immediate area is the Castle, construction of which commenced in 1666. Block A was part of the open land to the south of the Castle, which according to historic maps appears to contained a large dune on which gallows and pillory were erected (Figures 2 and 3). The area appears to have been used as an execution ground (*Justitie plaats*) for much of the 18th century. Lady Anne Barnard's panorama of 1798 depicts the execution ground as a gallows and pillory erected on a large elevated earth platform surrounded by a retaining wall (Figure 4). Gates and

steps were situated on the corners of the platform and a small structure (thought to be an observation area for officials) on the southwest corner.

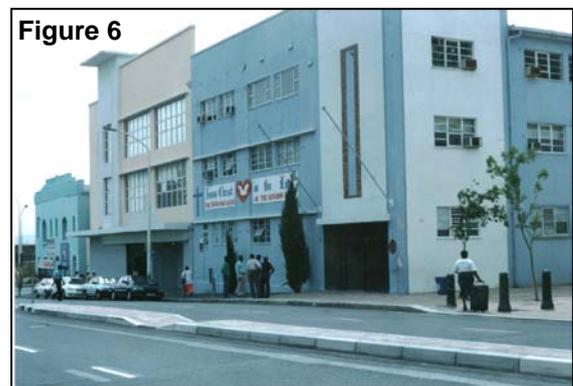
Figure 6

At present much of the Block (Figure 6) forms temporary premises for the United Church of the Kingdom of God (erf 4964), which conducts services for its congregation on a daily basis. Buildings on the Buitenkant frontage are leased out on a short-term basis for various retail purposes. Buildings that made up the old Nedbank Building (erven 4967, 4966 and 4965) are un-occupied. Only erf (9453) has a basement with a well. Locations of erven are indicated on Figure 7.

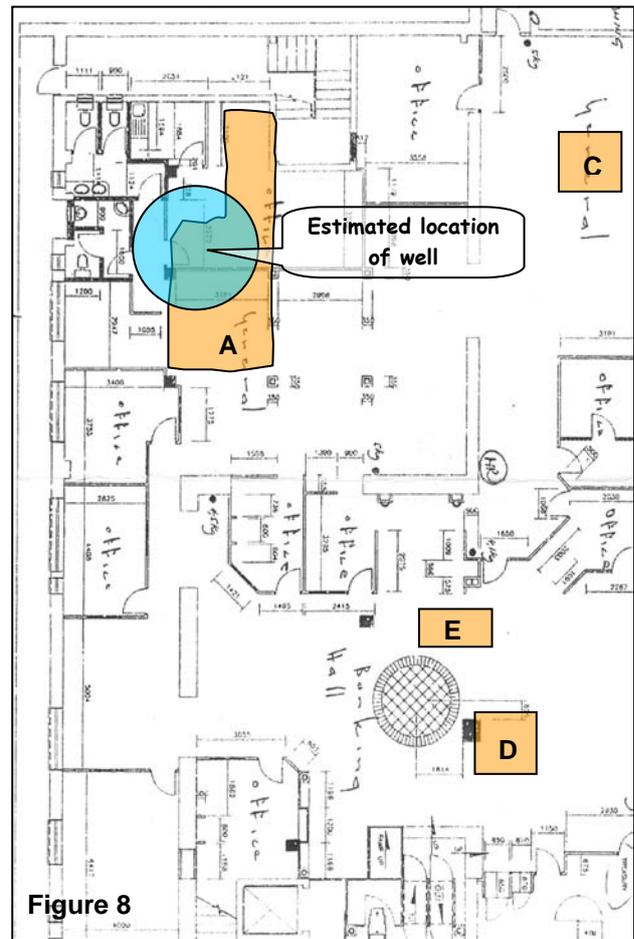
Figure 8

The areas available for trial excavations in December 2001 were restricted to those areas of the block that did not have tenants, or were not in use as an interim church. This meant that we had to focus our activities to erven 4965, 4966, 4967 - the old Nedbank/Plate glass building (Figure 8).

Early plans of this erf (see Thorold, T. 2001 Buitenkant City Block Heritage impact Assessment) indicated the presence of a well (Figure 8) situated in what used to be part of the rear yard/courtyard. Excavation A was positioned in an attempt to locate this feature. The floor of the building was covered with carpet tiles and 3 layers of concrete (250 mm thick in all). Underneath the floor was a layer of demolished building rubble (19th century). In all, 5 discernable stratigraphic layers were noted, before

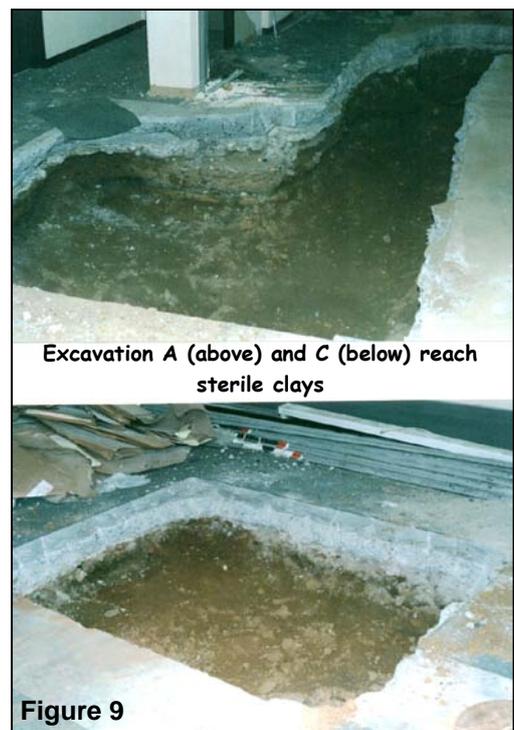
Figure 9

consolidated natural clays were reached at a depth of 900 mm (Figure 9). Layer 5 immediately above the *in situ* clay contained a small amount of fragmented 18th century material (characteristic pipe stems, bone and oriental porcelains).

Since no evidence of any built structures such as a well were found in excavation A, a second trial hole (B) was opened and linked with trial hole A. This also proved unsuccessful in locating the well despite being enlarged to cover the entire reasonable target area where the historic plans indicated that the well existed.

The well, which is indicated on plans to have existed in the warehouse section of the Nedbank building was not discovered despite exhaustive excavations based on overlays of plans of the building. It is quite possible that the feature does exist but was incorrectly plotted on existing diagrams and may yet be found during demolition of the building.
