PHASE 1 ARCHAEOLOGICAL IMPACT ASSESSMENT OF NO 43-47 BUITENKANT STREET, CAPE TOWN

November 2002

Archaeology Contracts Office

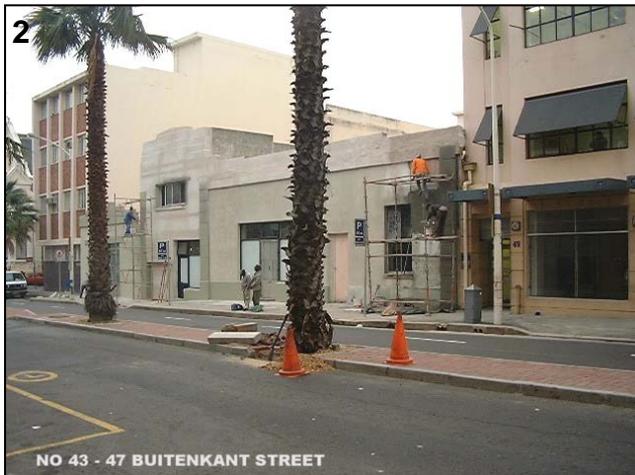
The shop fronts (Figure 2) incorporate the fabric of early 19th century buildings that have been highly modified to the extent that it is difficult to establish details of the construction sequence. Both Jake de Villiers and Trevor Thorold

have expressed the opinion that the structures have been altered to the extent that their significance is irrevocably compromised, and that demolition should be permitted. The buildings have been abandoned for some years and occupied intermittently by vagrants.

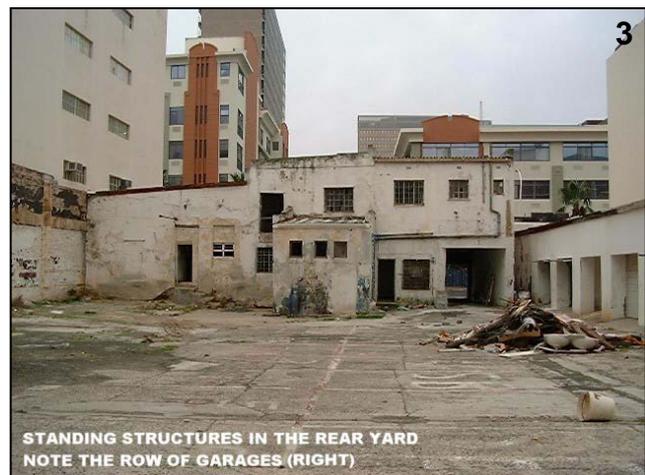
The large yard behind the buildings (Figure 3) used to contain various *ad hoc* structures and extensions to the rear of the standing structures. A row of garages remains along the North West side of the yard. It appears that in recent years standing structures in the yard were demolished to create parking space. Access to this is via an opening through the business front into Buitenkant Street. At time of commencement of the study the yard was covered with a concrete surface of variable thickness and condition.

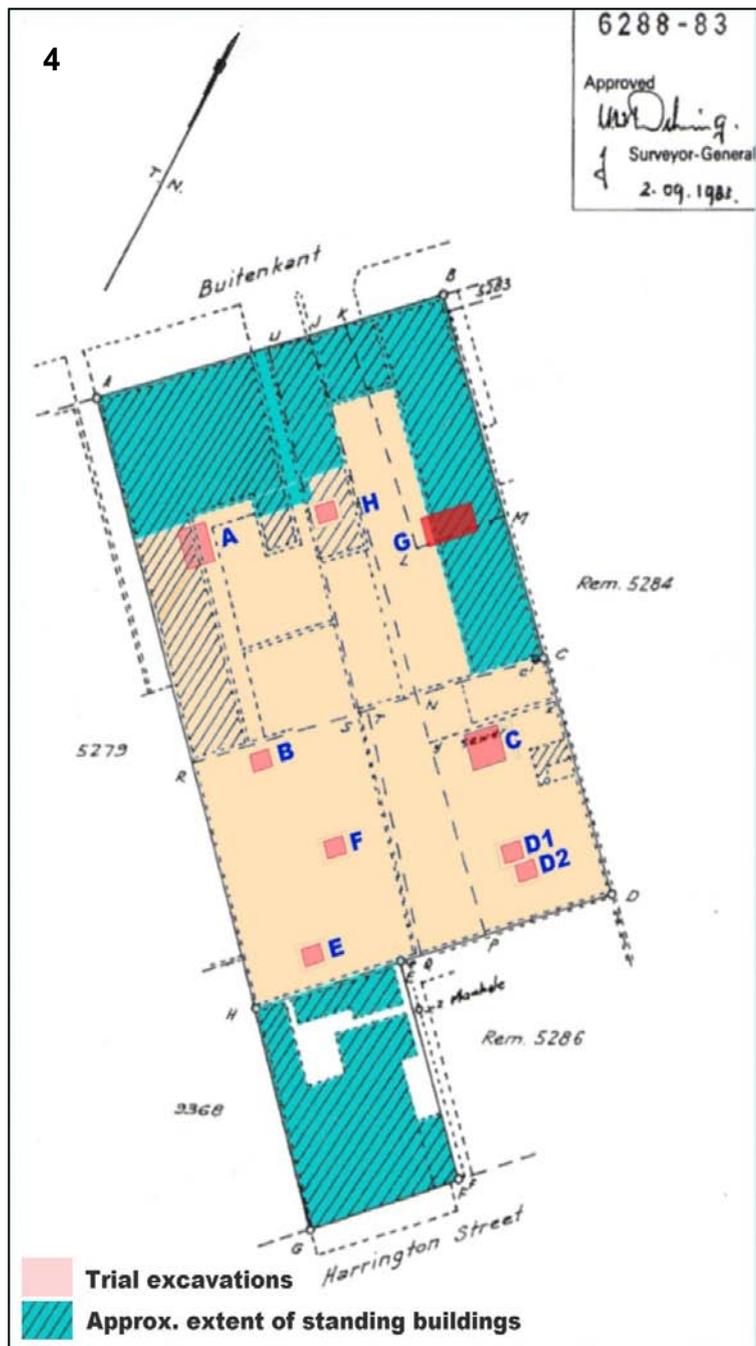
The approach used was to sink a pattern of trial excavations over the property. Some of these were strategically positioned to test specific features such as the backyard areas of buildings, possible wells and footings. Other trial holes were evenly spread across the property to test the depth and quality of subsurface deposits. Excavation was done according to the stratigraphic layering of the various fills; however the sizes of the holes were adjusted in response conditions. Artefactual material was transported to UCT where it was washed and sorted, and presently stored. The locations of the trial holes are indicated on Figure 4.

The locations of the trial holes are indicated on Figure 4.

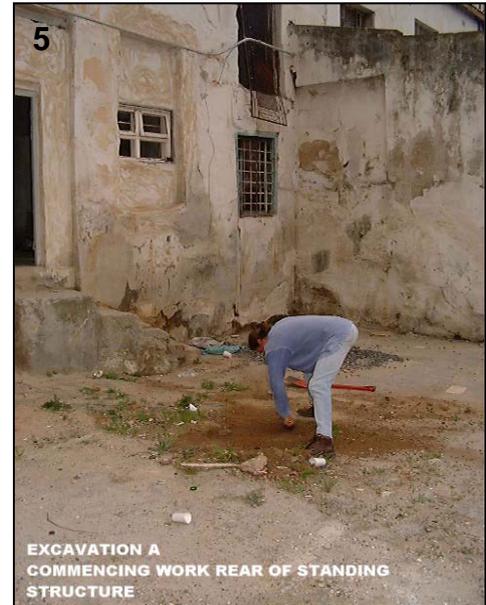
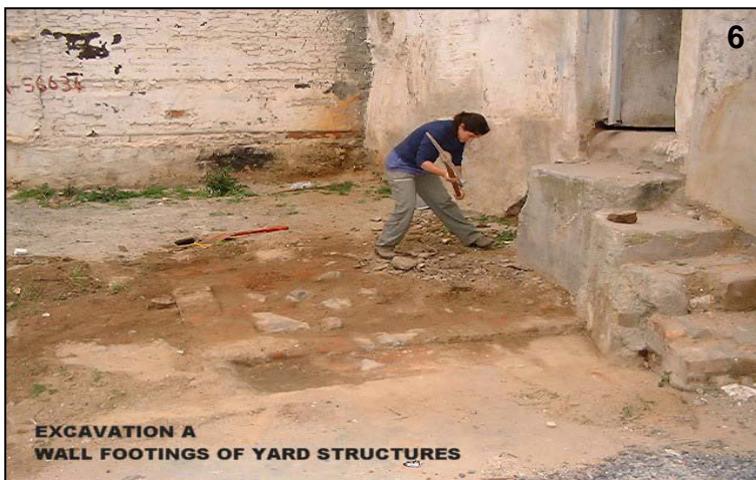
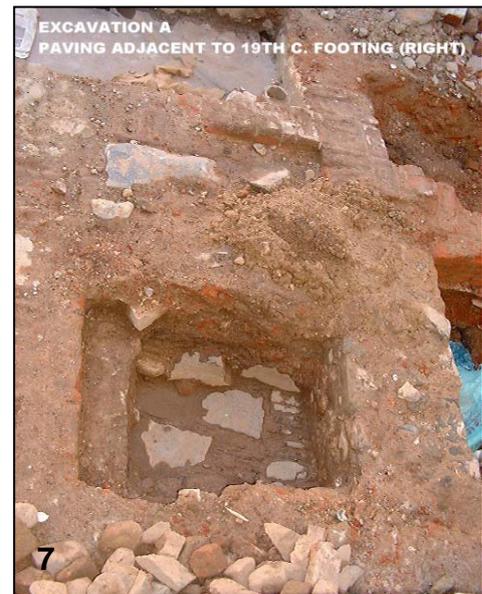
Trial excavations set adjacent to the rear of the house (Figure 5) revealed dense brick rubble packed among old wall footings (19th century frog bricks with stone footings) that once made up part of the rear outbuildings (Figures 6 –7). The presence of chip packets in this rubble attests to a recently laid fill made from demolished older fabric. Underlying this was an older fill containing some 19th century artefactual material. This continued down until natural clays and gravel were encountered at a depth of 1006mm. The water table was encountered at a depth of 800mm.

Some patches of stone cobbble work were found in extensions to the trial excavation on the exterior of the rear outbuildings showing that during the 19th century parts have the rear yard had been paved with cobbles. Two separate layers of cobbles and paving were identified in this area indicating a long use of the backyard of the property. The exterior plaster (shell-lime) is contemporary with or shortly postdates the cobbled surfaces. The cobbles surface slopes steeply towards the east implying that there was once a gutter or drainage channel in the yard. Finds between the cobbles include some fragments of willow pattern refined earthenware indicating that the cobbled surface of the yard was in use during the 19th century. Cobbled surfaces on the site appear to be limited to this area.

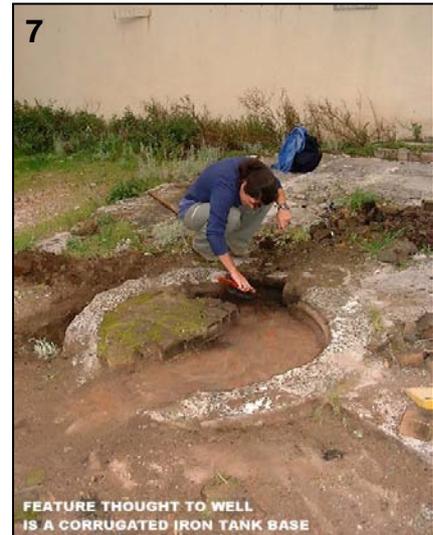
This exploratory excavation was positioned to explore what was thought to be a well built from rounded well bricks (Figures 7–8). This was shown to be a 20th century construction built on a concrete slab. We interpret it as being the base of a cistern or tank made from galvanised iron sheets.

The excavation was sunk deeper adjacent to the feature to reveal a dense rubble layer containing English frog bricks and fragments of ceramic sewerage pipe. The rubble contained willow pattern refined English earthenware ceramic, fragments of decomposing iron as well a bottle glass.

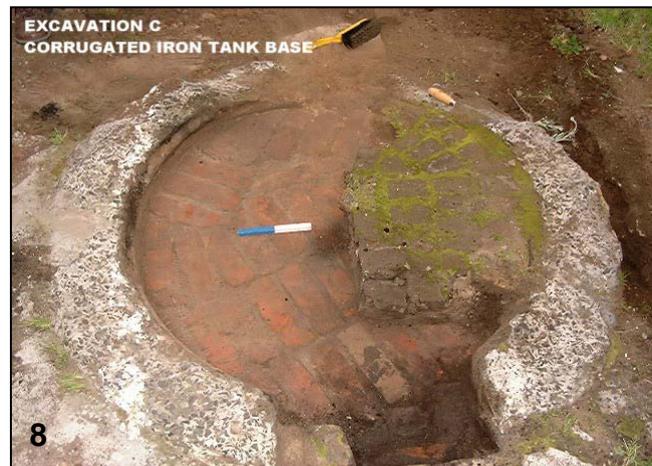
Below this lay a compacted rubble containing artefacts of the mid-19th century (ceramics, glass iron). The water table severely polluted by oil and other industrial waste was encountered at a depth of 1200 mm, at which point work had to be terminated (Figure 9).

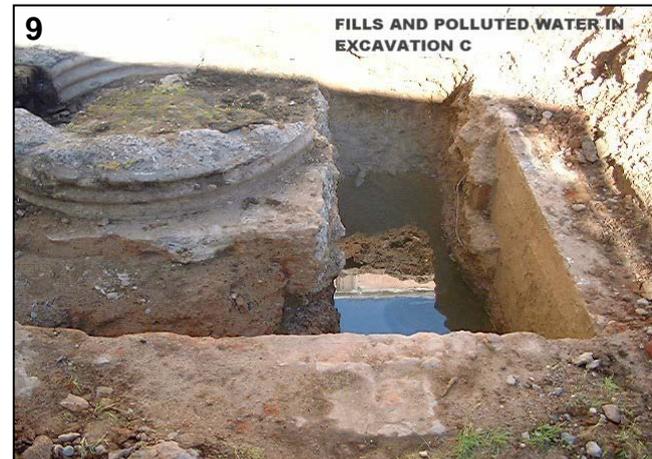
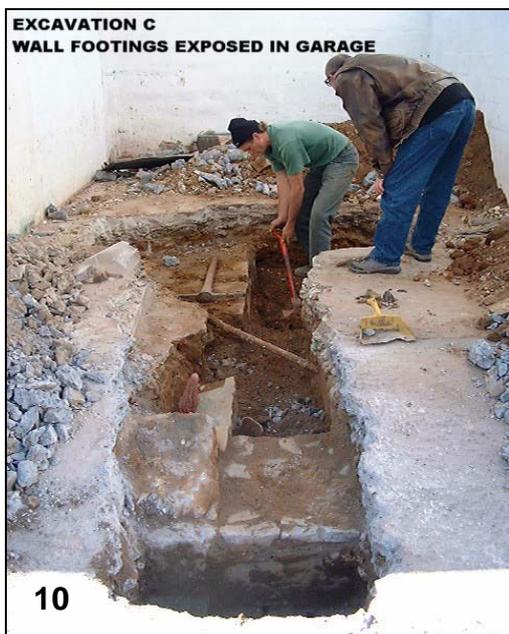
Located in and around the third garage (Figure 11) Harrington Street side) the excavation was positioned to test the fabric of the foundations of these structures (Figure 10). Although the garages appear to be modern, they are positioned along the alignment of buildings indicated on some of the early plans of the site. The excavations revealed the presence of stone

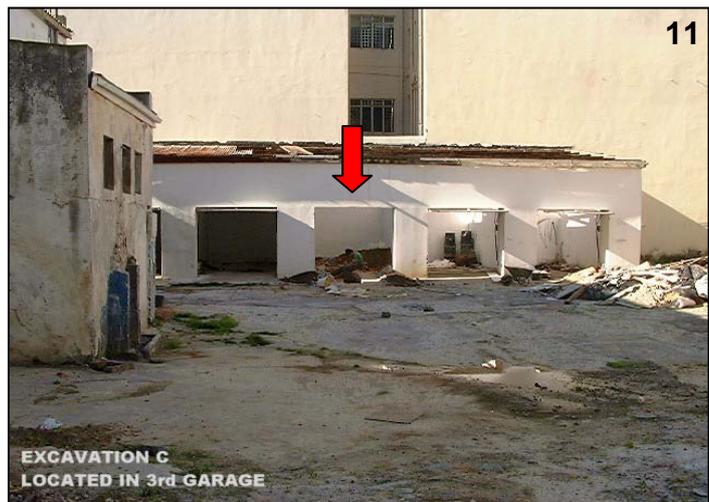
wall-footings the outer one of which roughly followed the alignment of the garages. Built of shale, and being about 650mm in thickness (Figure 12), the foundations penetrate into the soil 530mm. The outer walls of the garages follow the earlier stone footings indicating that there may be places where earlier fabric is included in the existing walls. Artefactual material emanating from the trial excavation was characteristically 19th century.
