INTERIM REPORT NO 2
PHASE TWO ARCHAEOLOGICAL IMPACT ASSESSMENT
ERF 110460, CAPE TOWN -
PREVIOUSLY THE GARDEN WELGELEGEN

(HWC Ref No C13/3/6/2/1/1/1/A1 Permit No 2006-10-002)

This report is the preliminary report of the second field season of Phase 2 excavations on the site of the old farmstead of Welgelegen. In October 2006 the northern portion of the house was uncovered, appearing to date predominantly to the late 19th century, with some evidence of an older core. The second field season was undertaken September –October 2007 to expose the earlier phases of the dwelling more clearly and to expose the full extent of the dwelling. The development, previously owned by Metier/Kuvula Trade 13 (Pty) Ltd was sold in September 2007 to Udonga Property Investments¹.

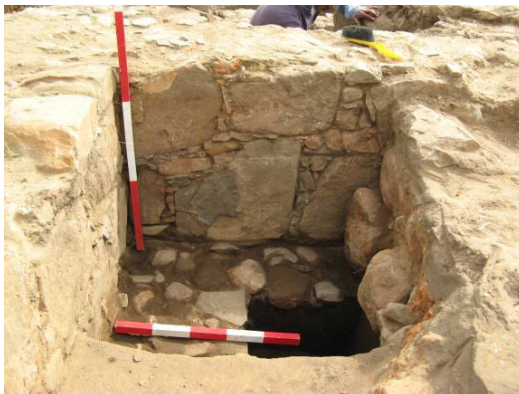
Plate 1: NW corner of Room 3 Wall IV.

The three-roomed structure (Rooms 1 to 3) is characterised by walls varying in thickness between 460 -520 mm (average 490mm) with foundation between 850 and 1030mm thick. Furthermore, these walls are constructed using a combination of large boulders with smaller cobbles set in a yellow clay mortar (Plate 1, and 2).

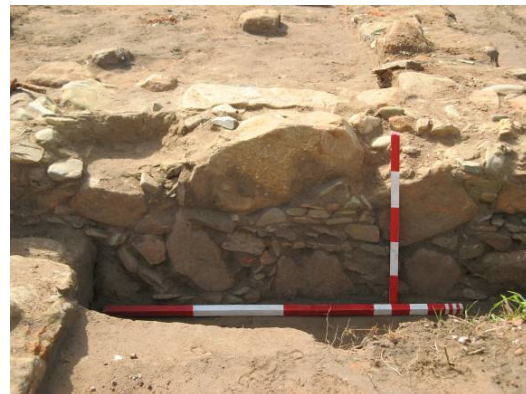
Plate 2: Wall V, 'exterior' Room 3

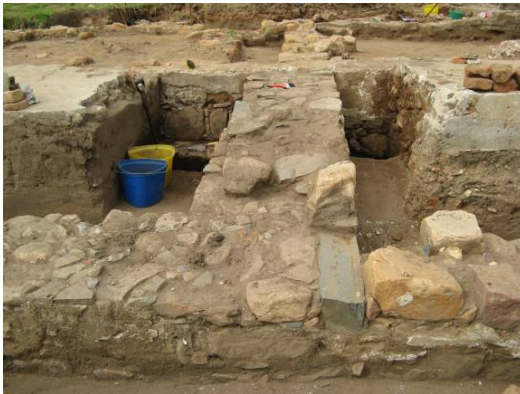
Plate 3: The construction method used in the stoep is similar to that used in the original core, but with a brown clay mortar. NW corner.

The walls of Stoep I vary between 680 and 750mm thick, with a foundation of 840 – 900mm. The wall is constructed of a combination of large cobbles and some slate set in a brown clay mortar (Plate 3 and 4). This wall is only plastered on the 'exterior'.

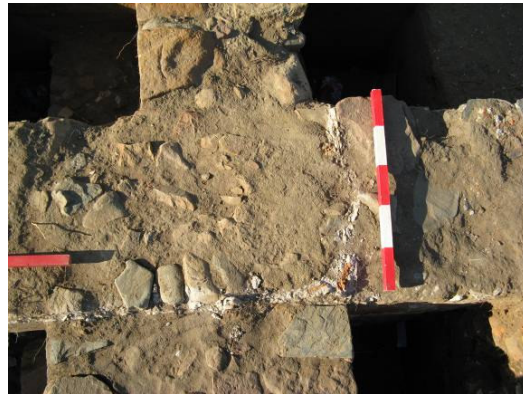
Plate 4: The plaster line showing the exterior corner of the original core.

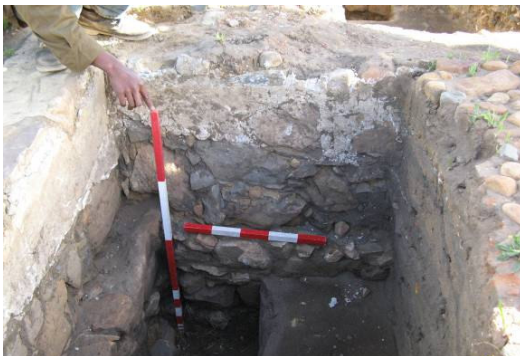
Plate 6: Test pit NW corner of stable, taken facing north. The plaster on the retaining wall (facing) underneath the cobbled surface show and earlier ground surface predating the floor.

The stable area has been much altered and only the cobble flooring remains of its eastern and southern edges (Plates 6 and 7).

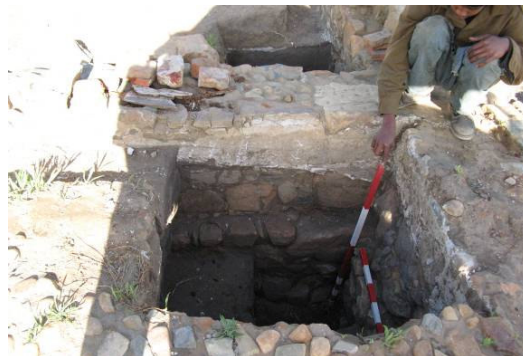
Plate 7: Test pit NW corner of stable, taken facing west showing plaster line indicating ground surface predating cobbled surface.

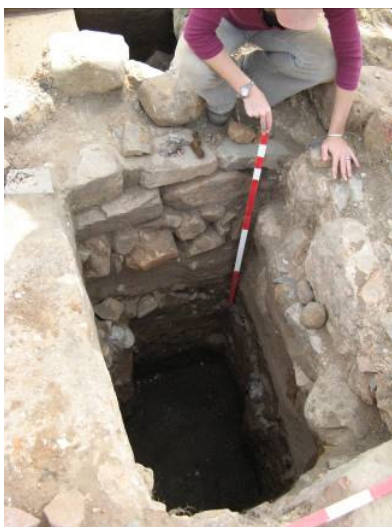
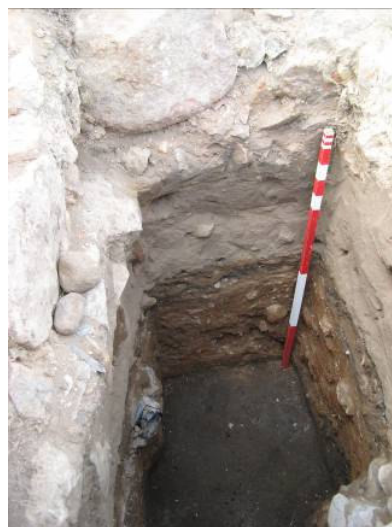
A red brick rubble layer, becoming increasingly less fragmented as the depth increased was situated between the ashy layers and the dark brown sandy layer at 1220mm below the surface. The volume of artefacts dropped off dramatically once the dark brown soil was reached, which only became sterile at 1350mm. The hole was dug another 100mm deeper.

Plate 8 and 9: Northern and southern sections of the test pit respectively. The dump continues to the east, the south and the west, but was not found in any of the test pits to the north of Wall 7.

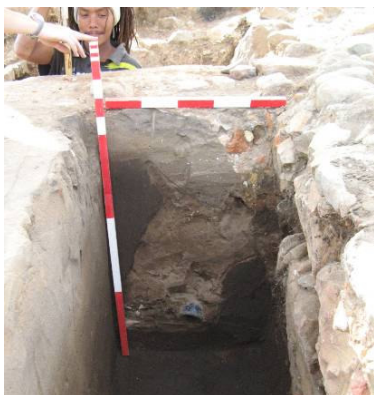
Plate 10: Eastern section of the test trench to locate the western most extent of the dump. In the section it is clear that a pit was dug into which the refuse was dumped.

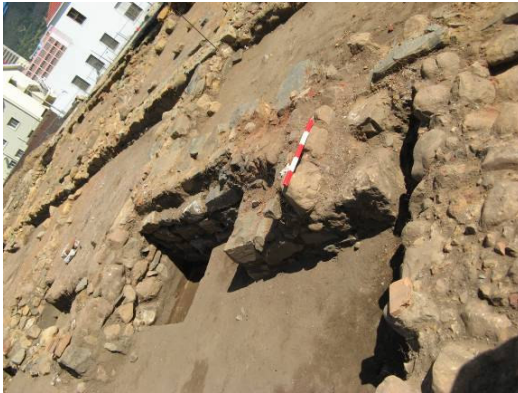
Plate 11: The step indicated by the arrow in Figure 8
Photograph taken facing north.
The 500mm measuring stick is lying on top of a later
19th century crosswall which aligns with the crosswall
bisecting the Stable (Plate 12)

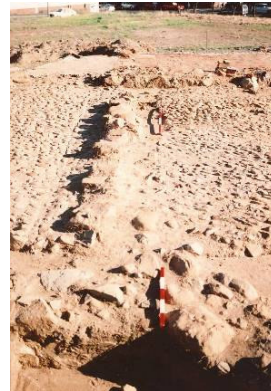
Plate 12: Crosswall bisecting
Stable area. October 2006.

The dividing wall shown in Plates 12 and 13 is visible on Figure 10 and dates to the end of the 19th century.

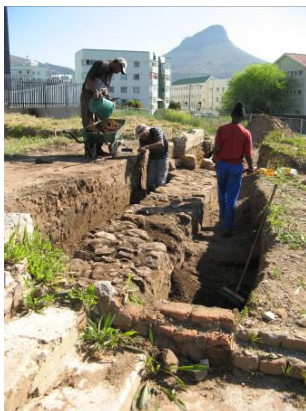
Plate 13: The cement stairway. Wall II of Stoep I visible in background.

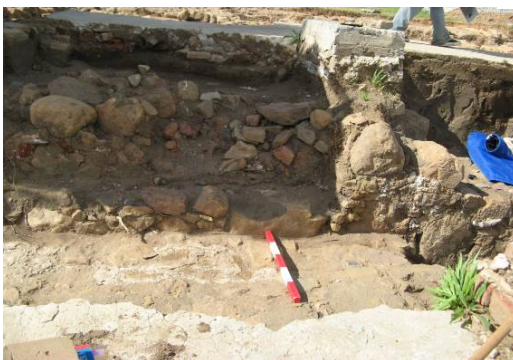
Plate 15: Plaster mark in the fill showing the position of the stair

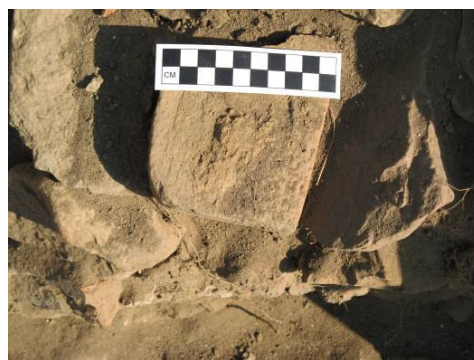
Plate 16: Detail of the edge tile.

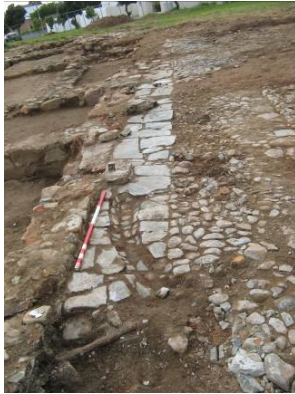
A slate walkway separates the house from the courtyard (Plate 17). A packed cobble drain is visible in a portion of the cobbled courtyard (Plate 18).

Plate 17: View of cobbled walkway between courtyard and house. Note the drain feature. Photo taken facing east.

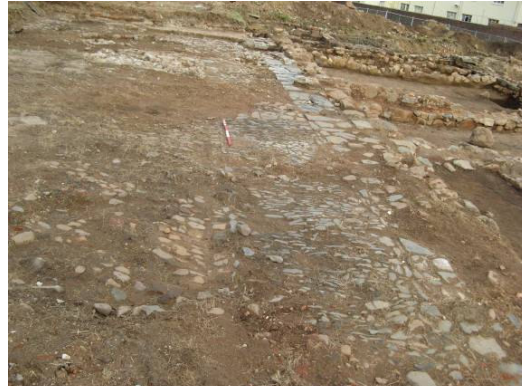
Plate 18: View over the courtyard. Remains of a cobble packed drain visible in foreground. Photo taken facing west.

The cobbled courtyard was damaged during the early 20th century when modern drainage and plumbing was put in.

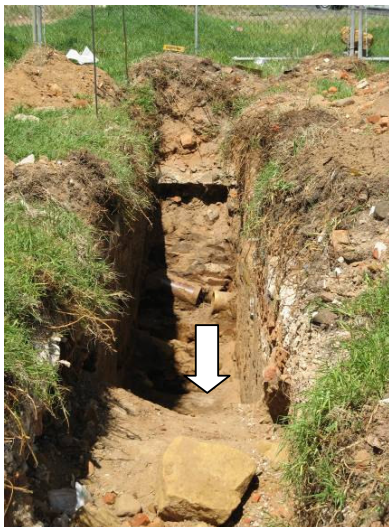
In this test trench, underneath the service pipes and about 2m below the present surface of the ground, evidence of a stream was found and it would appear as if this stream was used to dispose of household rubbish. Ceramics, bone, charcoal were found amongst the cobbles. It would also seem as if the raw material for building the original core, was taken from the stream.

Plate 19: Test Trench A: the arrow shows the position of the streambed.
