ARCHAEOLOGICAL IMPACT ASSESSMENT OF ERF 153692, LONGKLOOF STUDIOS PARKING AREA, CAPE TOWN

Project conducted under Section 38 (1) of the National Heritage Resources Act
in response to the recommendations of a desktop AIA forming part of a
Heritage Impact Assessment.

May 2006

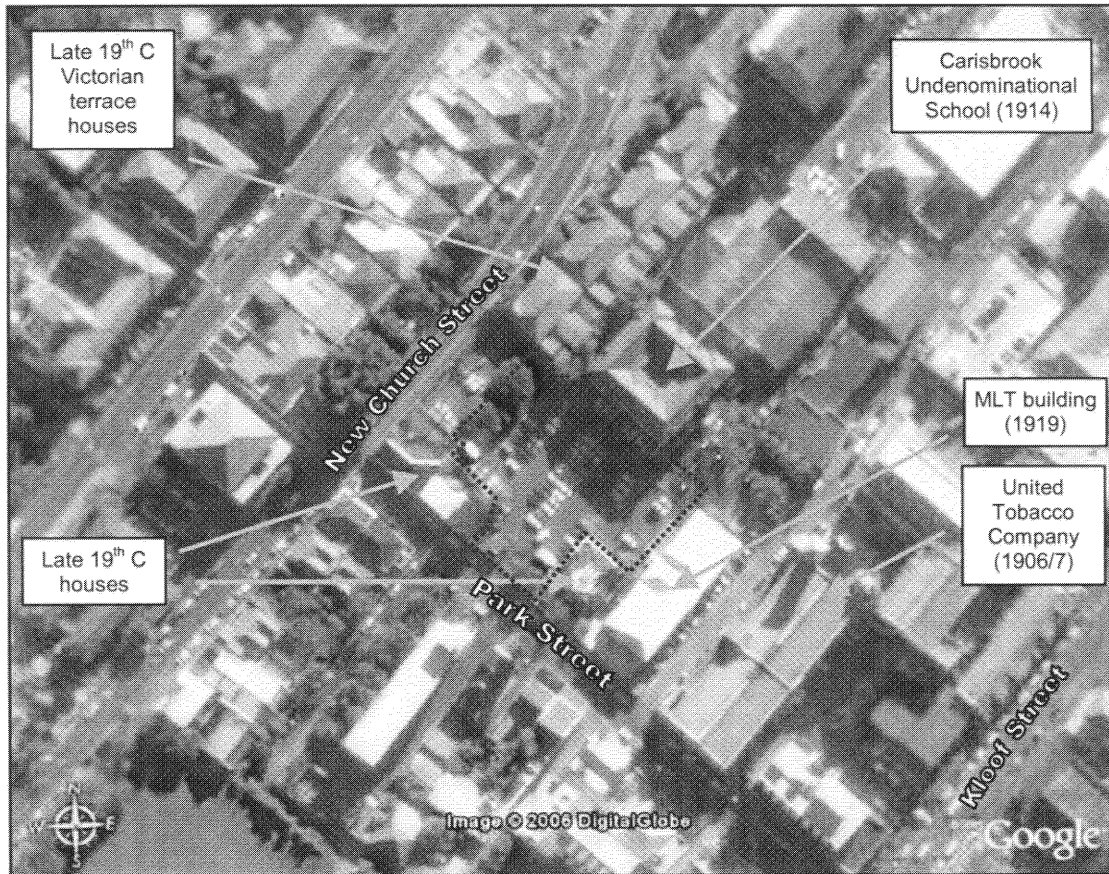
Figure 2: Aerial photograph of the site showing the surrounding structures and street names. Dotted red line indicates the site polygon.

At present the entire surface of the site is covered with tarmac and is in use as a car park (Plate 1). It is bounded by historical buildings on three sides with the fourth also being car park (Figure 2). The neighbouring buildings are all late 19th (houses) or early 20th century (industrial and educational). The most significant of these is probably the building currently housing the Varsity College which was designed by Herbert Baker's architectural firm and built in 1914 (Seemann 2005). The historical buildings surrounding the site are indicated in Figure 2.

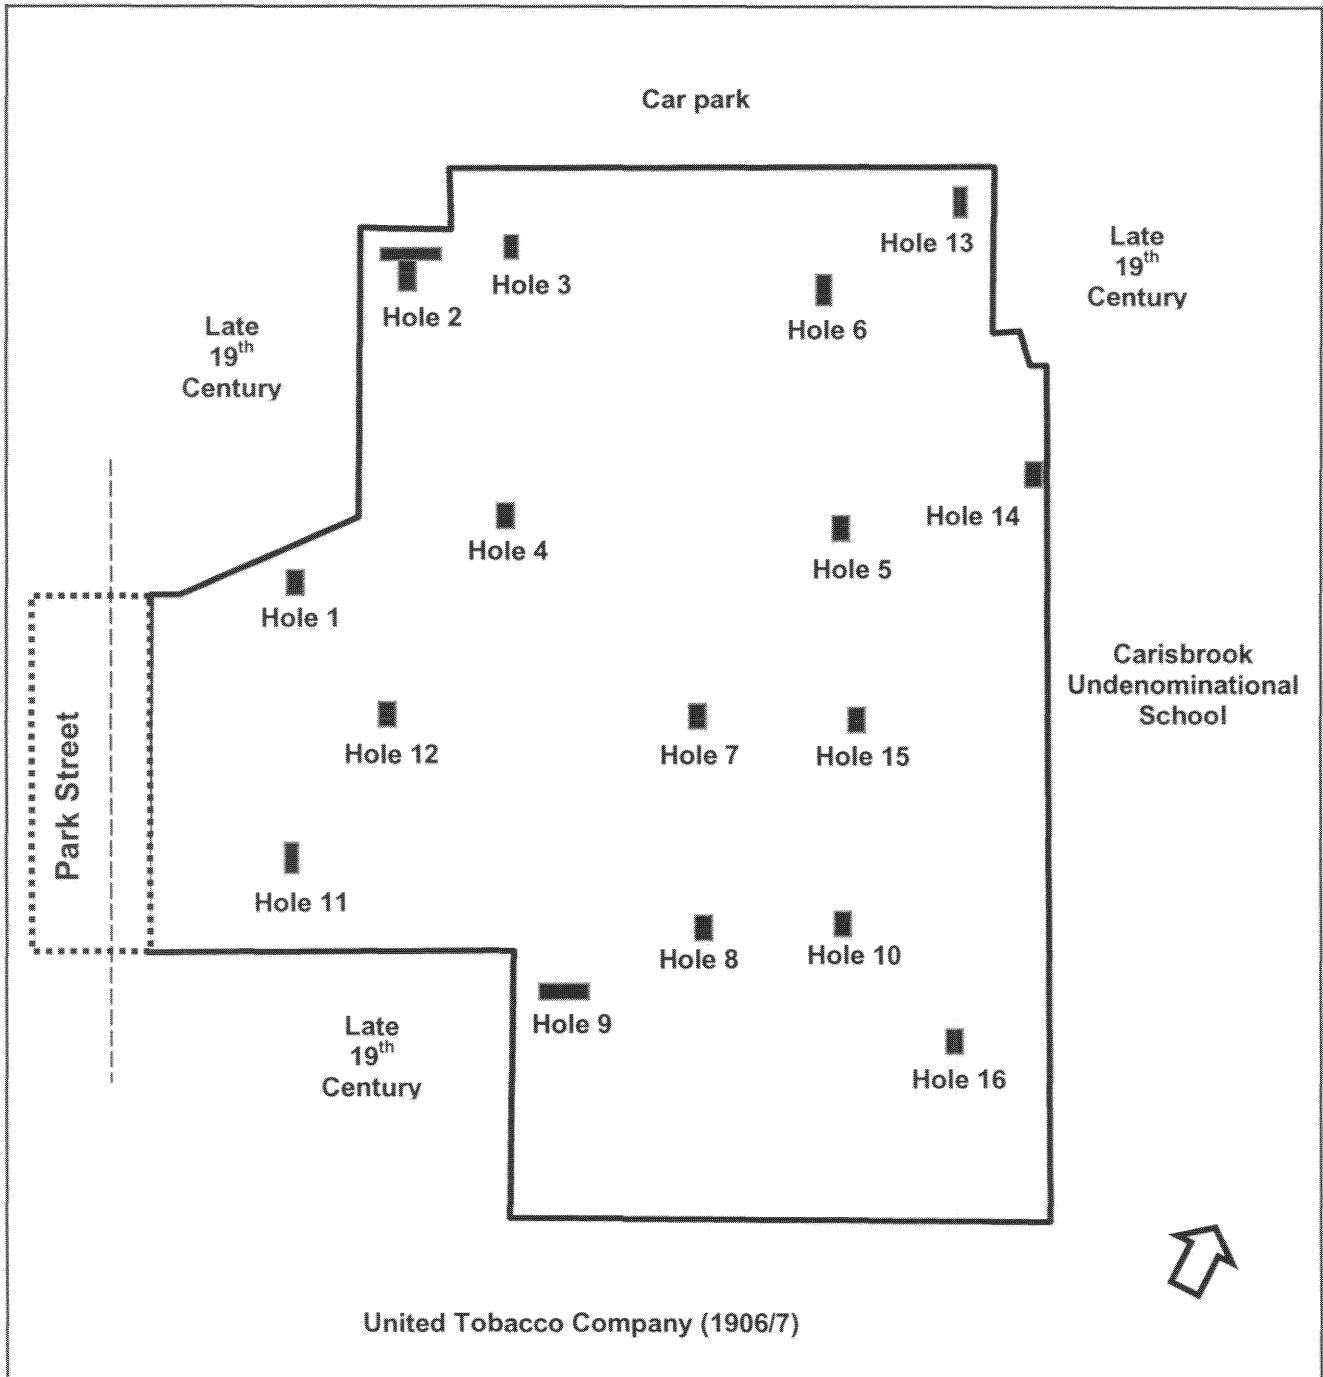
Figure 3: Plan of the site (traced from a survey diagram) with the approximate positions of the 16 test holes indicated. The surrounding buildings are also labelled. Note that the dotted line on the left side of the diagram indicates a small portion of the property that extends out into Park Street but this is unaffected by the development. The dashed line indicates the edge of the pavement.

Altogether 16 holes were excavated and I am satisfied with the degree of coverage attained. The approximate locations of these holes are shown on Figure 3.

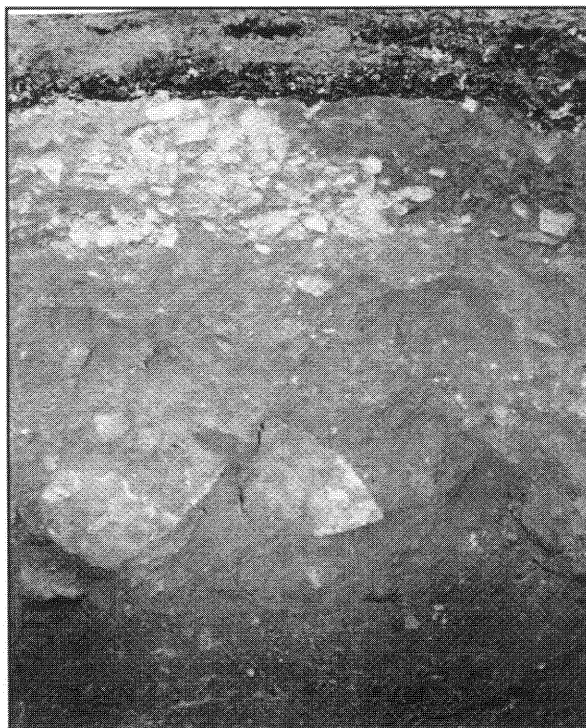
Stratigraphy: Tar / grey gravel (0-150 mm)
Mixed rubble, rocks & clay (150 – 750 mm)
Malmesbury shale (bedrock)

Comments: Disturbed right down to base. No archaeological interest.

Plate 2: Section of Hole 1 showing the tarmac, gravel sub-base and mixed rubble, rocks and clay.

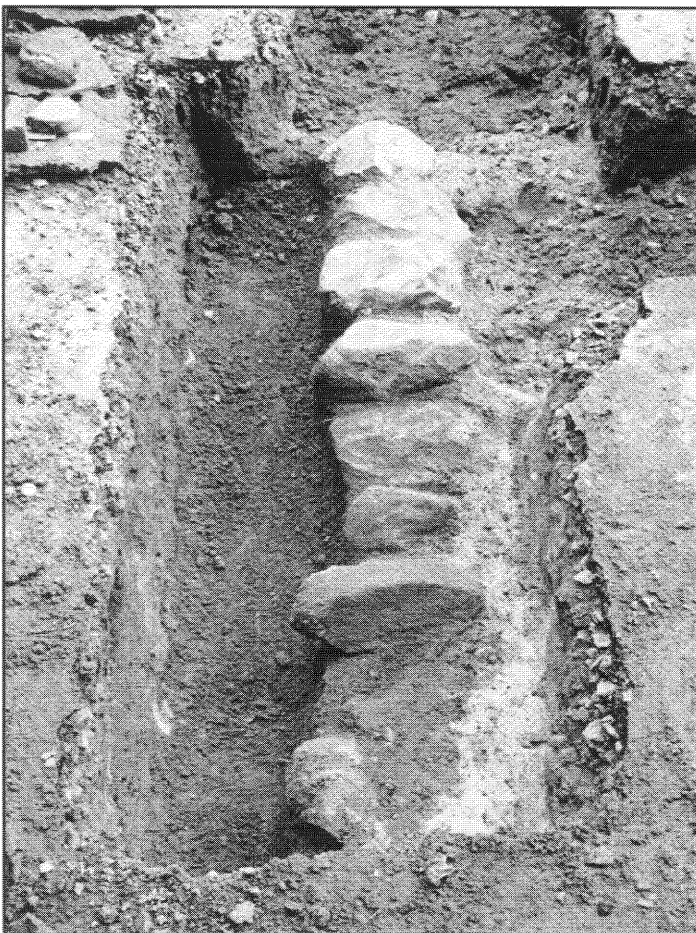
Finds: A single row of stones was present at the same level as the beige sand and that sand occurred only on the southeast side of these stones (Plates 3 & 4).

Comments: It is possible that a memorial of some sort was once located near this hole but aside from the brown ceramic tile which may have been related, no further evidence of this was found (besides the plaque). The plaque could also have originated elsewhere. An additional point to note is the presence of the historical wall to the northwest of the excavation. This wall appears somewhat unstable and has been strengthened recently by the addition of modern cement.

Plate 3: (left) The single row of stones found just below the surface in Hole 2. The beige sand occurring on the southeast (downslope) side of this alignment can be seen both here and in Plate 4.

Plate 4: (right) Hole 2 during the early stages of excavation. The stone alignment can be seen in the centre and a historical wall bordering the property of one of the late 19th century houses can be seen at the top. This wall has been strengthened with modern cement.

1. Further traces of a memorial may be evident in the vicinity of Hole 2;
2. It may be possible to ascertain further contextual information with regards to the floor surfaces found in Holes 9 and 15;
3. The location of further features in the vicinity of Hole 11 may help identify the origin of the possible post-hole found there;
4. The examination of any further artefactual material and building fabric uncovered during earthworks may help to refine the ages of the buildings represented by the rubble; and
5. Any remaining features associated with the river (marked by the gravel in Hole 2) may be revealed by a larger excavation.

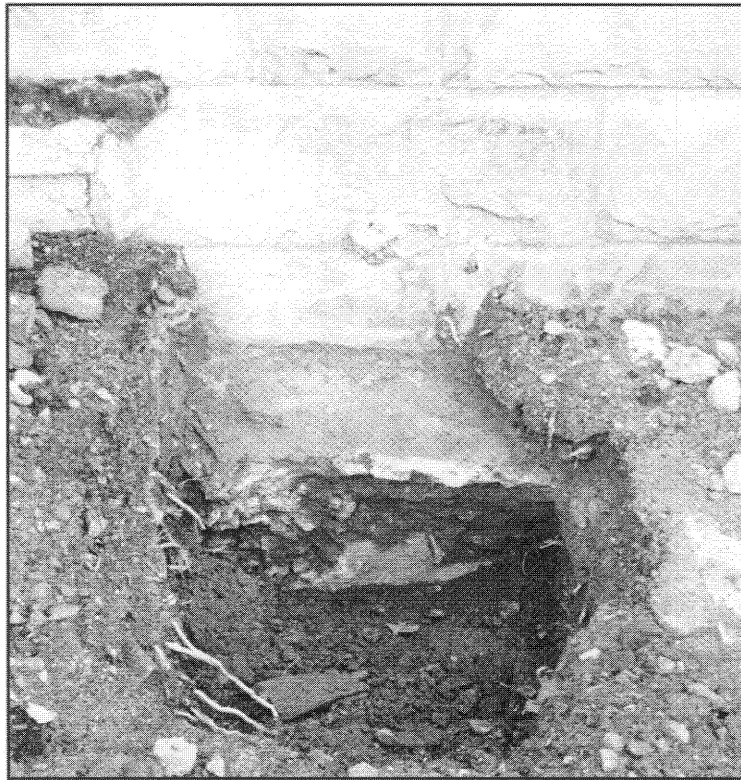
Comments: The building is constructed on top of a concrete foundation. The lip extending out from the base of the stones is 280 mm wide and the size and shape of the underlying concrete appears to be quite variable. The concrete continues down below the excavated depth of 0.65 m.

Plate 16: The concrete foundation at the foot of the wall of the Varsity College Building.
