# AN ARCHAEOLOGICAL INVESTIGATION OF THE VALKENBURG CEMETERY AND BURIAL VAULT

Prepared for

**University of Cape Town**

July 1995

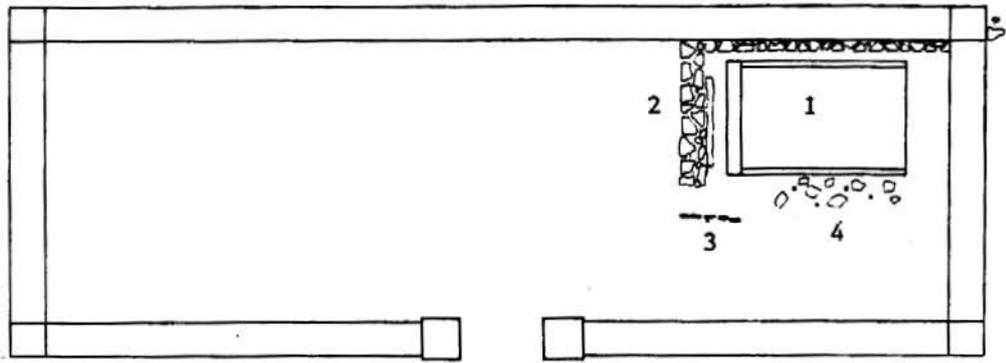
**1**

Excavations in the immediate vicinity of the vault showed evidence of a previous structure (Figure 1, Figure 2). This took the form of partial stone foundations directly in front of the vault (Plate 1). This continued along the east side of the structure almost directly under the cemetery wall. The western and southern sides of the foundation are missing. Fragments of lime plaster and loose stone in the surrounding deposit suggest that it had existed here but has been removed. There is a large slate step/slab on the inside of the north side of the foundation indicating that there may have been an entrance/exit to the structure on this side.

1. Vault
2. Stone foundation in front of vault
3. Alignment of shell lime plaster
4. Stone and plaster indicating demolished wall
5. Cemetery wall

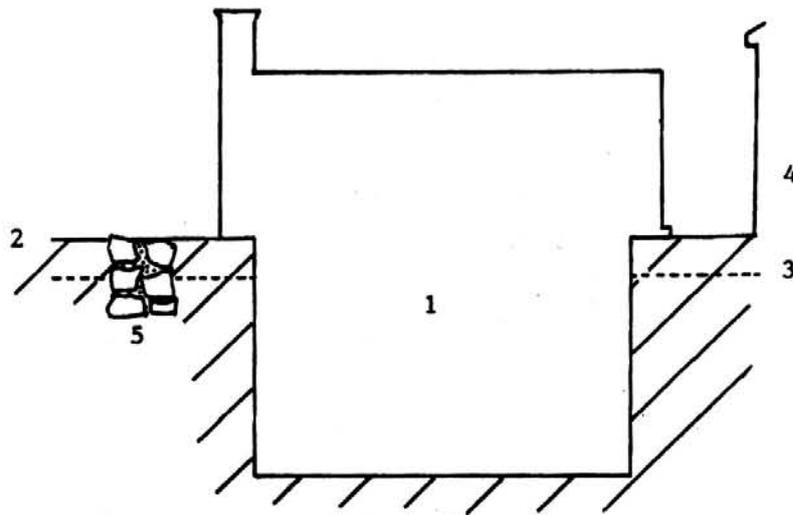
**2**

1. Vault interior
2. Present land surface
3. Earlier land surface
4. Cemetery wall
5. Earlier foundation

The base of the foundations clearly relates to an earlier lower land surface and predates the cemetery wall.

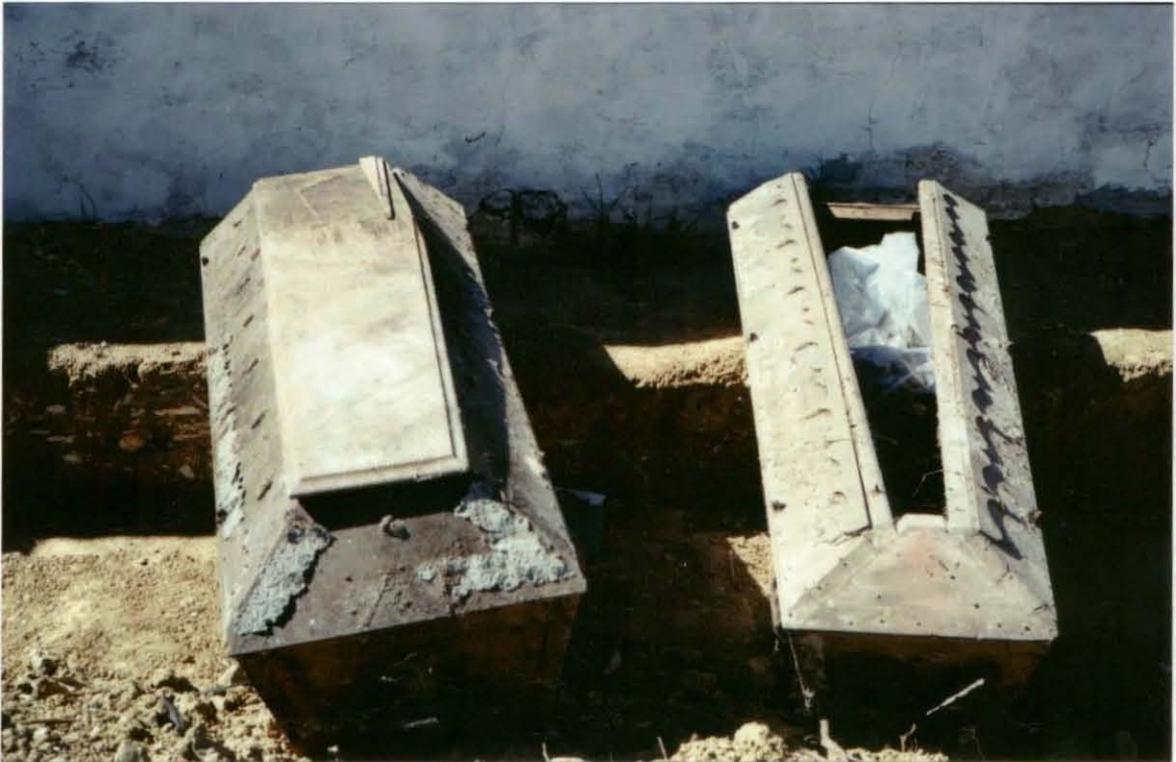
2

The two semi-complete coffins (Plate 2) were removed from the vault. The excavators were then able to climb into the vault and remove the fragments of coffins in the bottom. These were then re-articulated as far as possible for photographic recording and to determine the minimum number of coffins. The periodic flooding of the interior had resulted in the coffins floating and eventually coming apart. The human remains then settled in an untidy pile in the bottom of the vault along with other organic particles, nails, metal items (handles) and saturated sawdust. The resulting wet organic sludge had to be excavated by hand, then sieved so that smaller items and bones could be retrieved. All skeletal and artefactual material was stored on the premises in the unoccupied "Edwardian House" nearby.

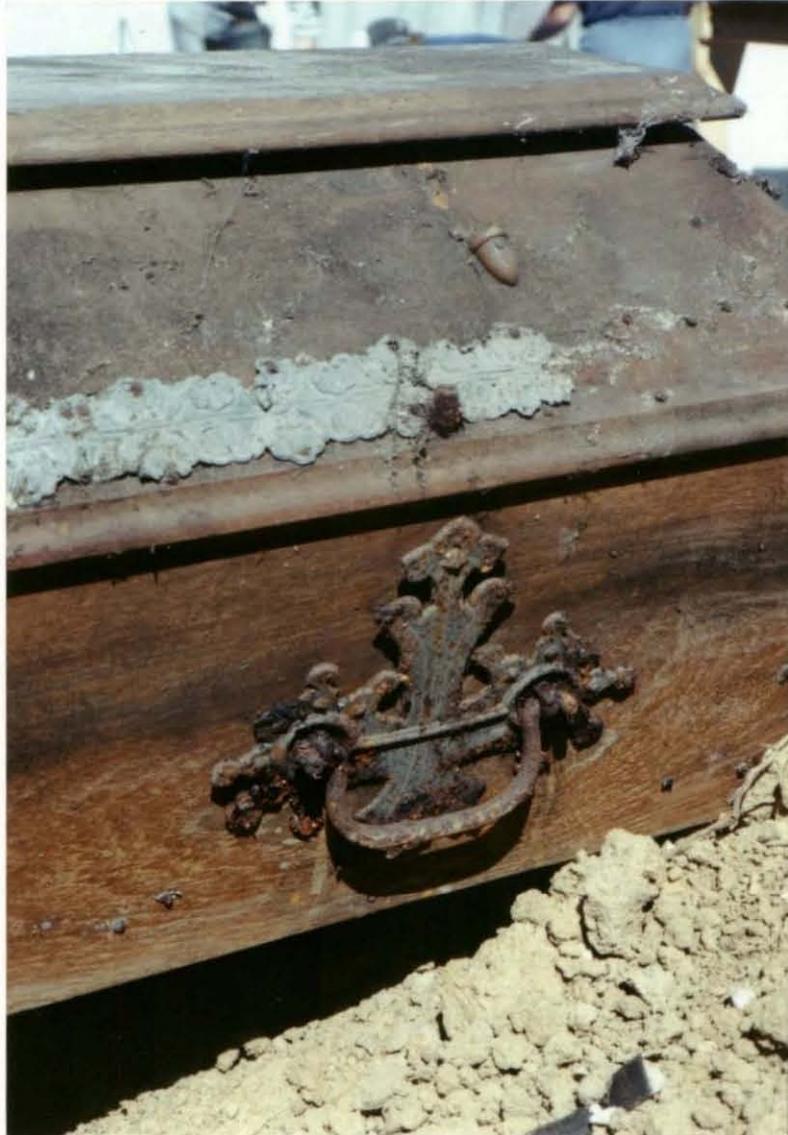
4

In all, the remains of six coffins and six adult individuals were removed. One coffin containing the remains of individual "C" is complete but missing a lid. It is trapezium-shaped, with elaborate wood and metal decoration. Both sides of the lid were decorated with a line of wooden acorns linked to ornamental panelling (Plate 3). The presence of many of these items in the deposit in the vault suggests that this was a fairly standard decoration. The areas around the handles (3 on each side and 1 on each end) had been decorated with thin metal plate (foil) which may have been gilded (Plate 4). Very little of this was still adhering to the coffin. The body had been placed in the coffin on a layer of sawdust (4 buckets full) - the purpose of this is unknown but probably to absorb body fluids. The sawdust had become compacted and matted which meant that it had to be scraped out and broken up to locate the smaller bones. There was no evidence of any grave goods apart from some fragments of shroud, brass pins and two silk bows. Some of the bones had fragments of desiccated tissue adhering. The identifiable remains of the other coffins are similar in form apart from one extraordinary large oak coffin that probably had to be custom made for an extremely obese individual (Plate 5).
