REPORT ON AN ARCHAEOLOGICAL INVESTIGATION

OF THE VARSCHEDRIFT FARMSTEAD

ERVEN 26126 & 27661

MUNICIPALITY OF CAPE TOWN

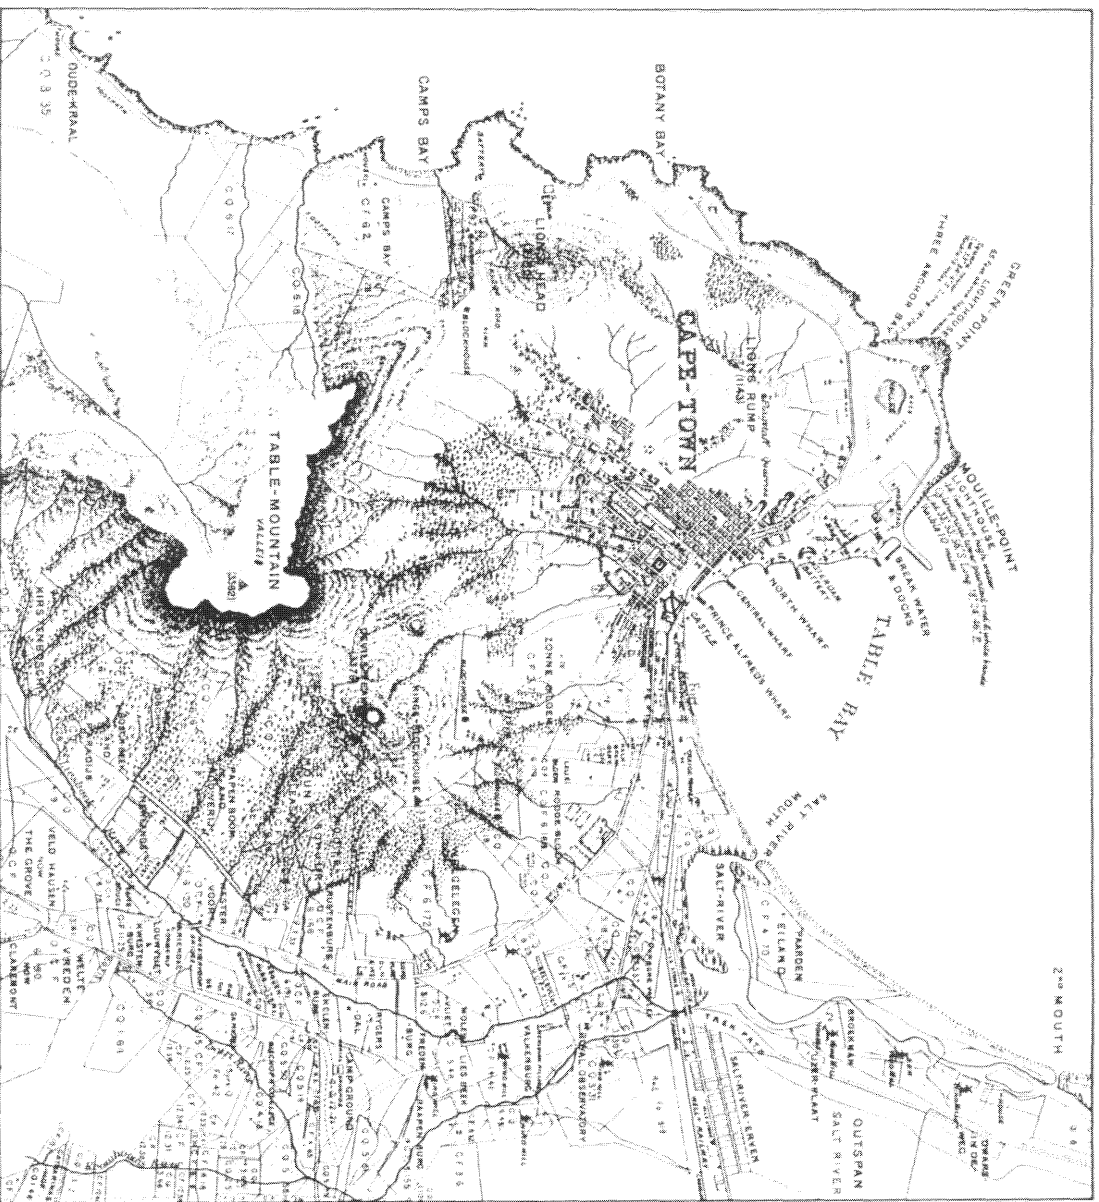
Fig. 1. Map of Cape Town, 1863, showing the windmills and locations mentioned in the following text (Reference: Waltons, James. 1974. *Water-Mills, Windmills and Horse Mills of South Africa*. Cape Town: C Struik, p 145).

A map of Cape Town, dated to 1863, highlighting the windmills and locations along the Liesbeeck and Black Rivers mentioned in the following text is shown in Figure 1 on the next page.

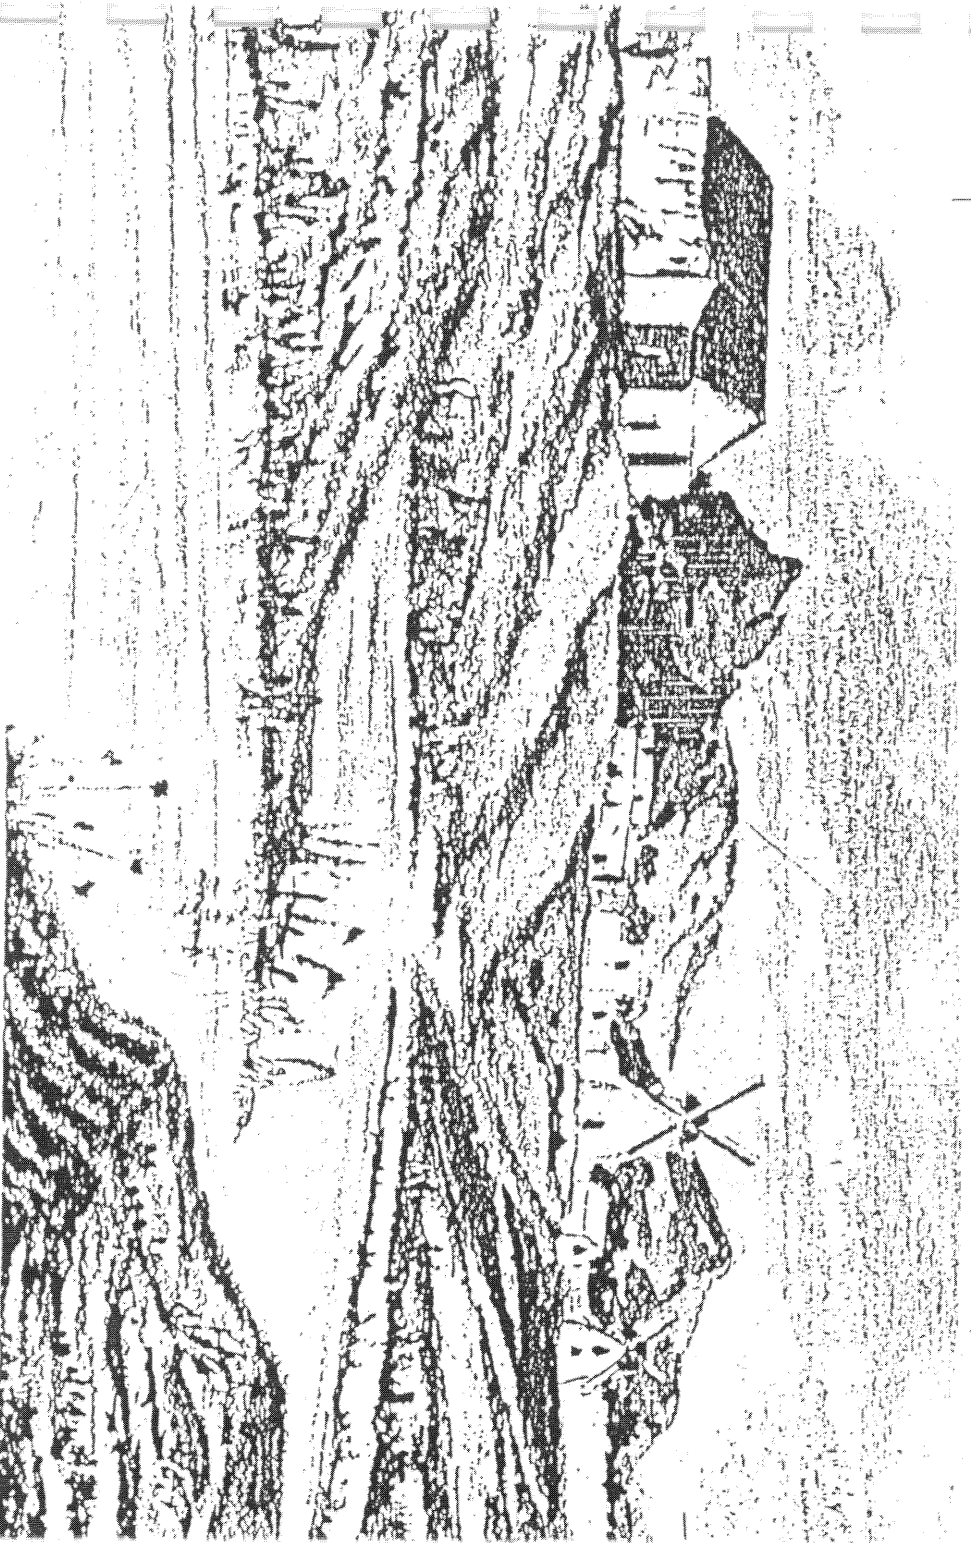
Fig. 8. The Salt River Windmills, 1844-45, illustrating the built environment of the Liesbeeck River settlements. By JC Pootermans. (Reference: Todeschini & Japha, op cit; illustration A4)

The Cape flats seem to have been a favourite hunting ground. Some farming took place, wagonloads were conveyed, drawn by a span of trek-oxen. A closer view of the farm buildings along the northern end of the Liesbeeck River is given in Figure 8¹². Pootermans' painting clearly shows the characteristic built environment of the area: whitewashed walls and thatched roofs of dwelling, barns and lean-to's arranged in linear form.

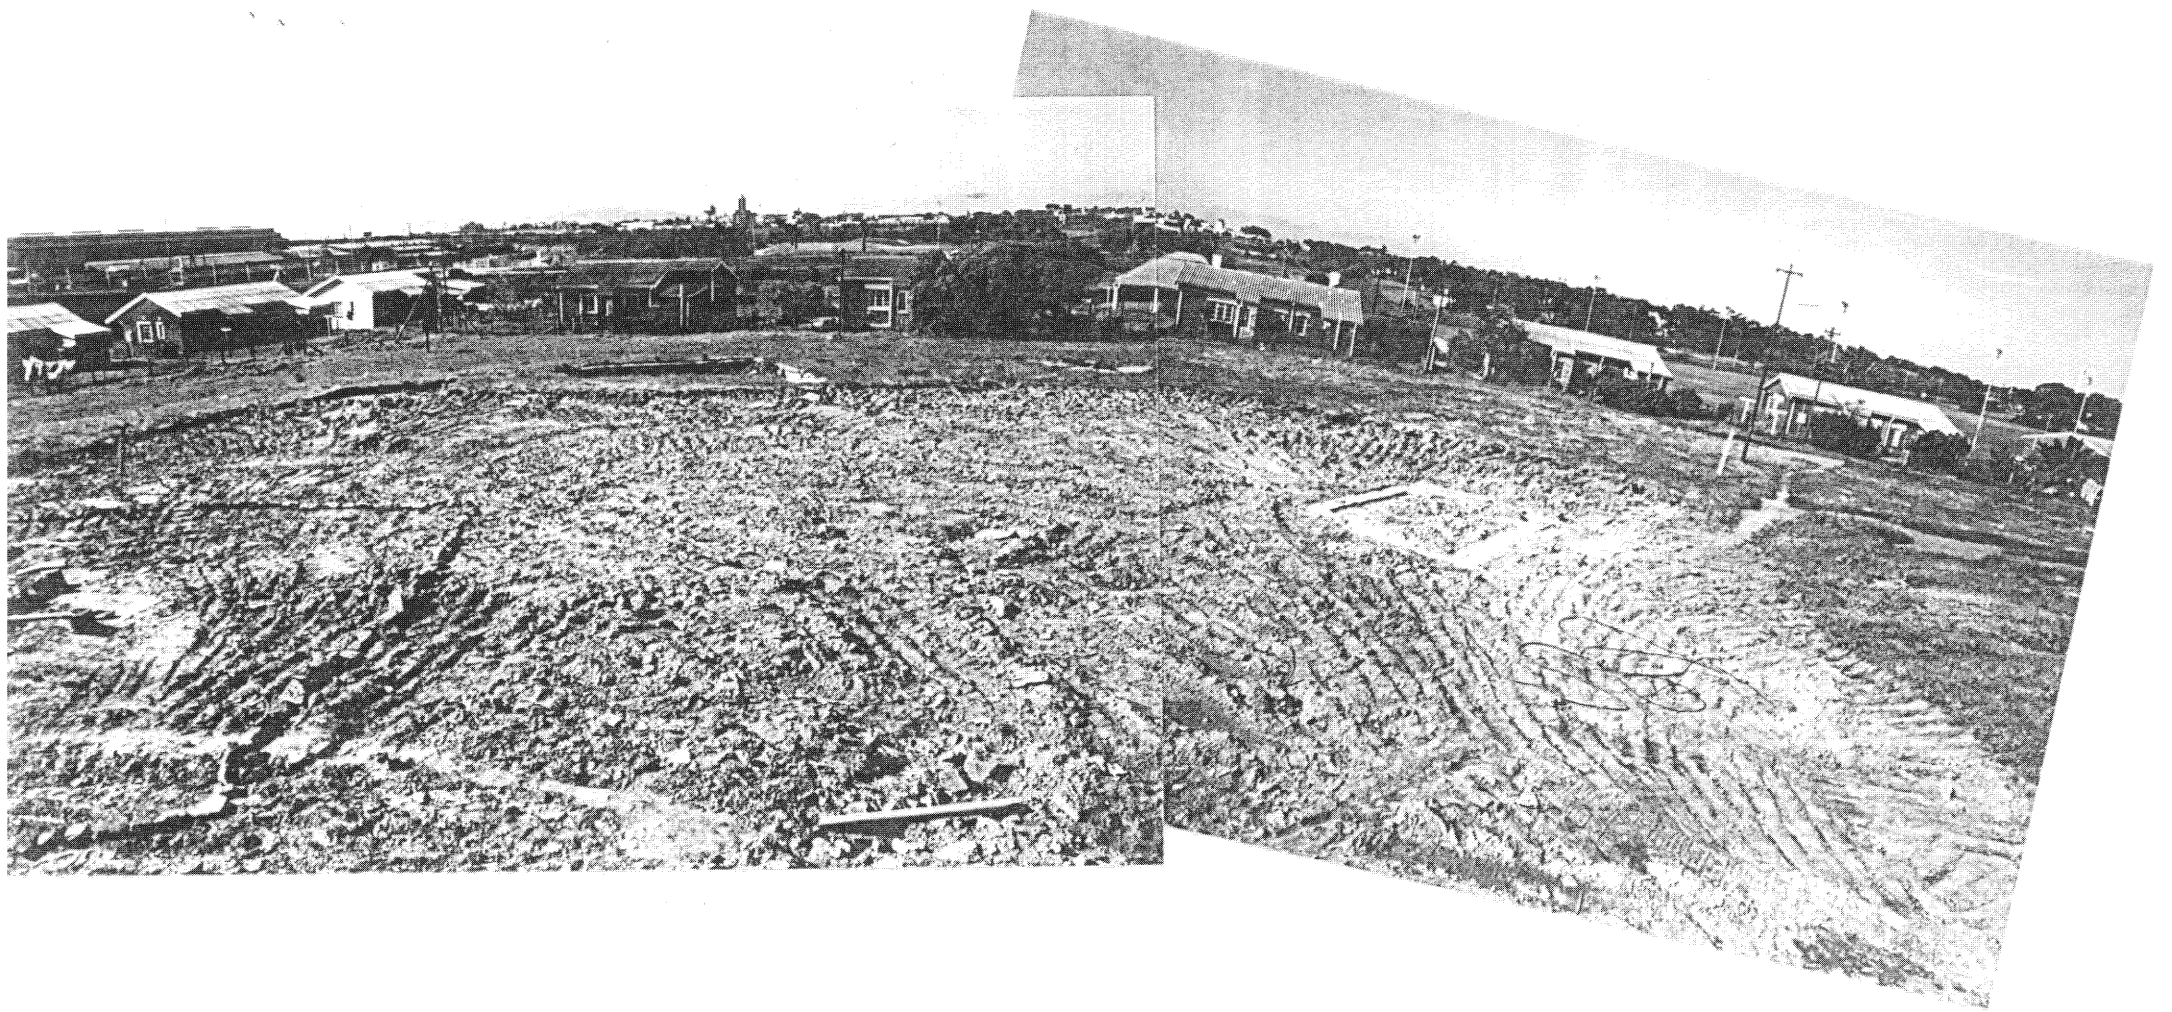
Prior to the commencement of the archaeological investigation, the concrete floors on the mount were lifted and removed by an excavator (Fig. 11). The surface vegetation over the remainder of the area likely to contain archaeological material was scraped off to a depth of about 100-300 mm. Remains of a concrete/cement floor and wall footings of two early twentieth century buildings with sewerage disposal facilities were found underneath (marked in Fig. 12 as 'concrete floor' and 'ablution facility' respectively), and identified as matching one of the pre-fabricated buildings in the 1944 aerial photograph¹⁸. An iron pole set in concrete near recent cement steps on the north side of the mount was retained as datum point and a grid established over the site.

The exposed area on the mount was heavily disturbed by twentieth century building activity and previously demolished building fabric used as infill. Pockets of beachsand, cement, stone slabs, red and orange hard fired brick fragments were encountered over the whole site, as were building materials manufactured from plastic, rubber, iron, metal alloys, asbestos and slate, rooftile fragments, electricity and telephone cables, broken sanitary ware.

Fig. 11. The Varschedrift site, concrete overburden removed, 2001.

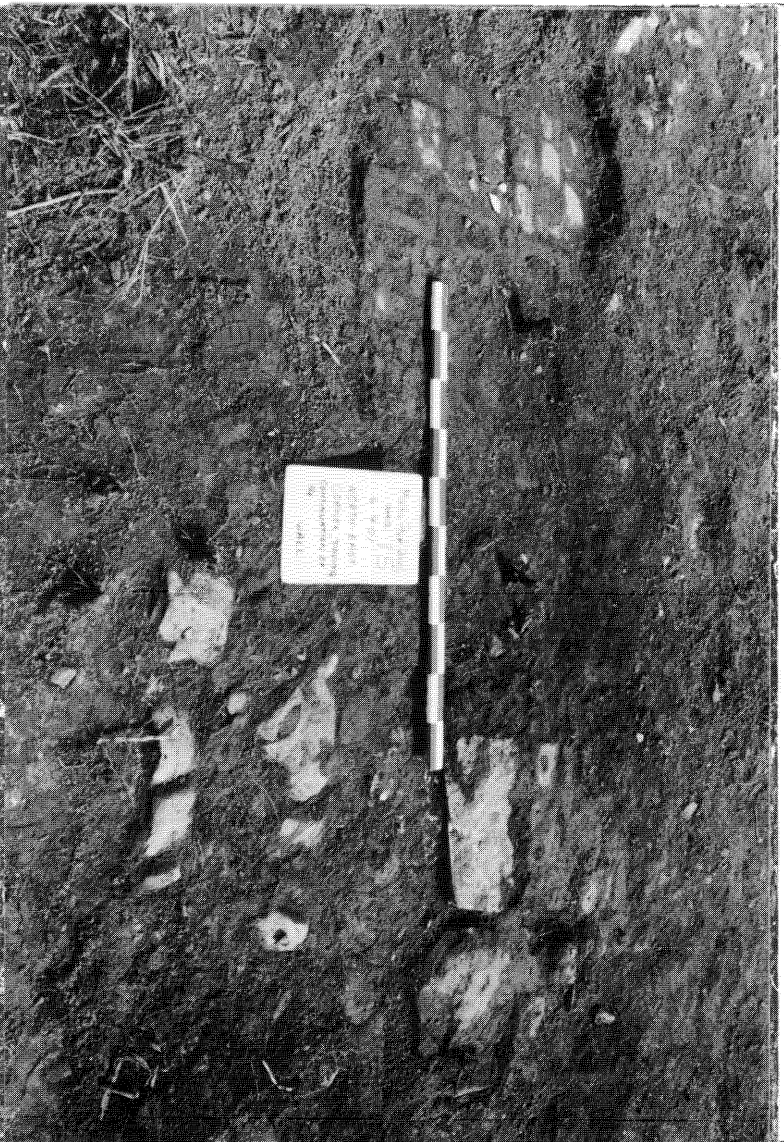
Fig. 21. Above: The south-east wall. Below: Paving in the south-east corner of the homestead, possibly second half of 19th century, photographed in 2001.

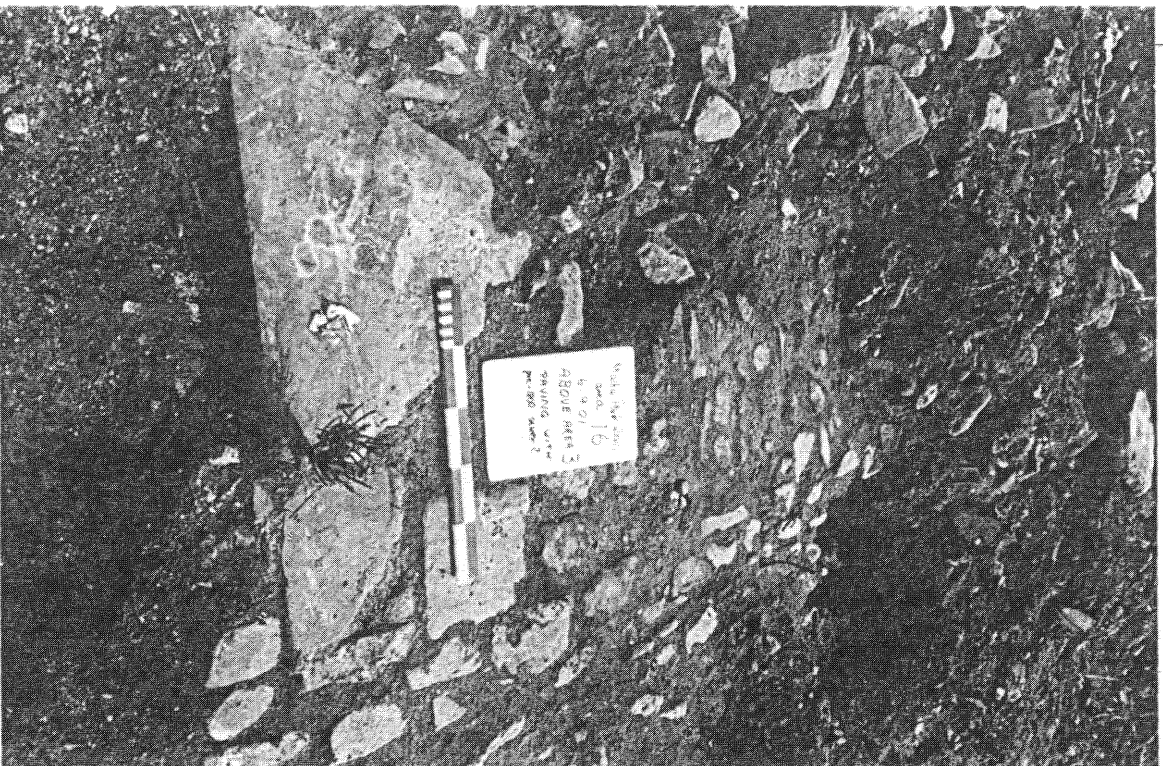
Cobbled areas were found in the southern and south-eastern half of the site after scraping off only a few centimetres of soil. They were usually about half to one square meters in size, possibly the remains of outside surfaces, interior cobbled surfaces of stable, outbuilding or shed, or in one case a drain (Fig. 22).

Fig. 22. Above. Cobbled area in the south-east of the mount. 2001.

Due to heavy disturbance of the southern and south-eastern area no further investigation was conducted.

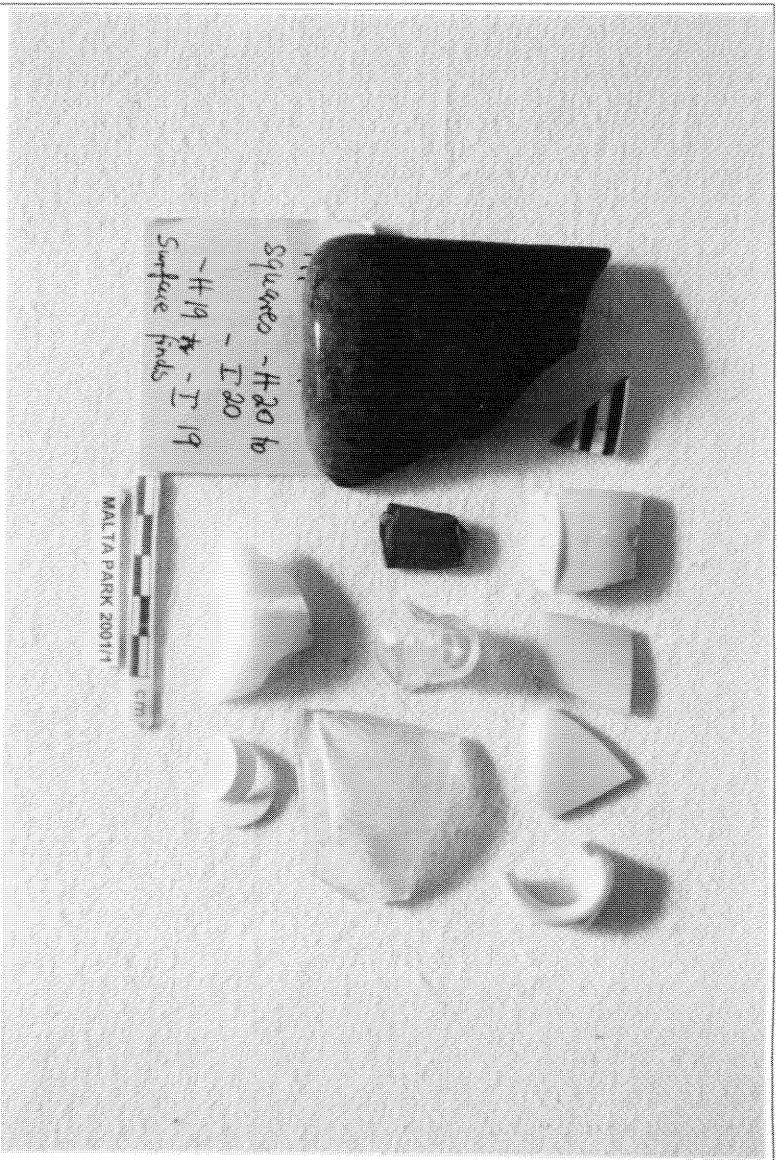
Fig. 34. A selection 19th and 20th century artefacts, on the left a British wine bottle base fragment, possibly late 18th century.

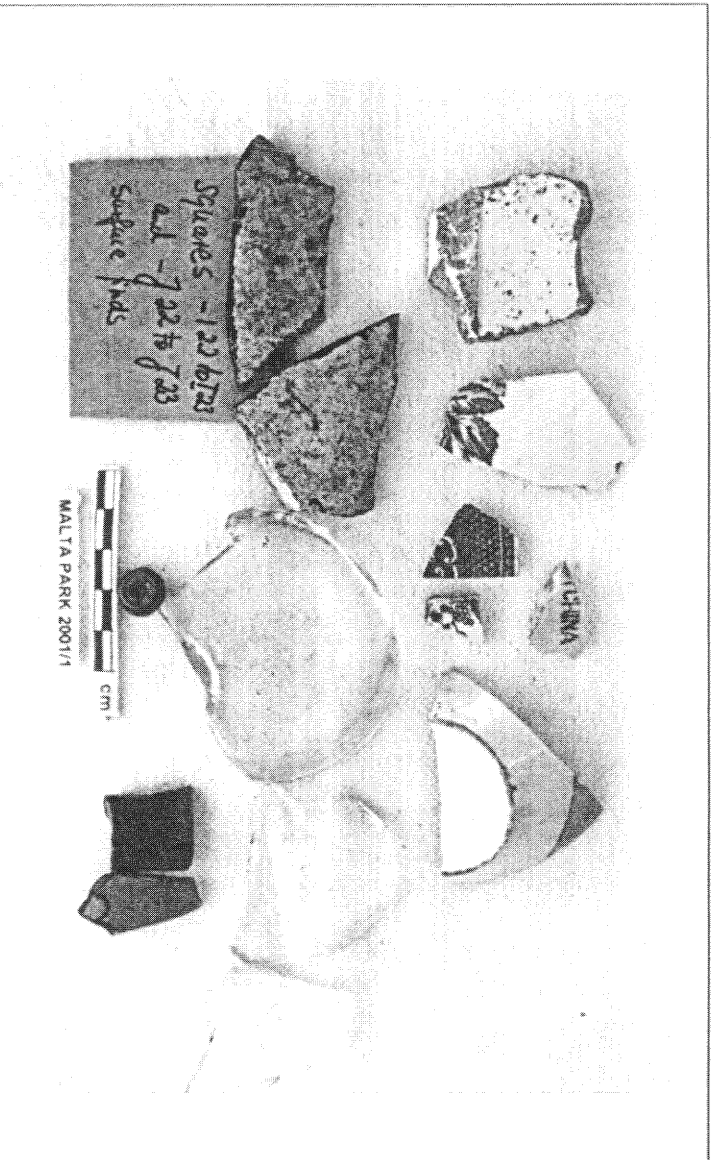
Fig. 35. Top: British ceramics, refined ware of the 19th century. Bottom left: wine bottle fragments, 18th century, bottom right: 19th / 20th century bottle glass.

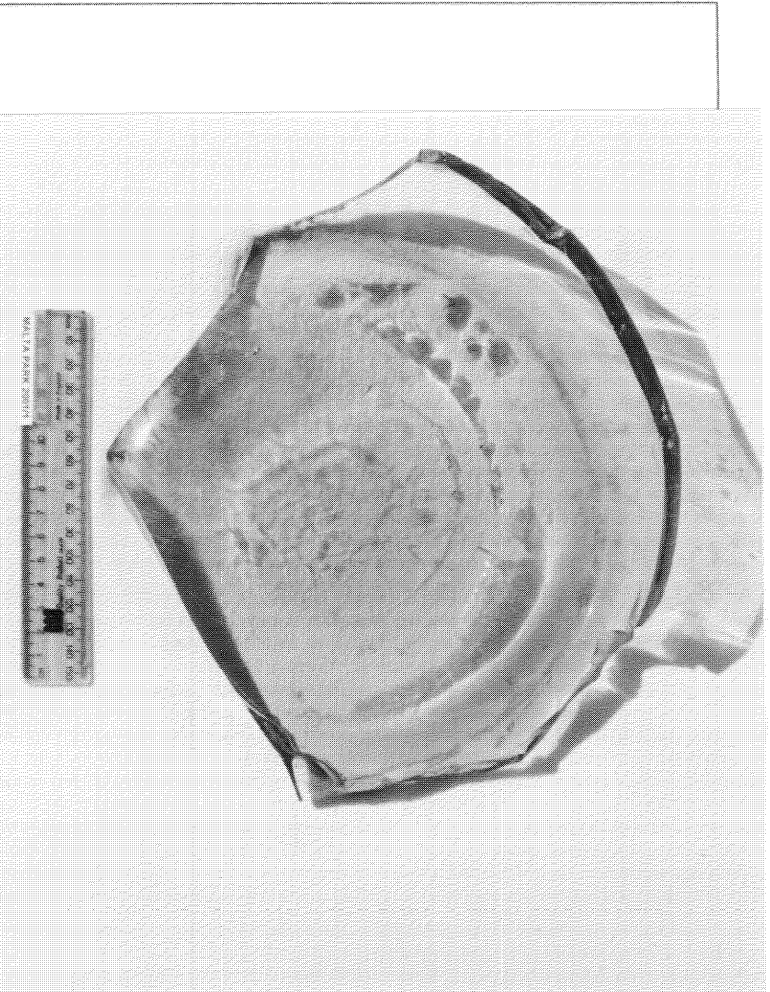
Fig. 40. A hand-blown base of an approx. 5 litre wine vat, used to be carried in a wicker basket, deep aqua green, pontil scar not finished, dated to the late 18th century.

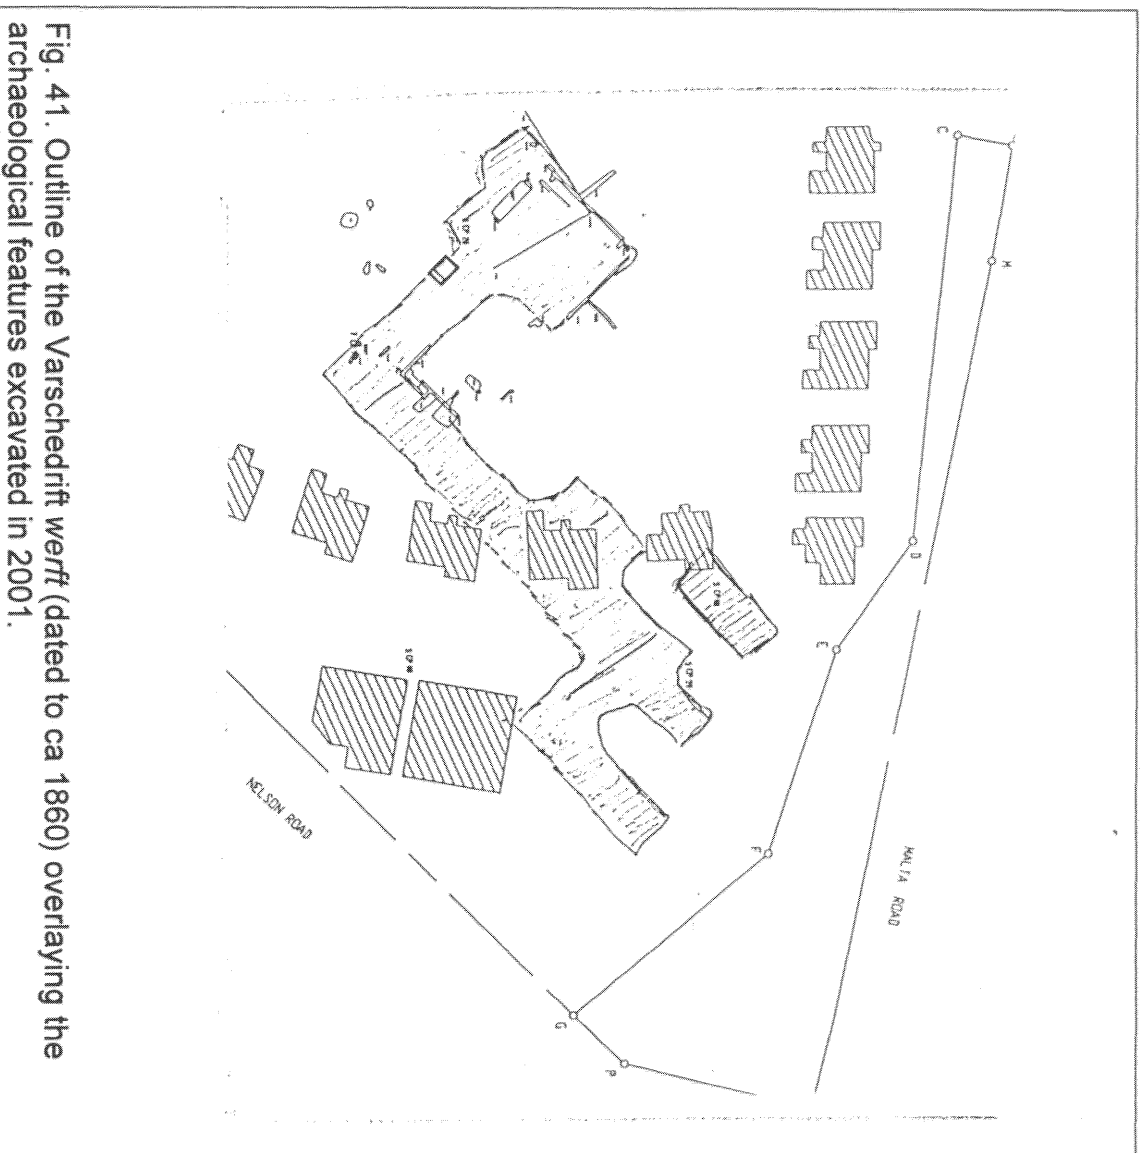
We were able to "fit" an outline of the north part of the *werft* complex, dating to 1814, within the remaining outline of existing perimeter walls (Fig. 41). The second 'arm' of the L-shaped farmstead complex depicted on Thibault's map of 1814 is represented by paved surfaces and stable or shed wall footage remains. Household rubbish was discarded frequently on the south side of the mount, or buried there in pits.

Fig. 41. Outline of the Varschedrift werft (dated to ca 1860) overlaying the archaeological features excavated in 2001.
